## Bridge 03374 Inspection Report

Asset #03374(Routine, Underwater type 2)

SH 130-06 LM 9.45 over Wildcat Ditch - Ark Co

Team Lead: Phillip Dowell Inspection Date: 04/15/2025

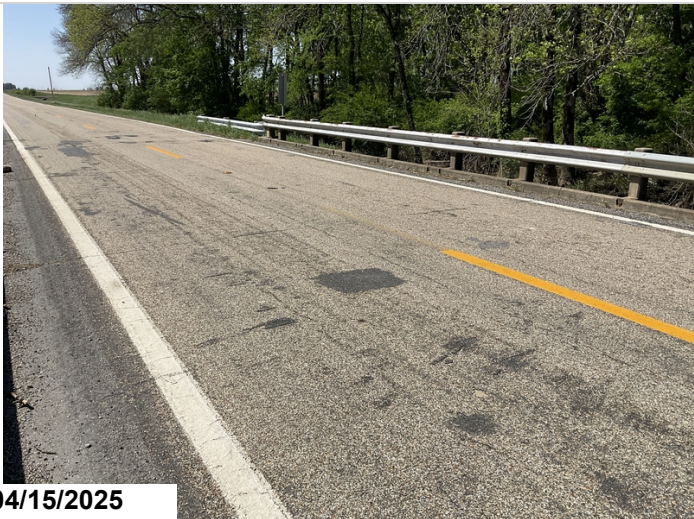
Deck is in very good condition with no notable problems.  
Wearing surface has some minor cracks.

Deck - Spans 1-3: Typical

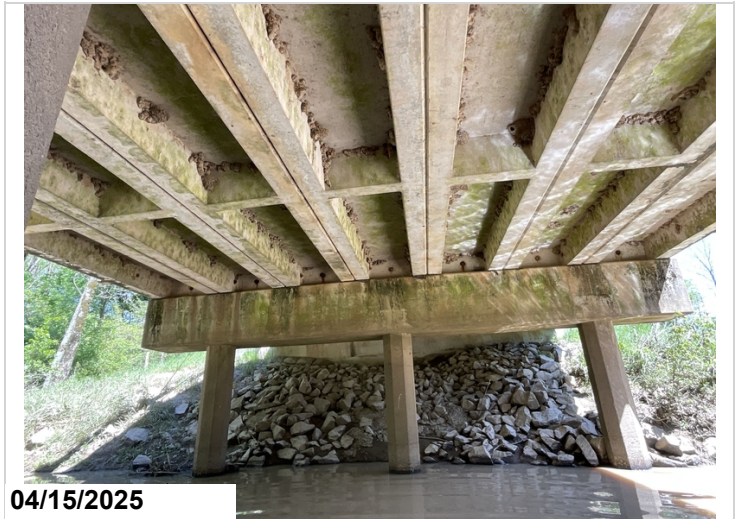
Superstructure is in good condition with a couple spalls/exposed rebar and one area of cracking.

Undersurface - Span 2: Typical

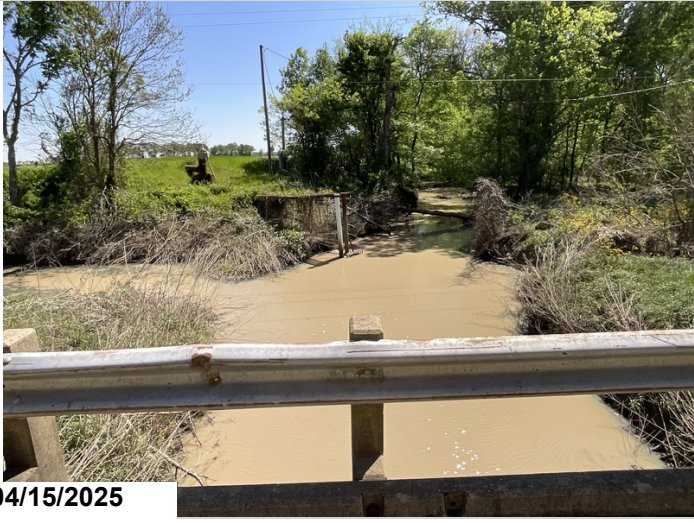
Channel is in very good condition with well-vegetated/protected banks and no notable problems.

Channel - Left side view

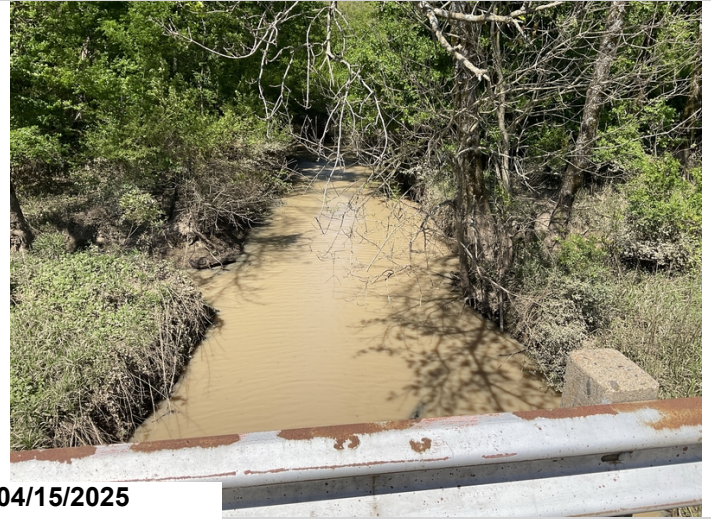
Channel - Right side view

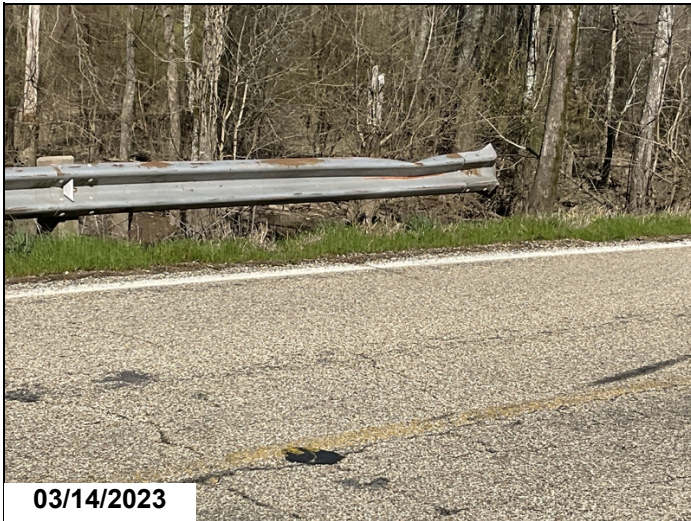
Bent 1 right: One missing post.

Bent 1 right approach railing has missing rail post.

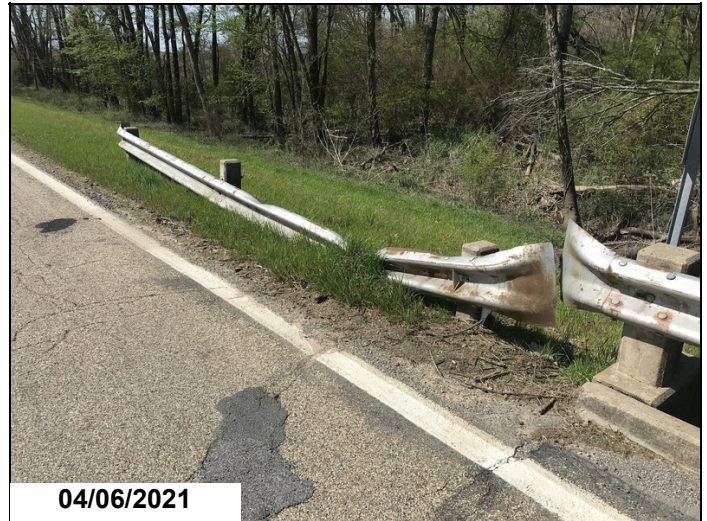
Bent 4 right: Damage from fallen tree.

Approach railing - Bent 4 right: Damage from fallen tree

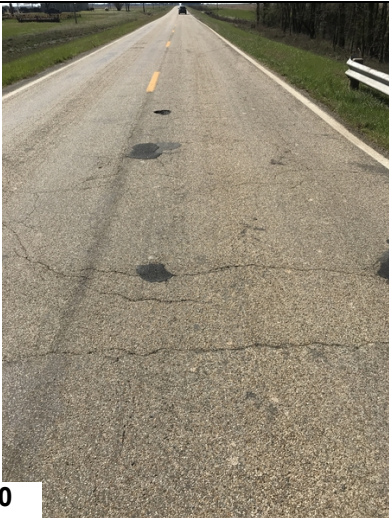
Approach roadway - Bents 1 & 4: Some deterioration and cracking of asphalt wearing surface - with minor settlement - resulting in several small potholes and a slight bump right at bridge ends.

Approach roadway - Bent 4: Settlement and pot hole

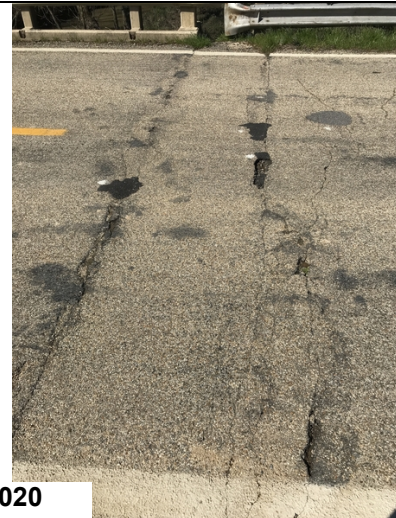
Approach roadway - Bent 1 : Pot hole and settlement

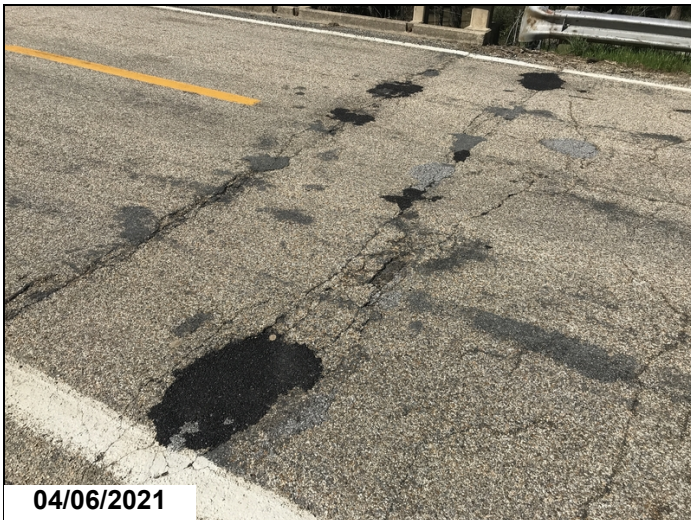
Approach roadway - Bent 1: Deterioration/settlement

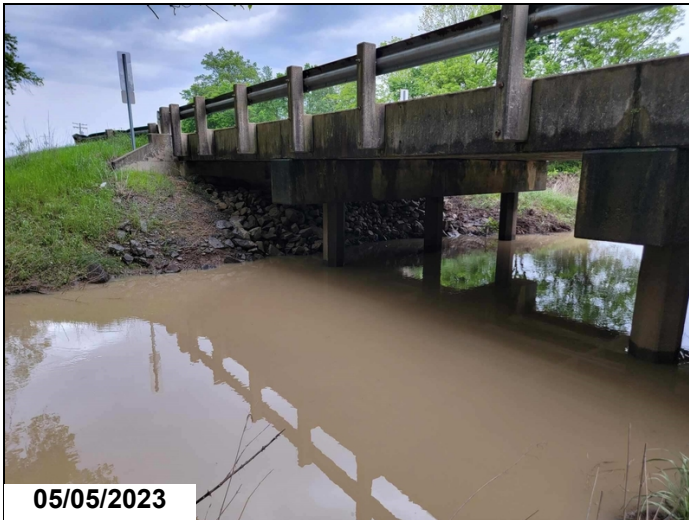
**CORRECTED -**  
picture of the area cleared

05-03-2023: Vegetation cut/cleared.

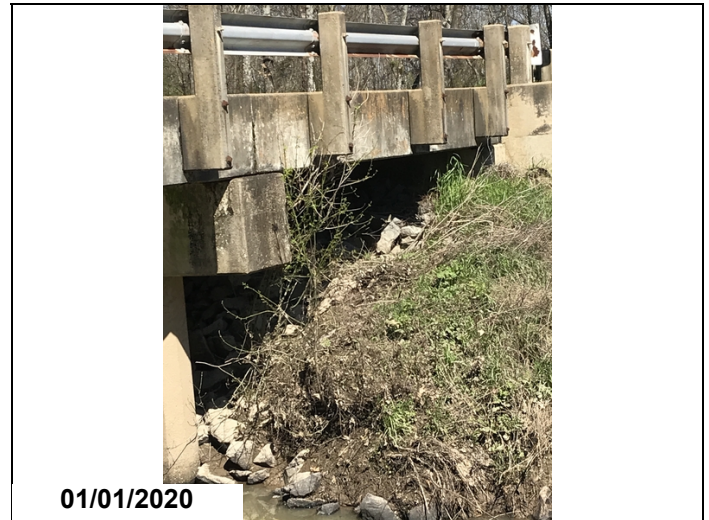
End-slopes - Bents 1 & 3 left: A couple small trees/bushes growing up right along edge or under bridge.

End-slope - Bent 1 : Vegetation

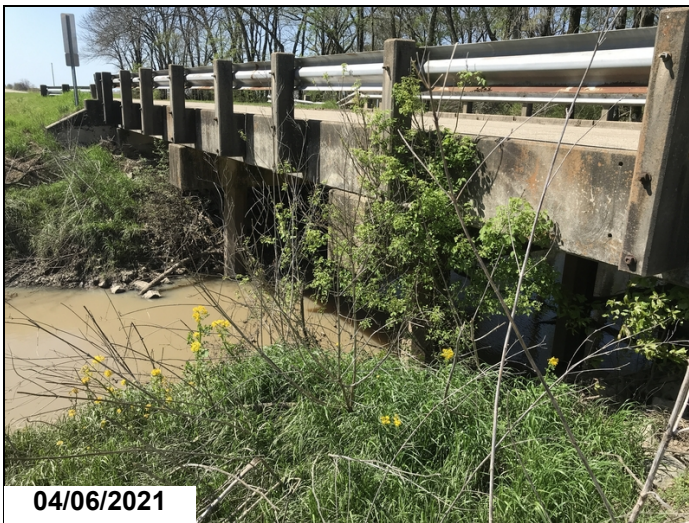
End-slopes - left side: Vegetation
