## Bridge 03377 Inspection Report

| IDENTIFICATION | |
|---|---|
| (6) Features Intersected | Little Lagrue Bayou |
| (7) Facility Carried | SH 130-06 LM 22.38 |

**Asset #03377** (Routine, Underwater type 2)  
**SH 130-06 LM 22.38 over Little Lagrue Bayou**  
**Location: 2.93 Mi N SH 1B-DeWitt - Arkansas County**  
**Team Lead: Phillip Dowell Inspection Date: 08/07/2025**

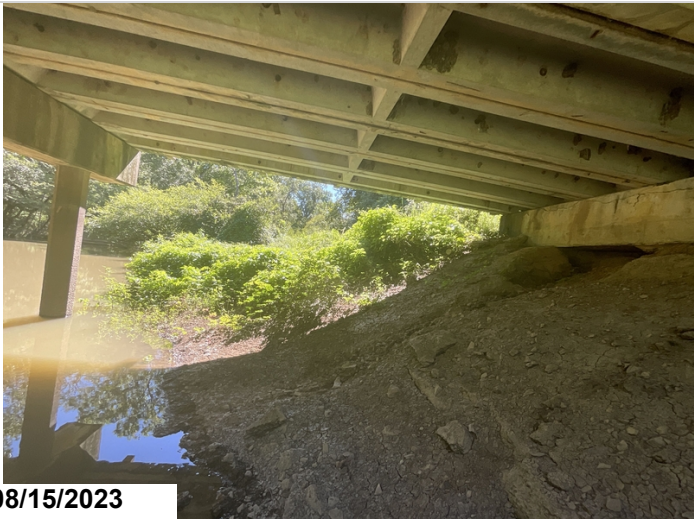
End-slope - Bent 5 left: Trees, vines and vegetation

Trees, vines, and vegetation on all end slopes needing removal.

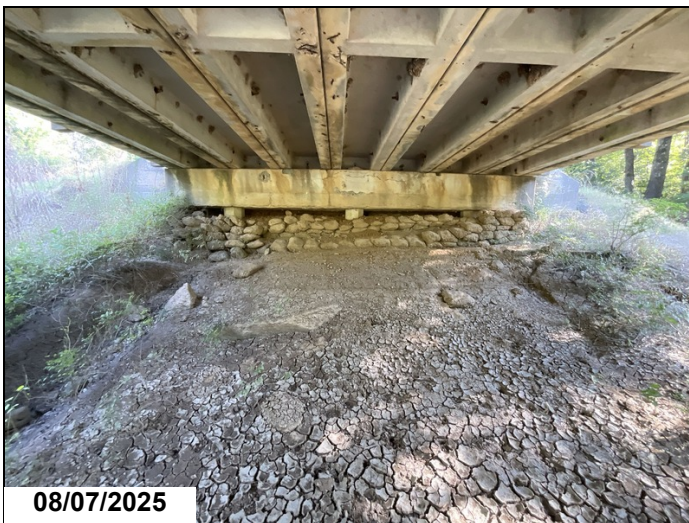
End-slope - Bent 1: Some settlement of embankment - full-width/depth with bottom of abutment cap and piling exposed.  
NOTE: Some bag concrete has been placed in past to protect slope.

End-slope - Bent 1: Erosion/settlement

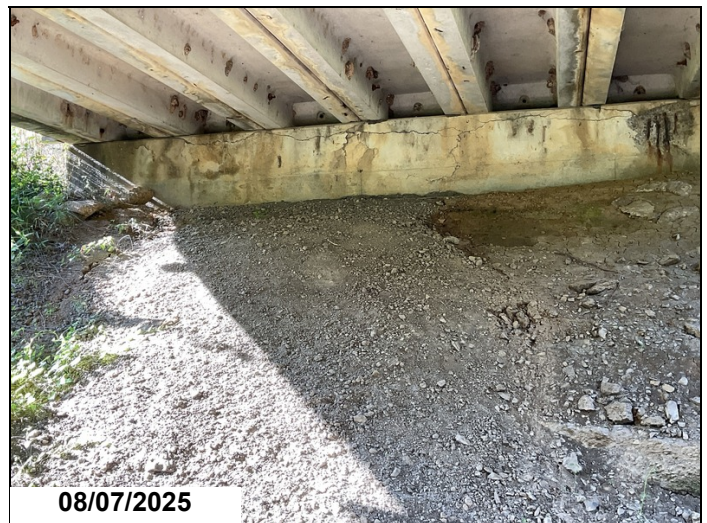
Ebd-slope - Bent 5: Material has been added to mitigate erosion previous to 2025 inspection.

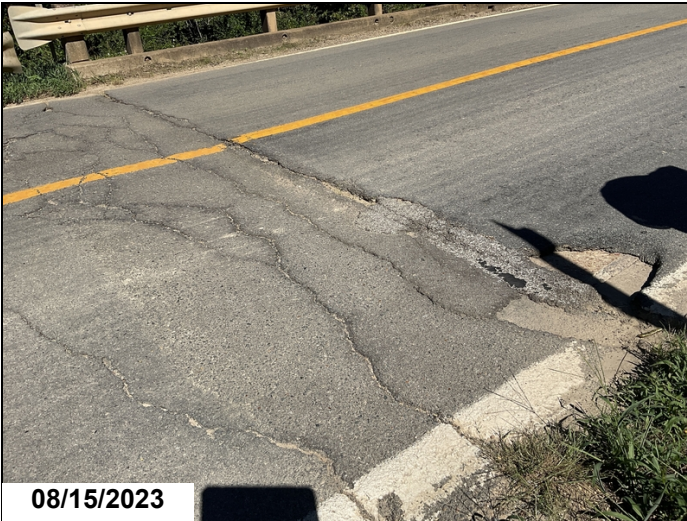
Bent 5 approach roadway has settlement with heavy spalling.

NOTE: End-slope - Bent 5: Material has been added to mitigate erosion previous to 2025 inspection.

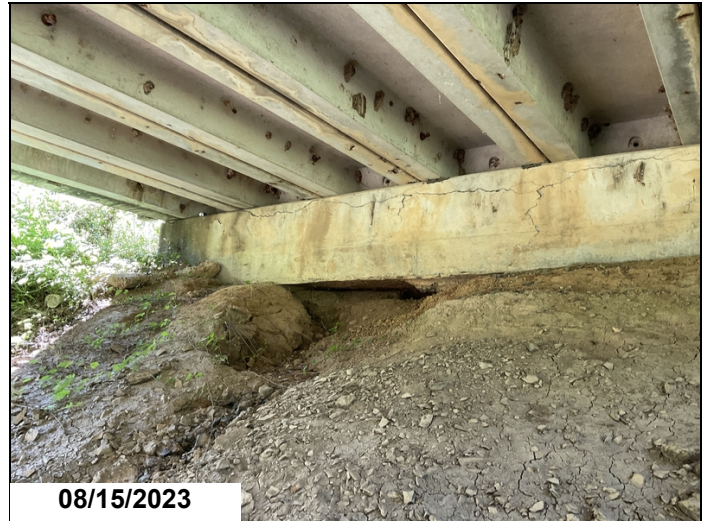
Bent 5 abutment has erosion under cap towards road bed.

NOTE: End-slope - Bent 5: Material has been added to mitigate erosion previous to 2025 inspection.

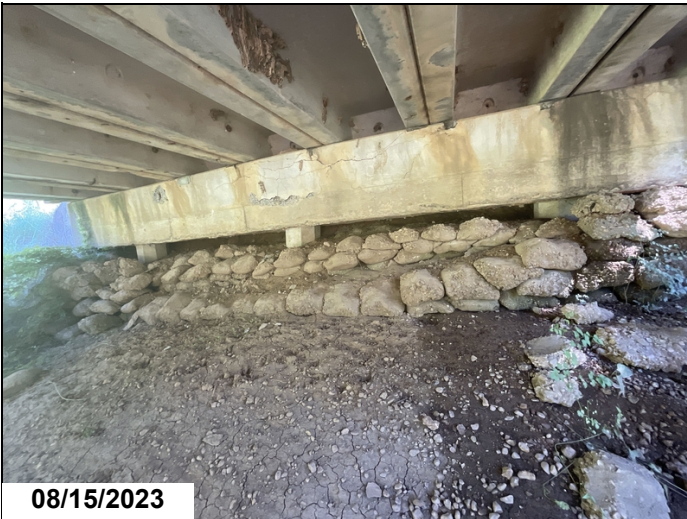
Bent 1 abutment with erosion under cap.

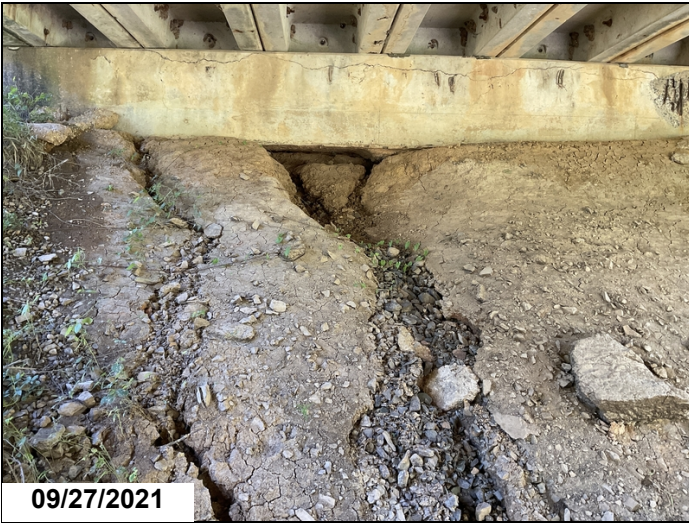
End-slope - Bent 5: Erosion

NOTE: End-slope - Bent 5: Material has been added to mitigate erosion previous to 2025 inspection.

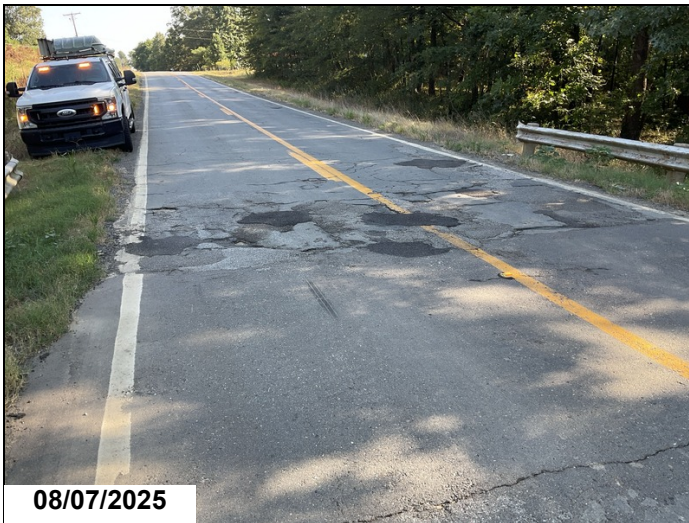
Approach roadway - Bents 1 & 5: Heavy deterioration/cracking/spalling (potholes).

Approach roadway - Bent 1:  
Deterioration/cracking/potholes

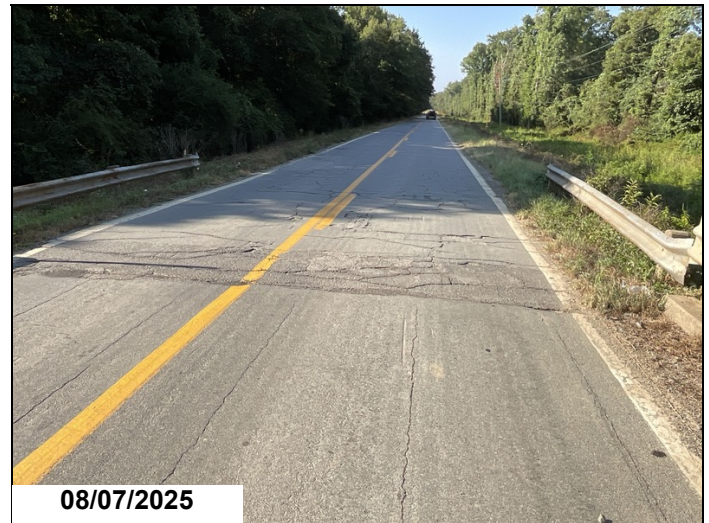
Approach roadway - Bent 5:  
Deterioration/cracking/potholes

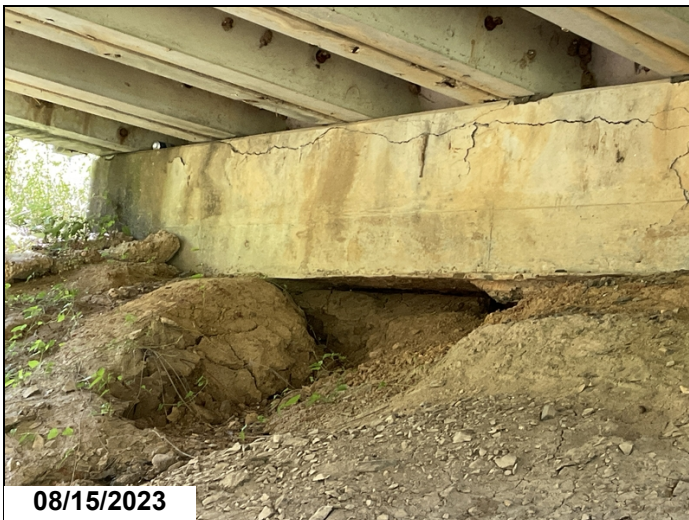
Bent 5 erosion under cap due to drainage from cracked and spalled approach roadway.

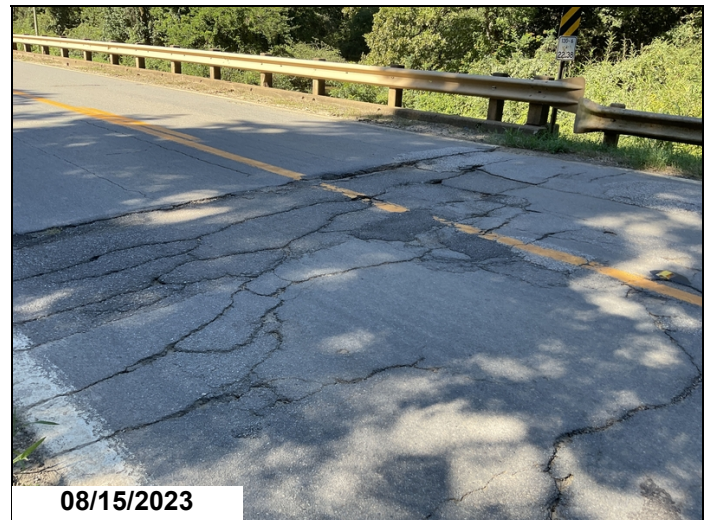
Approach wearing surface has heavy spalling and settlement causing impact to bridge.

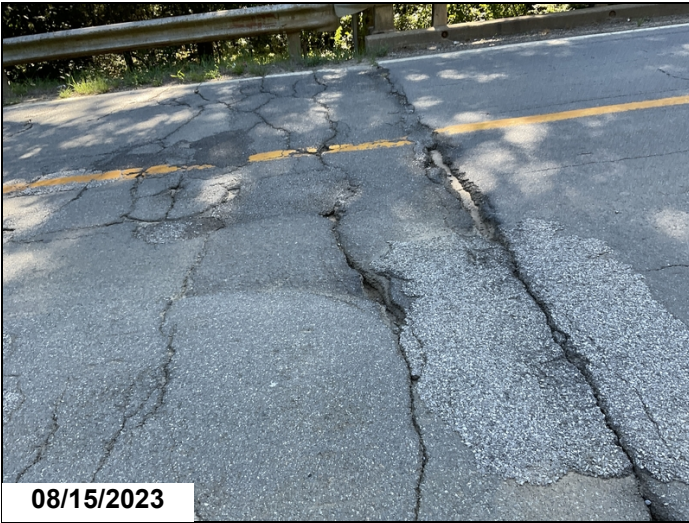
Approach roadway at Bent 1 has heavy spalling of Asphalt approach causing impact to bridge. Common at Bent 5

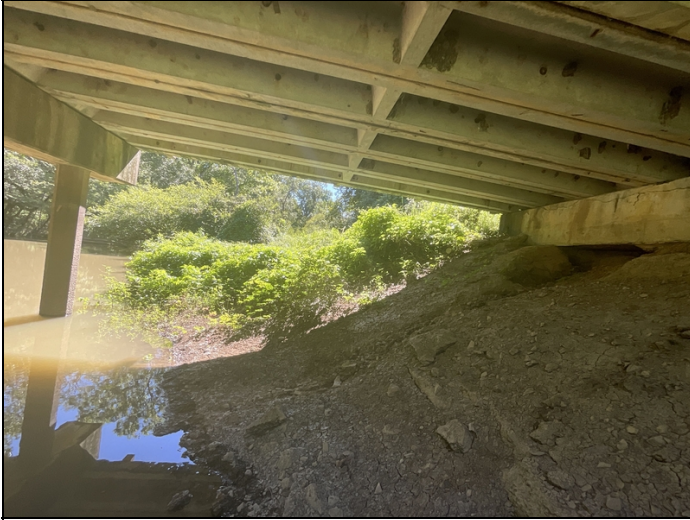
End-slope - Bent 5 left: Trees, vines and vegetation
