Bridge #07134(Routine)

S.H. 195 -01-0.50 over UNION PACIFIC RR SPUR

Location: 0.50 MI NE OF FULTON

Team Lead: Charlie Rogers Inspection Date: September 06, 2018

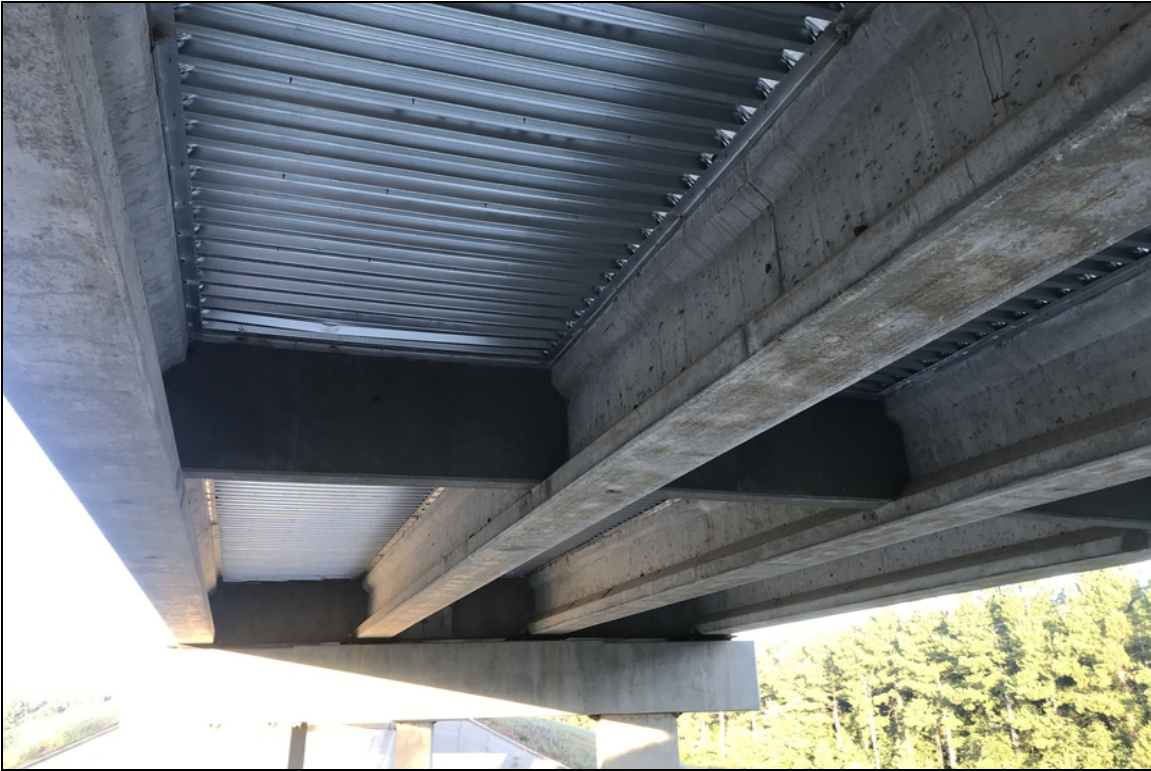
Underside of deck typical all spans

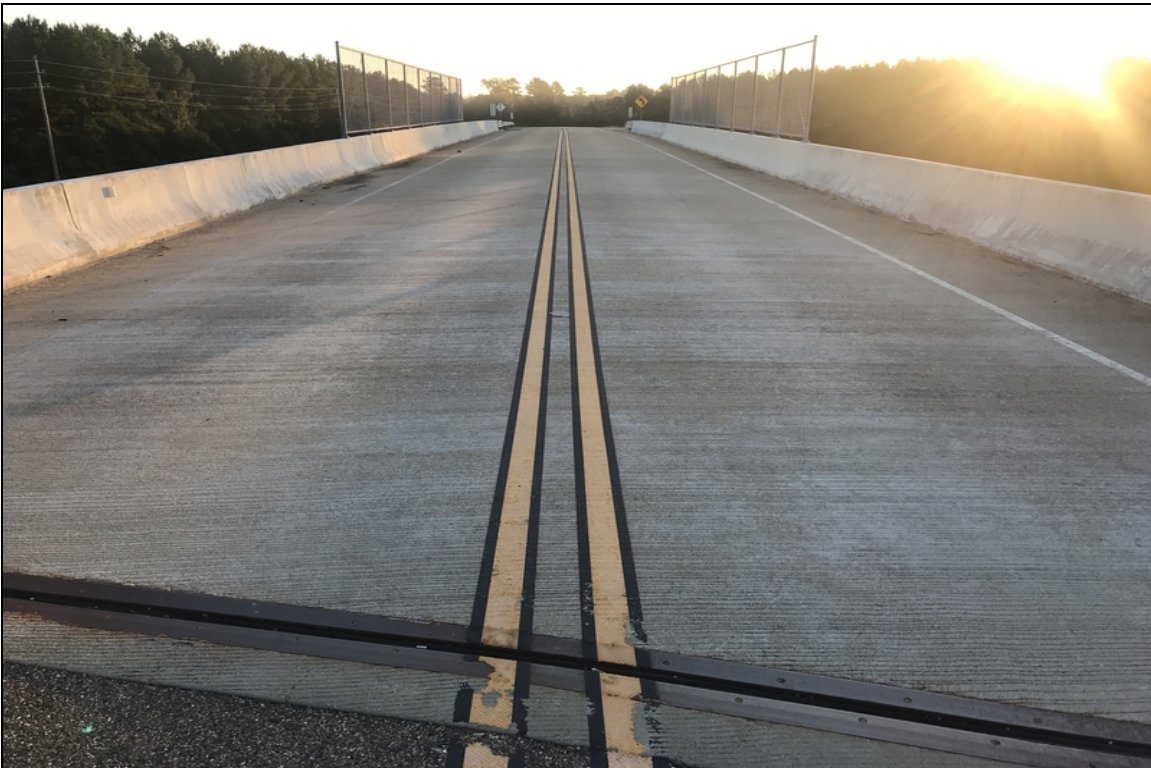
ELEM	DESCRIPTION	UNITS	TOTAL	CS1	CS2	CS3	CS4
12	Reinforced Concrete Deck	SF	6300	5750	550	0	0
1120	Efflorescence/Rust Staining	SF	200	0	200	0	0
1130	Cracking (RC and Other)	SF	350	0	350	0	0
(12)	Efflorescence on concrete overhang Minor hairline cracking across entire deck						
109	Prestressed Concrete Open Girder/Beam	LF	840	840	0	0	0
205	Reinforced Concrete Column	EA	4	4	0	0	0
215	Reinforced Concrete Abutment	LF	108	43	65	0	0
1130	Cracking (RC and Other)	LF	65	0	65	0	0
(215)	30ft of cracks on bent 4 abutment 35ft of cracks on bent 1 abutment						
234	Reinforced Concrete Pier Cap	LF	66	66	0	0	0
302	Compression Joint Seal	LF	69	69	0	0	0
310	Elastomeric Bearing	EA	24	24	0	0	0
331	Reinforced Concrete Bridge Railing	LF	420	390	30	0	0
1130	Cracking (RC and Other)	LF	30	0	30	0	0
(331)	30 ft of cracks between both parapet walls
