**Bridge #M2289(Routine)**  
**SH 195 - 01- 3.22 over TURKEY CREEK**  
**Location: 3.3 MI N.E. OF FULTON**

**Team Lead: Charlie Rogers Inspection Date: September 06, 2018**

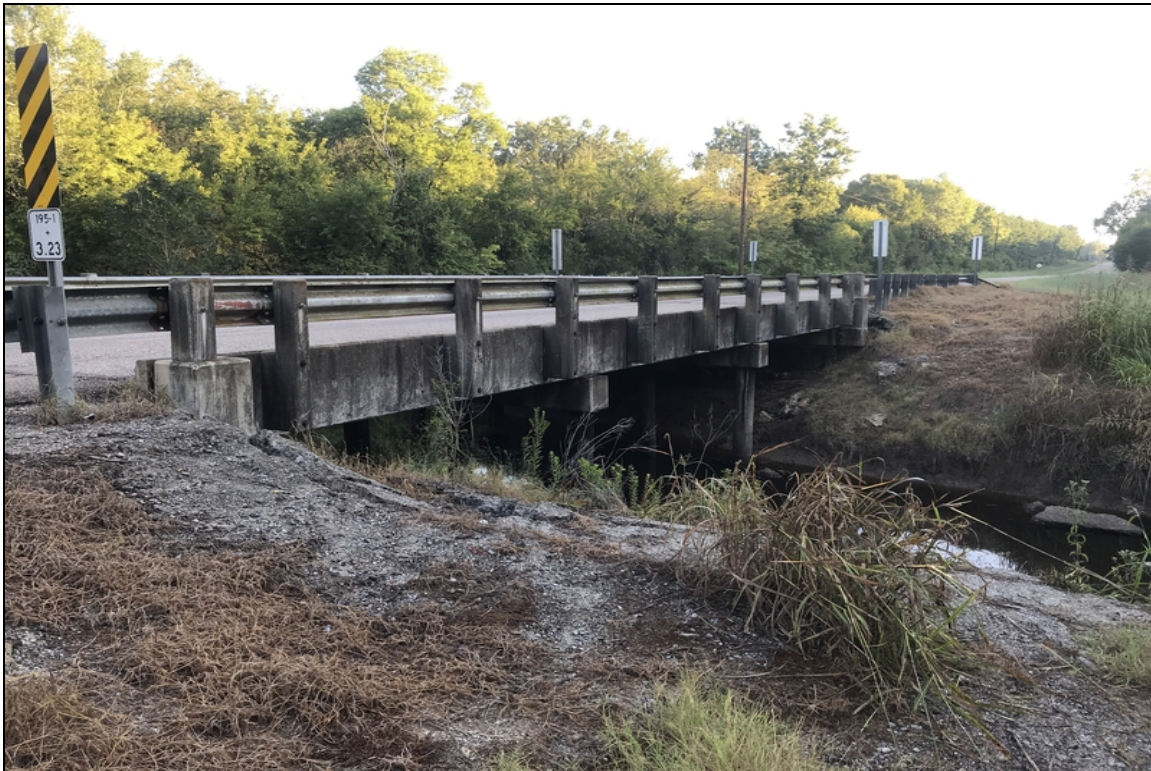
SS

2016..CHANGE IN CONDITION, LOWER SUPERSTRUCTURE TO 6 SAT. DO TO SPALLS WITH REBAR EXPOSED ON BOTTOM OF UNITS..

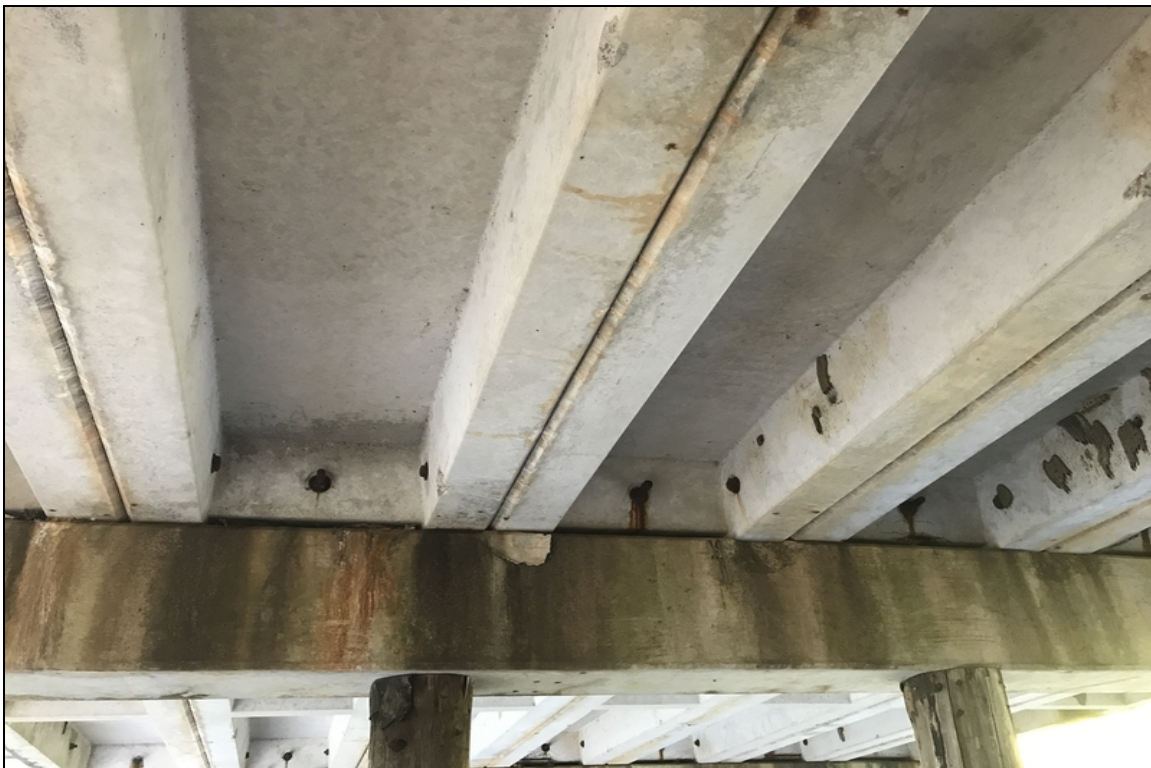
Underside of deck typical all spans

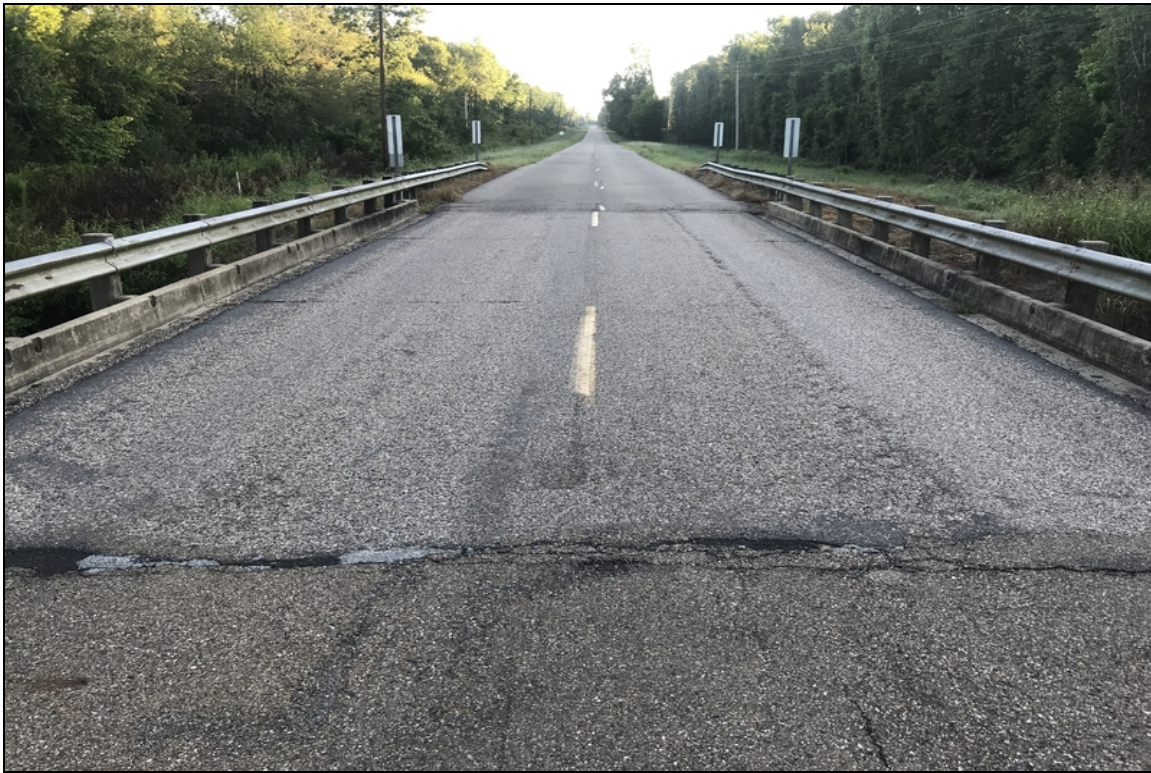
Deck

3 SPAN CONC. PRECAST UNITS...

unit 7 span 1 diaphragm spall with rebar

unit 4 spall with rebar exposed...9/6/2018...AL, SS, Deck, Def. photos taken...
