Bridge #M2291(Routine)

SH 195 - 01 - 6.43 over SANDY BOIS DE ARC CREEK

Location: 6.45 MI N.E. OF FULTON

Team Lead: Charlie Rogers Inspection Date: September 05, 2018

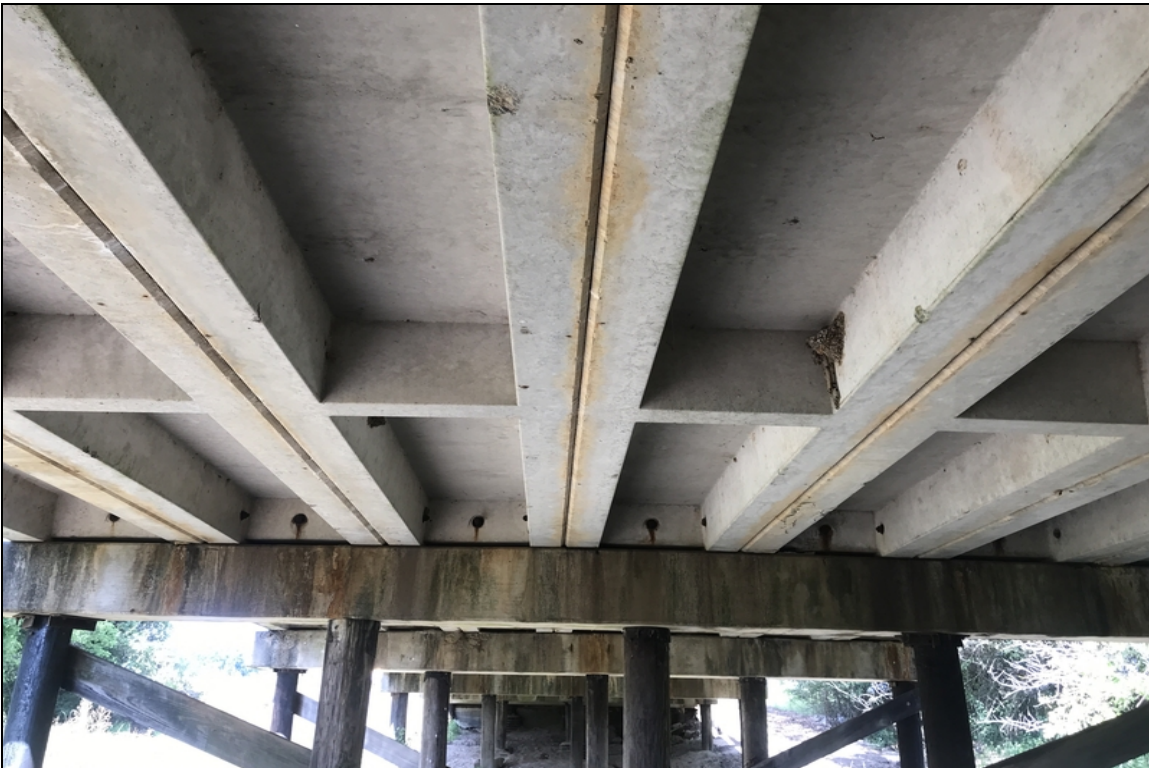
Underside of deck typical all spans

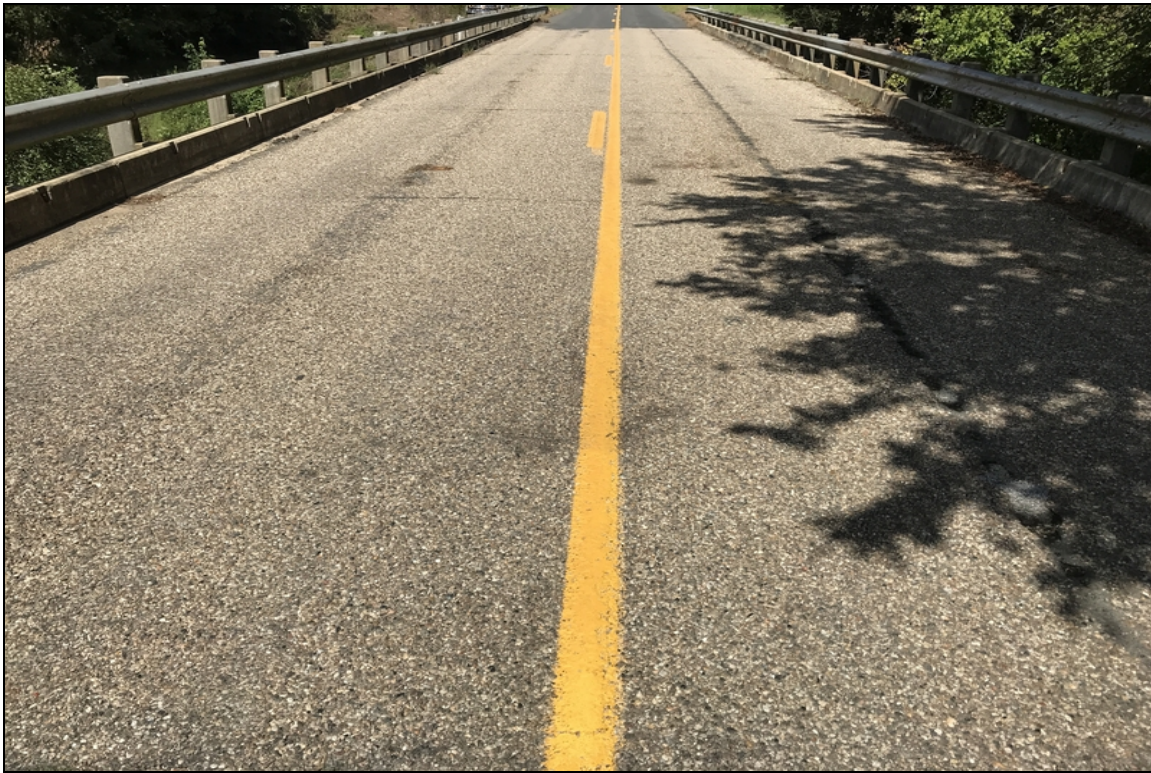
Deck

9/5/2018...AL, SS, Deck, Def. Photos taken. Asphalt unraveling at bent 6 joint...
