**Bridge #M2294**(Routine, Underwater type 2)  
**SH 195 -01-11.78 over BLACK BOIS DE ARC CREEK**

**Location: 2.1 MI SW SH 4**

**Team Lead:** Charlie Rogers **Inspection Date:** May 06, 2020

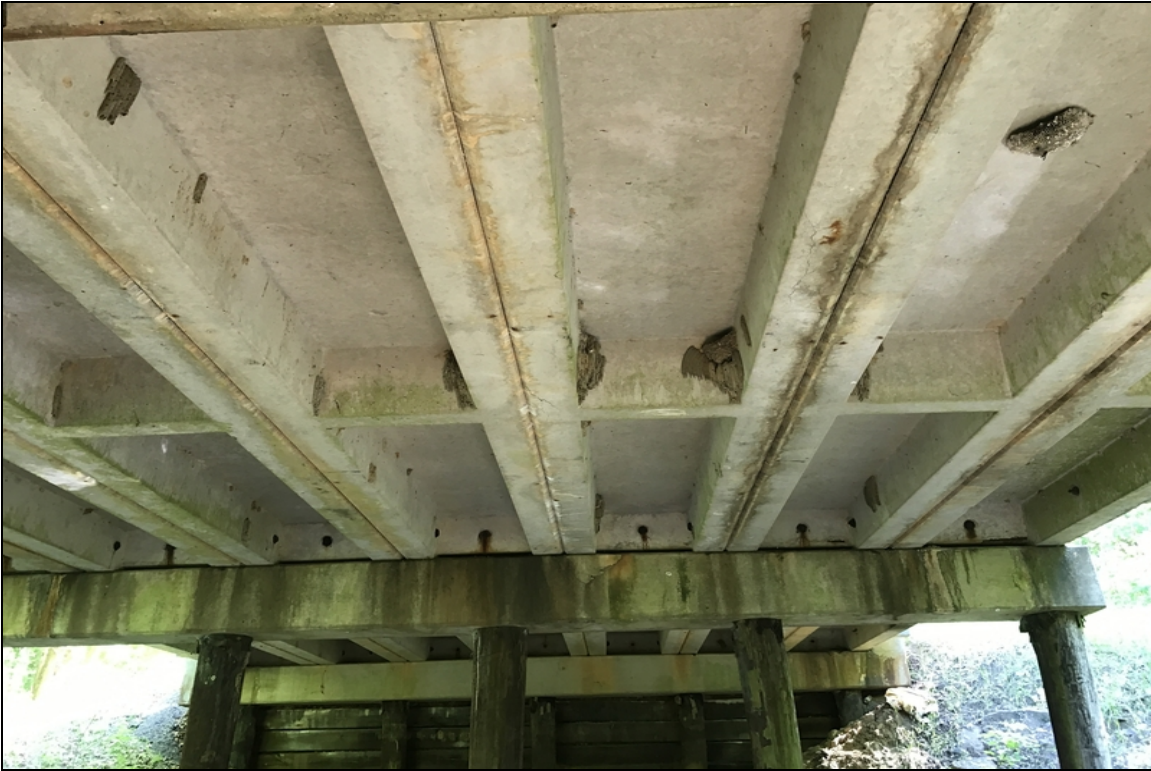
Underside of deck typical all spans

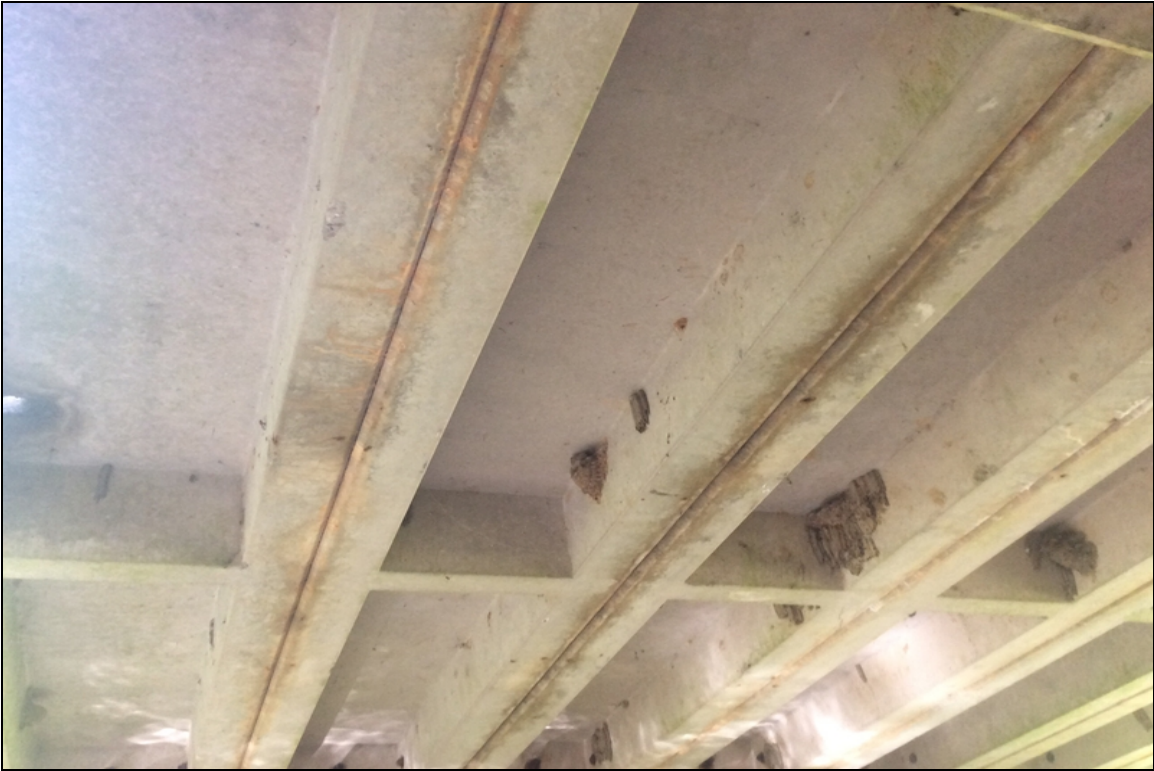
**BOTTOM OF DECK TYPICAL ALL SPANS**

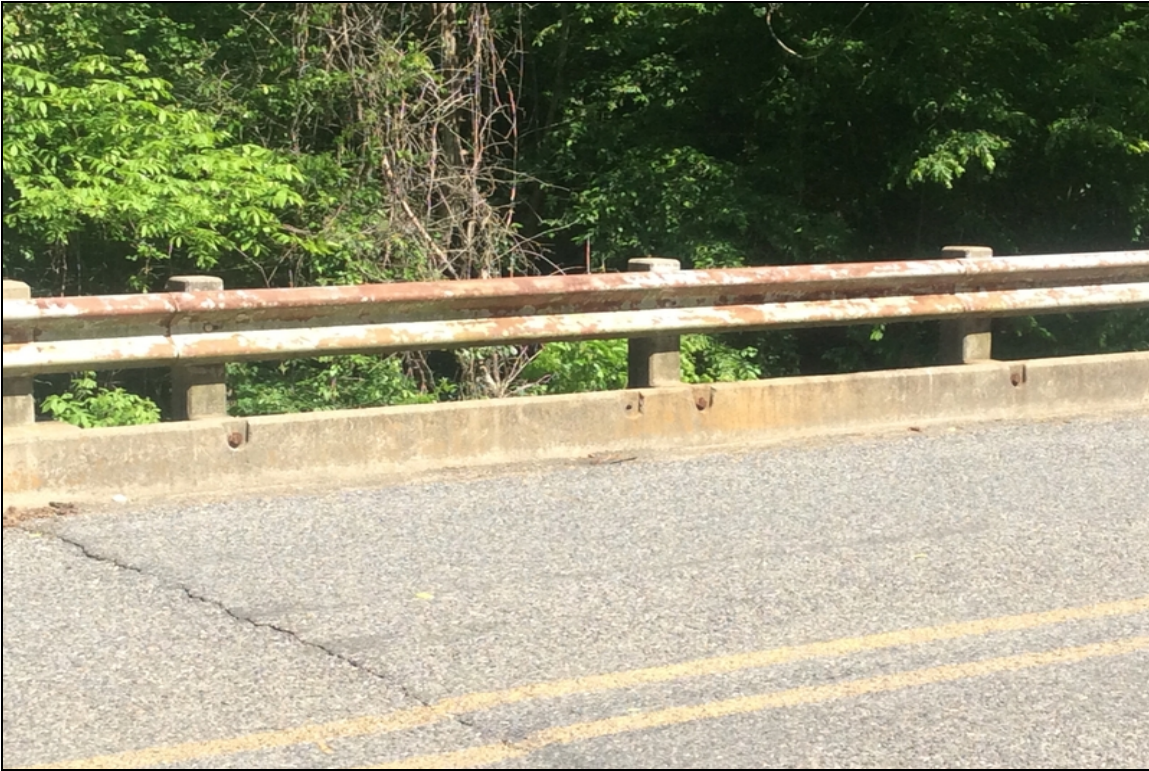
GUARD RAIL NEEDS TO BE PAINTED ENTIRE BRIDGE.

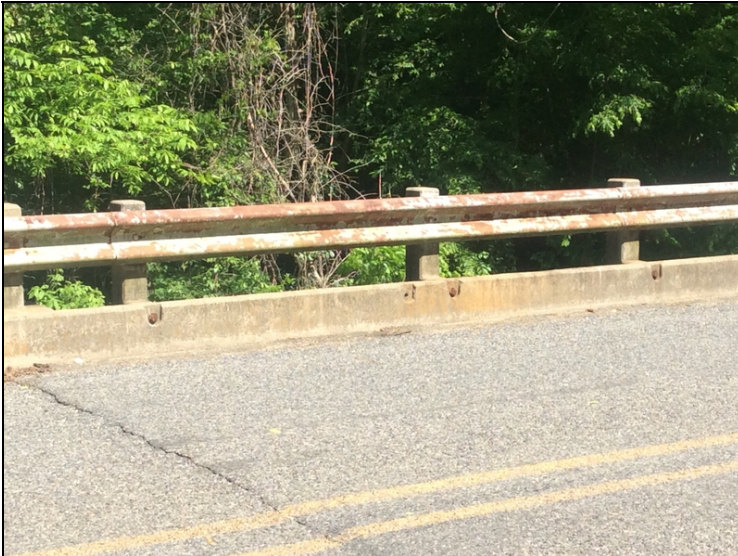
GUARD RAIL NEEDS TO BE PAINTED ENTIRE BRIDGE.

GUARD RAIL NEEDS TO BE PAINTED ENTIRE  
BRIDGE.
