**Bridge #03027**(Routine, Underwater type 2)

**US 371 - 03 - 4.59 over BRUSHY CREEK**

**Location: 4.59 MI E HOWARD CO LN**

**Team Lead: Charlie Rogers Inspection Date: January 10, 2022**

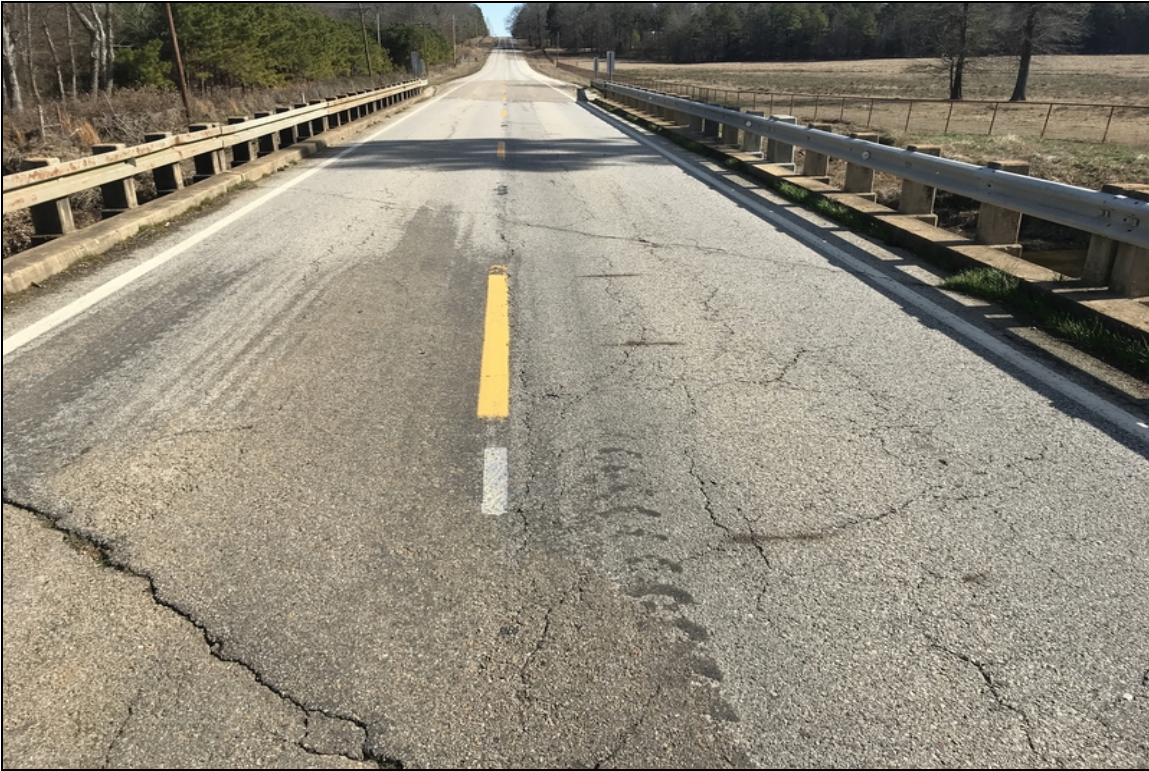
Asphalt overlay on deck is cracking

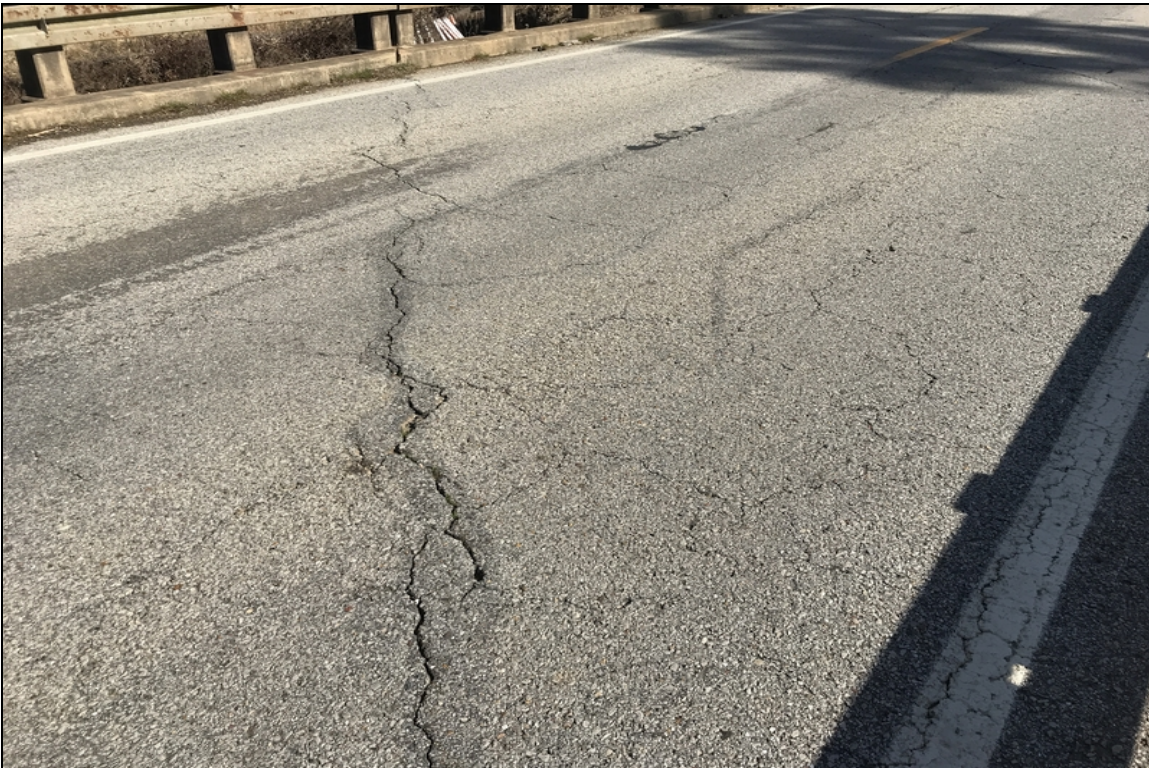
Asphalt overlay is cracking on deck

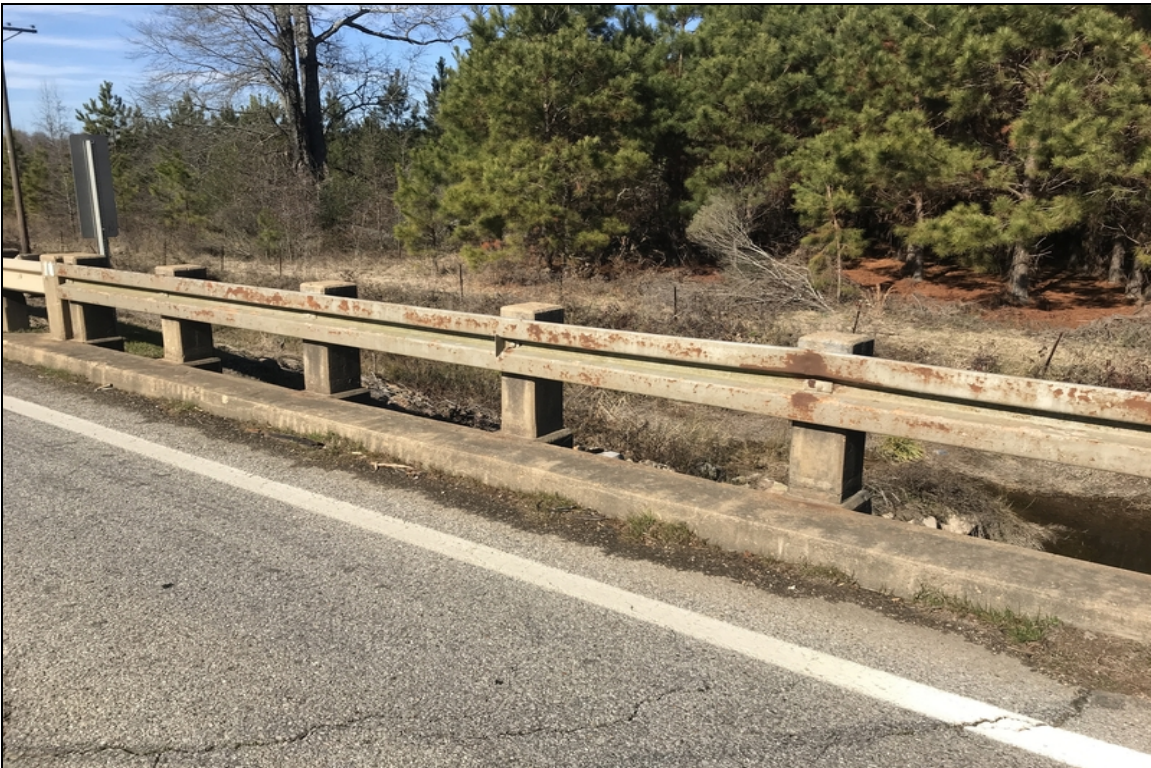
(330)							
2 SF OF DAMAGE TO GUARDRAIL POST LT SIDE, END OF BRIDGE paint loss to bridge railings on left side

Paint loss to railings on leftside of bridge

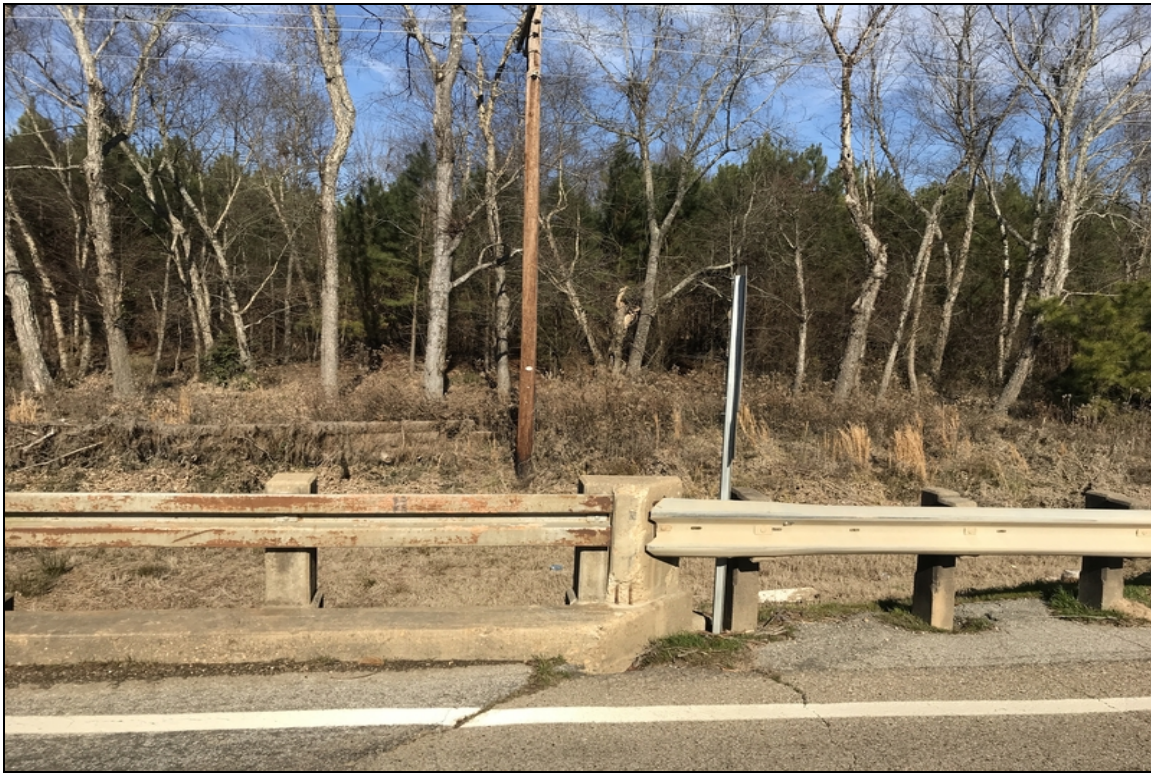
Left side end bridge concrete post. Bridge railings

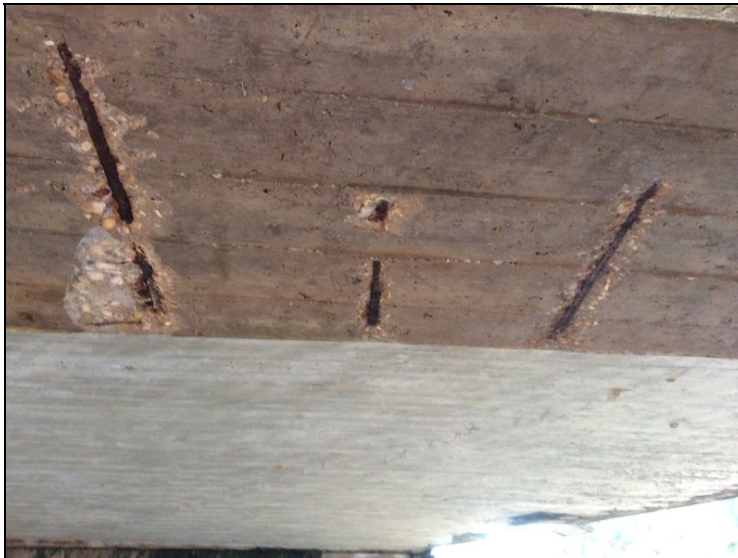
(234)							
SPALL W/ REBAR EXPOSED ON BOTTOM OF BENT 3 CAP SPALL ON END OF CAP LT SIDE BENT 3							
330	Metal Bridge Railing	LF	280	138	142	0	0
1000	Corrosion	LF	140	0	140	0	0
7000	Damage	LF	2	0	2	0	0
515	Steel Protective Coating	SF	280	235	0	45	0
3440	Effectiveness (Steel Protective Coatings)	SF	45	0	0	45	0

SPALLS WITH REBAR EXPOSED VARIOUS LOCATIONS ON BENT 3 CAP

SPALLS W/ REBAR EXPOSED AT BENT 3  
BOTTOM OF CAP and in span 3 left side cap

**Date Reported:** 01/09/2018  
**Priority:** G - General/ Preventive maintenance  
**Type of Work:** Repair  
**Status:** Monitor  
**Inspection Direction** W to E  
**Component:** 234 - Reinforced Concrete Pier Cap

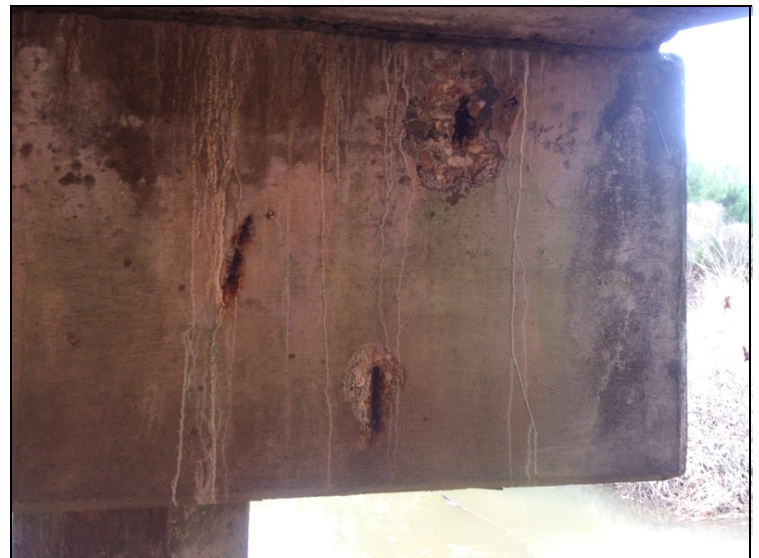
BENT 3 SPAN 3 SIDE SPALLS W/ REBAR  
EXPOSED

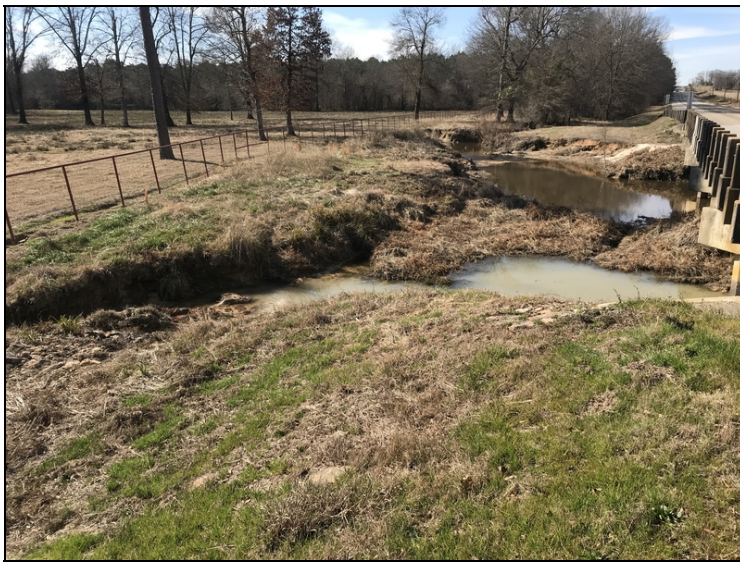
Channel erosion down stream side

**Date Reported:** 01/07/2020  
**Priority:** G - General/ Preventive maintenance  
**Type of Work:** Repair  
**Status:** Assigned  
**Inspection Direction** W to E  
**Component:** Channel

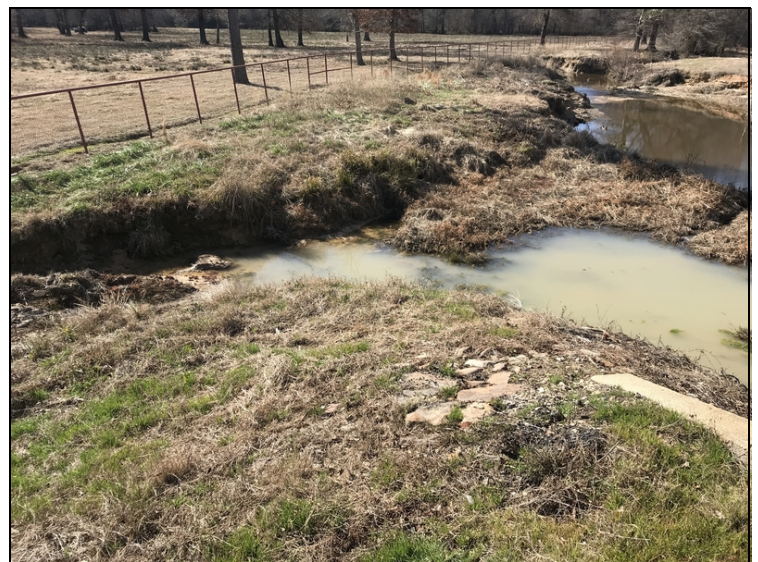
Channel erosion down stream side

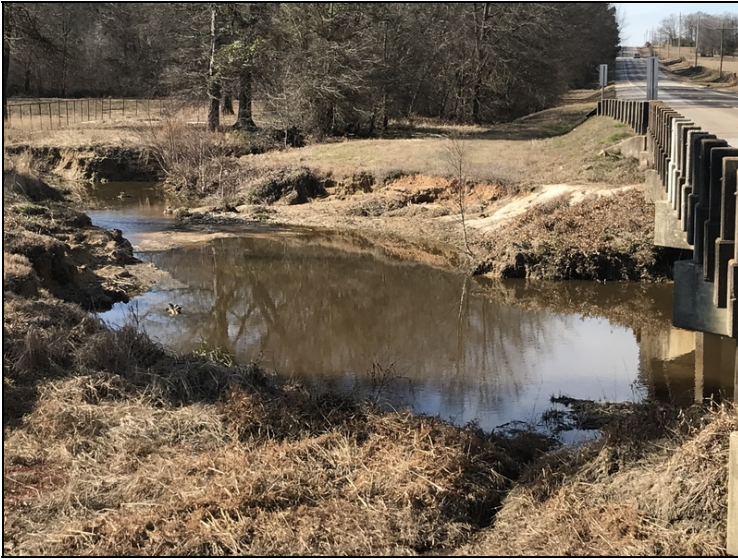
Channel erosion down stream side
