Bridge #07215(Routine, Underwater type 2)

US 371 -03-2.91 over OZAN CREEK

Team Lead: John King **Inspection Date:** May 19, 2021

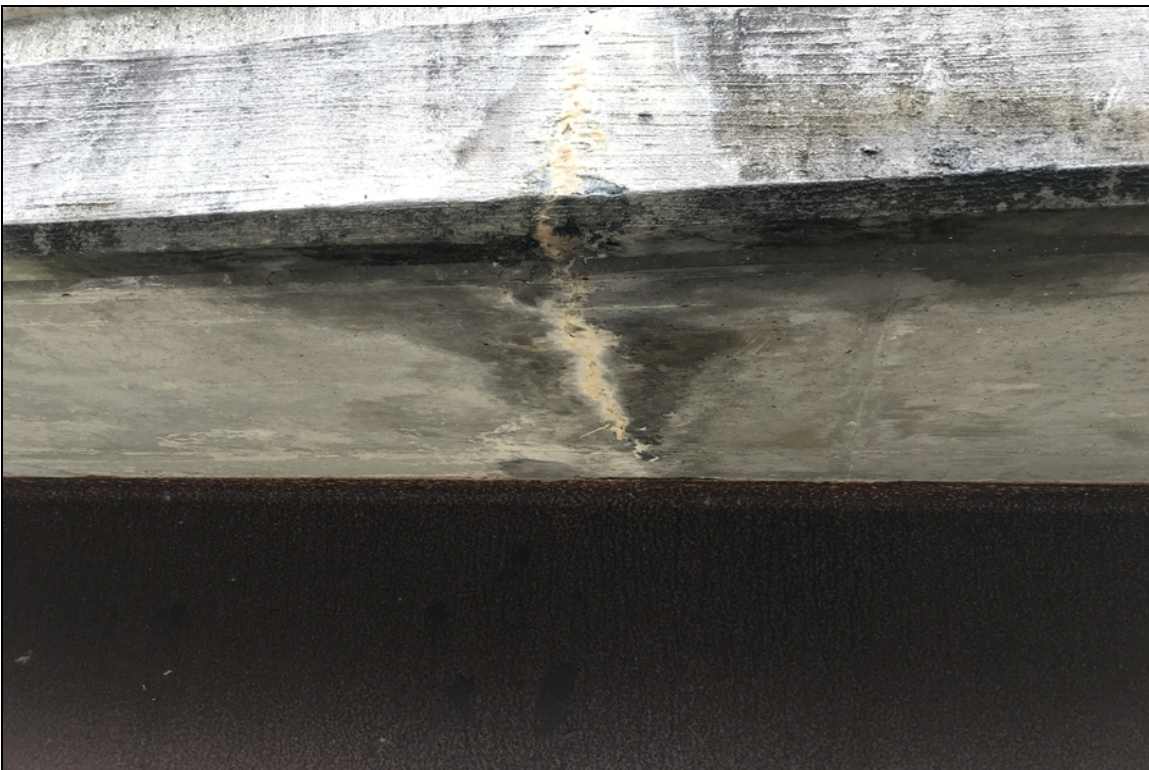
Efflorescence on the soffits with cracking

Deck cracks also cracks in the parapet wall small none sealable. Cracking also in the soffits typical both sides

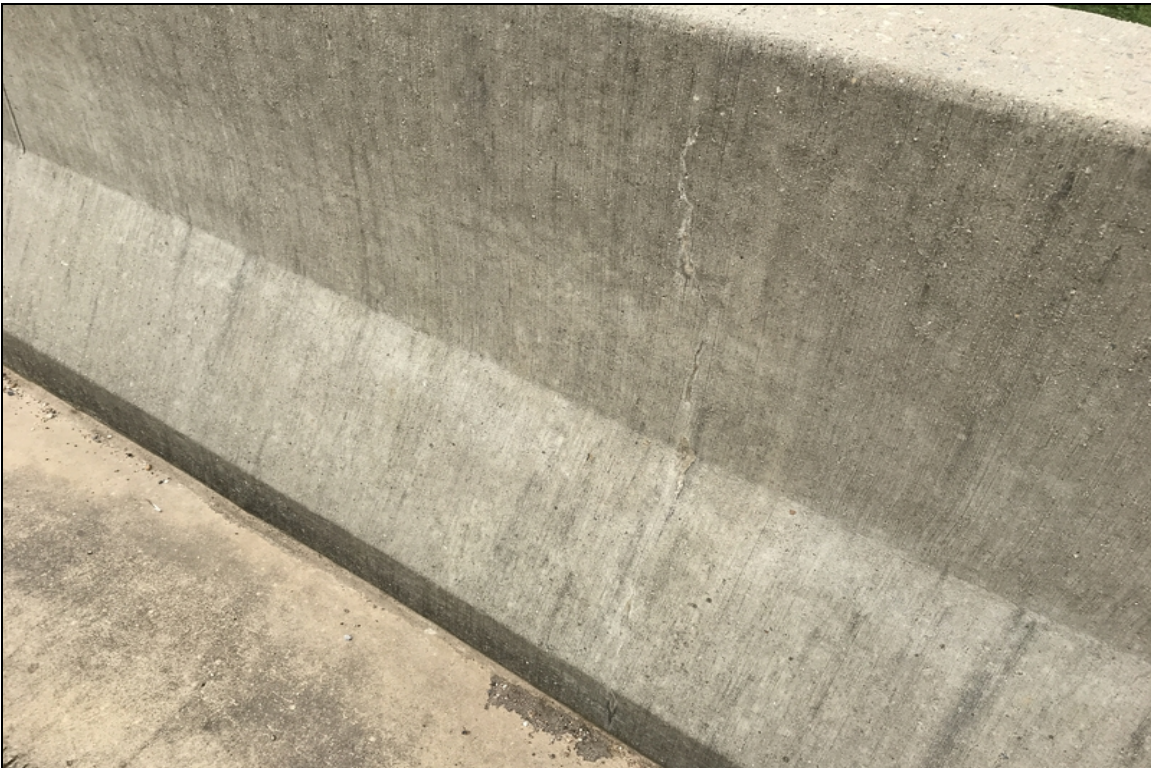
Cracks in the parapet wall

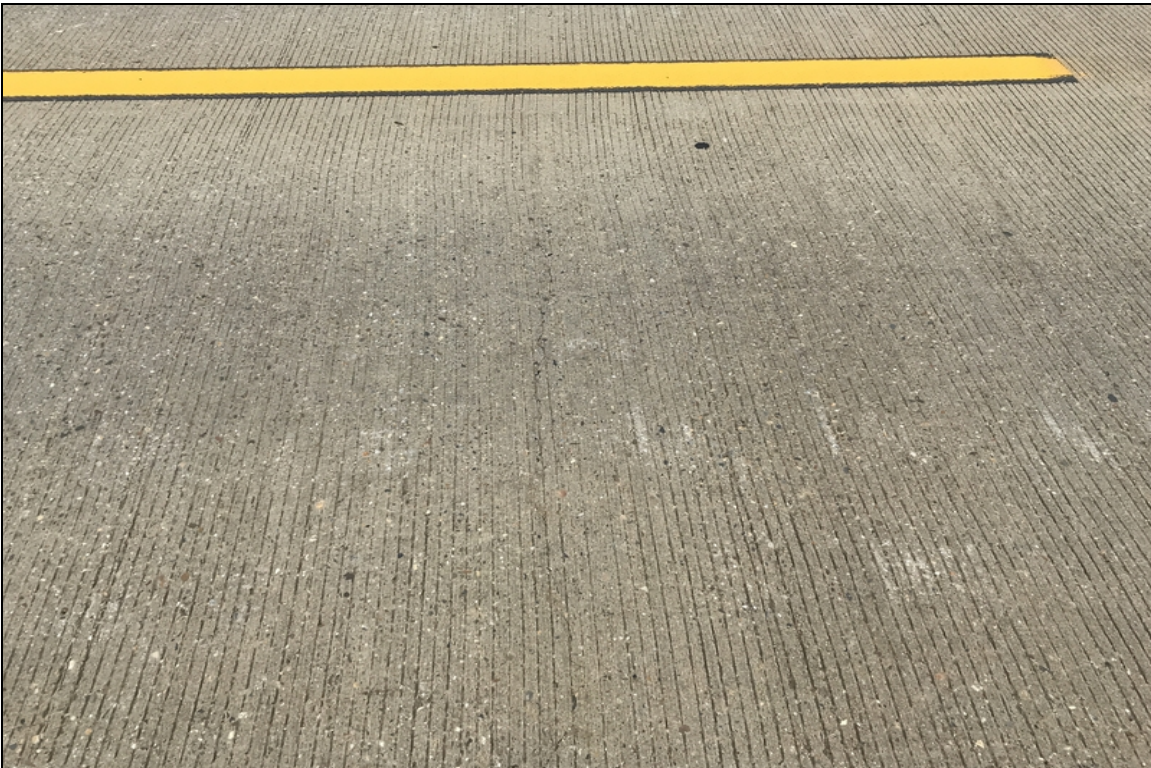
Cracks in the typical

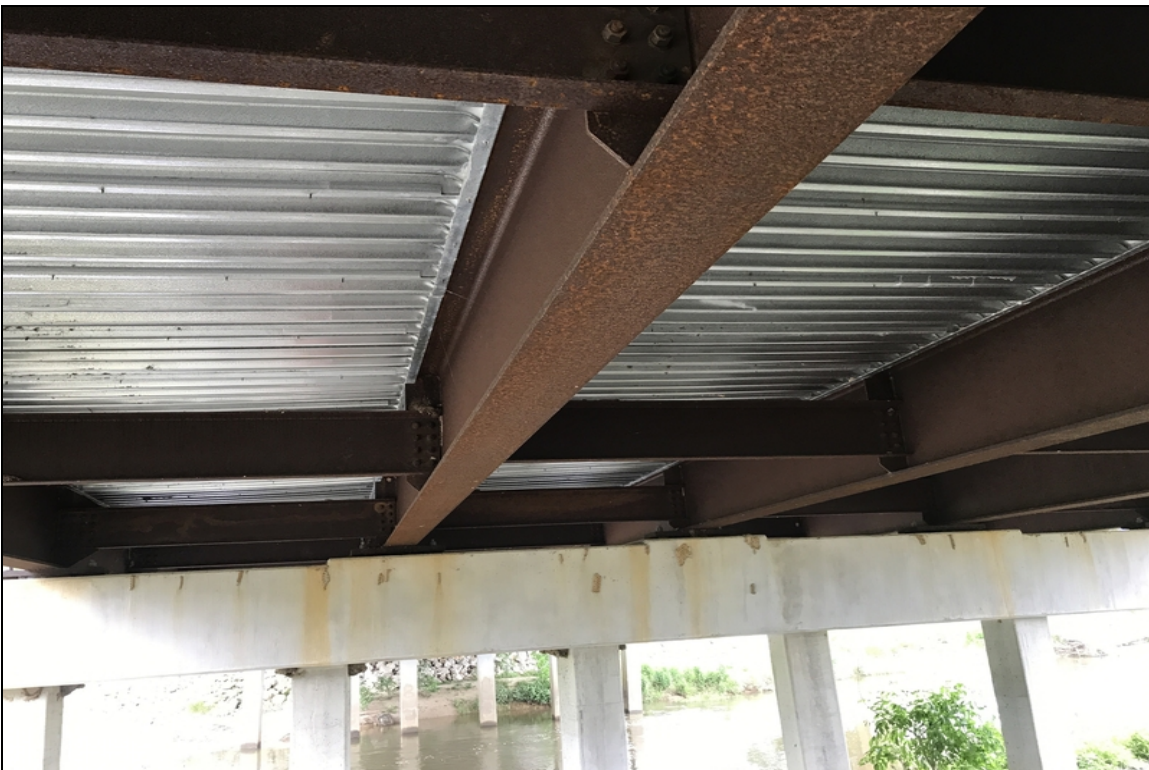
Underside of deck typical all spans
