Bridge #02864(Routine)
SH 26-SEC.03-16.63 over ANTOINE RIVER

Location: EAST EDGE OF ANTOINE

Team Lead: John King Inspection Date: September 21, 2021

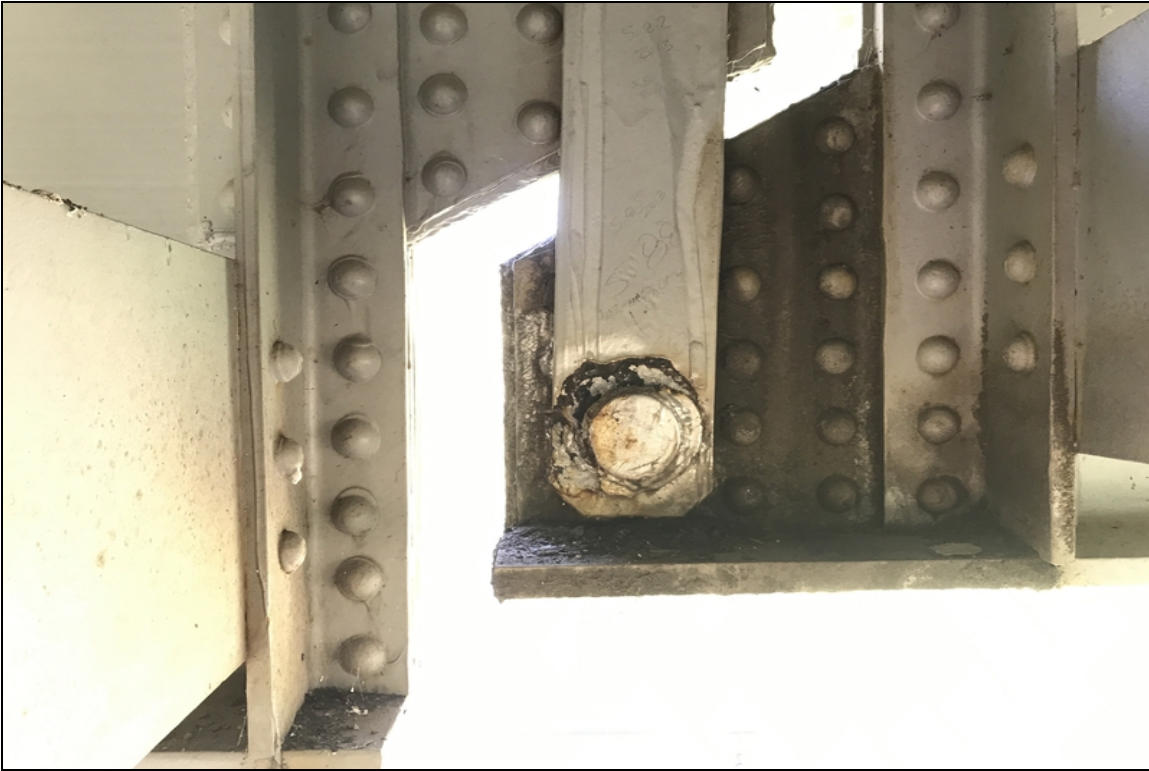
Beam 1 span 4 pin is offset

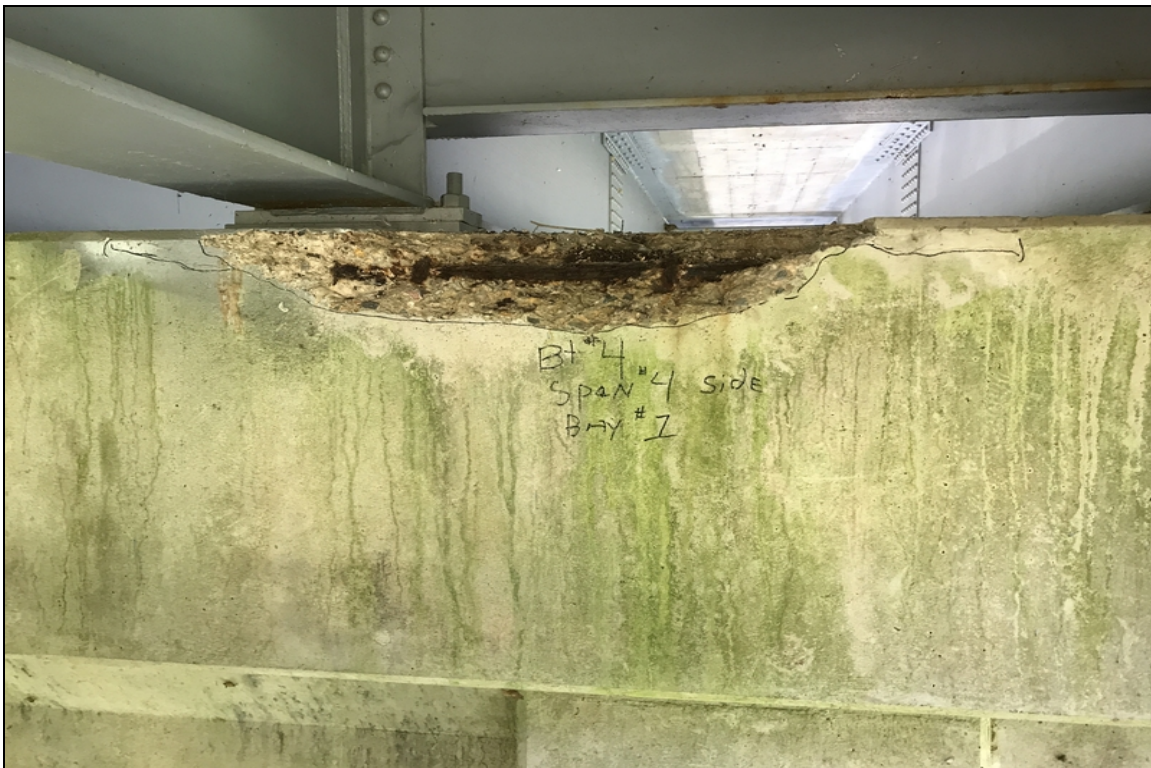
Spall with rebar exposed bent 4 bay 1 span 4 side

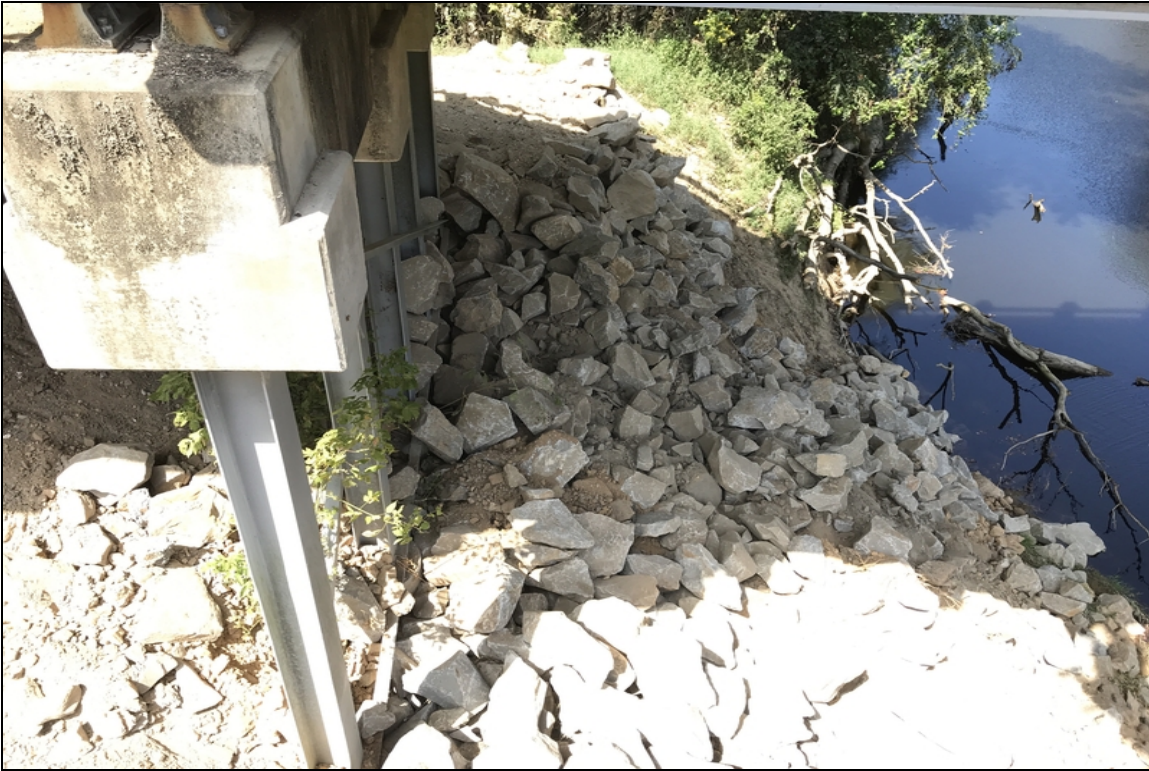
Bent 2 repair

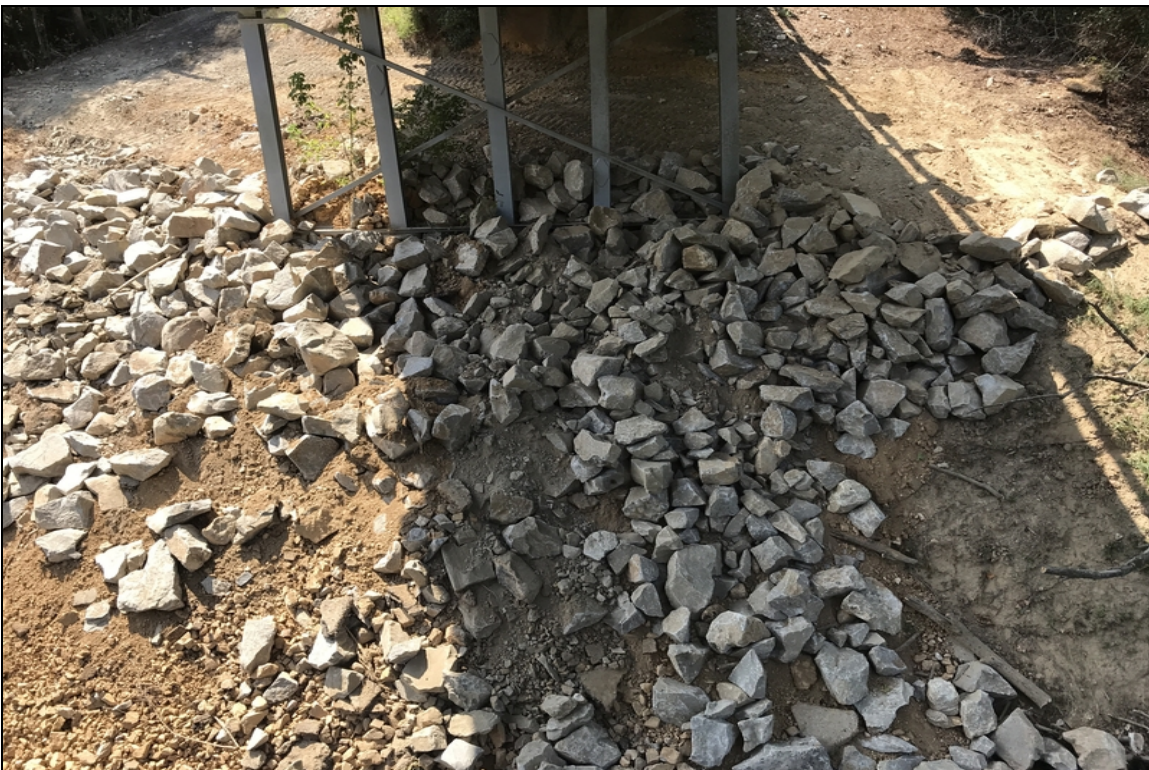
Bent 2 repair

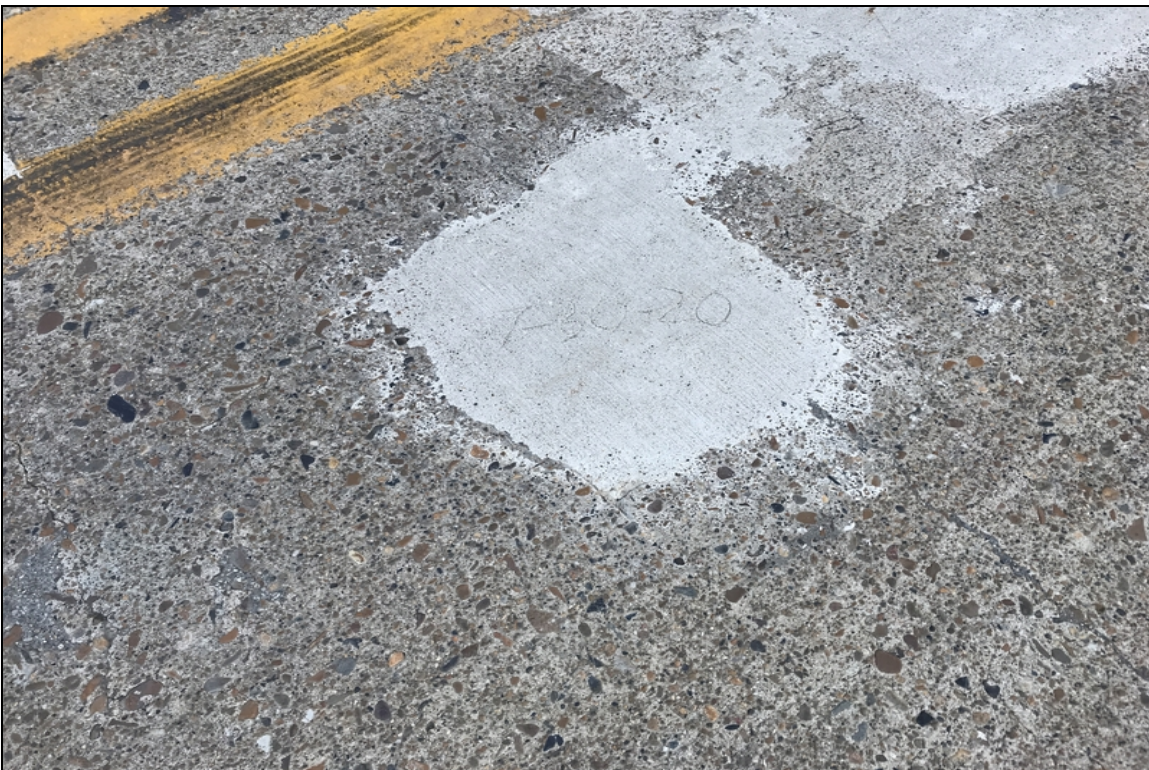
New patch

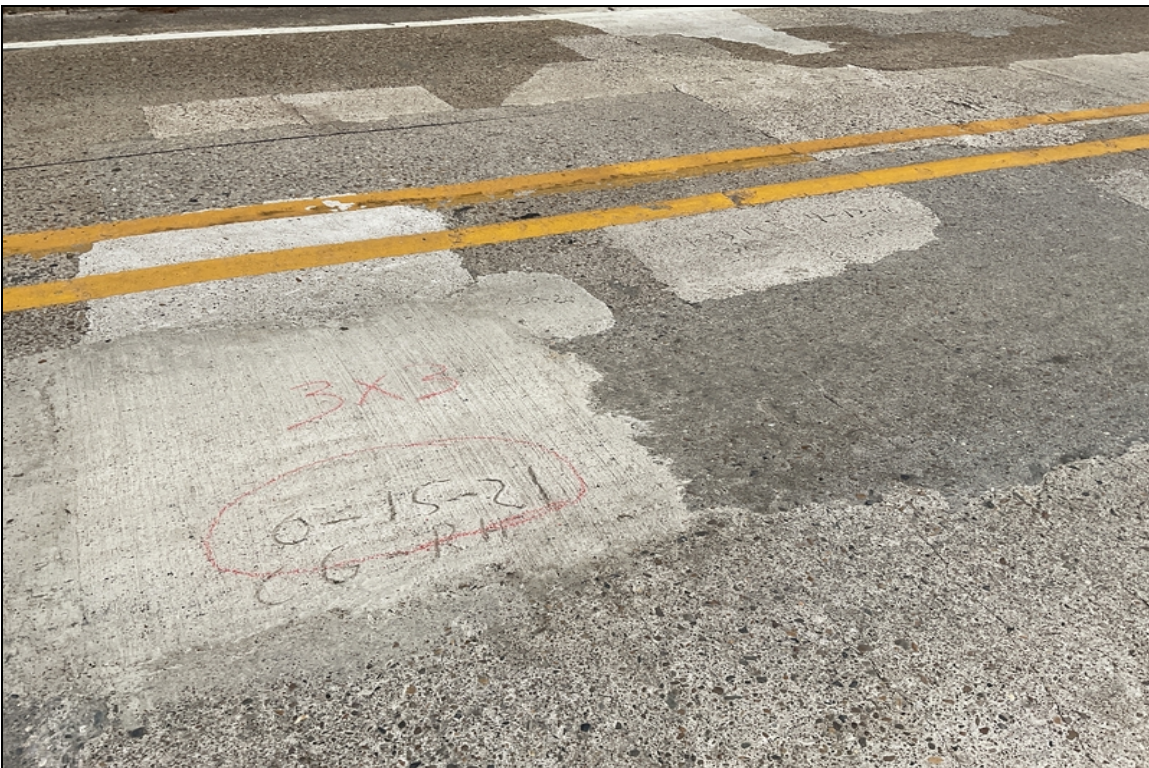
2021 patches

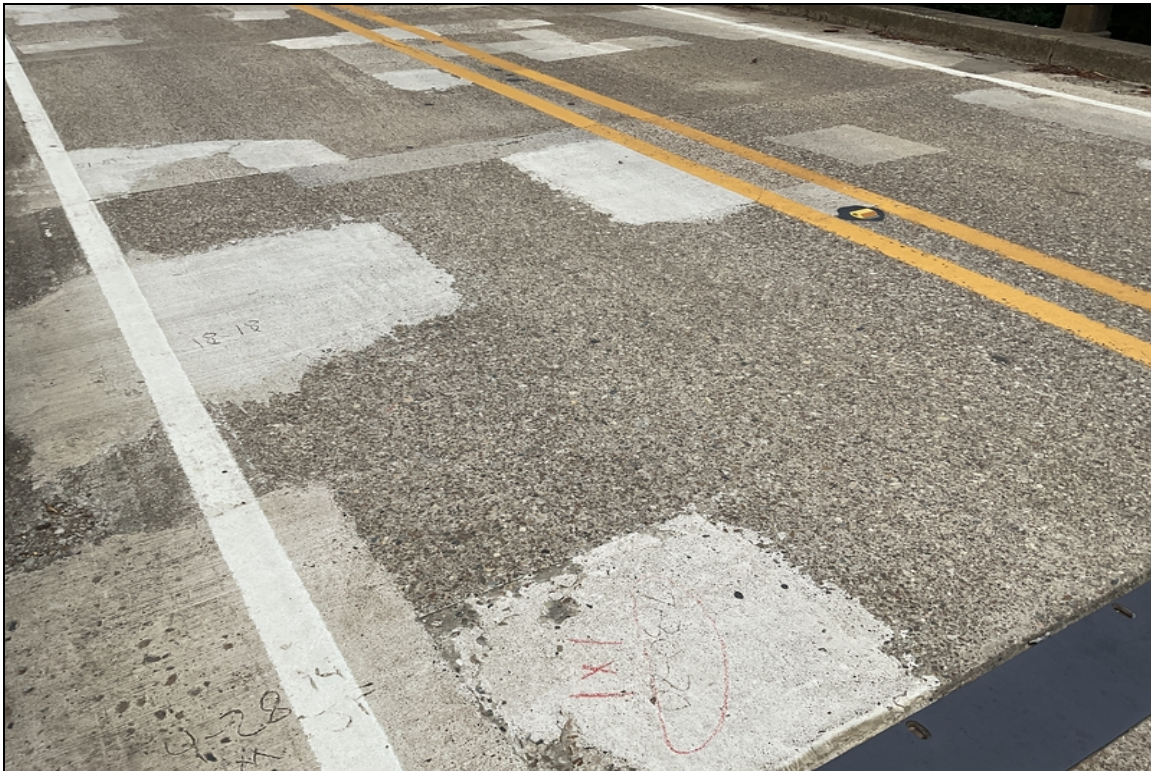
Deck patches 2020 and 2021

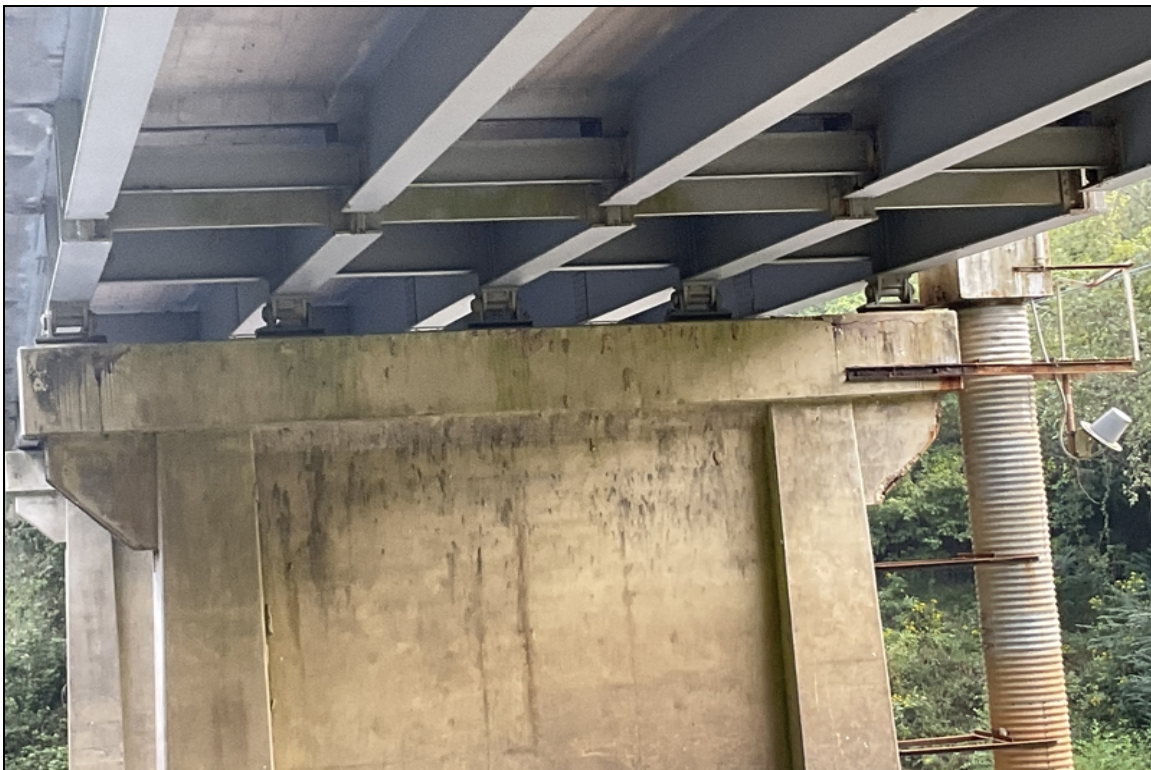
2021 Cracking at bent 3 bearing area right and left side of cap

6 SATISFACTORY 2021 5 fair Cracking at bent 3 bearing area right and left side of cap

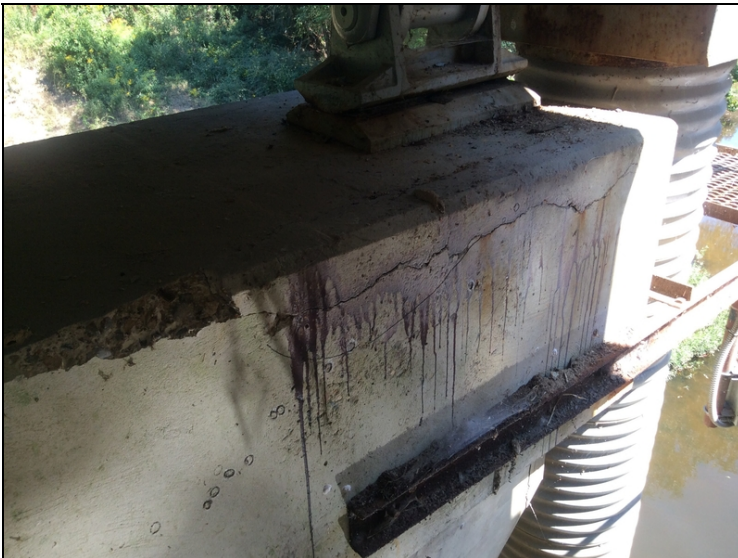
CONCRETE CAPS AT
BENTS #3 AND #4
HORIZONTAL CRACK NEAR THE TOP OF THE CAP.
NOTE: WAS SEALED YEARS AGO BUT NEED SEALED AGAIN.

Bent 3 rt side south face span 2 side

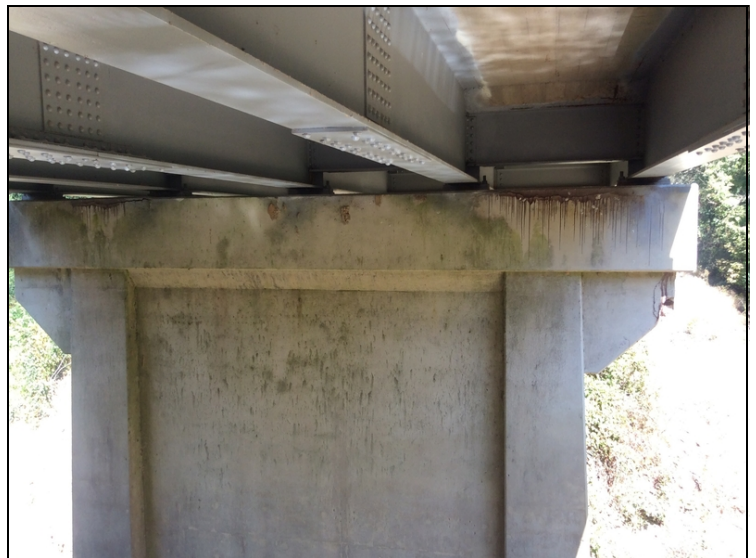
(234)							
BT 4 RT SIDE SOUTH FACE CRACK AT TOP OF CAP UNDER BEARING AREA							
303	Assembly Joint with Seal	LF	144	0	96	48	0
2310	Leakage	LF	48	0	0	48	0

Cracks in cap BT 4

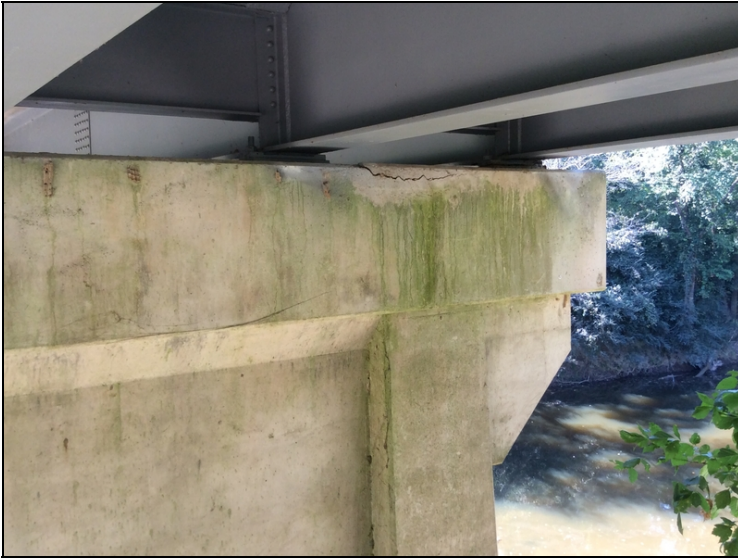
Bent 4 cap on north side above col.1

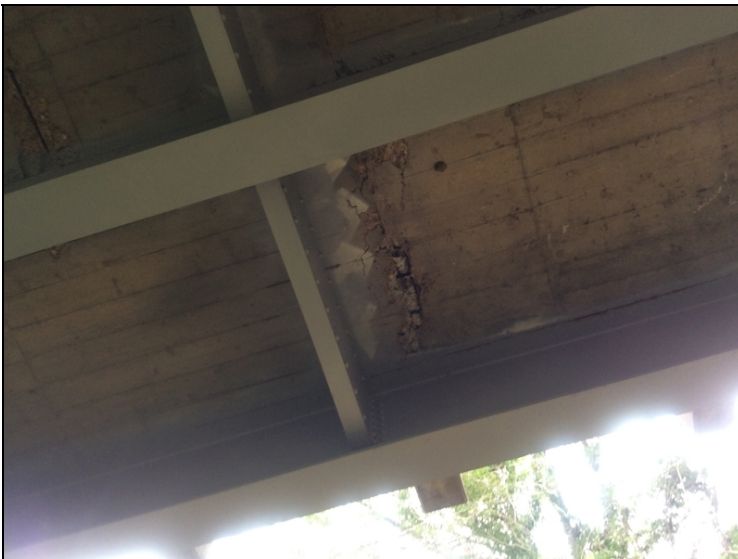
BOTTOM OF DECK IN SPAN #4
36"X18"X 1-1/2" SPALL WITH REBAR EXPOSED. SPALLS WITH REBAR EXPOSED IN ALL SPANS.
Span 4 bay 1 and 2 and 3 ,4 spalls with rebar exposed 2021
Span 1 bay 2,3, large spall with rebar exposed bottom side of deck 2021

Spall span 4

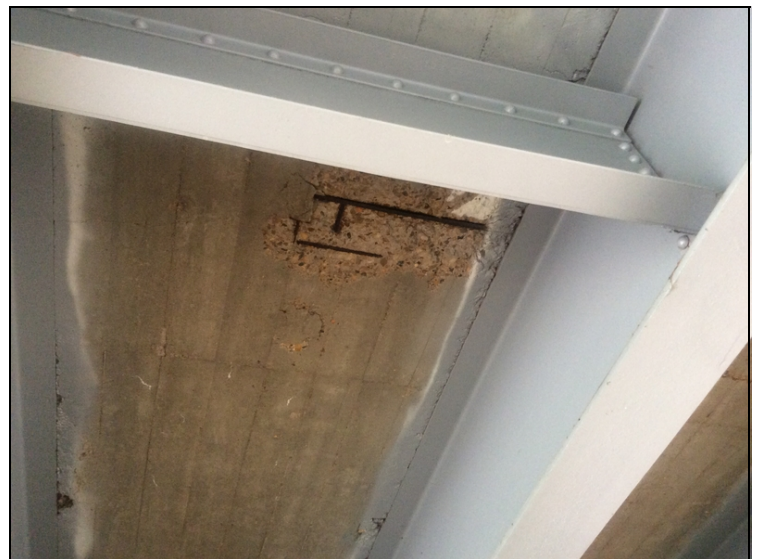
Spalls with rebar exposed all spans under deck

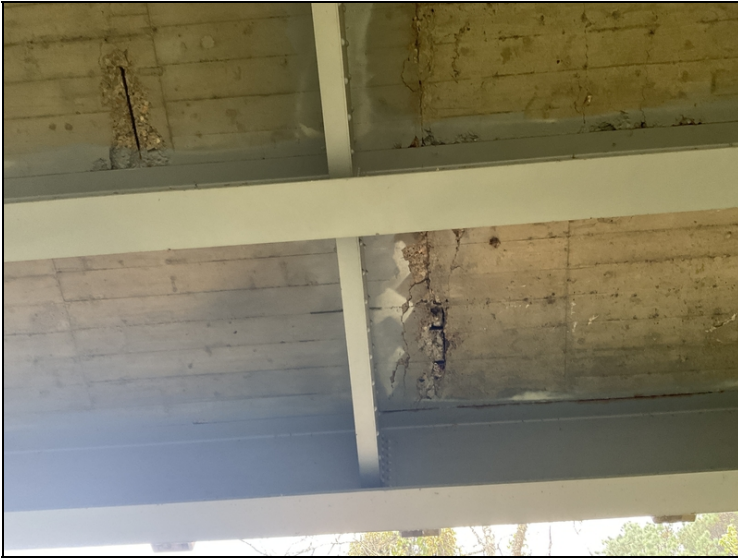
Span 4 bay 1 and 2 and 3 ,4 spalls with rebar
exposed 2021

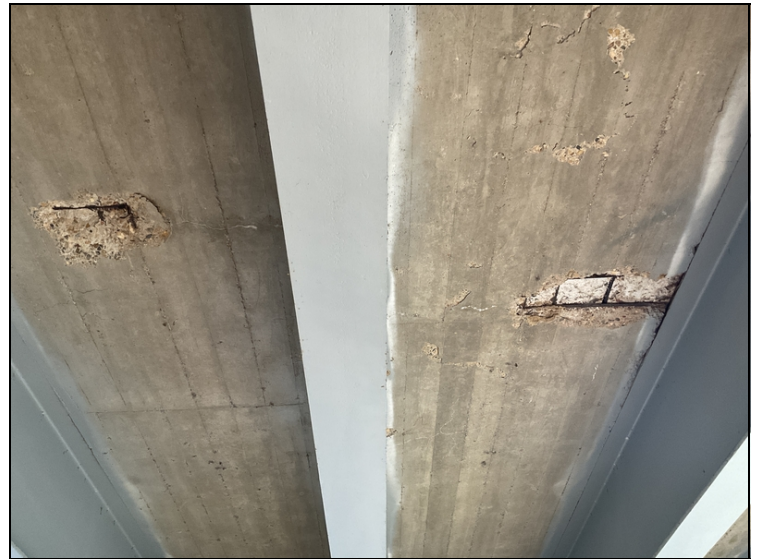
2021 Span 1 bay 2,3, large spall with rebar
exposed bottom side of deck

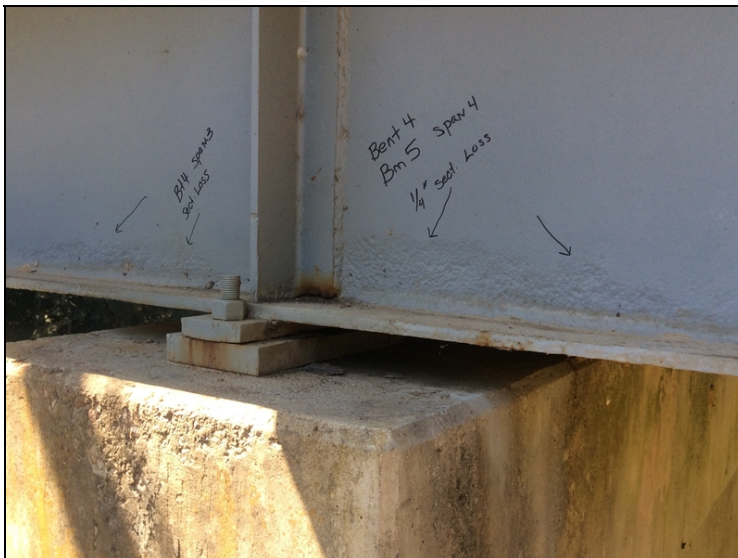
SECTION LOSS
BEAM #5 AT BENT #4
UP TO A 1/4 SECTION LOSS TO BEAM, 18" FROM
C/L OF CAP.

Section loss to beam 5 at bent 4

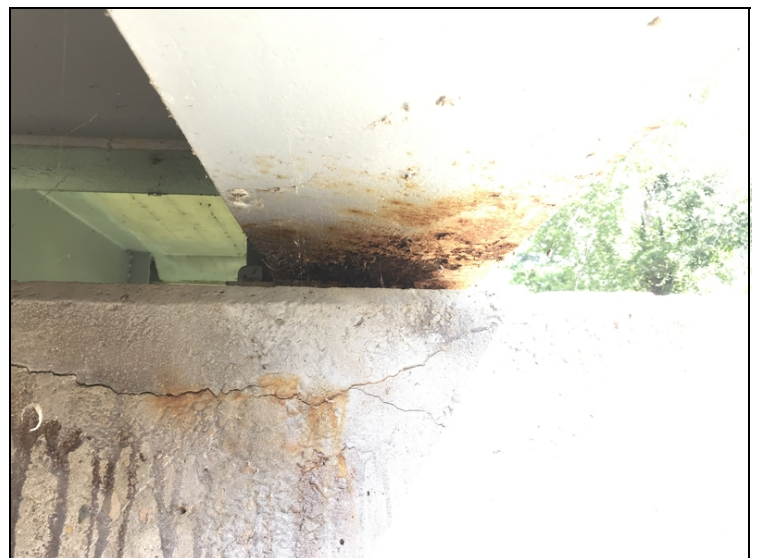
Rust and section loss at bent 4 beam 5

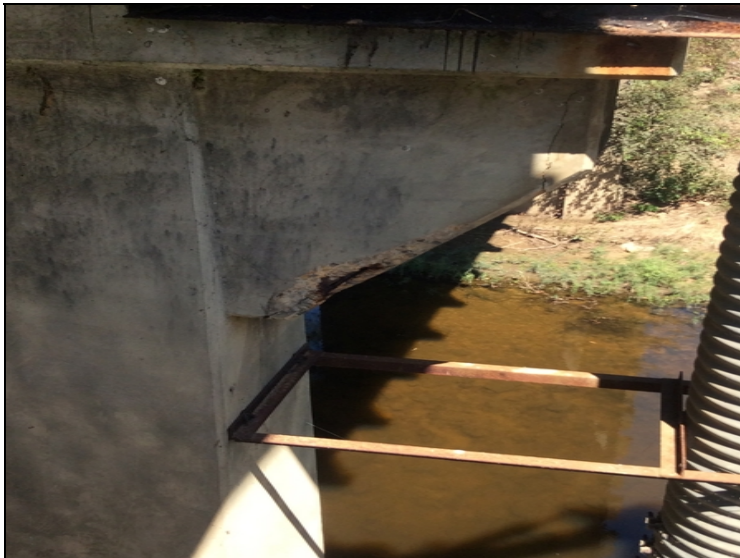
CONCRETE
CAP HAUNCHES
AT BENTS 3 &4
RT. SIDE
SPALLED W/ REBAR EXPOSED.

Bent 3 cap haunch rt side

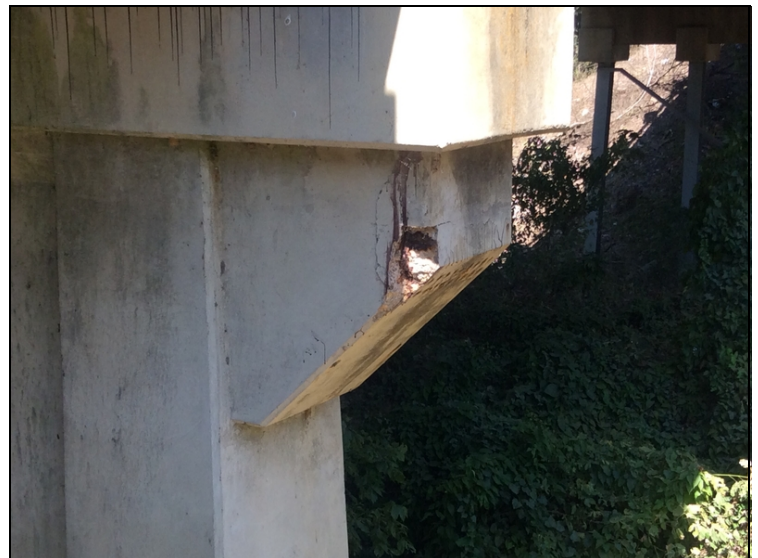
Cap haunch at bent 4 rt side

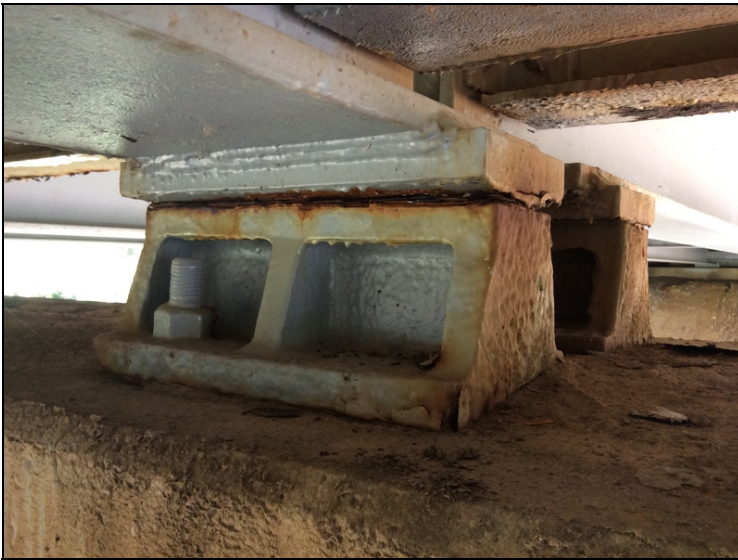
PACK RUST AND SECTION RUST TYPICALLY ALL BEARINGS

PACK RUST AND SECTION LOSS TYPICAL ALL BEARINGS

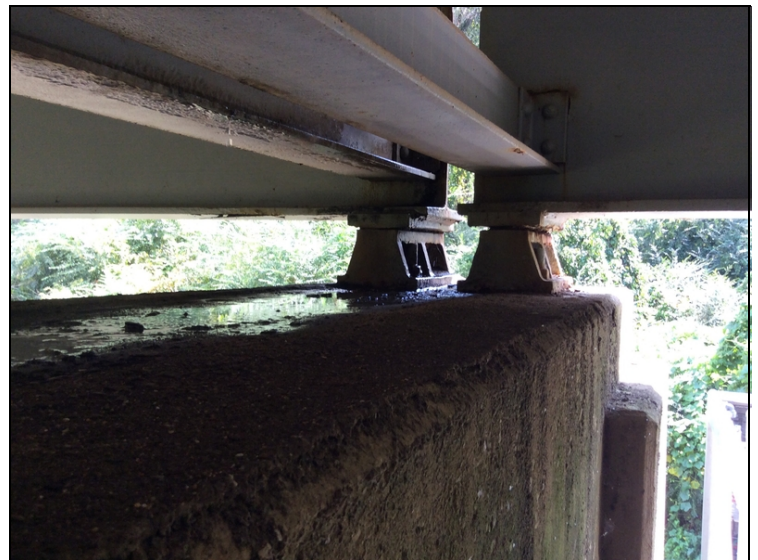
WATER LEAKING CAUSING PACK RUST

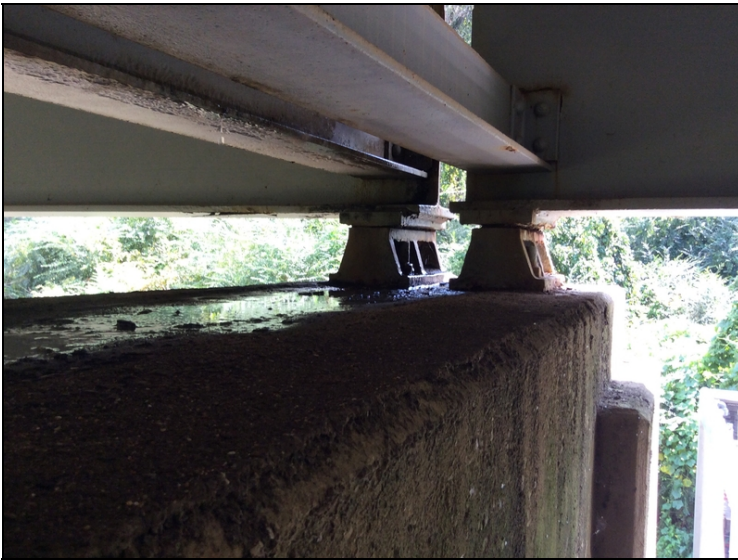
ALL JOINTS LEAKING WATER ON BEAMS AND CAPS

WATER LEAKING CAUSING PACK RUST

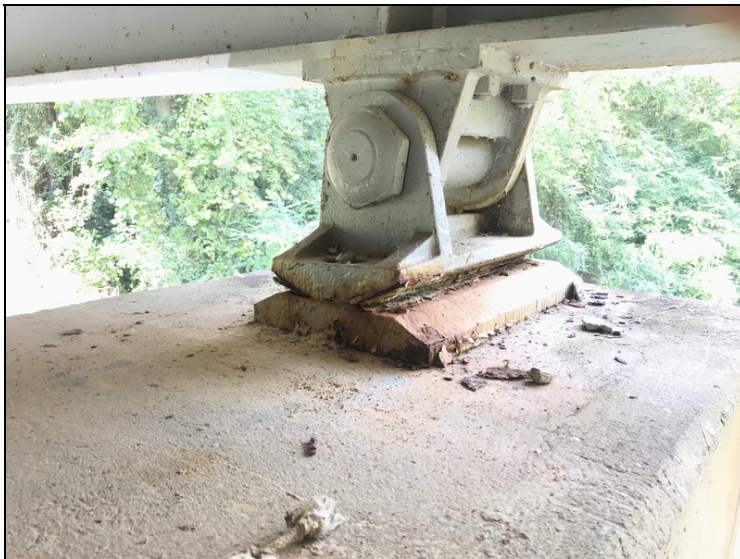
BENT #3 ANCHOR BOLTS

BEARING #1—HAS 2 BOLTS ATE IN TWO BY SECTION LOSS

BEARING #2—HAS 2 BOLTS ATE IN TWO BY SECTION LOSS

BEARING #3,#4& #5—HAS 1 BOLT ATE IN TWO BY SECTION LOSS

ANCHOR BOLTS ATE IN TWO BY SECTION LOSS

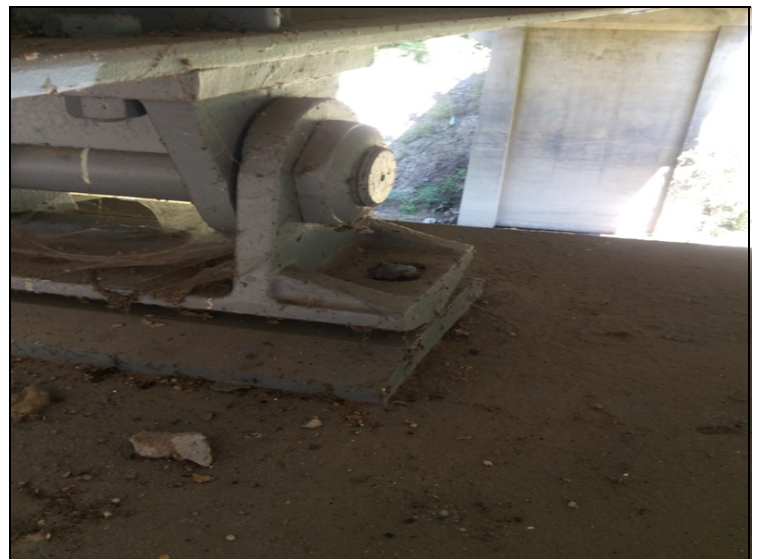
Missing anchor bolt top and nut

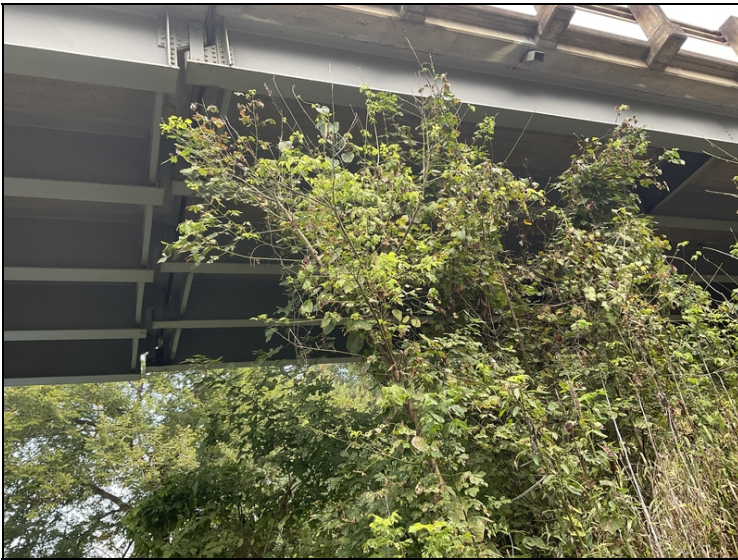
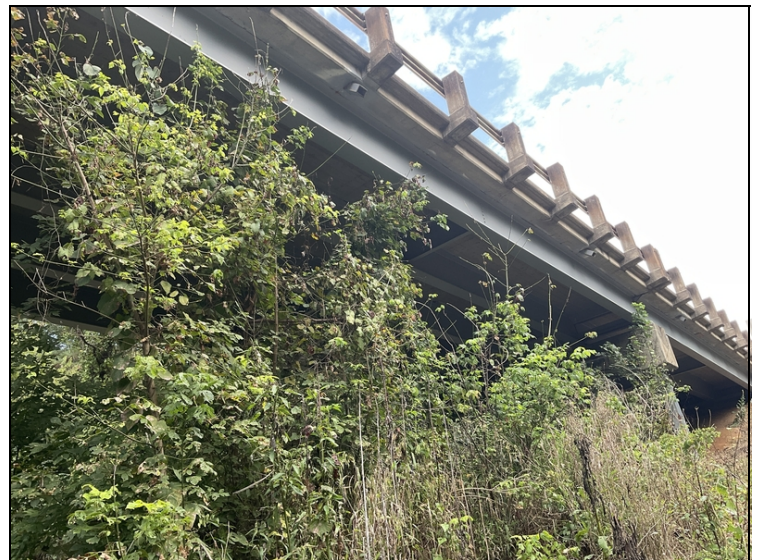
Trees need cut back

Trees and brush needs cut and sprayed around pin and hangers to get access with snooper
