Bridge #03571(Routine)

SH 108- 04 - 6.44 over I 30-SEC 11-L.M. 6.51

Team Lead: John King Inspection Date: August 10, 2022

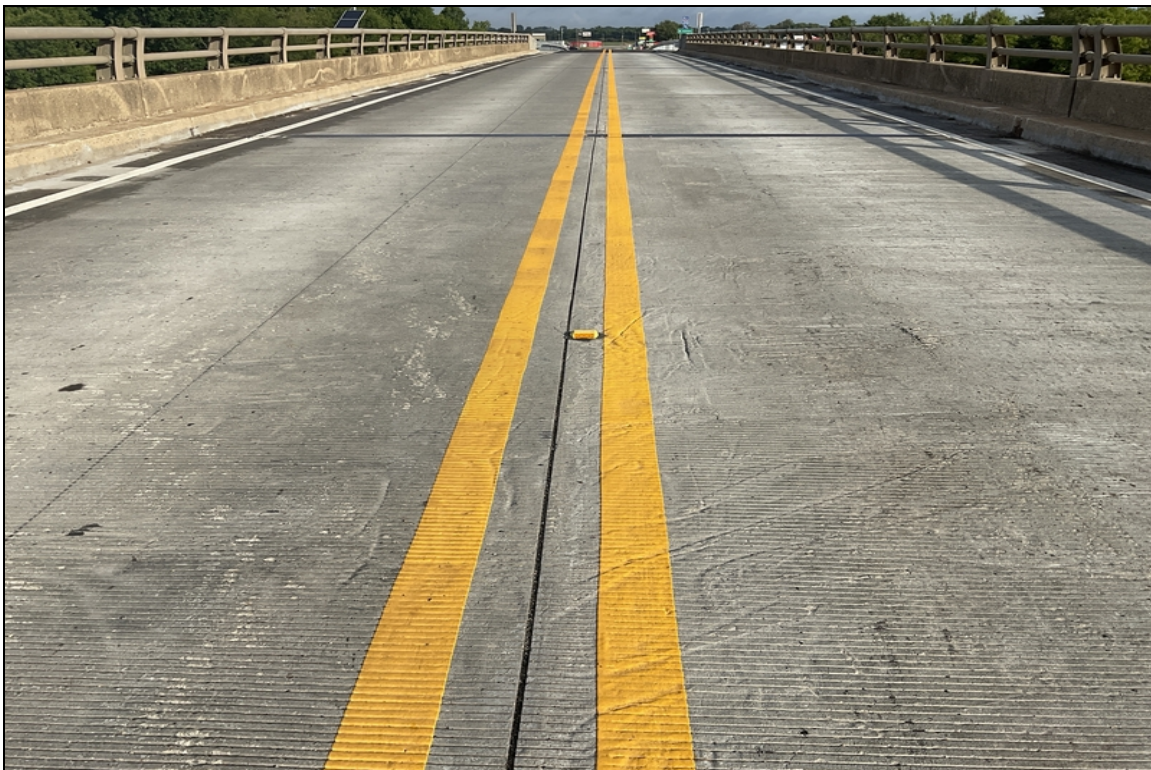
08/22 typical all spans photo of deck

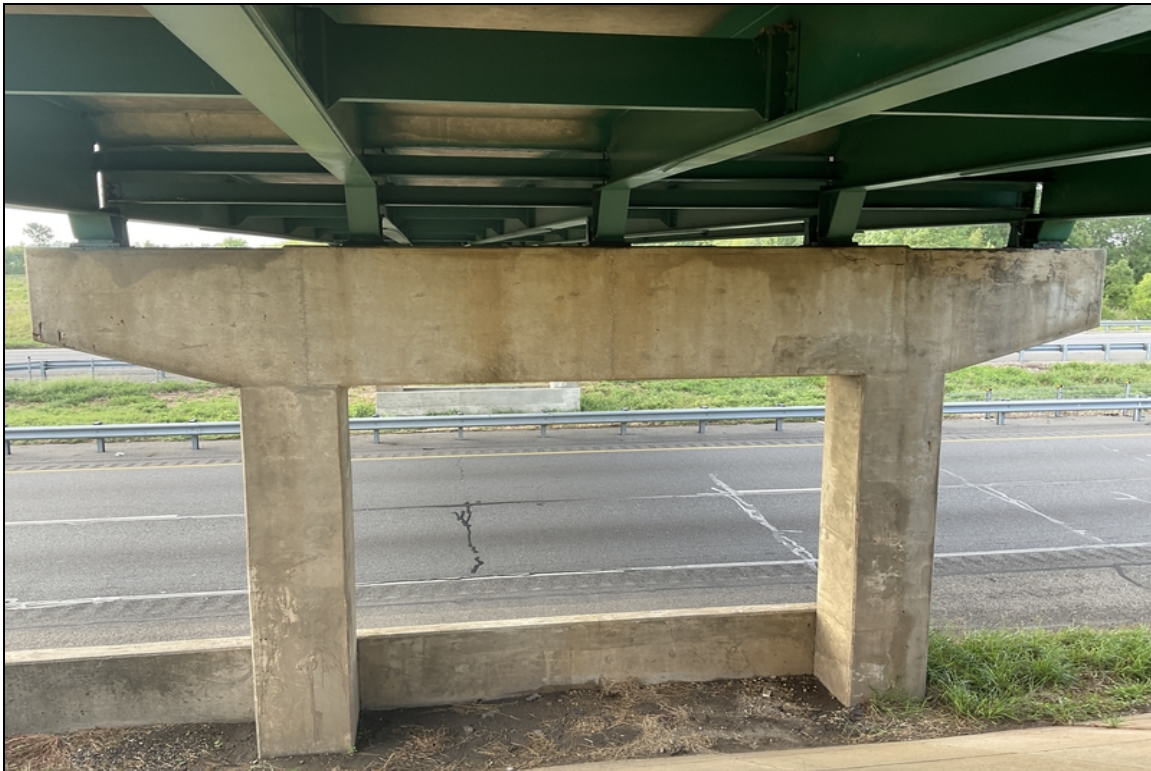
08/22 typical superstructure photo all bents

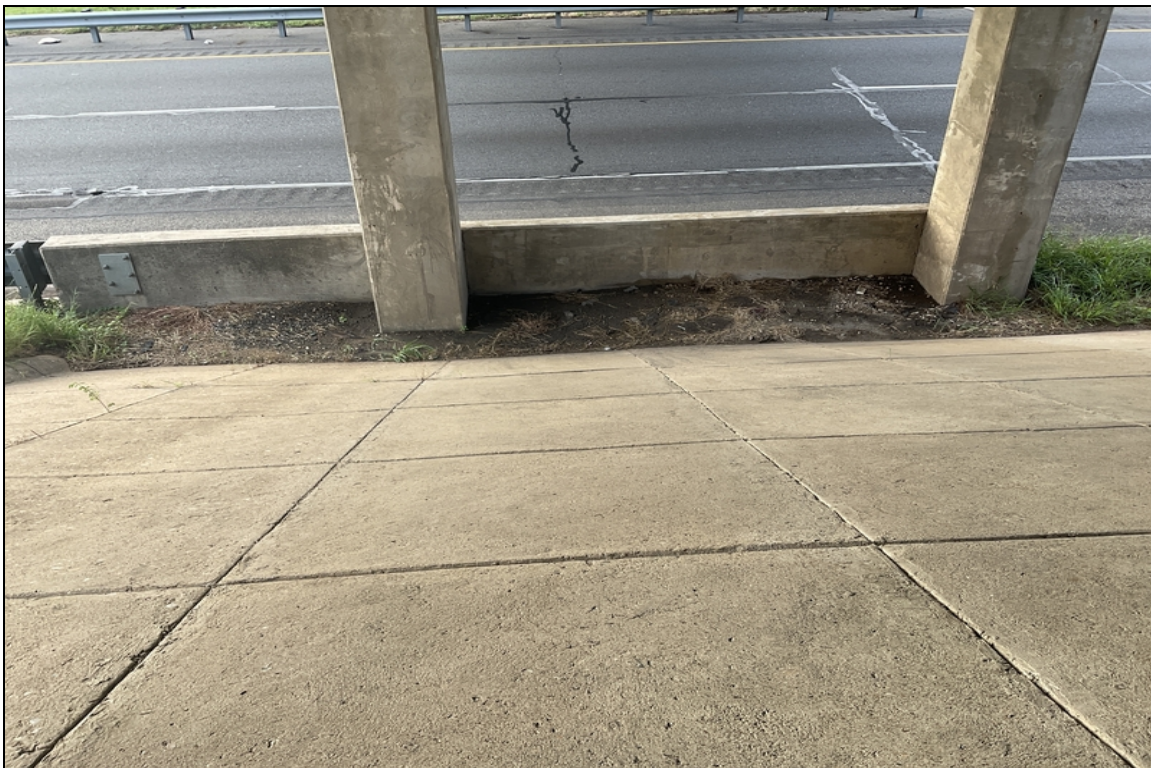
08/22 typical substructure photo all bents

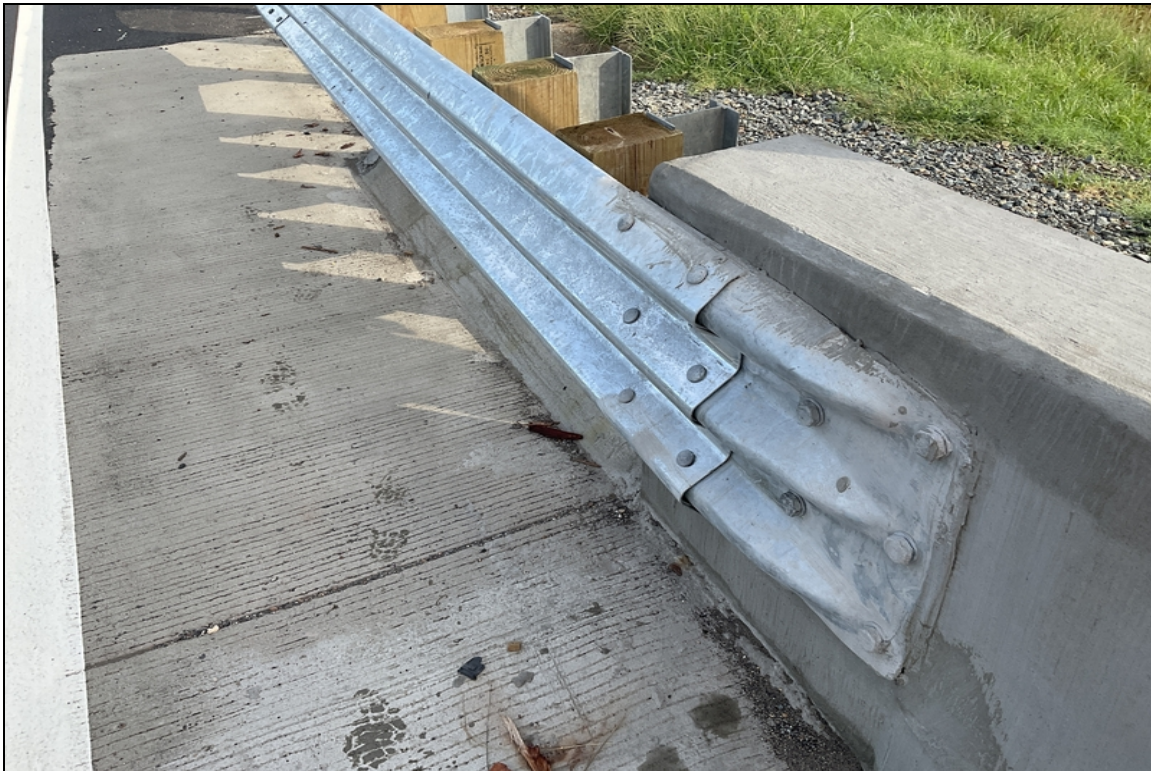
08/22 new guardrail installed per this inspection

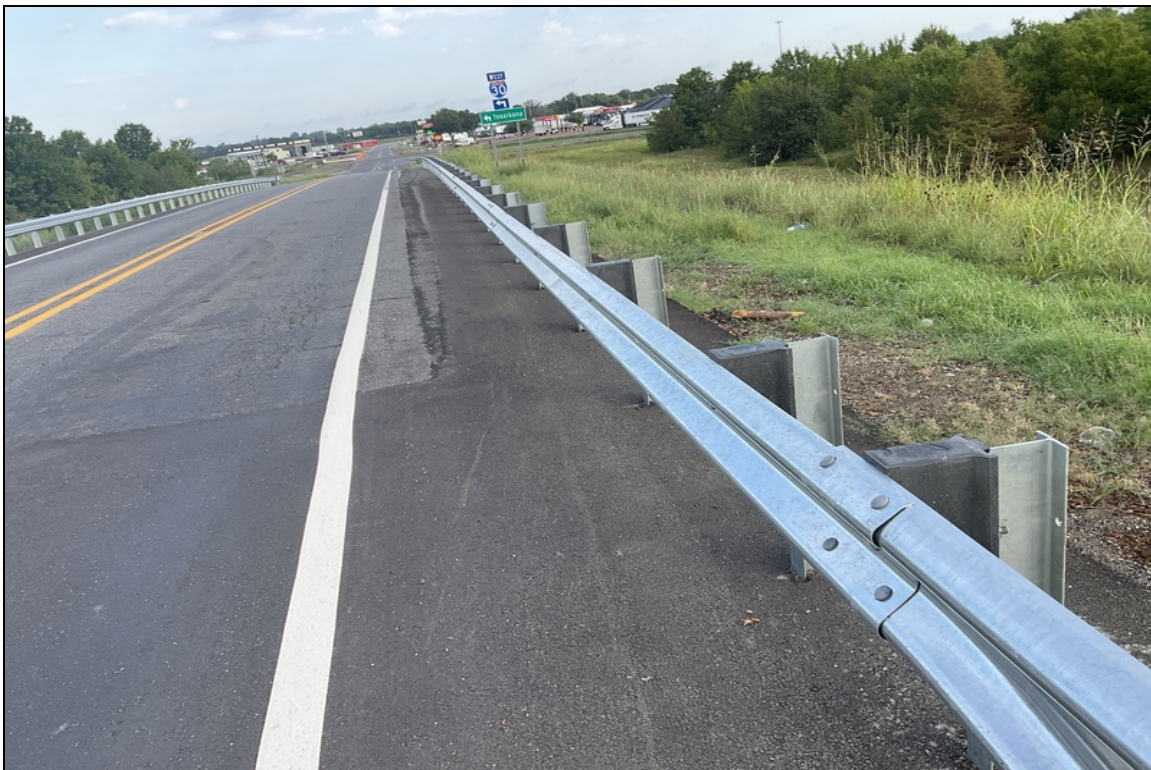
08/22 new guardrail installed per this inspection

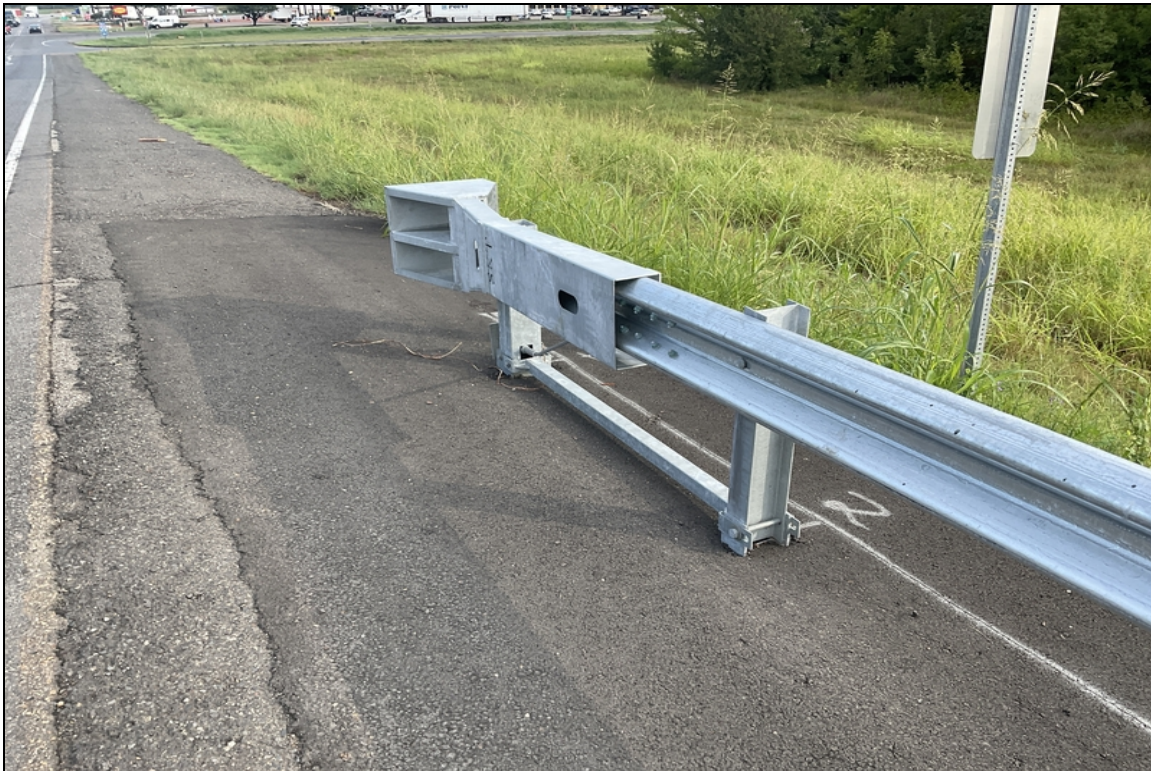
08/22 new guardrail installed per this inspection

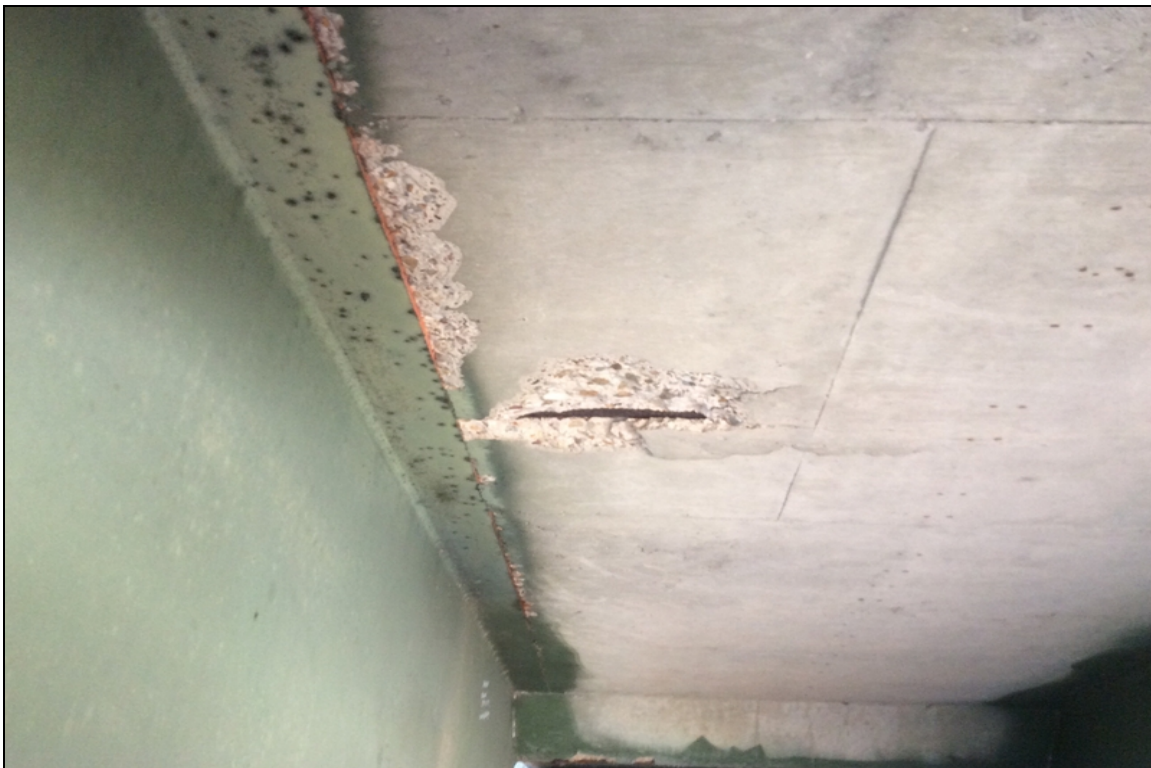
SPAN 1 SPALL WITH REBAR EXPOSED

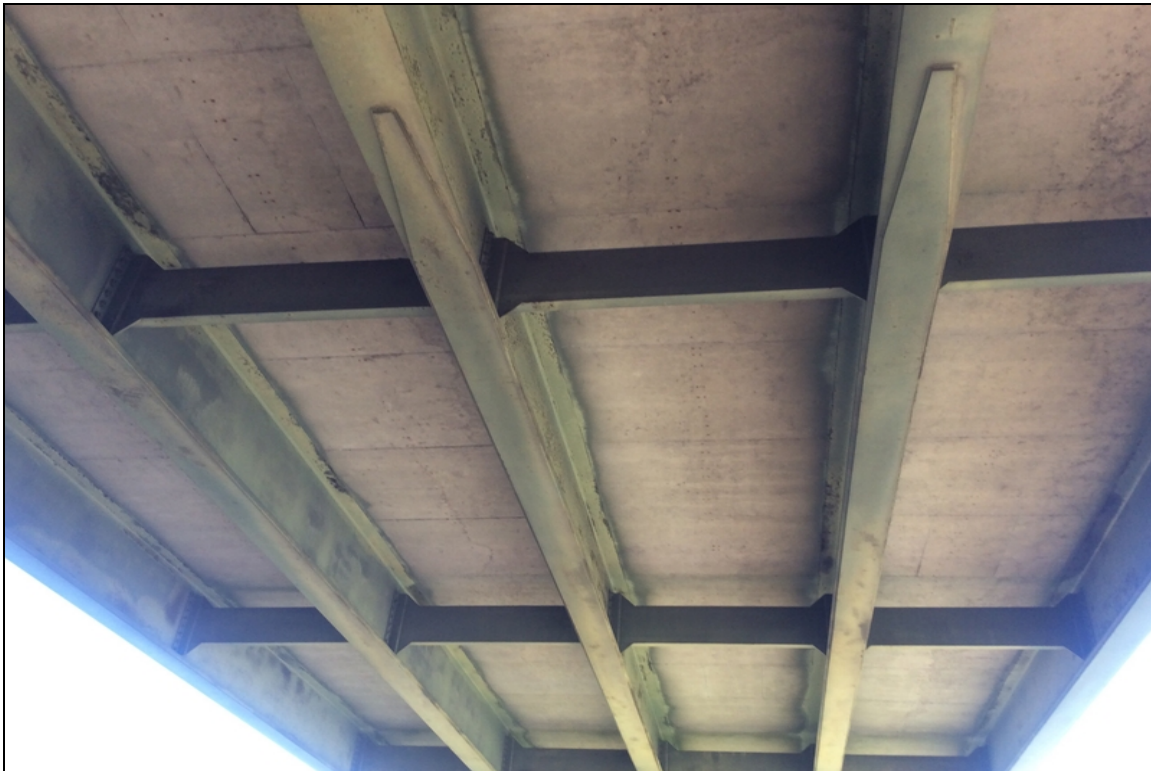
BOTTOM OF DECK TYPICAL ALL SPANS

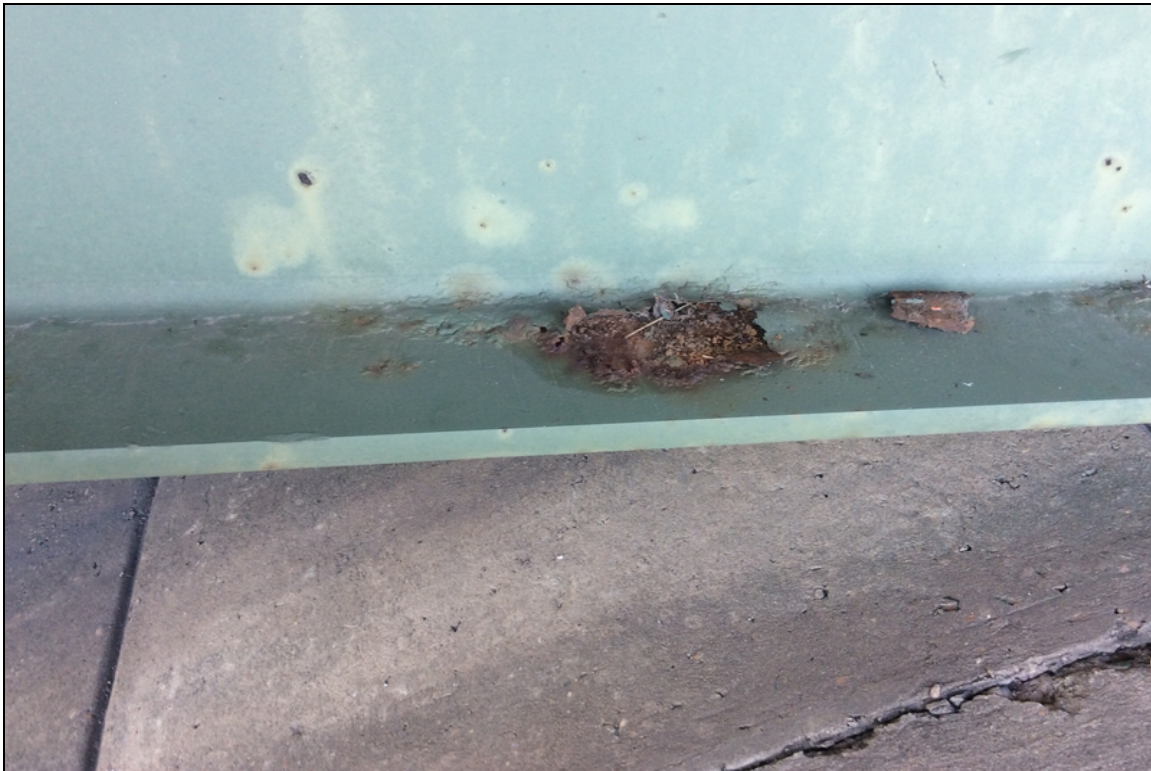
OUTSIDE BEAM RIGHT SIDE END BRIDGE

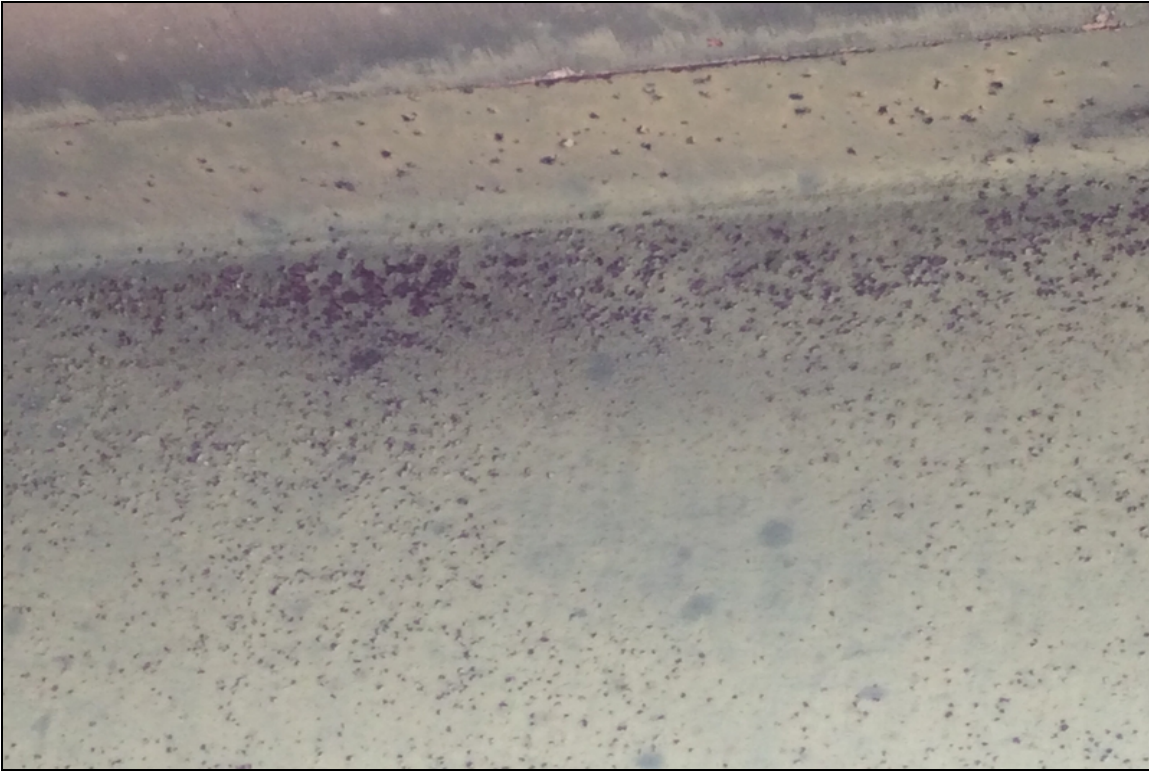
BEAMS RUSTING

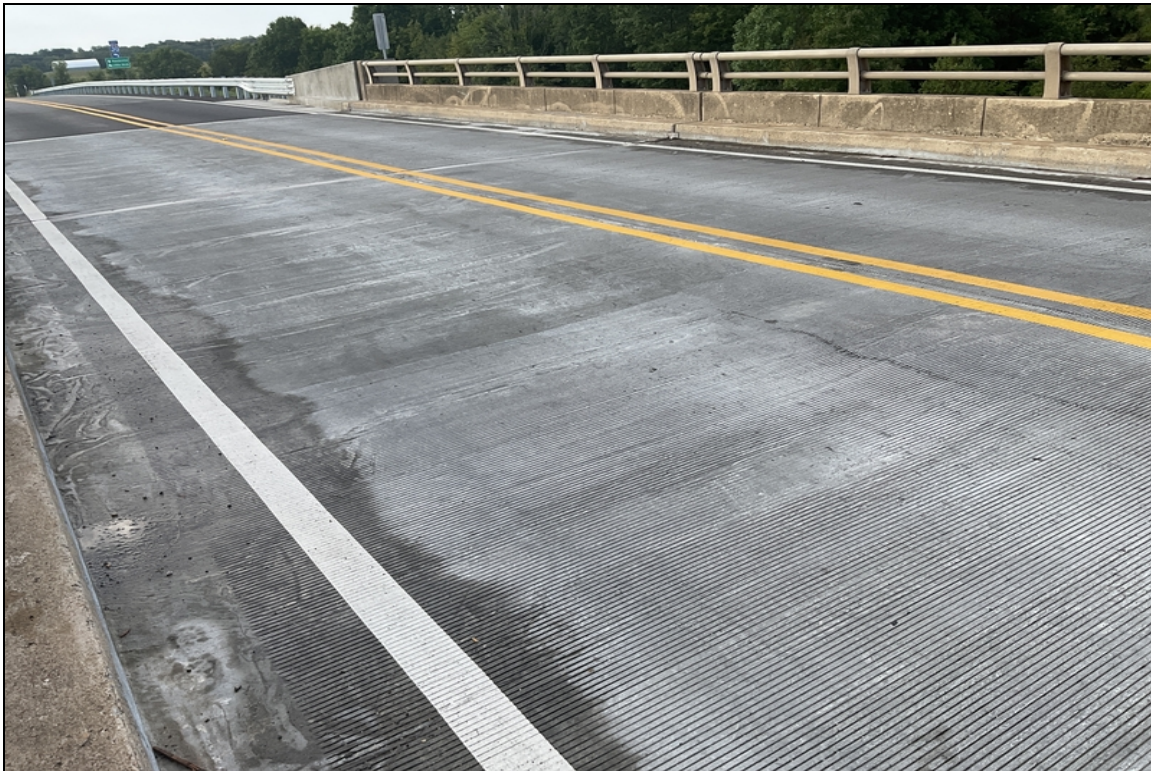
08/22 per this inspection hydro was completed on bridge deck

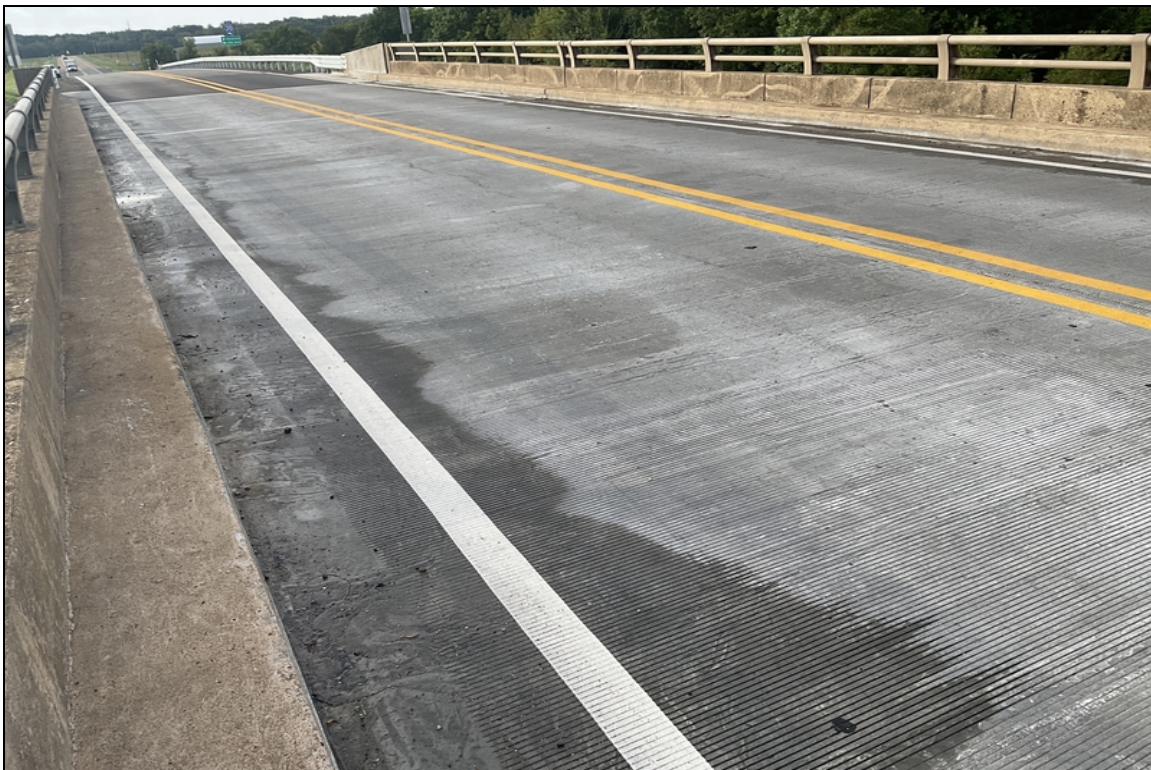
08/22 new hydro overlay per this inspection

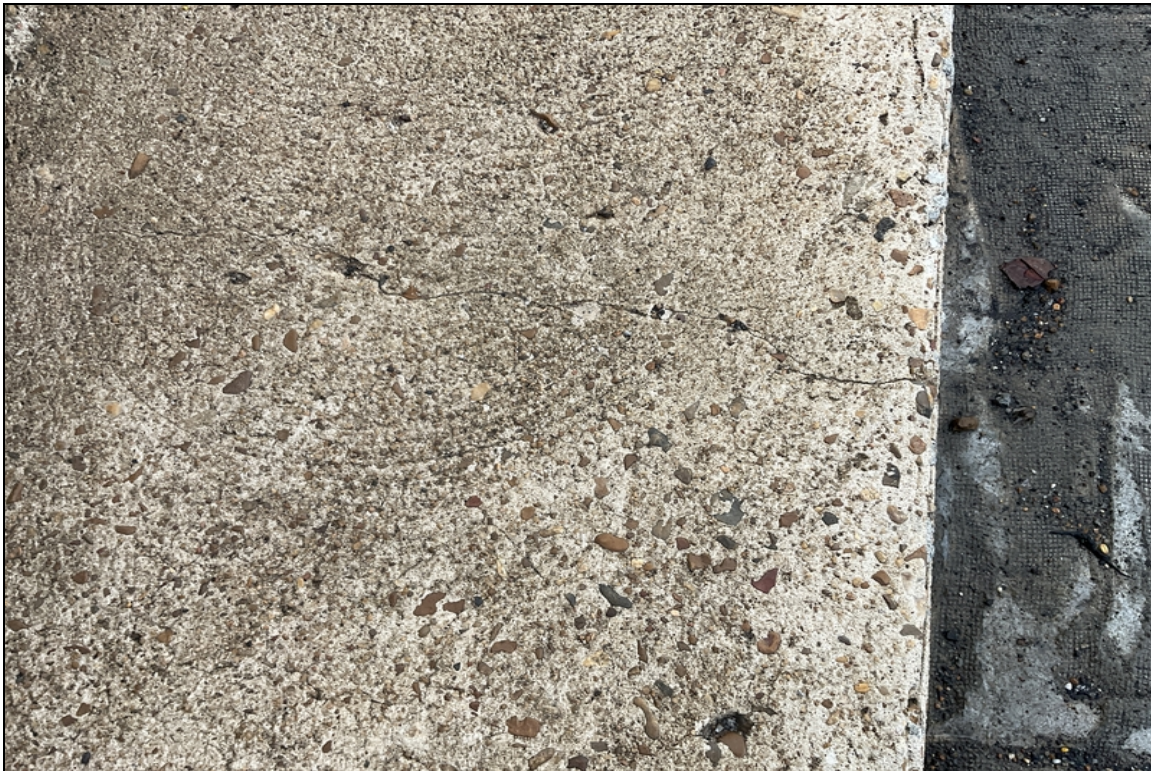
08/22 cracking in side of deck wheelguard various locations

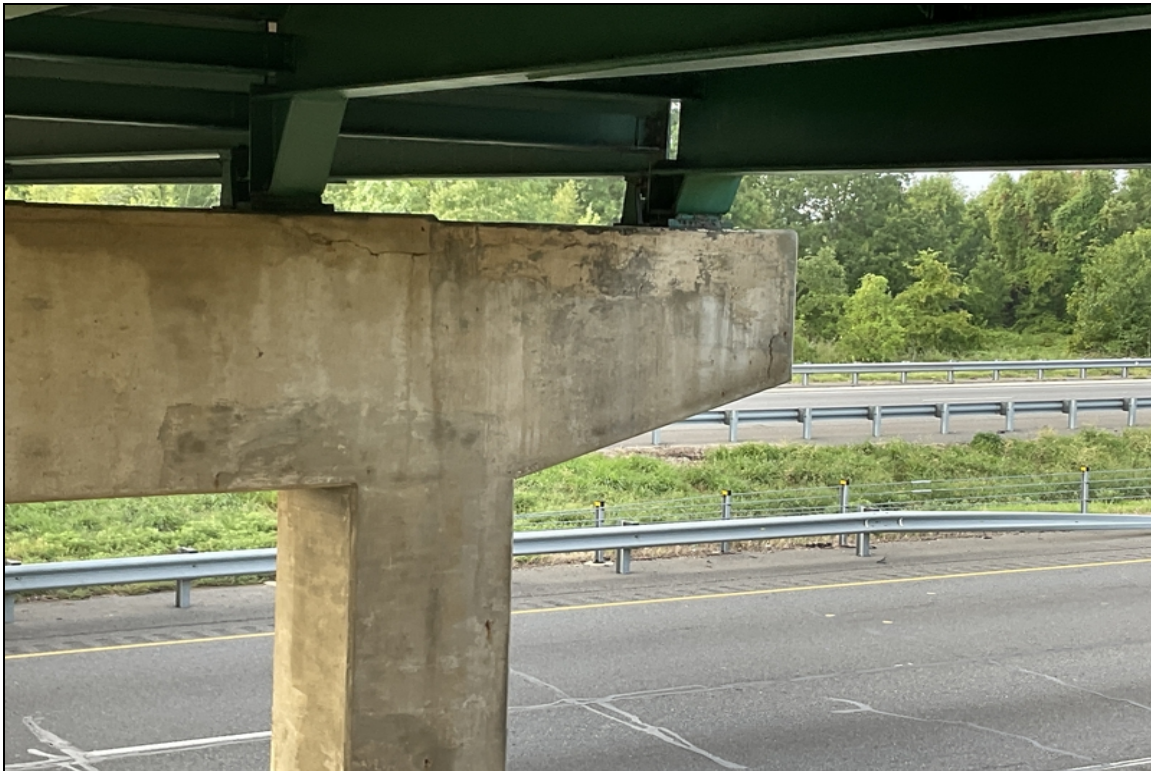
08/22 cracking on bent 2 grows to end of cap

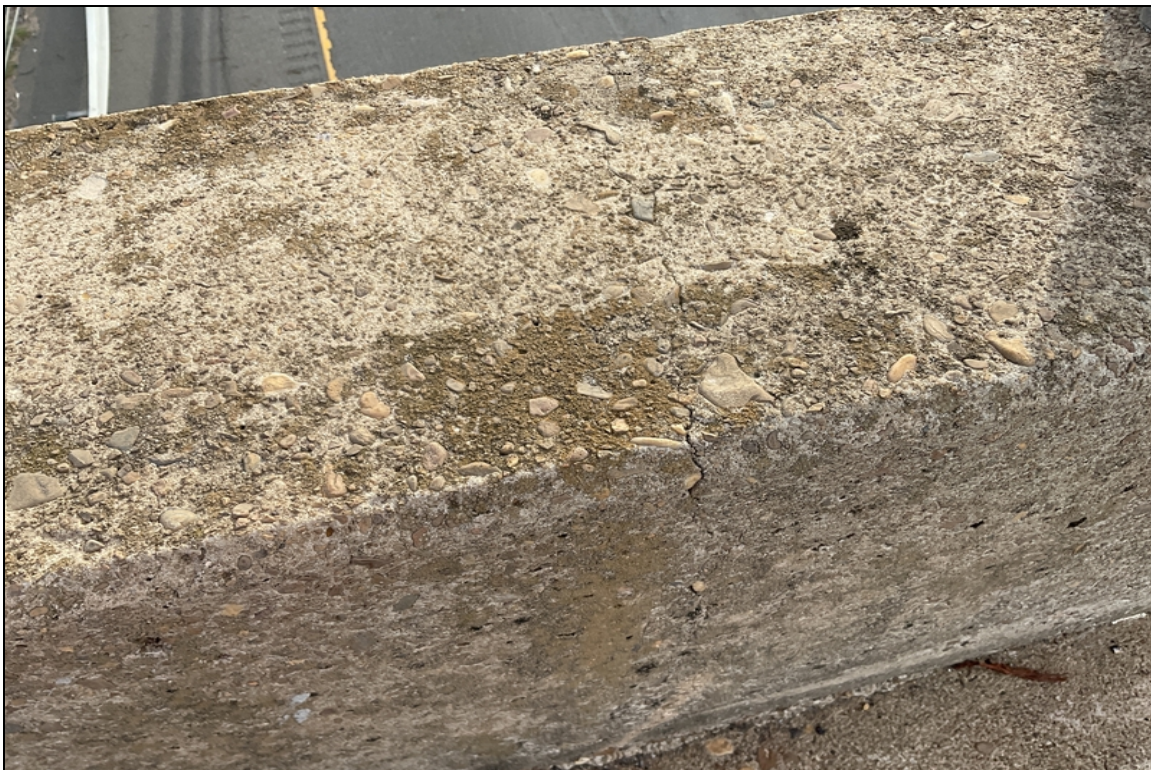
08/22 cracking in concrete bridge railing various locations

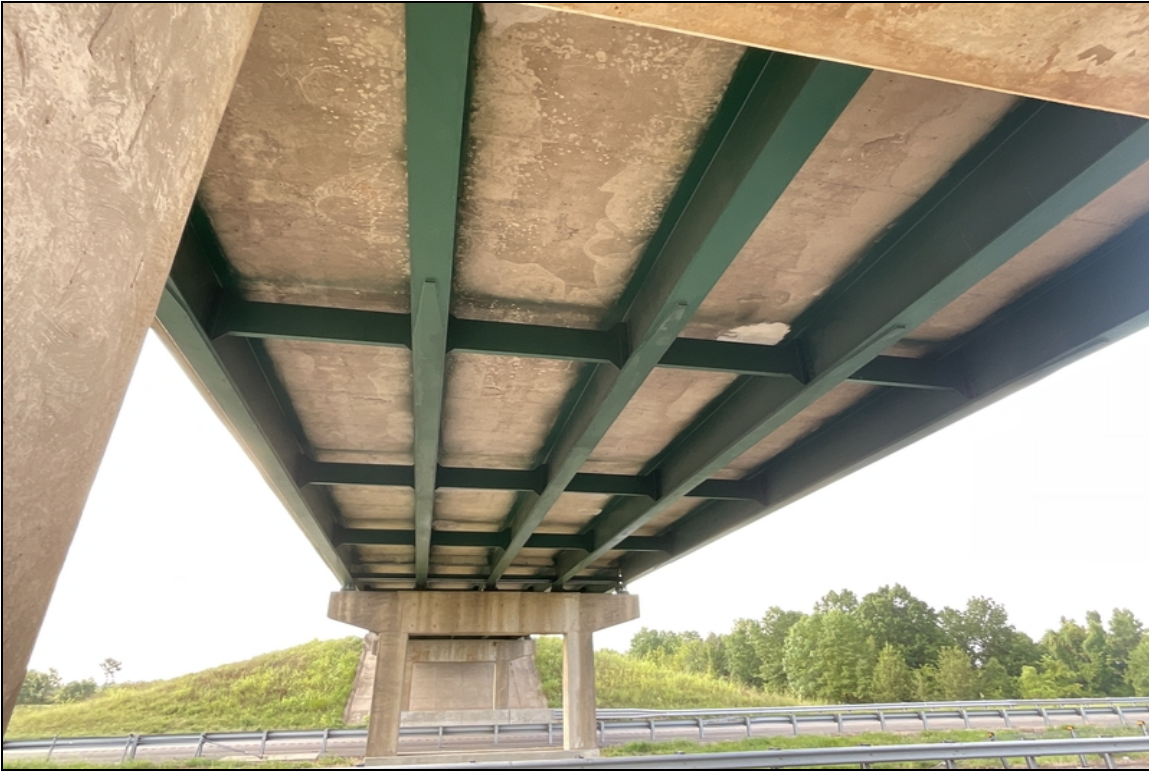
08/22 underside of deck typical all spans

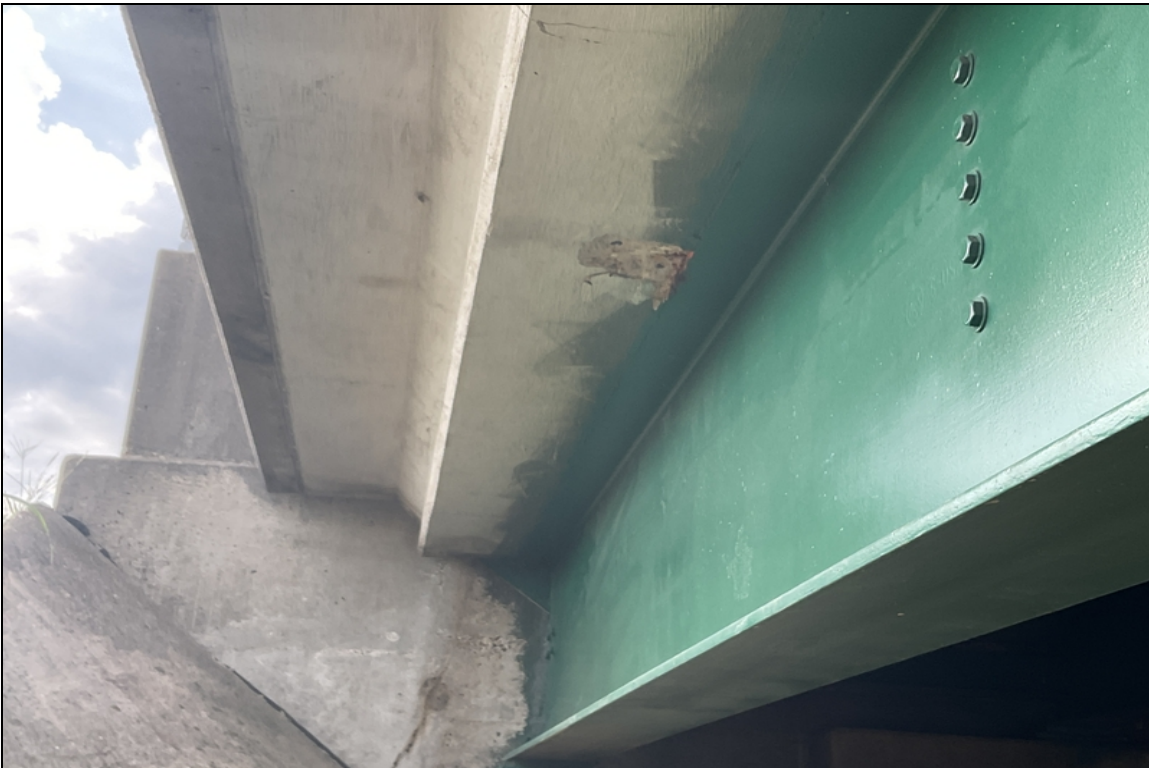
08/22 small delam span 4

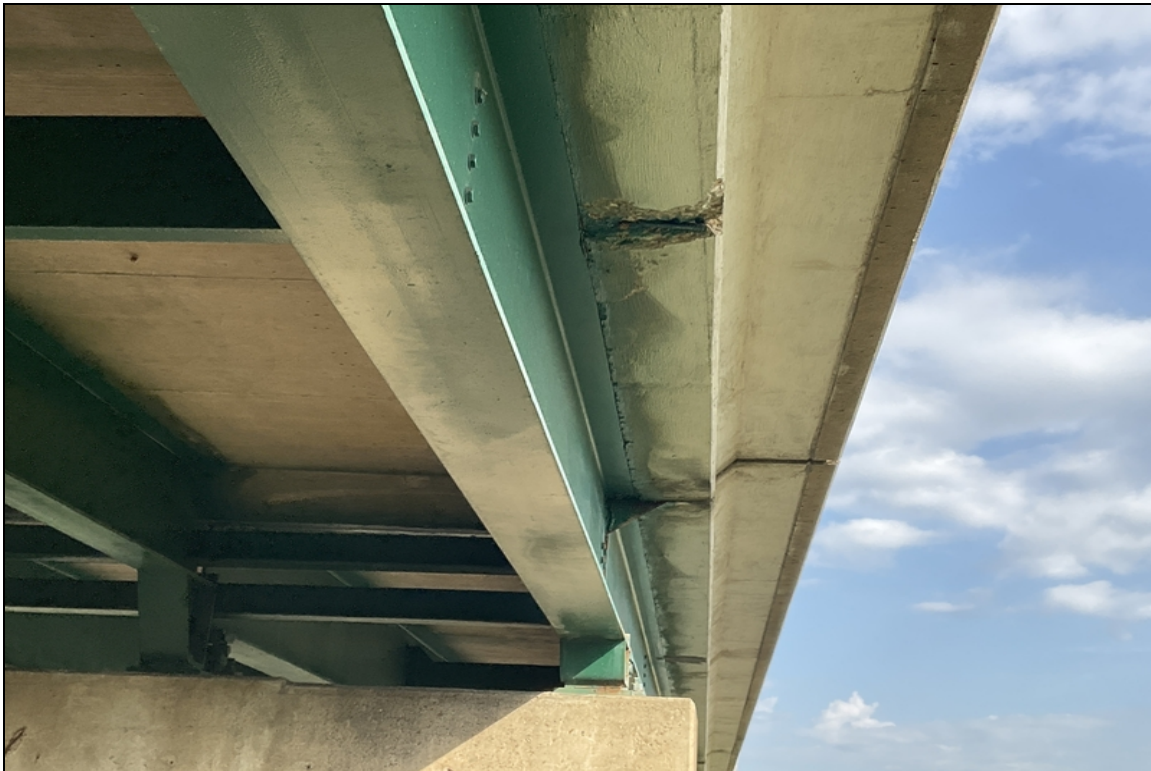
08/22 exposed rebar span 4

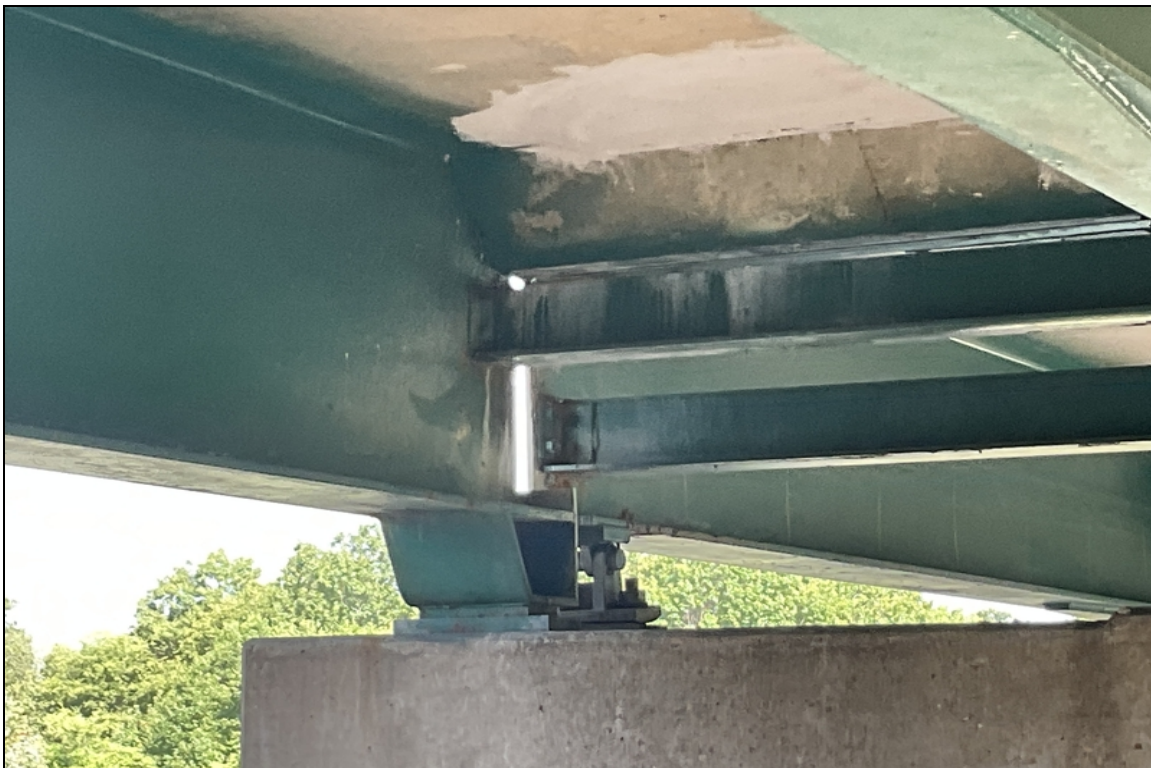
08/22 rust at end of beams various locations

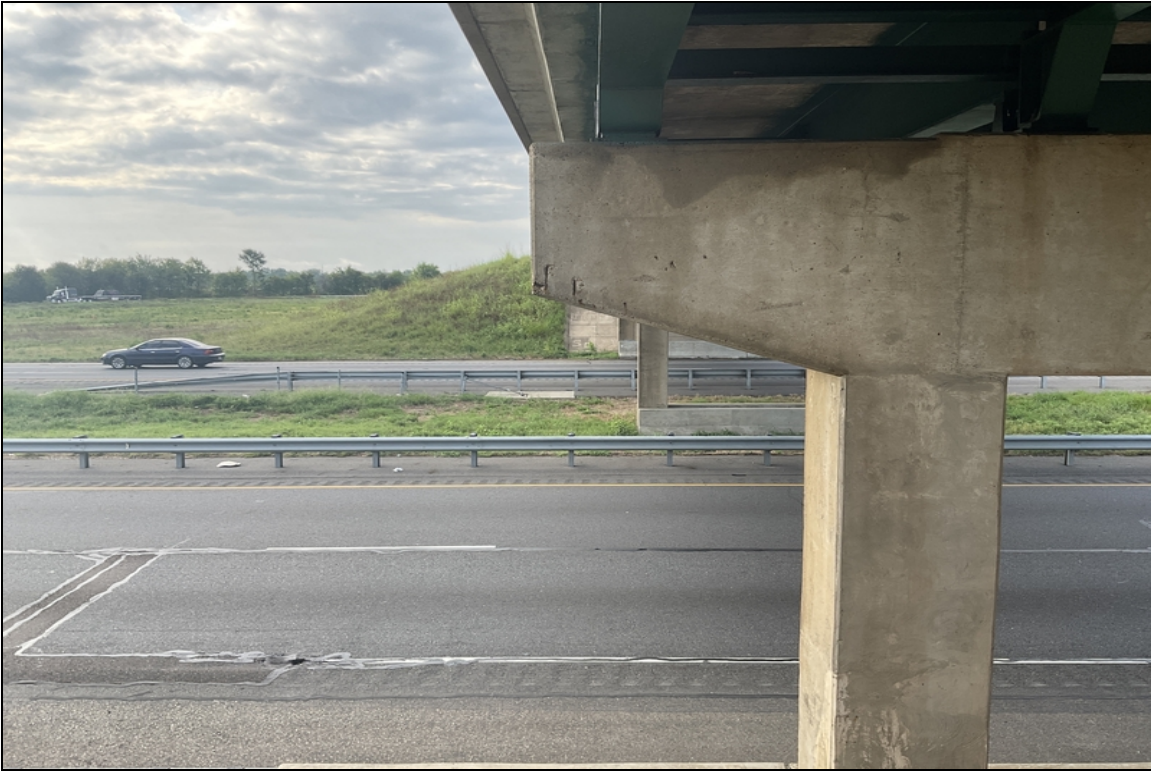
08/22 exposed rebar bent2 on cap

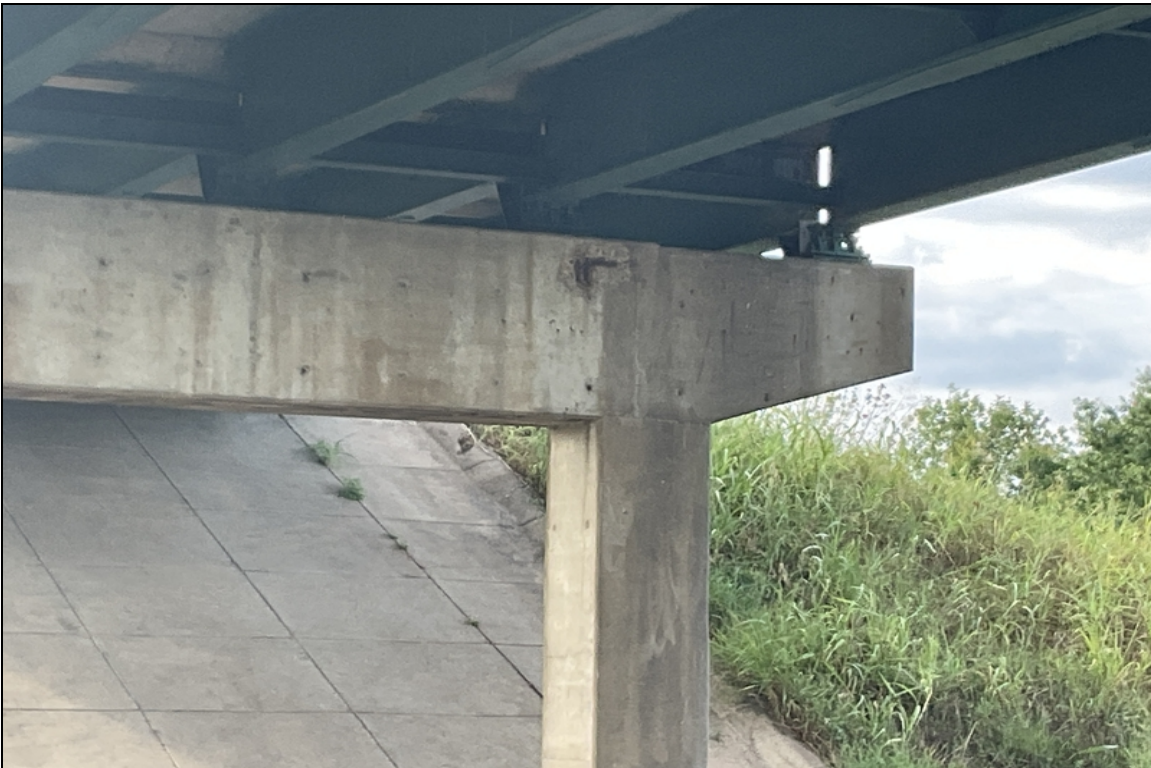
08/22 exposed rebar bent 4

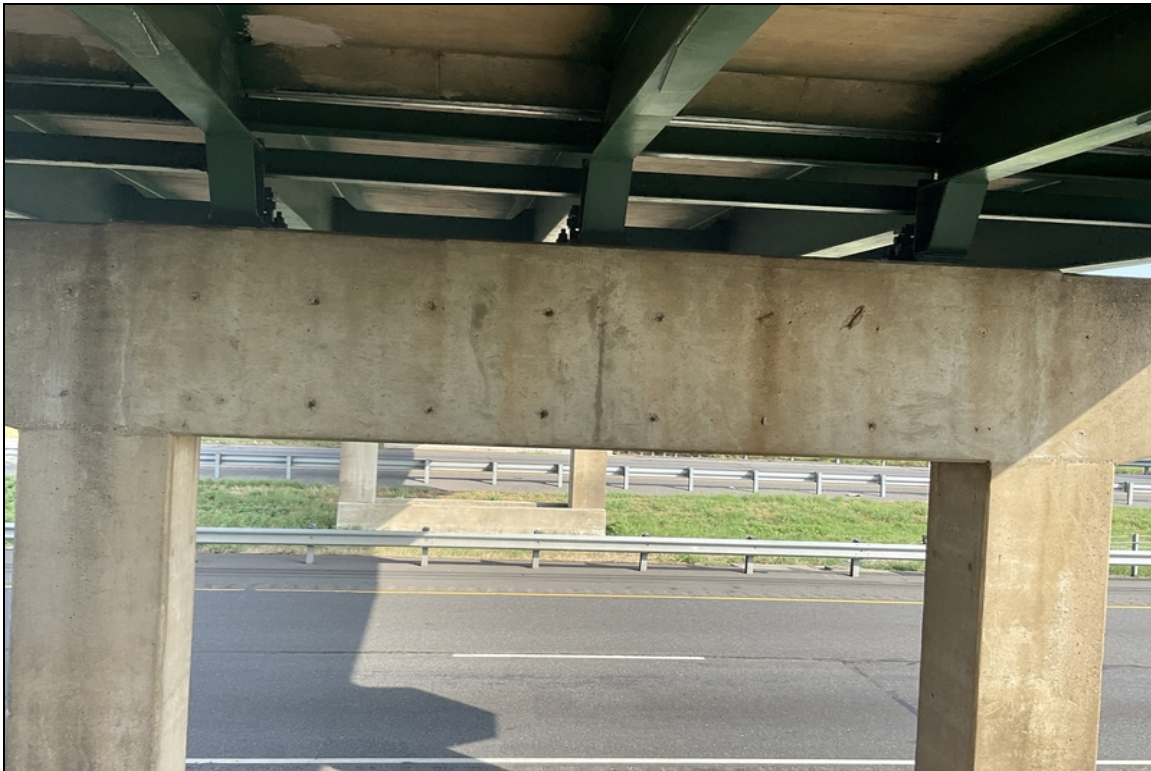
08/22 exposed rebar on bent 4

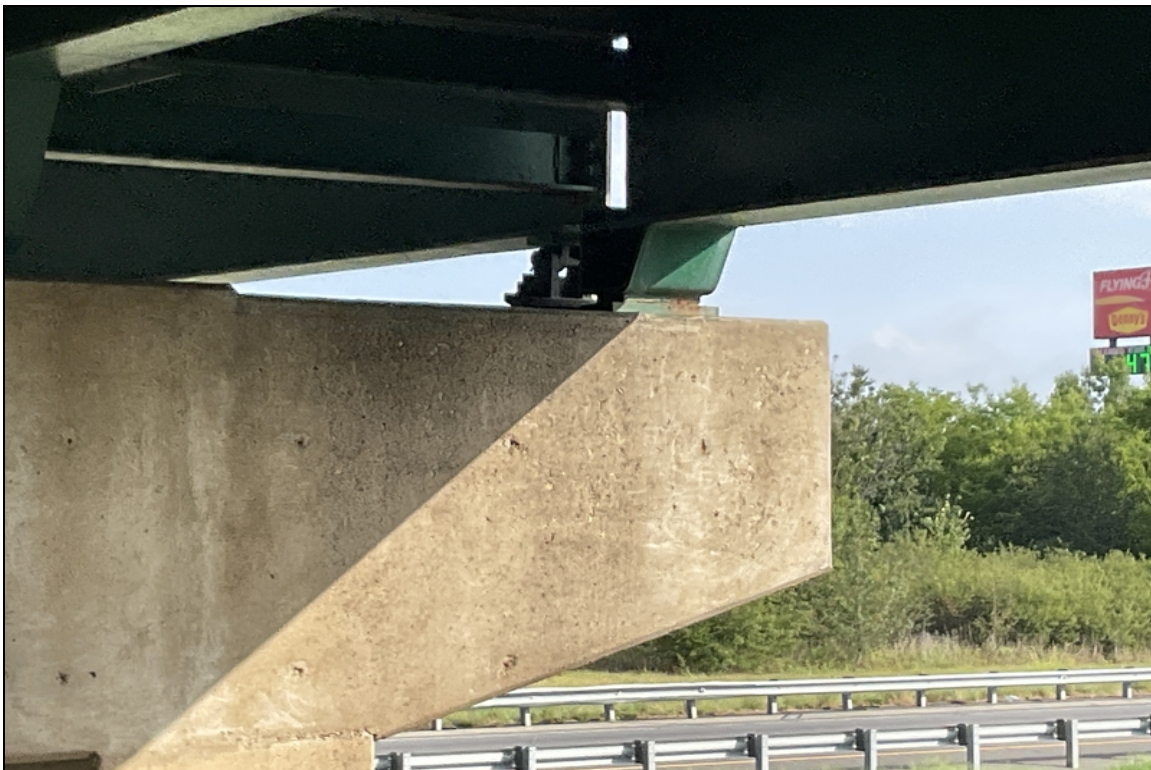
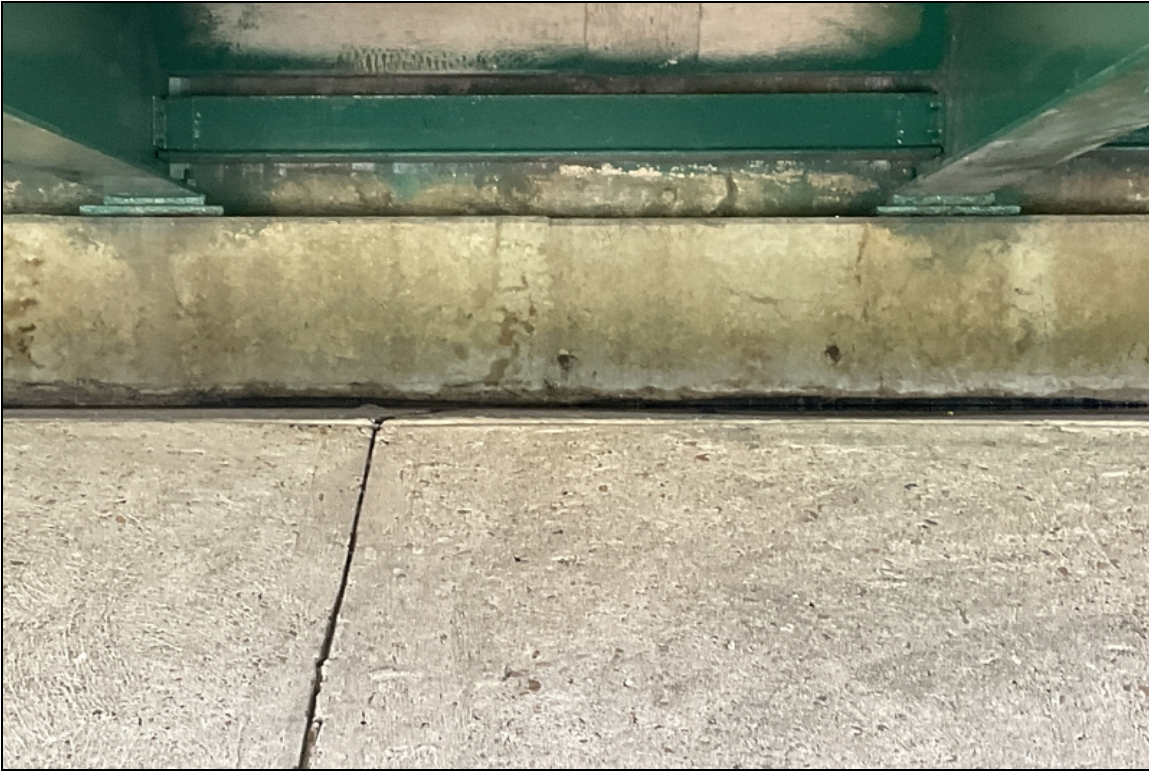
08/22 rust beginning to show on all bearings

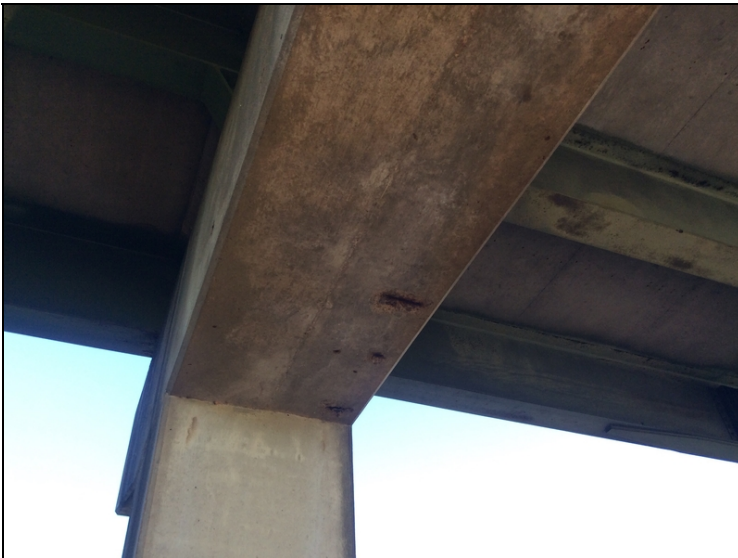
Bottom of bent 4 cap

CONC. CAP AT BENT #2 & #4, CAP HAS MINOR SPALLS WITH REBAR EXPOSED.
Bent 2 crack on Right side cap, under bearing, at beam 4 and 5

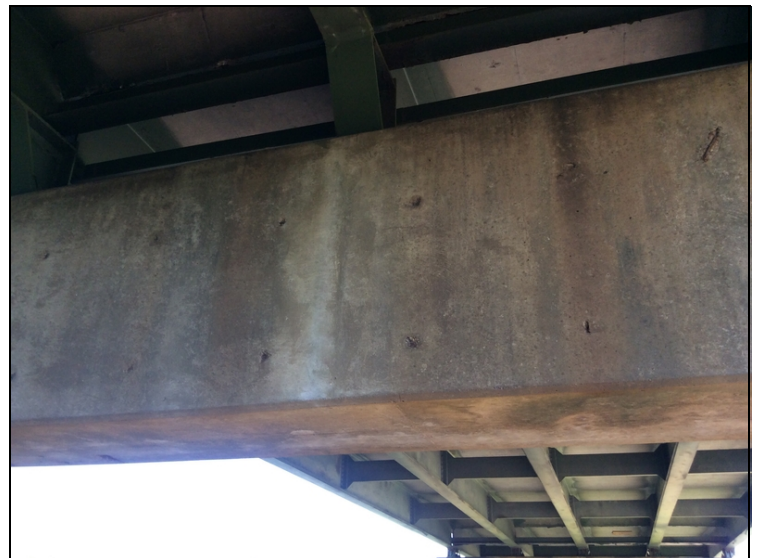
Minor areas bent 4 cap rebar exposed

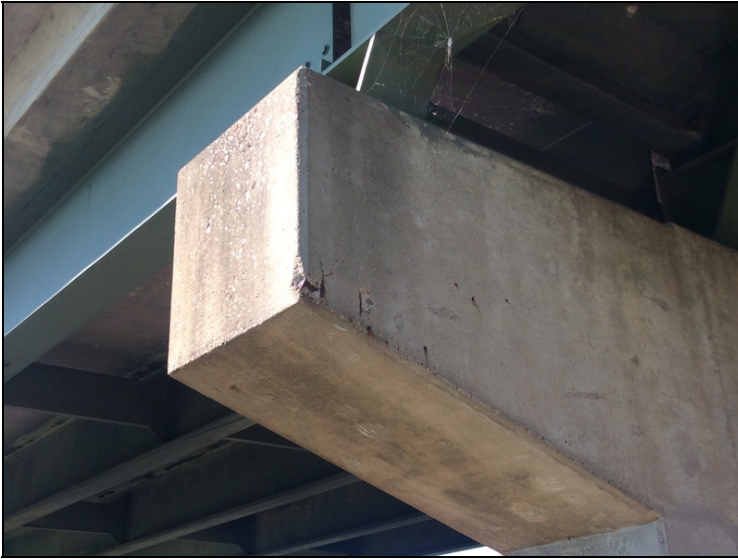
Bent 2 cap minor spall with rebar

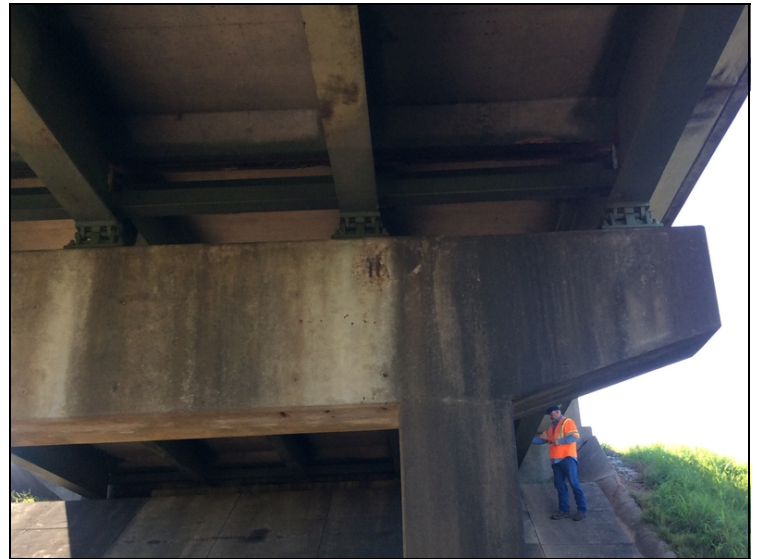
Bent 4 cap rebar exposed
