Bridge #03571(Routine)

SH 108- 04 - 6.44 over I 30-SEC 11-L.M. 6.51

Team Lead: John King Inspection Date: August 10, 2022

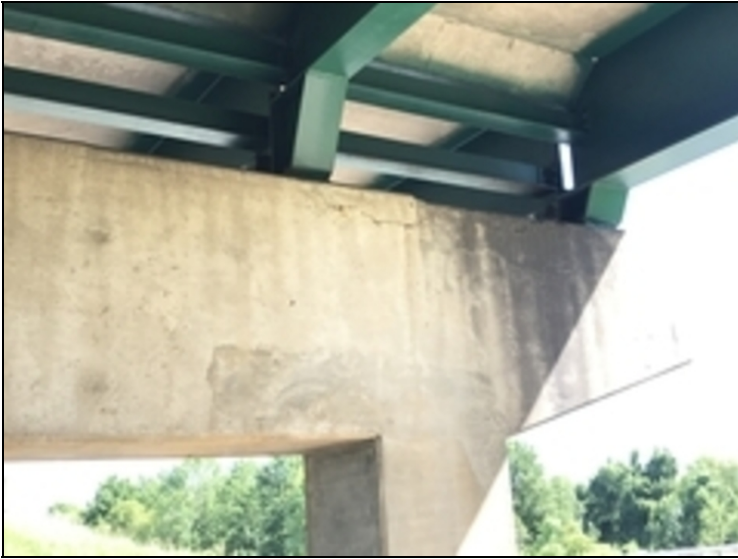
Bent 2 crack on Right side cap, under bearing, at beam 4 and 5

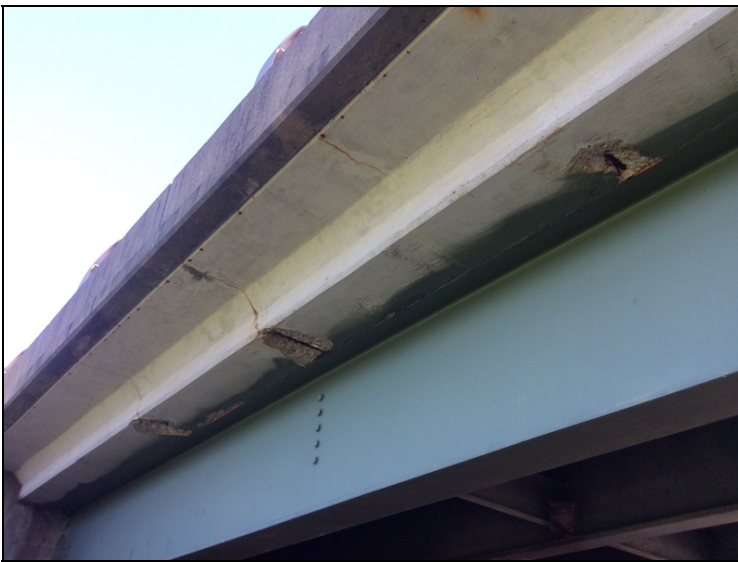
LEFT AND RIGHT SIDE OVERHANG AREA
NUMEROUS SPALLS WITH REBAR EXPOSED

Spalls in overhangs left and right sides

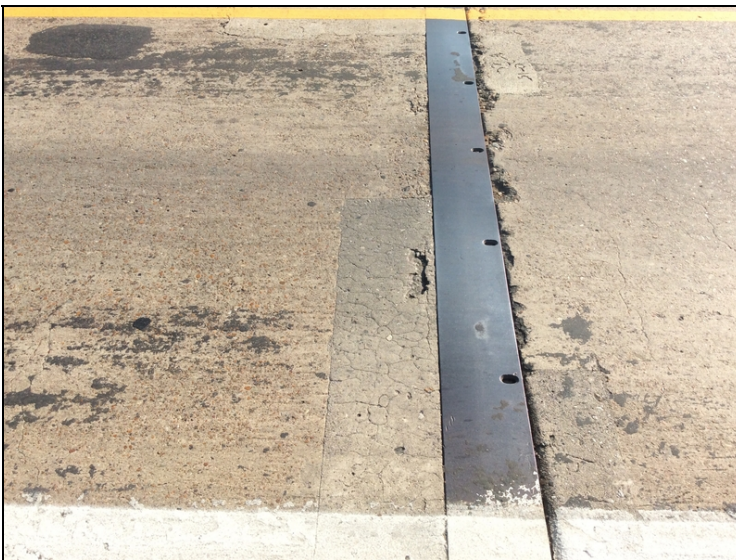
SPAN 3 RIGHT SIDE

POPOUT IN OLD PATCH ON DECK SPAN 3 RIGHT SIDE...08/22 Repaired popout due to hydro overlay

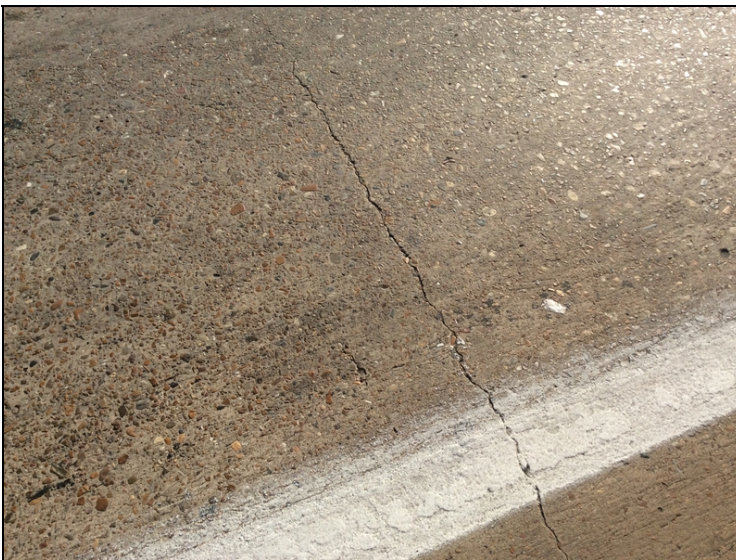
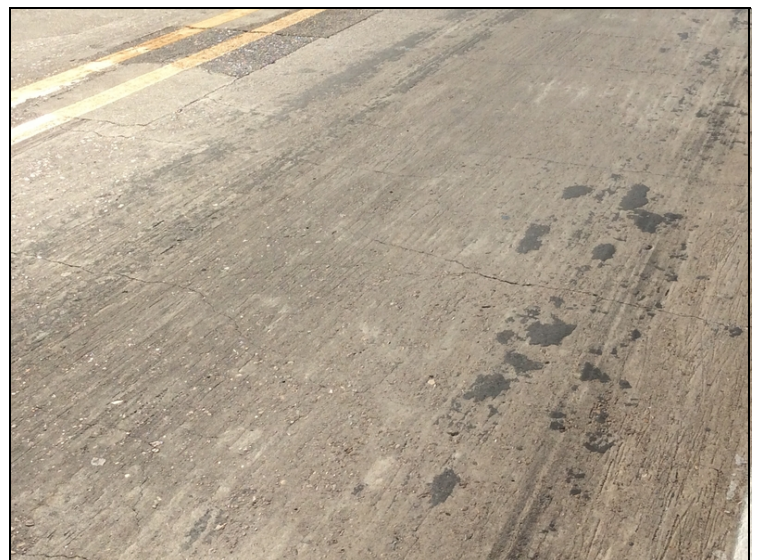
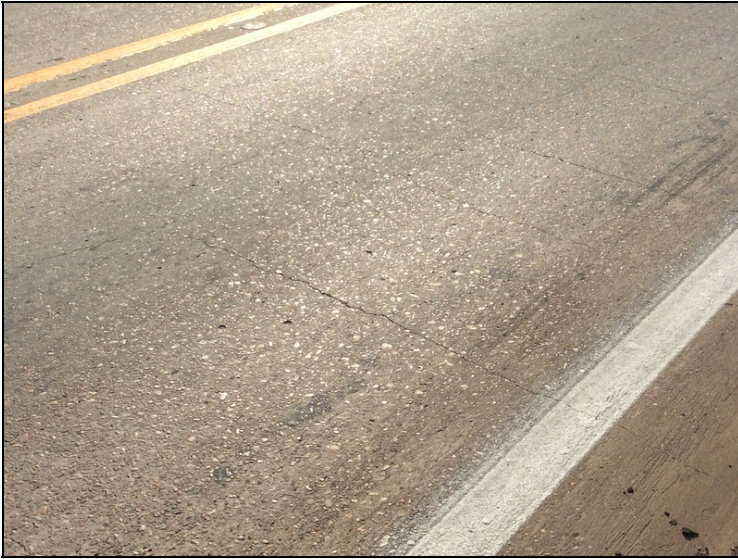
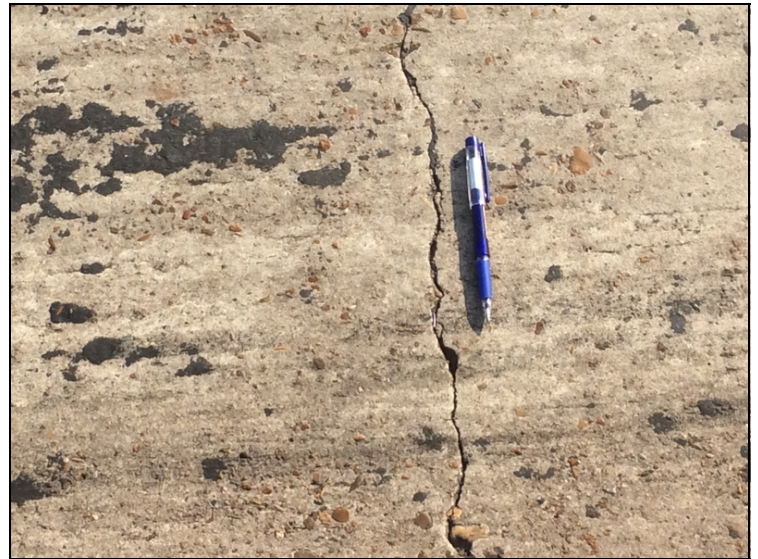
SEALABLE DECK CRACKS VARIOUS LOCATIONS ENTIRE BRIDGE...08/22 Repaired cracking due to hydro overlay

08/22 Repaired cracking due to hydro overlay

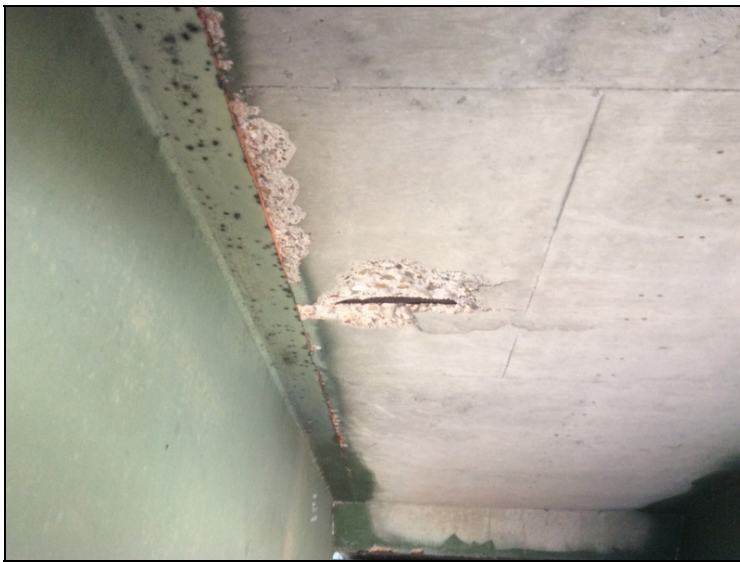
SPALL WITH REBAR EXPOSED BOTTOM OF DECK SPAN 1..08/22 Patch work was completed when new hydro overlay was done..

SPAN 1 SPALL WITH REBAR EXPOSED
