Asset #01029(Routine, Underwater type 2)

SH 27 - 04 - 4.40 over LITTLE MISSOURI RIVER

Location: 4.40 MI NE HEMPSTEAD CO

Team Lead: John King, Inspection Date: 07/20/2022

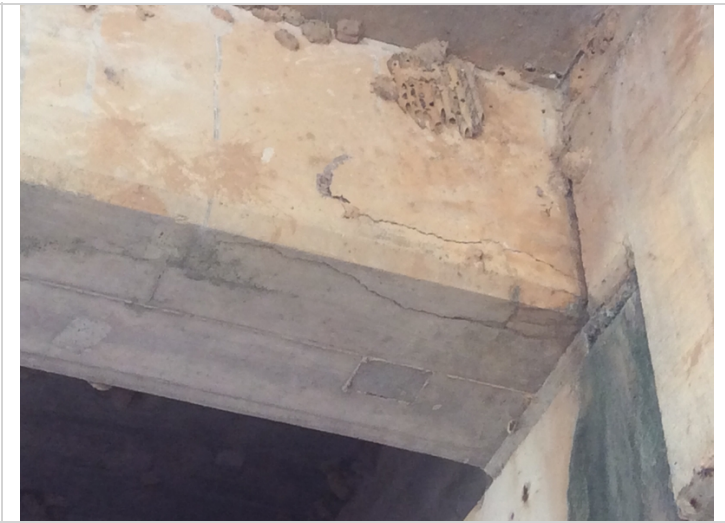
CRACKING BOTTOM OF GIRDER SPAN 9

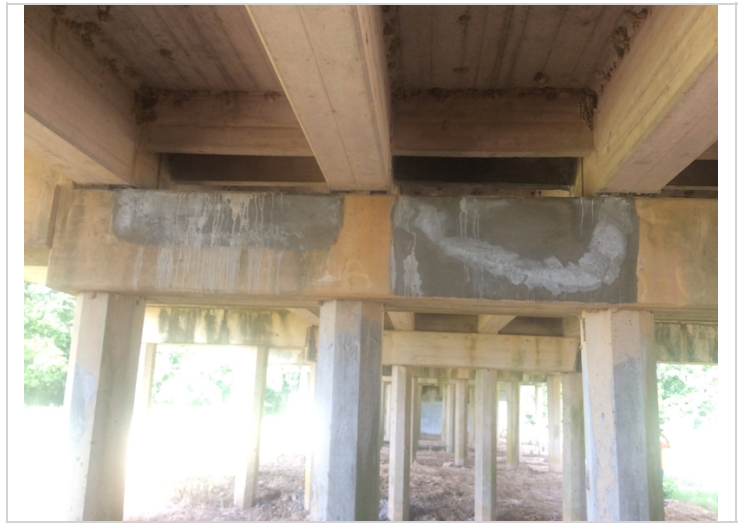
REPAIR WORK DONE BENT 10

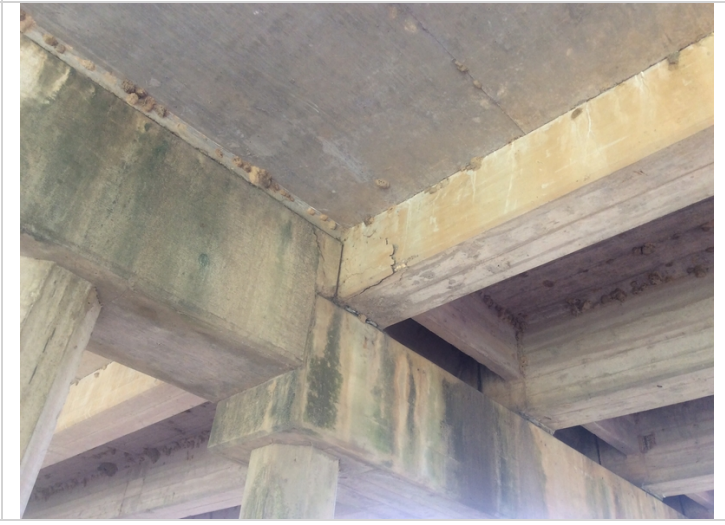
SPAN 7 CRACK IN GIRDER

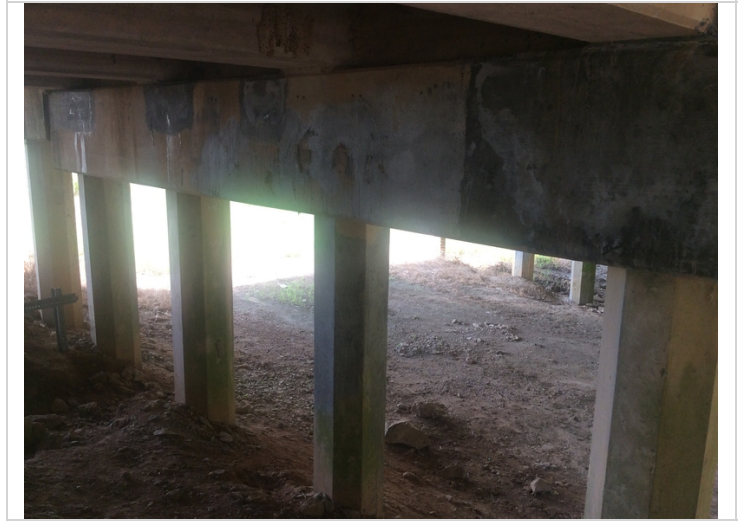
REPAIR WORK DONE BENT 11

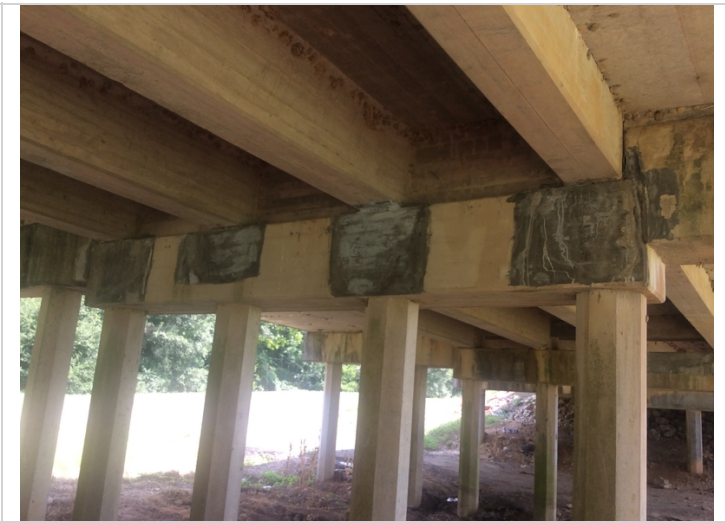
REPAIR WORK DONE BENT 9

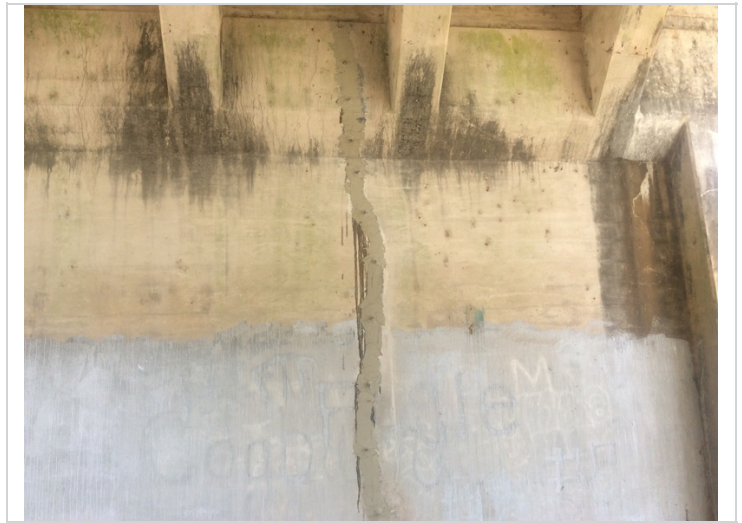
REPAIR WORK DONE BENT 5

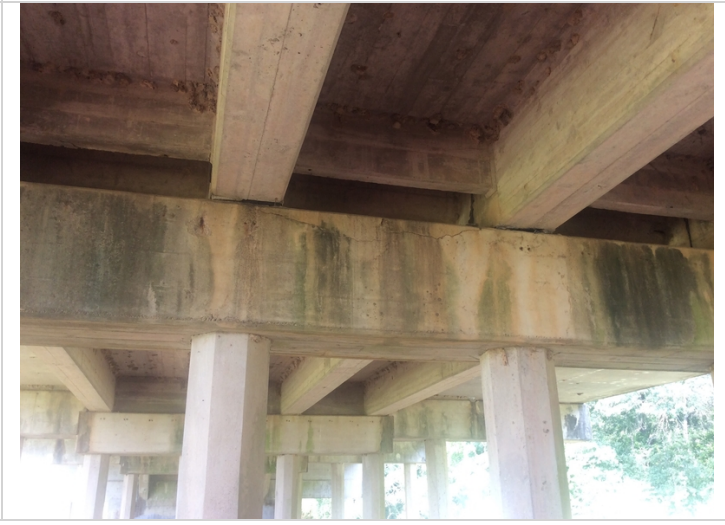
CRACKING TOP OF CAP BENT 8

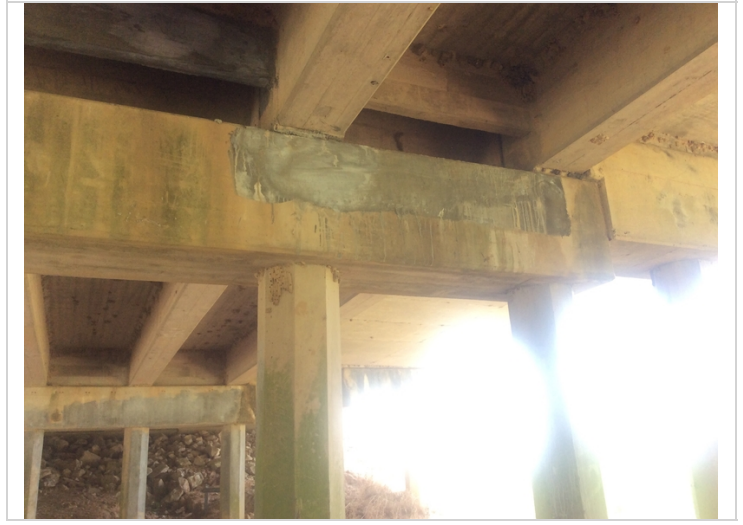
REPAIR WORK DONE BENT 10

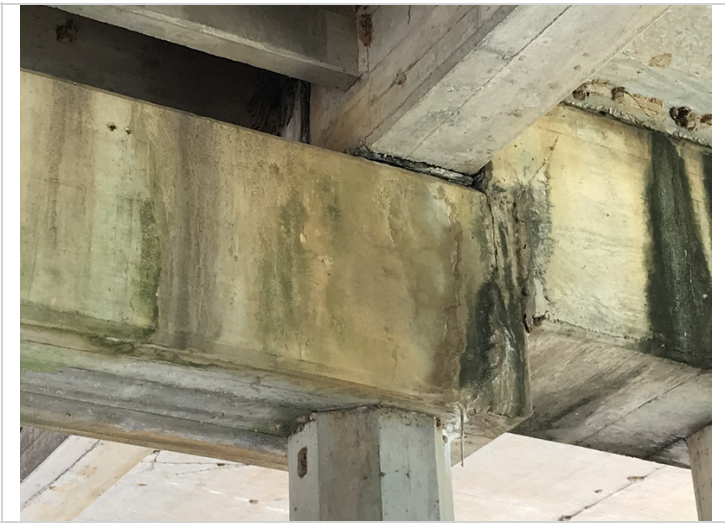
Bent 4 cracks in RCDG and cap

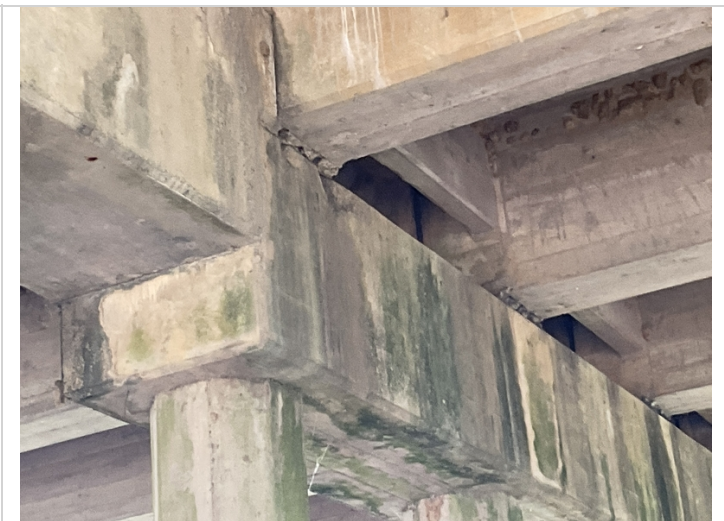
07/22 delams various locations.

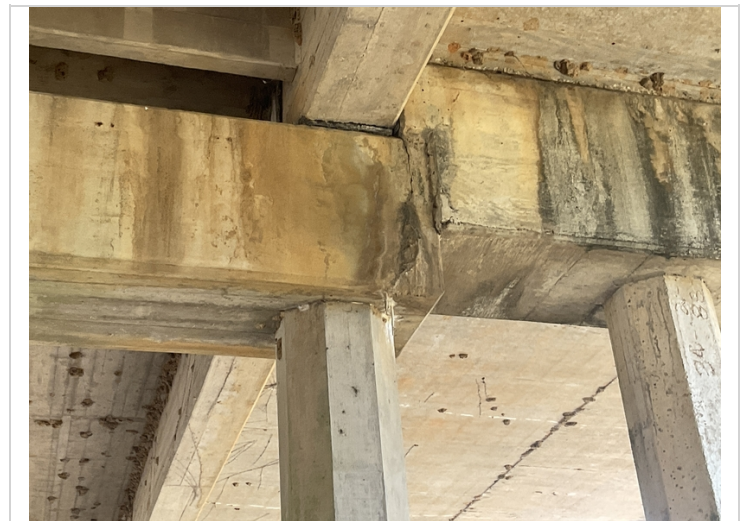
07/22 cracking with efflorescence on bent 4 center cap top right corner

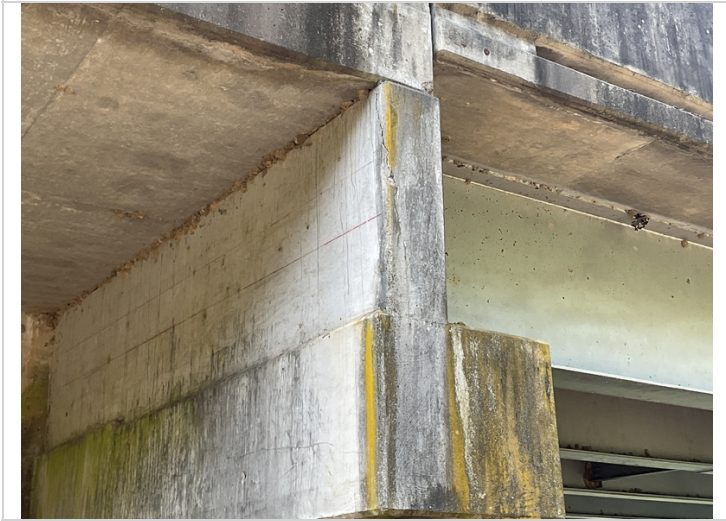
07/22 bent 8 cracking left side top of cap

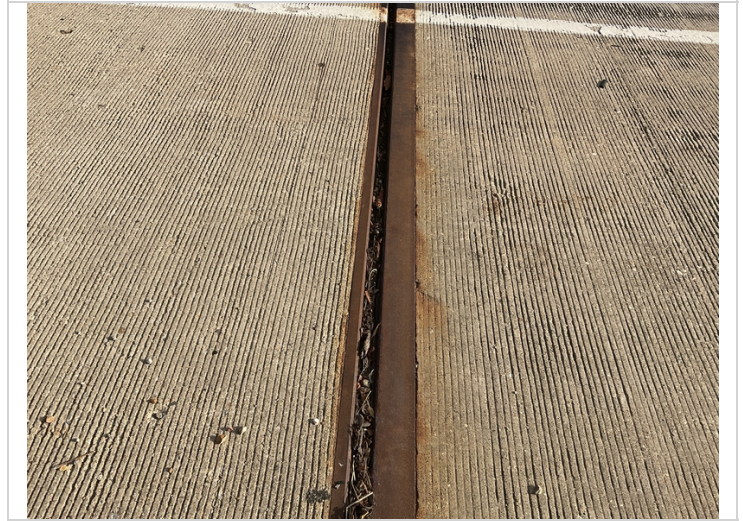
| ELEMENTS | DESCRIPTION | UNITS | TOTAL | CS1 | CS2 | CS3 | CS4 |
|---|---|---|---|---|---|---|---|
| (2350-301) 07/22 debris impacting on expansion joints | | | | | | | |

07/22 debris impacting on expansion joints

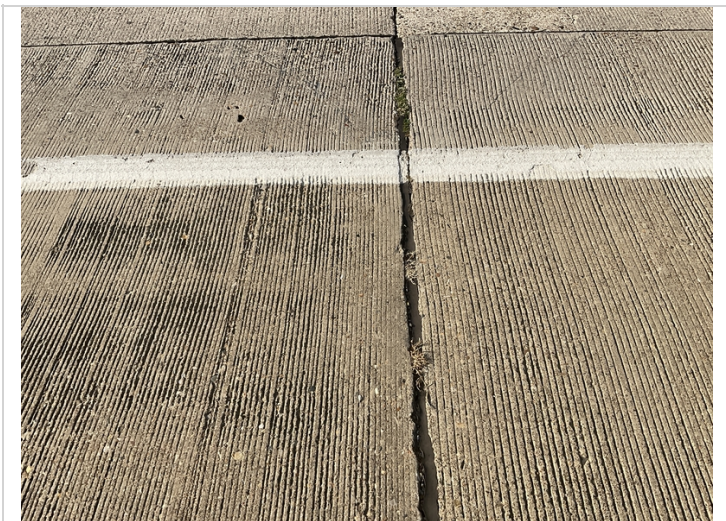
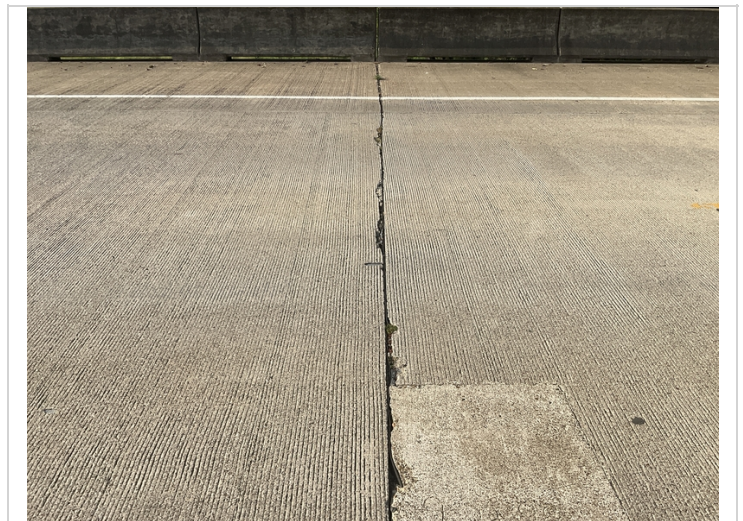
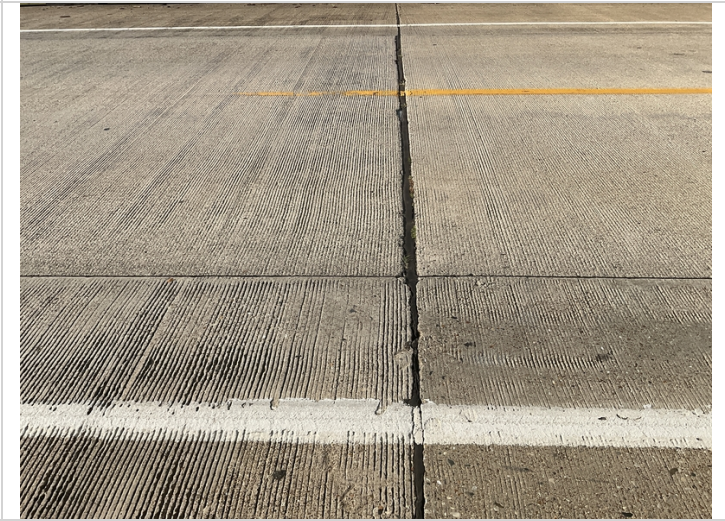
| ELEMENTS | DESCRIPTION | UNITS | TOTAL | CS1 | CS2 | CS3 | CS4 |
|---|---|---|---|---|---|---|---|
| (2320-301) 07/22 joints need cleaned and resealed | | | | | | | |

07/22 joints need cleaned and resealed

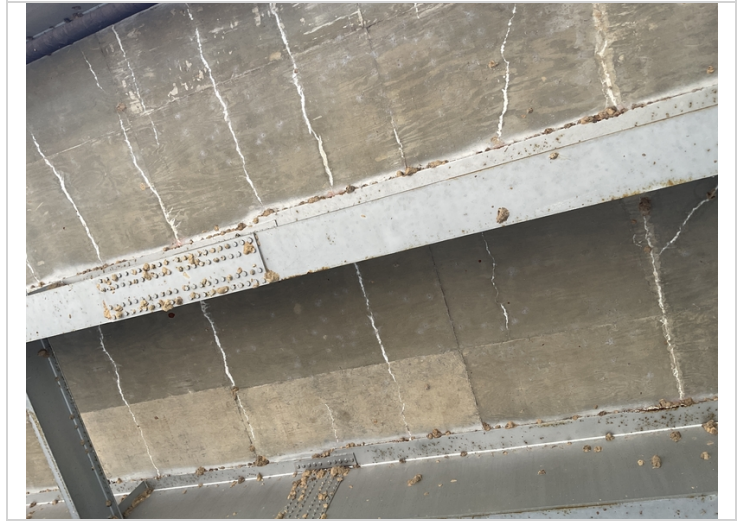
| ELEMENTS | DESCRIPTION | UNITS | TOTAL | CS1 | CS2 | CS3 | CS4 |
|---|---|---|---|---|---|---|---|
| (1120-12) Efflorescence on underside of deck at various locations all spans | | | | | | | |

Efflorescence on underside of deck at various locations all spans

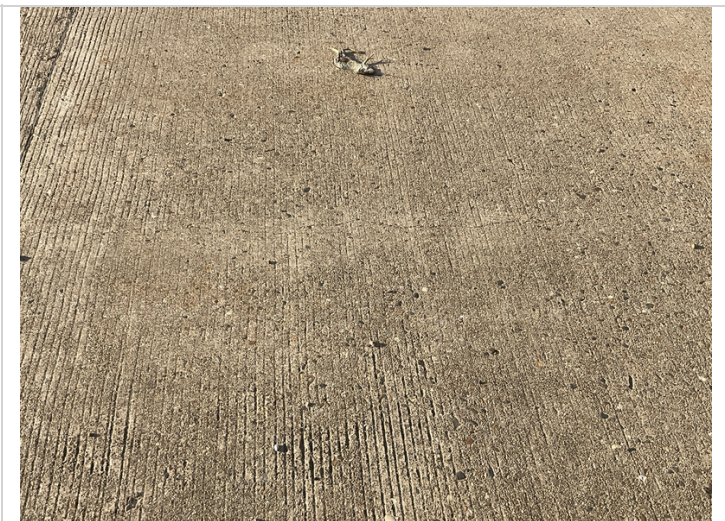
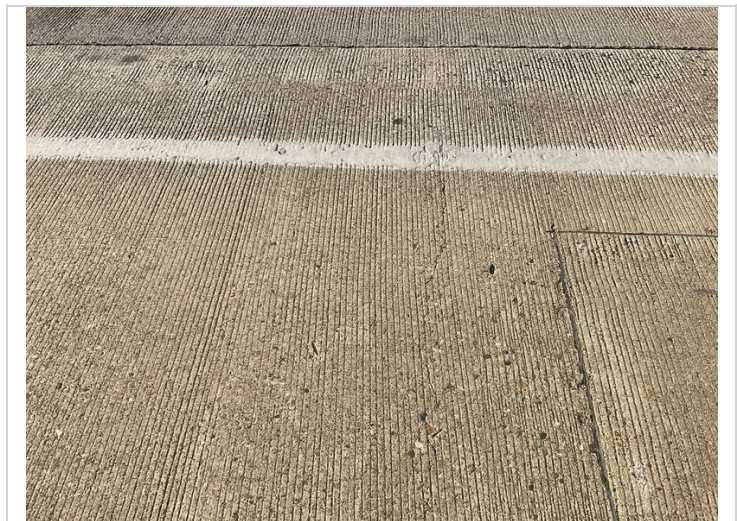
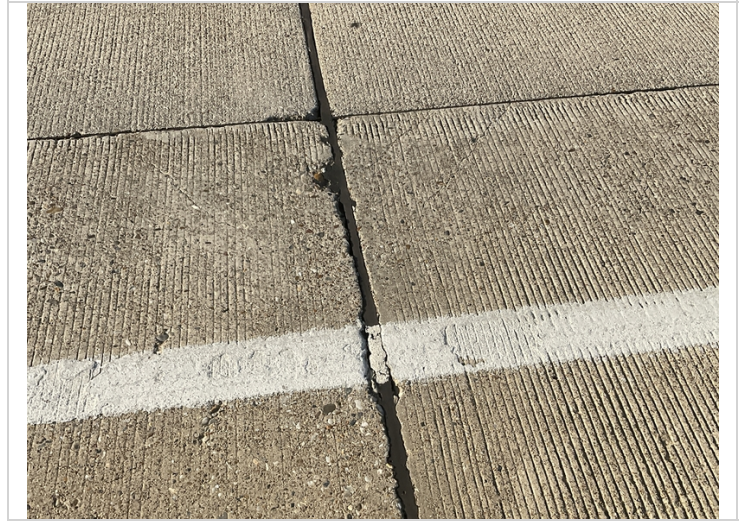
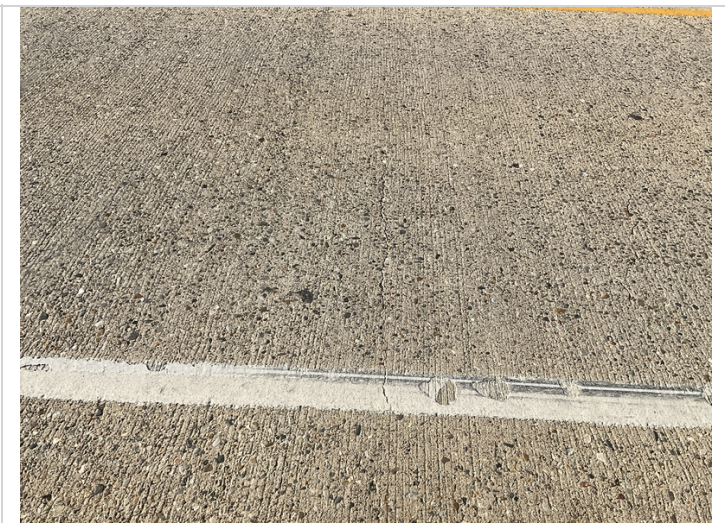
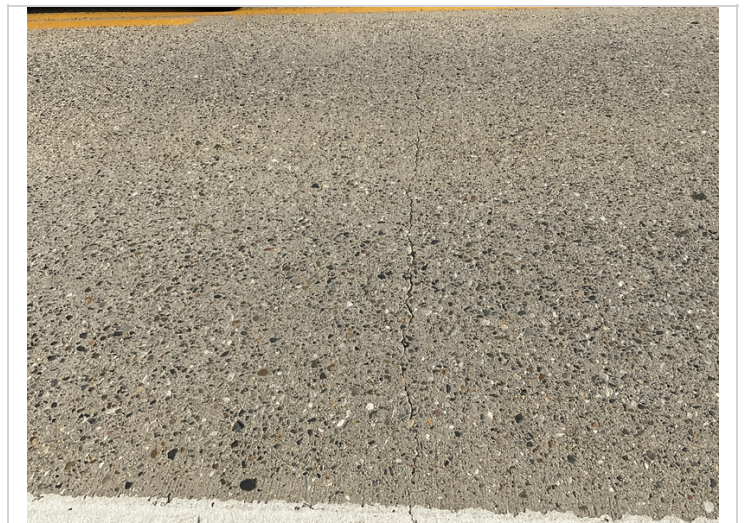
| ELEMENTS | DESCRIPTION | UNITS | TOTAL | CS1 | CS2 | CS3 | CS4 |
|---|---|---|---|---|---|---|---|
| (1130-12) 07/22 cracking in deck various locations ... | | | | | | | |

07/22 cracking in deck

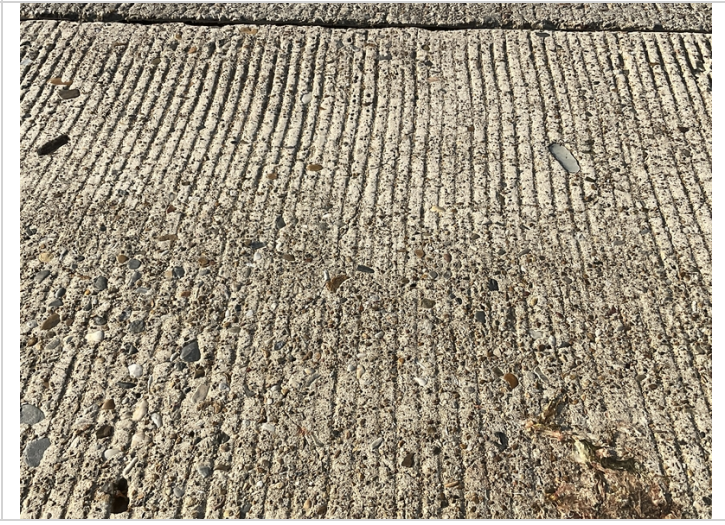
07/22 hairline map like cracking in deck

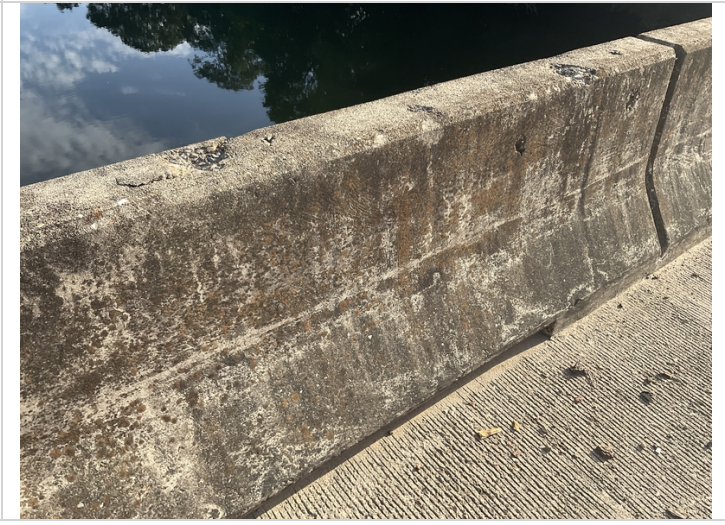
| ELEMENTS | DESCRIPTION | UNITS | TOTAL | CS1 | CS2 | CS3 | CS4 |
|---|---|---|---|---|---|---|---|
| (331) TOP OF PARAPET WALL LEFT SIDE OVER CHANNEL HAS SOME SMALL SPALLS IN TOP OF CONCRETE WALL.... | | | | | | | |

07/22 spalls in parapet wall

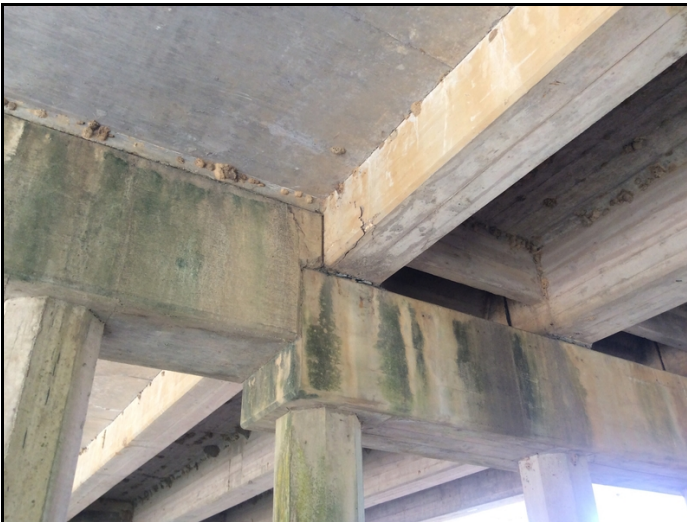
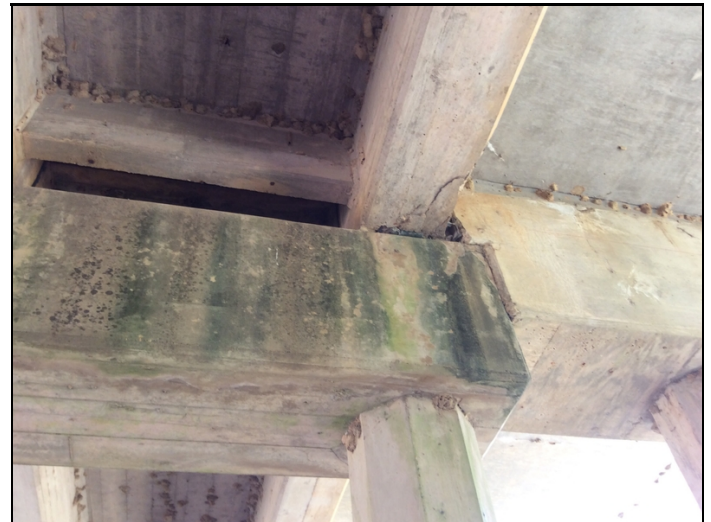
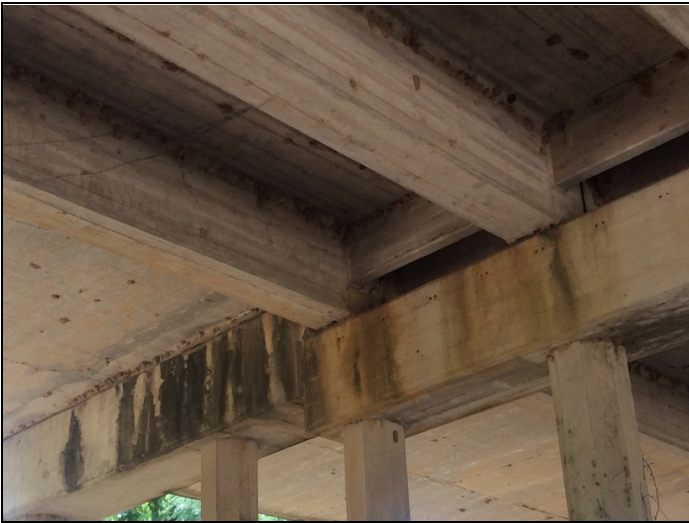
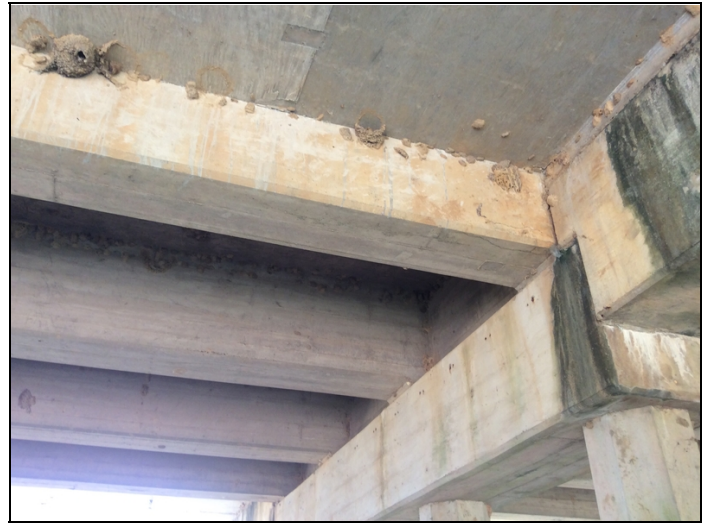
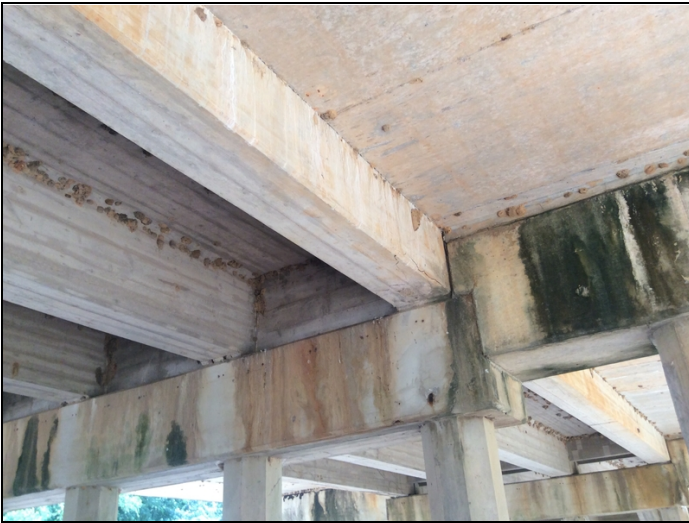
CONCRETE GIRDERS PHOTO TAKEN IN 2016...
BENT 3 SPAN 2 SIDE DELAM IN END OF RCDG... REPAIRS DONE PER.2018 INSPECTION
BENT 4 CRACK IN CAP AT PILE #6AND END OF RCDG #4
BENT 9 CRACK IN END OF RCDG #4....
BENT 11 DELAM IN END OF RCDG #1....
BENT 12 CRACK IN END OF RCDG #4....
