Asset #01622(Routine)

SH 27 - 04 - 5.41 over LAKE SLOUGH

Location: .5 M W OF MURFREESBORO

Team Lead: John King, Inspection Date: 07/20/2022

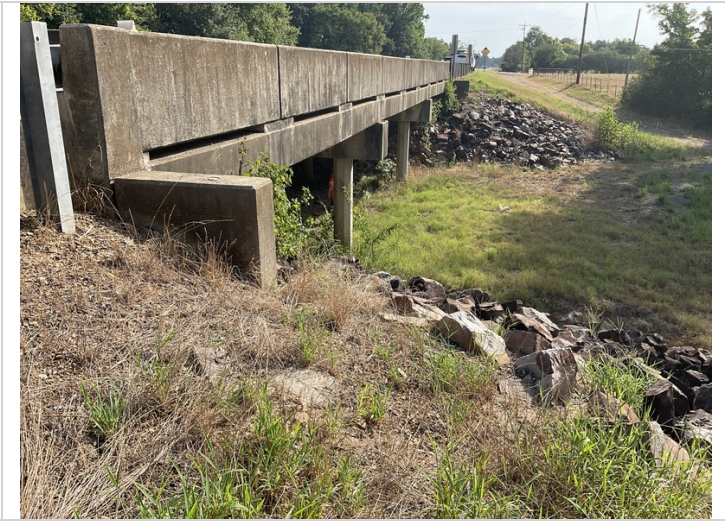
07/22 Elevation photo

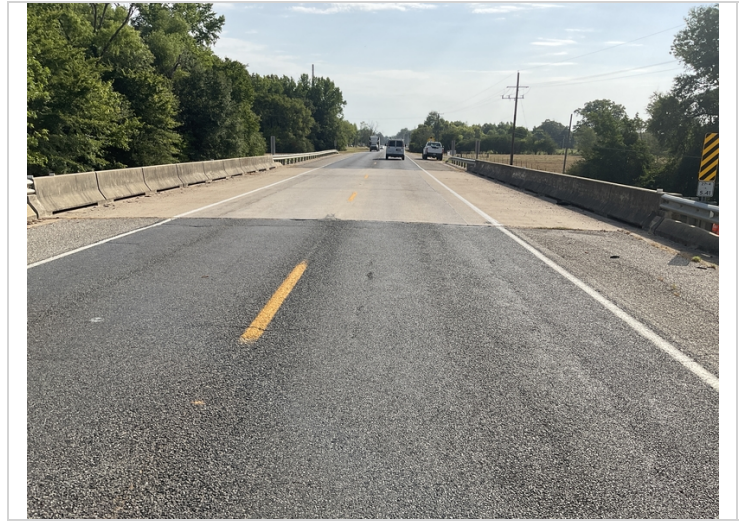
07/22 alignment photo

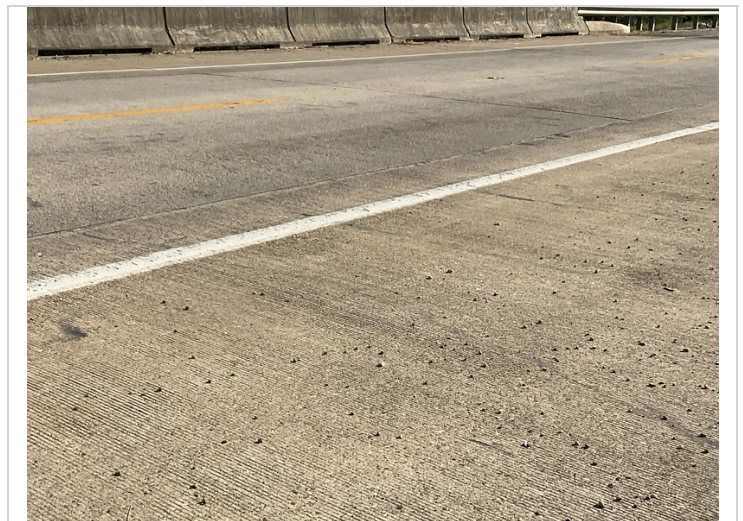
58 - Deck (7 - GOOD CONDITION - some minor problems.)

Comment: 20' Reinforced Concrete Top Flange section

27' Slab section add-on

07/22 typical deck photo

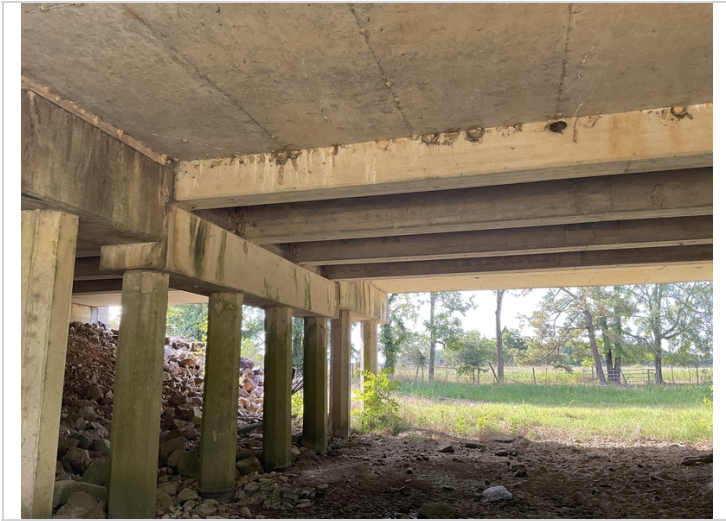
7/2022... underside of deck typical of all spans

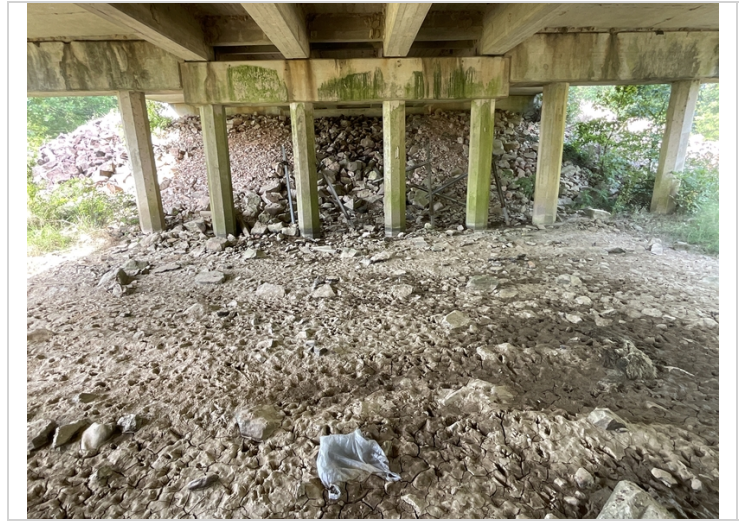
60 - Substructure (6 - SATISFACTORY CONDITION - structural elements show some minor deterioration.)

CONCRETE CAPS @BENT #1- RT. END SPALLED W/ REBAR EXP. LT. END END OF CAP IS SPALLED.BENT #2- LT. END SPALLED W/ REBAR EXP. CAP IS DELAMED UNDER BM'S # 1 & #3.BENT #3- RT. END OF OLD CAP. SPALLED W/ REBAR EXP.BENT #4- LT. END CAP IS SPALLED...07/22 no change per this inspection...

07/22 typical substructure photo

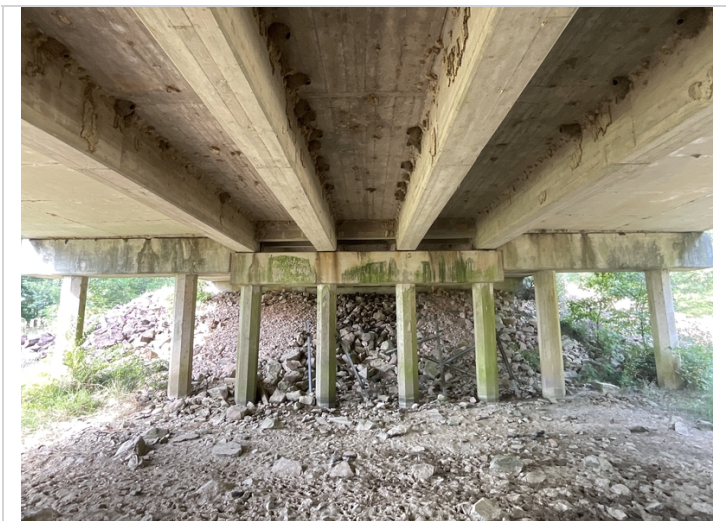
59 - Superstructure (7 - GOOD CONDITION - some minor problems.)

Comment: CONCRETE TEE BEAMS ON OLD PART OF BRIDGE AND WIDENING NEW PART IS R.C. SLAB....07/22 no change per this inspection...

07/22 typical superstructure photo
