Asset #01623(Routine)

SH 27 - 04 - 4.15 over LITTLE MISSOURI RIVER RE

Location: 2.25 M SW MURFREESBORO

Team Lead: John King, Inspection Date: 07/20/2022

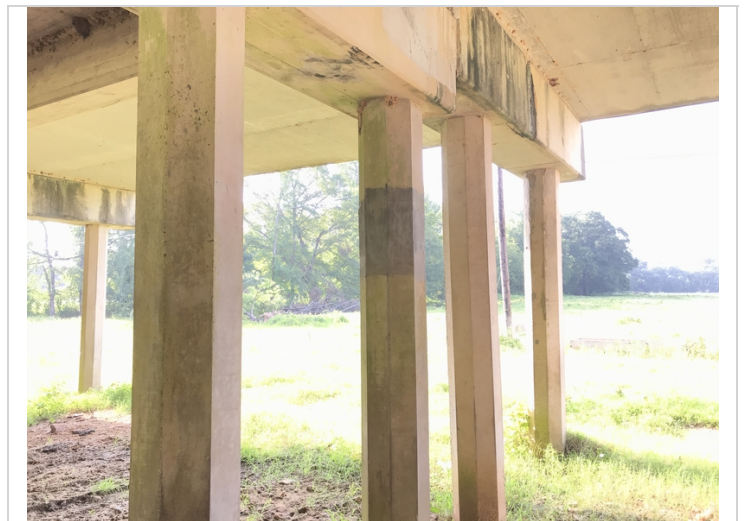
Bent 3 pile 6 patch

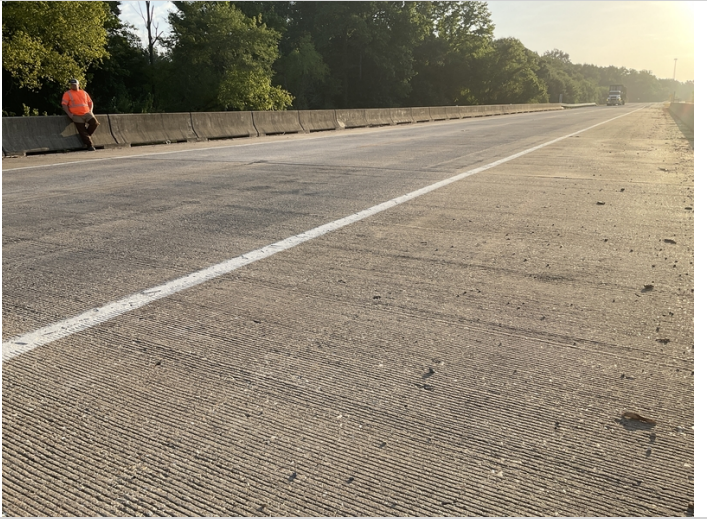
07/22 typical deck photo

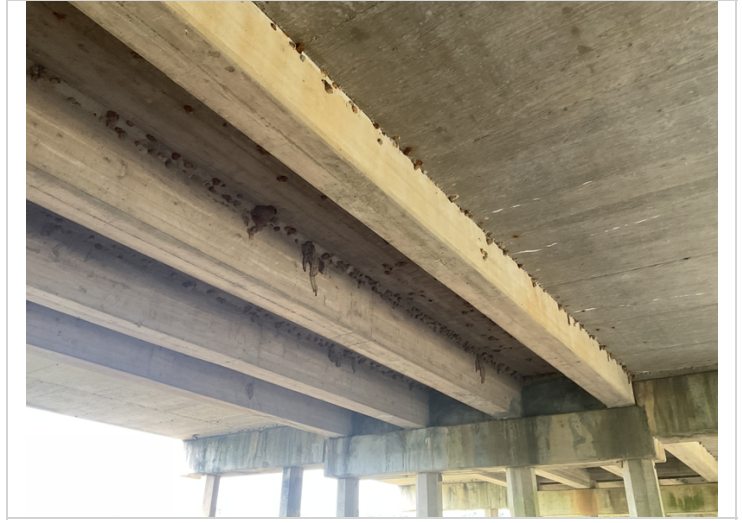
07/22 underside of deck

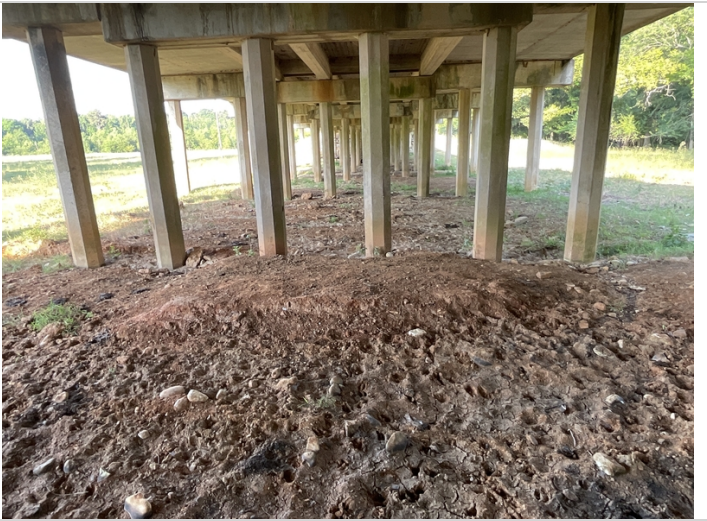
07/22 typical substructure photo

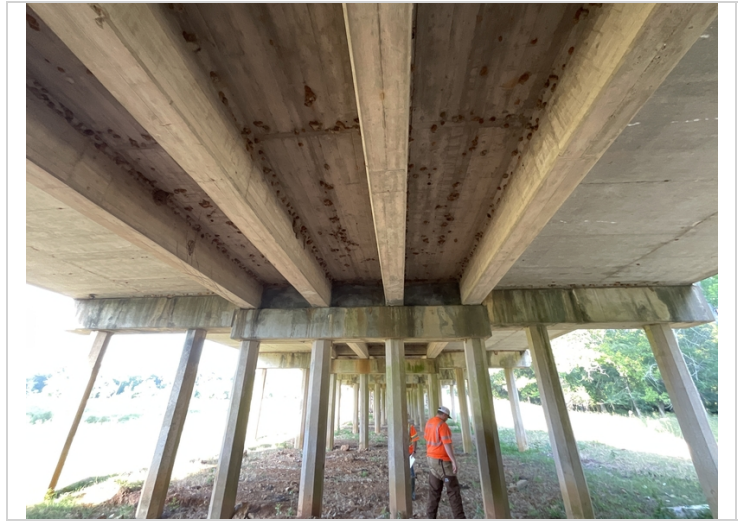
07/22 typical superstructure photo

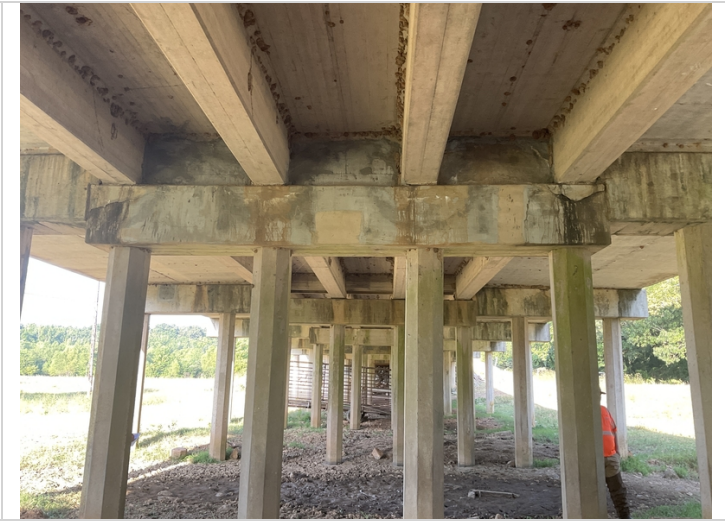
(234) ALL SPALLS AND DELAMS WERE FIXED IN ALL BENTS PER 2/12/2018 (1080-234) 07/22 bent 7 both ends of center cap have spalls in top corner, bent 6 has spall on face of cap.							
301	Pourable Joint Seal	LF	484	0	0	359	125
2310	Leakage	LF	37	0	0	0	37
2320	Seal Adhesion	LF	359	0	0	359	0
2350	Debris Impaction	LF	88	0	0	0	88

07/22 bent 7 both ends of center cap have spalls in top corner

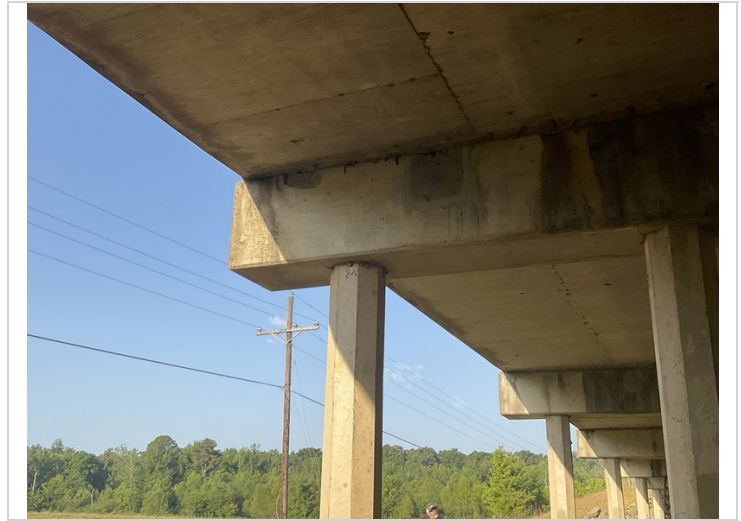
07/22 bent 6 top of right side outer cap has spall area

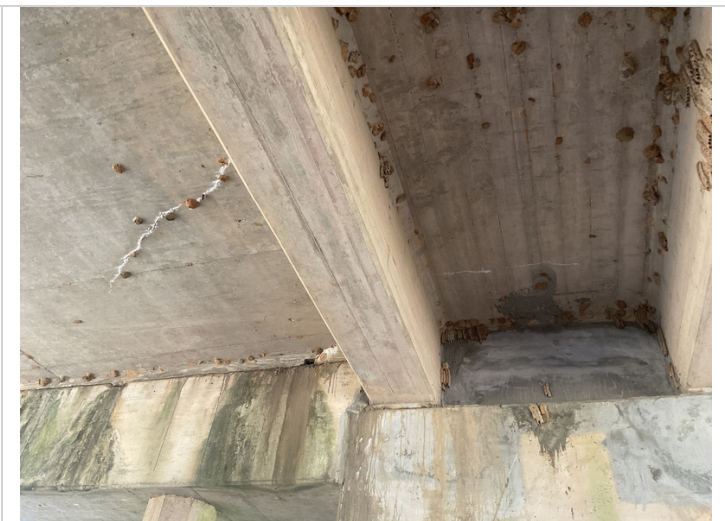
(38) Main Span RC Slab Approach span RC Slab (1120-38) 07/22 efflorescence in span 2 (1130-38) 07/22 cracking in deck							
110	Reinforced Concrete Open Girder/Beam	LF	960	960	0	0	0

07/22 efflorescence in span 2

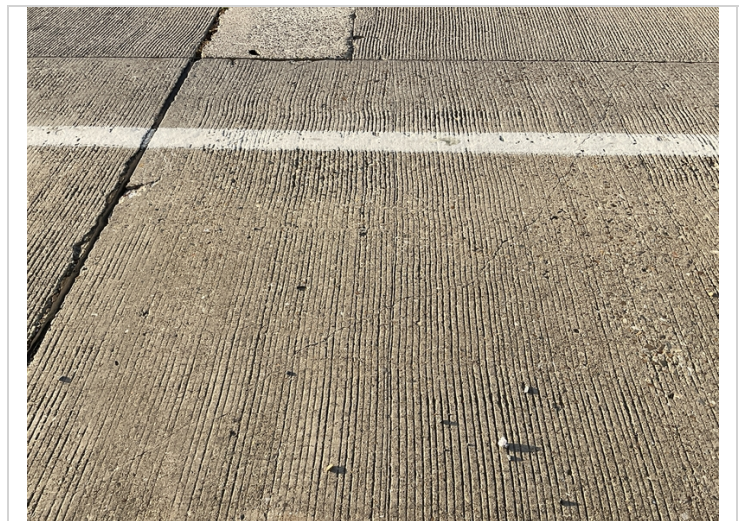
07/22 cracking in deck

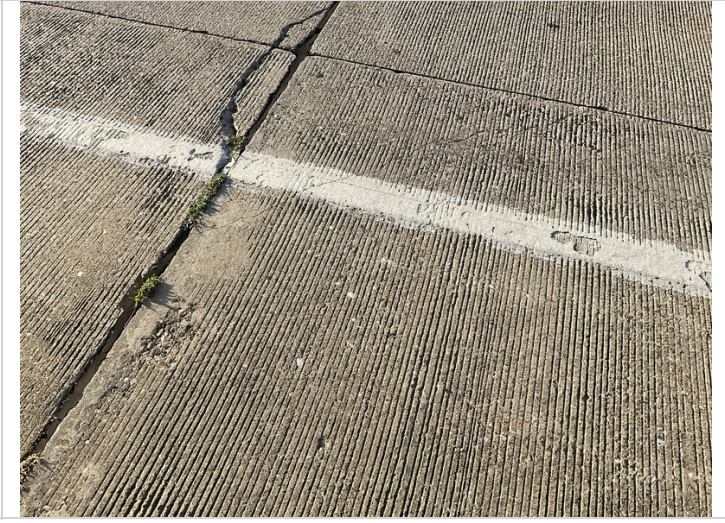
07/22 bent 6 large cracking in deck
