Asset #06418(Routine, Underwater type 2)

SH 27 SEC 3 - 0.67 over CARY CREEK

Team Lead: Charlie Rogers, Inspection Date: 01/11/2022

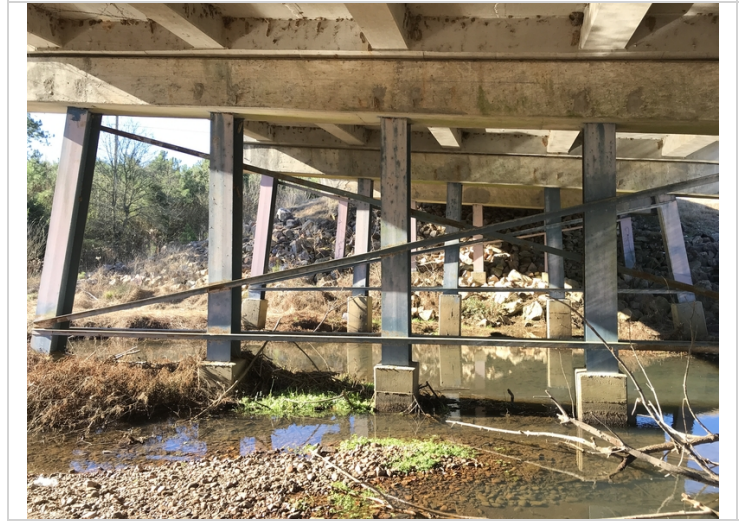
Footing: PAINTED STEEL PILES,BT 5 PILE 1 DAMAGE OR BENT

Steel piling on bridge bents has rust in different areas and oxide film or chalking of paint

Substructure

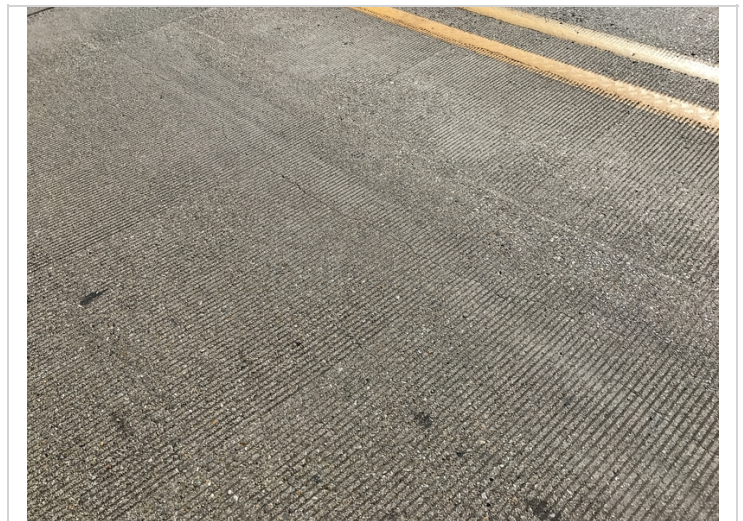
Cracking in the deck

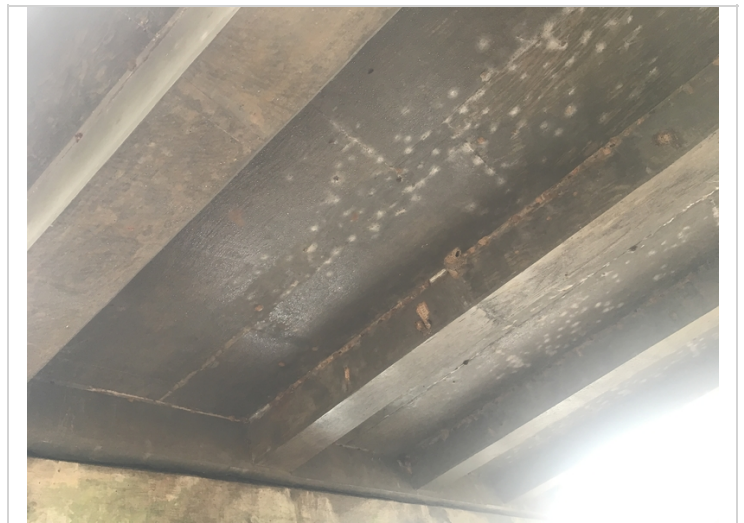
ELEMENTS	DESCRIPTION	UNITS	TOTAL	CS1	CS2	CS3	CS4
12	Reinforced Concrete Deck	SF	6420	6155	260	5	0
1080	Delamination/Spall/Patched Area	SF	5	0	0	5	0
1120	Efflorescence/Rust Staining	SF	200	0	200	0	0
1130	Cracking (RC and Other)	SF	60	0	60	0	0
(12) CONCRETE DECK HAS COATED BARS 200 LF OF EFFLORESCENCE THROUGHOUT ALL SPANS

Underside of deck typical all spans

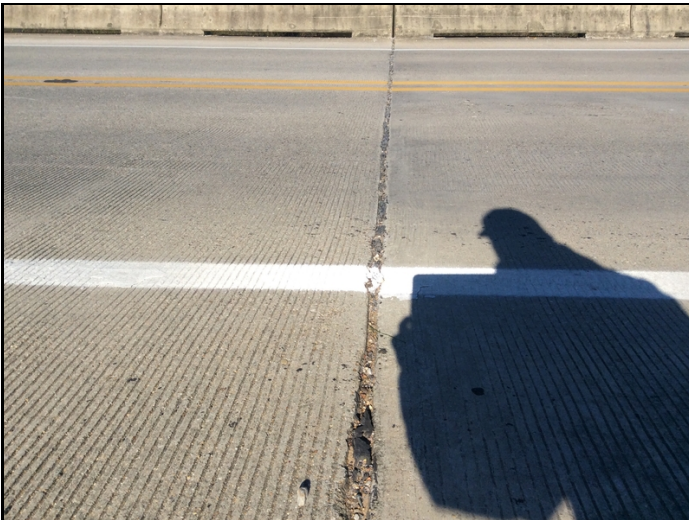
JOINTS NEED TO BE CLEANED AND SEALED ALL
SPANS

JOINTS NEED TO BE CLEANED AND SEALED ALL SPANS
