District 03, 57 - Hempstead County

Asset #06419(Routine, Underwater type 2)
SH 27- 03- 2.40 over N. FORK OZAN CREEK
Location: 2.4 NE HOWARD CO LINE

Team Lead: Charlie Rogers, Inspection Date: 01/11/2022

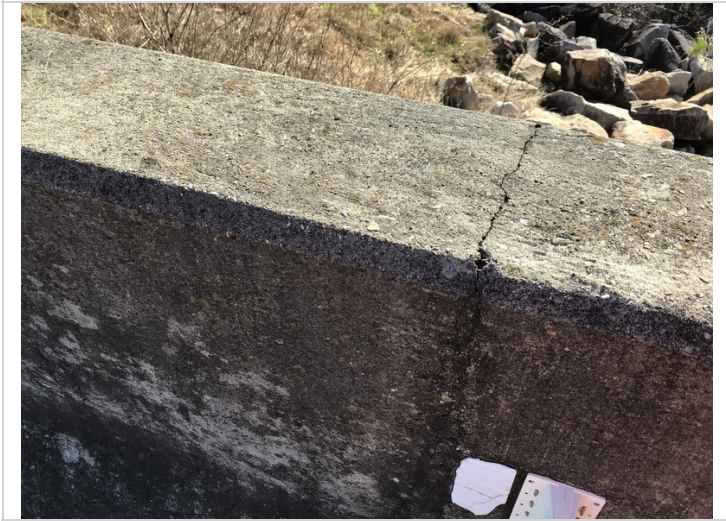
Cracking in the parapet wall

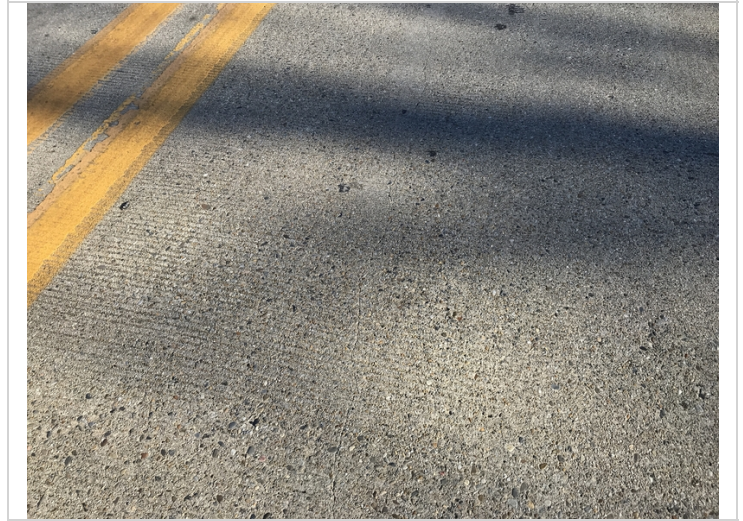
(12) CONCRETE DECK WITH COATED REBAR 60 LF OF EFFLORESCENCE SPAN 1 10 LF OF EFFLORESCENCE SPAN 2 50 LF OF EFFLORESCENCE SPAN 3 SEALED DECK CRACKS ON TOP OF DECK							
110	Reinforced Concrete Open Girder/Beam	LF	375	375	0	0	0
215	Reinforced Concrete Abutment	LF	126	122	0	4	0
1080	Delamination/Spall/Patched Area	LF	4	0	0	4	0
225	Steel Pile	EA	15	15	0	0	0
515	Steel Protective Coating	SF	466	0	466	0	0
3430	Oxide Film Degradation Color/Texture Adherence(Steel Protective Coatings)	EA	466	0	466	0	0
234	Reinforced Concrete Pier Cap	LF	86	78	8	0	0
1010	Cracking	LF	4	0	4	0	0
1120	Efflorescence/Rust Staining	LF	4	0	4	0	0
301	Pourable Joint Seal	LF	80	80	0	0	0
331	Reinforced Concrete Bridge Railing	LF	150	100	50	0	0
1130	Cracking (RC and Other)	LF	50	0	50	0	0

Cracking in the deck

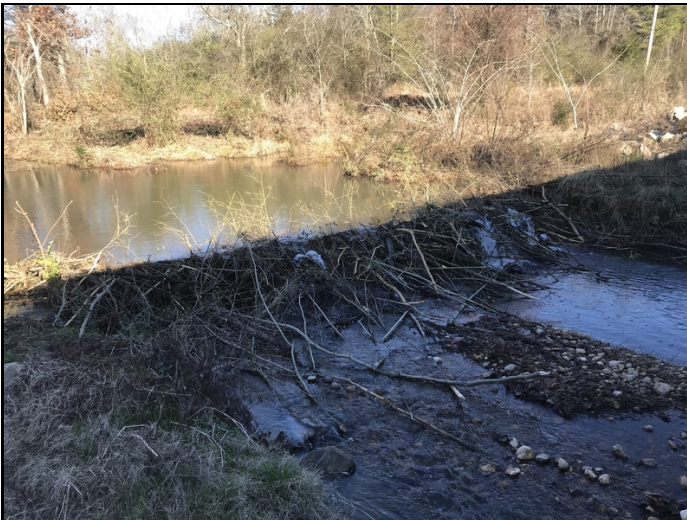
Beaver Dam upstream side of bridge

Beaver dam is cleared out per this inspection
