Asset #01708(Routine)

US 71 SEC. 05-3.20 over WILSON CREEK

Location: 3.20 MI N OF LITTLE RIVER

Team Lead: Jared Kegley, Inspection Date: 10/03/2023

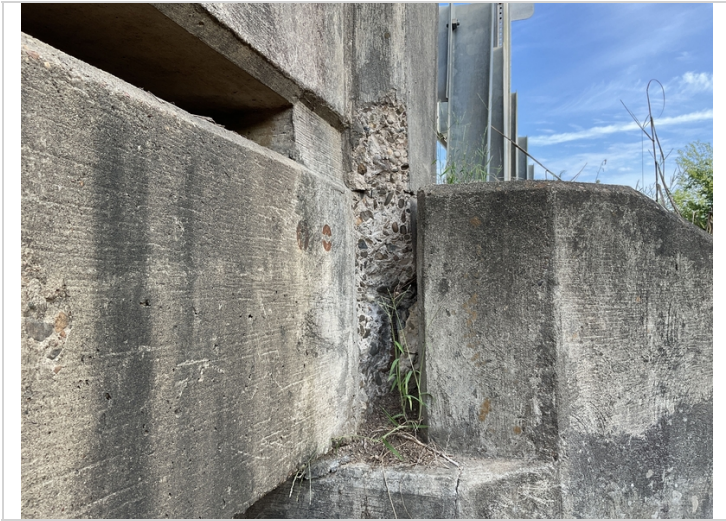
(38) Deck has various locations of efflorescence present along both Rt and Lt outsides of slab as well as underside of slab along center joint line. Spall with efflorescence cracking at left side above bent 2. Spall with rebar exposed at end of bridge right side.							
205	Reinforced Concrete Column	EA	4	3	1	0	0
1190	Abrasion/Wear (PSC/RC)	EA	1	0	1	0	0

End of bridge Rt side spall with rebar exposed

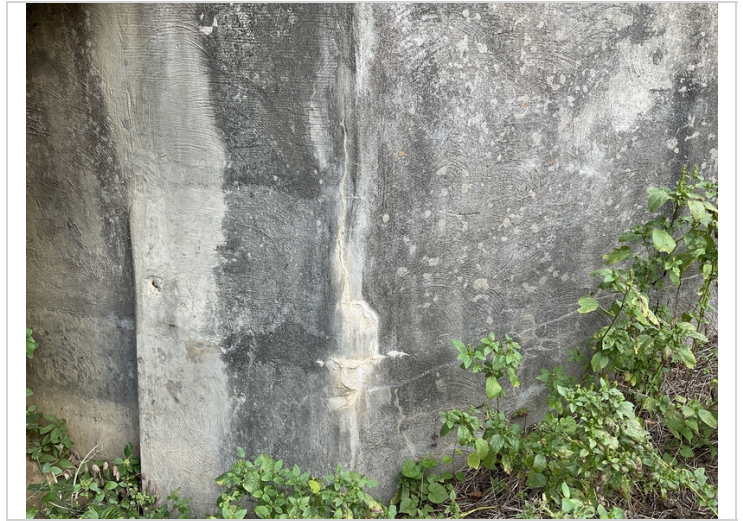
(215) Bent 1 abutment has various locations of cracking in backwall. Bent 3 abutment has various locations of cracking with efflorescence present in backwall.							
234	Reinforced Concrete Pier Cap	LF	47	45	2	0	0
1080	Delamination/Spall/Patched Area	LF	1	0	1	0	0
1120	Efflorescence/Rust Staining	LF	1	0	1	0	0

Abutment 2 efflorescence

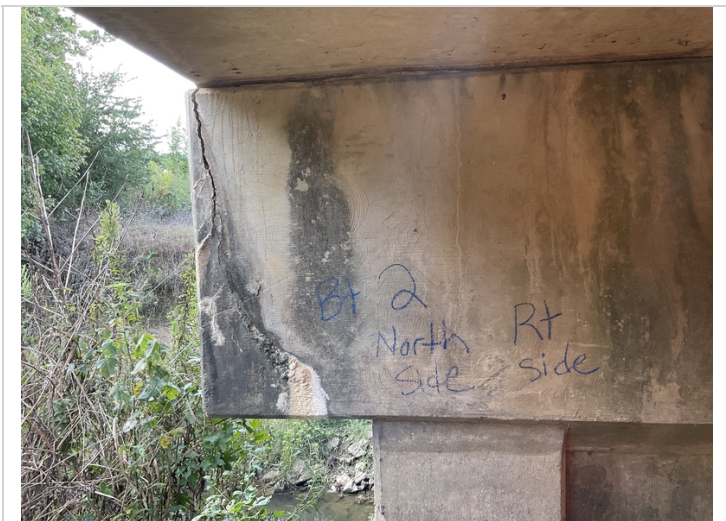
(234) Rt side of Bent 2 cap has large delamination with efflorescence.							
301	Pourable Joint Seal	LF	176	44	44	88	0
2310	Leakage	LF	44	0	44	0	0
2350	Debris Impaction	LF	88	0	0	88	0

Bt 2 Rt side Delam with efflorescence

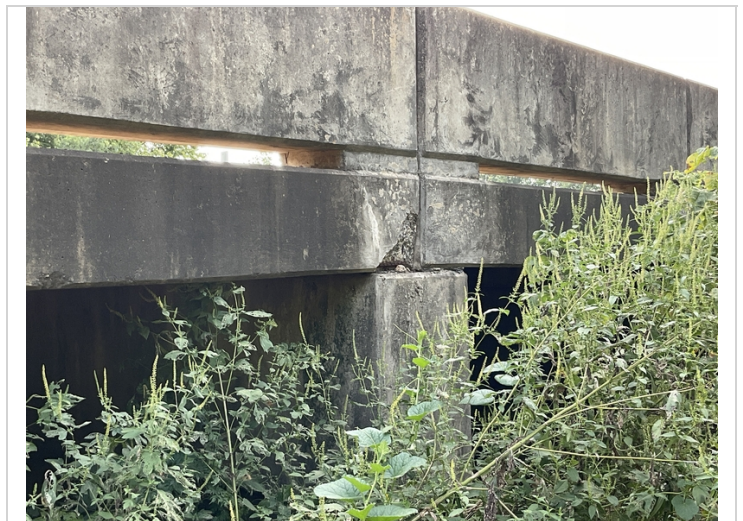
Spall with efflorescence cracking @ LT side bent 2

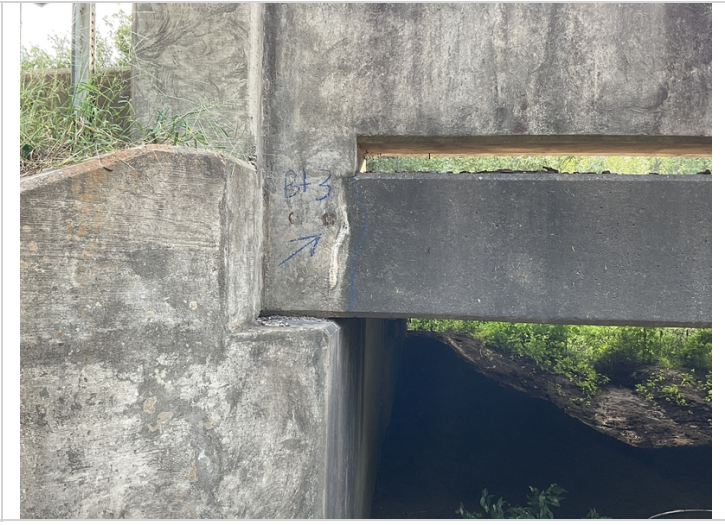
LT side @ Bt 3 efflorescence

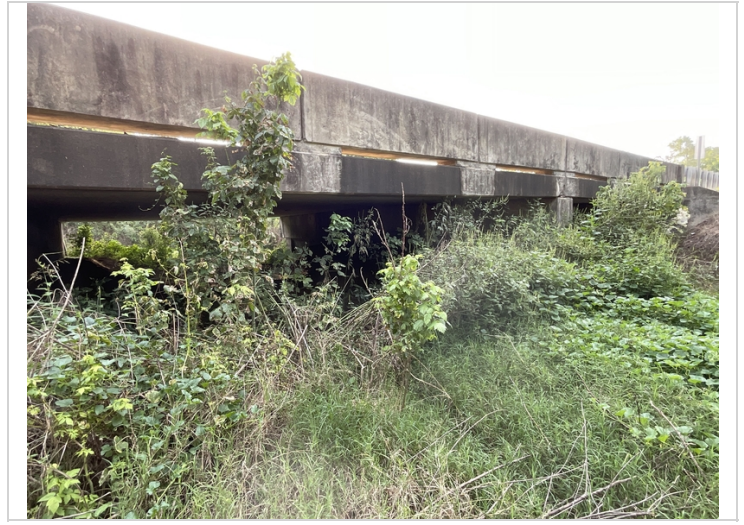
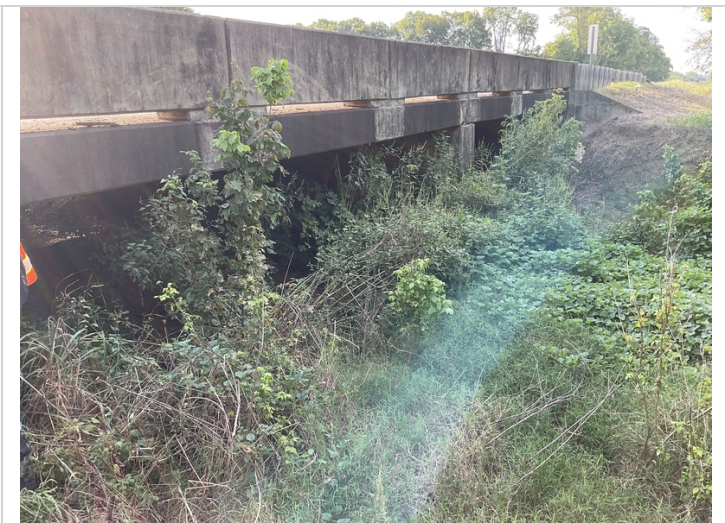
Vegetation under bridge needs removed

Trees and Vegetation under and along both sides of bridge need removed.

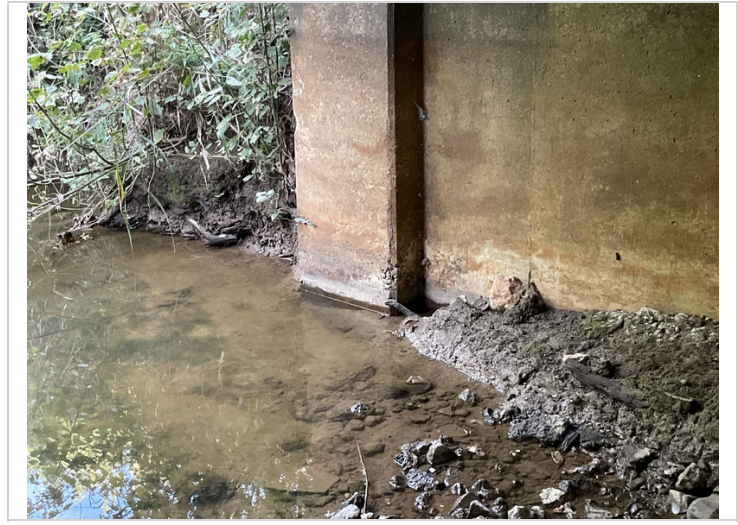
(205) Bent 2 column 1 has minor abrasion starting at bottom of column near existing waterline.							
210	Reinforced Concrete Pier Wall	LF	40	40	0	0	0
215	Reinforced Concrete Abutment	LF	138	133	5	0	0
1120	Efflorescence/Rust Staining	LF	3	0	3	0	0
1130	Cracking (RC and Other)	LF	2	0	2	0	0

Bent 2 column 1 abrasion

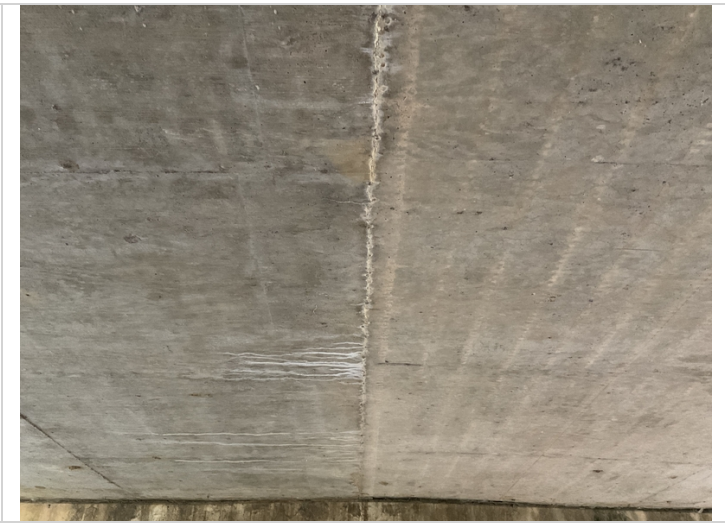
Deck is rated a 7 this inspection due to cracking with efflorescence on bottom side of slab. Cracks in deck have been sealed in the past.

Efflorescence on underside of slab

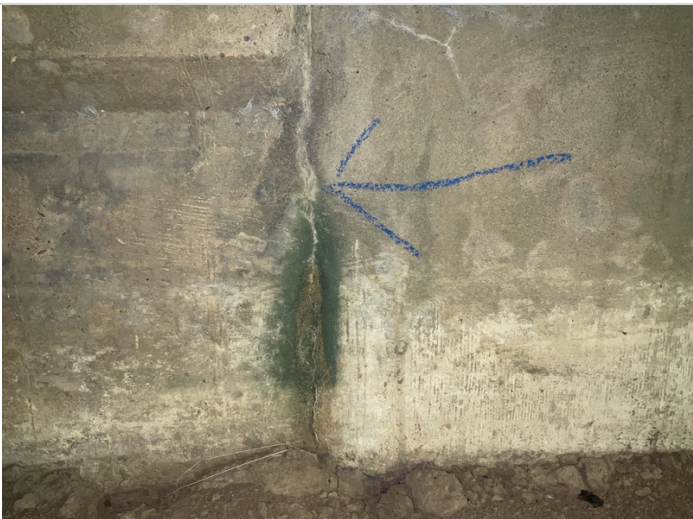
Abutment 1 cracking

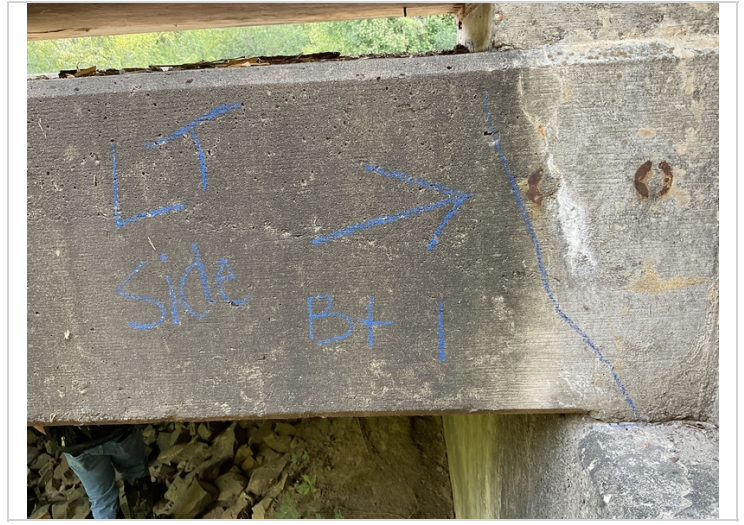
LT side @ Bt 1 efflorescence

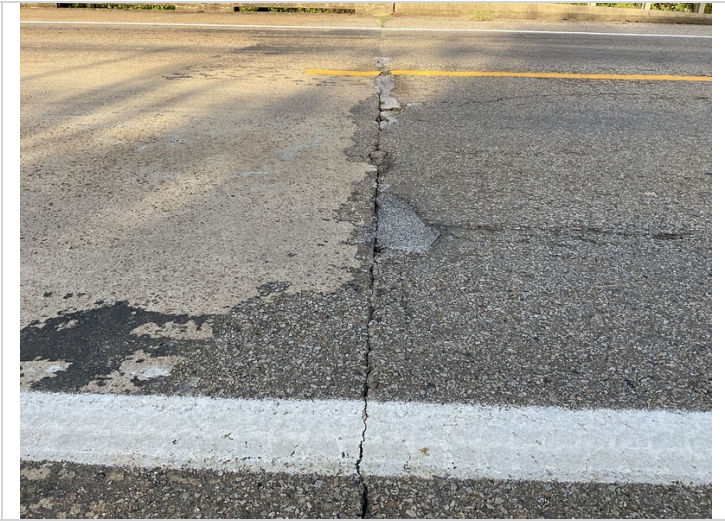
(301) Asphalt overlay is impacting pourable joints at bents 1 & 3. Various locations of leakage to pourable joint seal at Bent 2.							
331	Reinforced Concrete Bridge Railing	LF	135	135	0	0	0

Asphalt overlay impacting joints

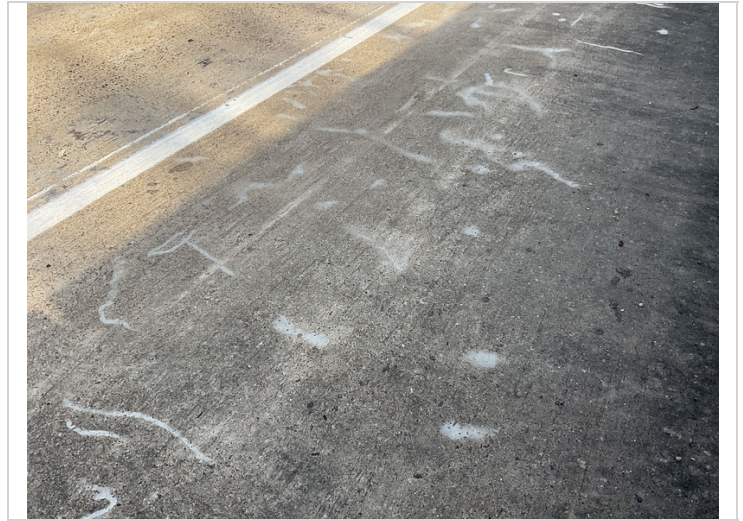
Deck cracking sealed in the past

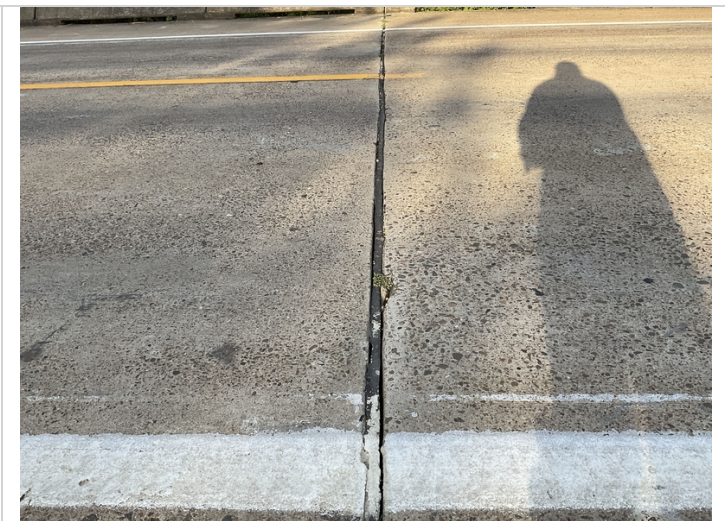
Leakage to pourable joint seal

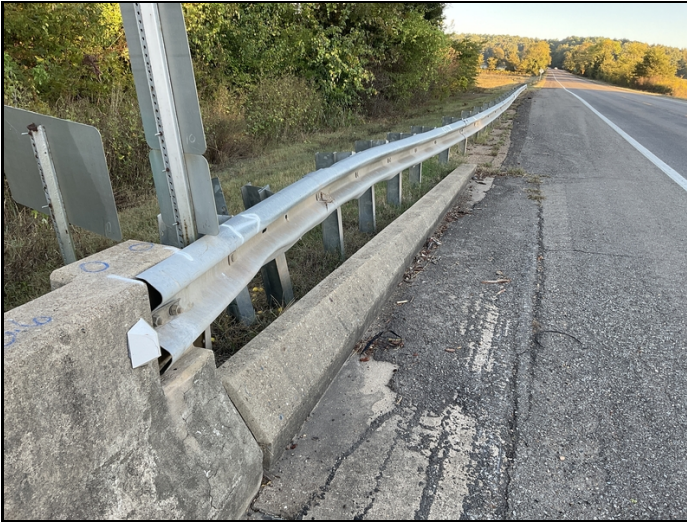
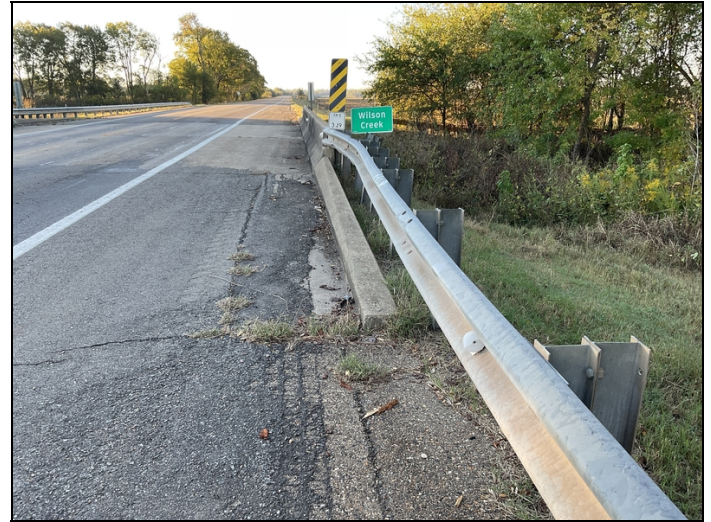
Approach guardrail damage on end of bridge, LT side approximately 15'.
