Asset #03673(Routine)

US 71 SEC.04-16.80 over LICK CREEK

Location: 0.75 M N OF WILTON

Team Lead: Jared Kegley, Inspection Date: 03/22/2023

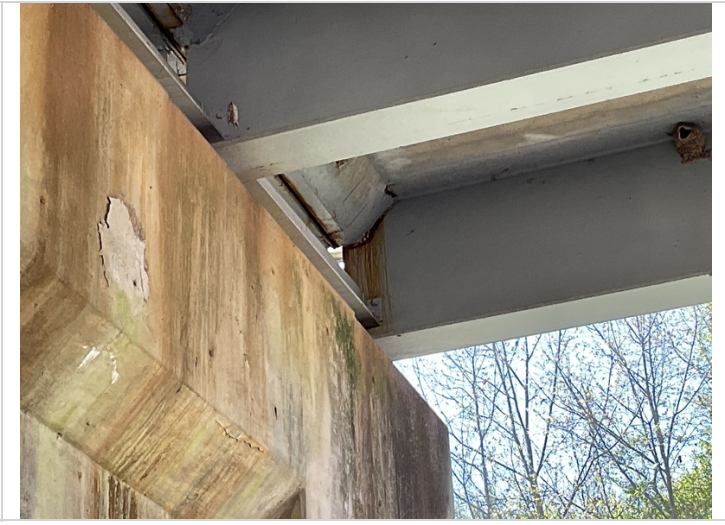
Superstructure is rated a 7 due to minor corrosion on various beam ends.

Beam end corrosion bent 3

Beam end painting needed.

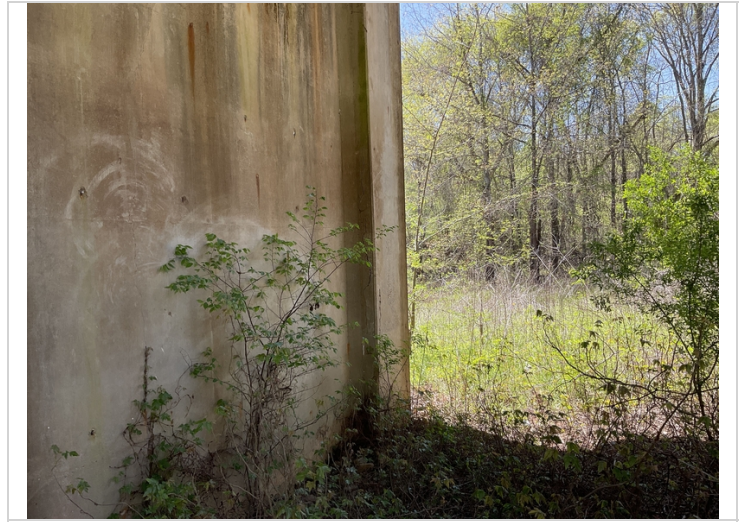
Bent 3 column 1 cracking

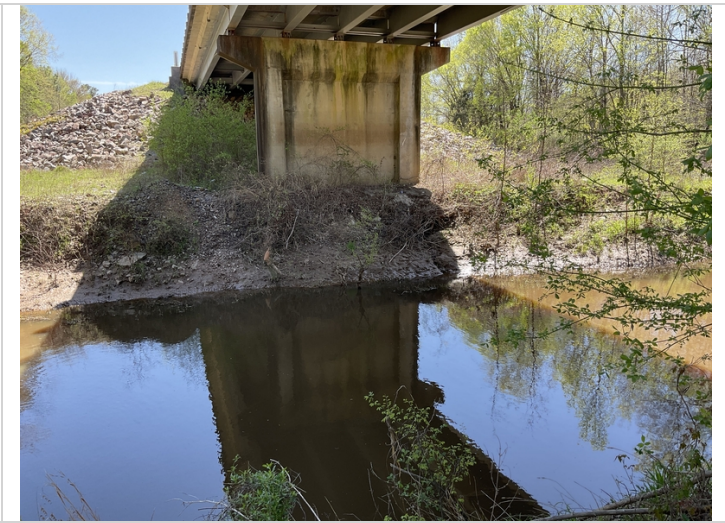
Scour rating is a 6 due to moderate scour near piers at channel.

Scour

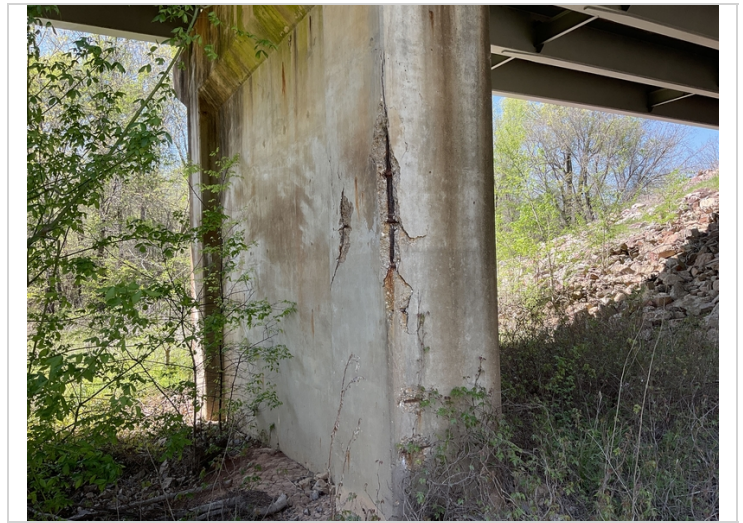
Bent 3 column 2 CS3 rebar exposed

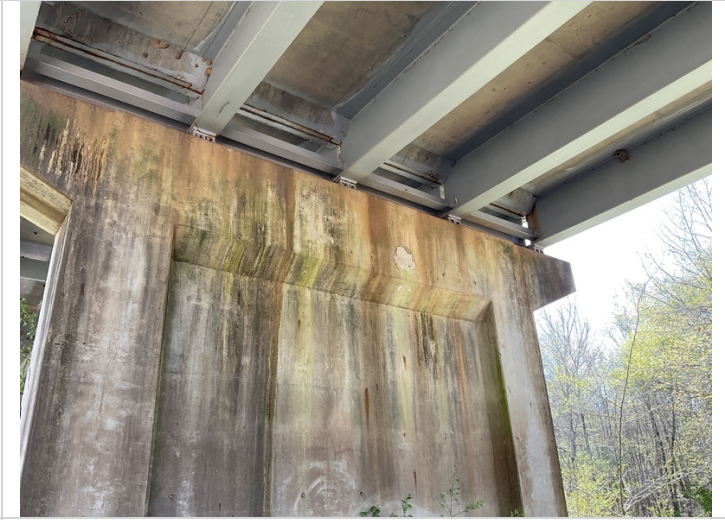
Bent 3 cap Delam

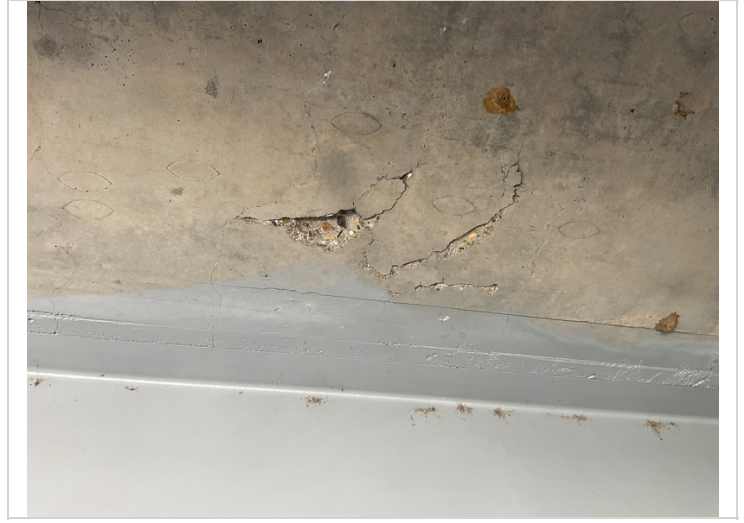
Delaminations on underside of deck

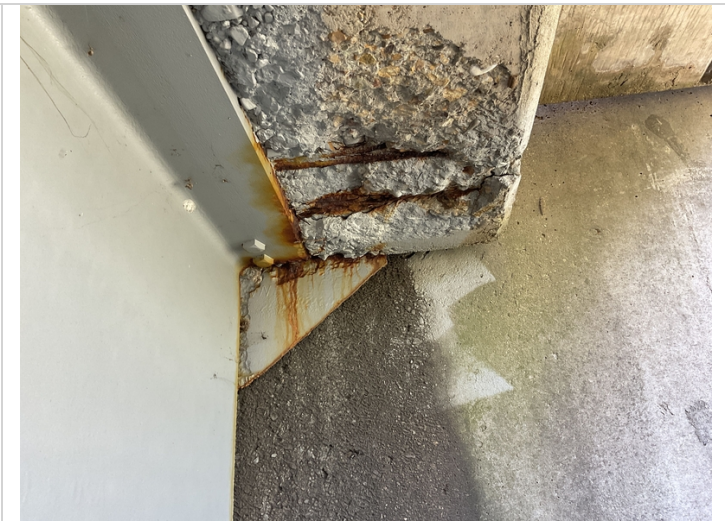
Exposed rebar span 3 RT side

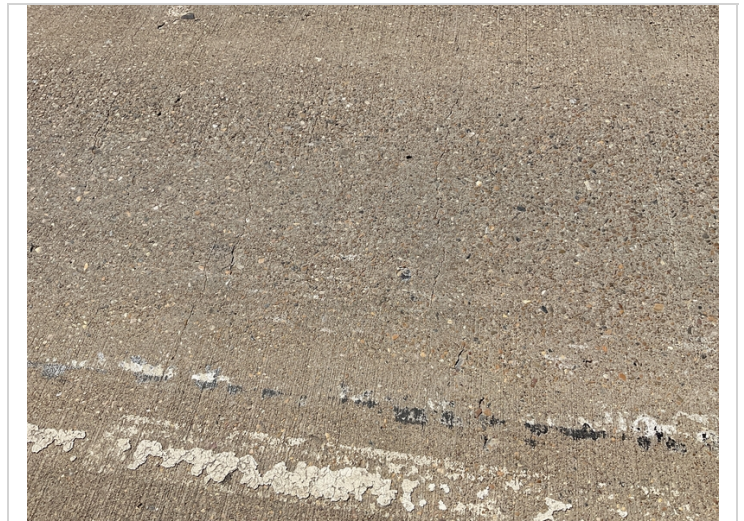
Sealable deck cracks throughout all spans.

Sealable deck cracking

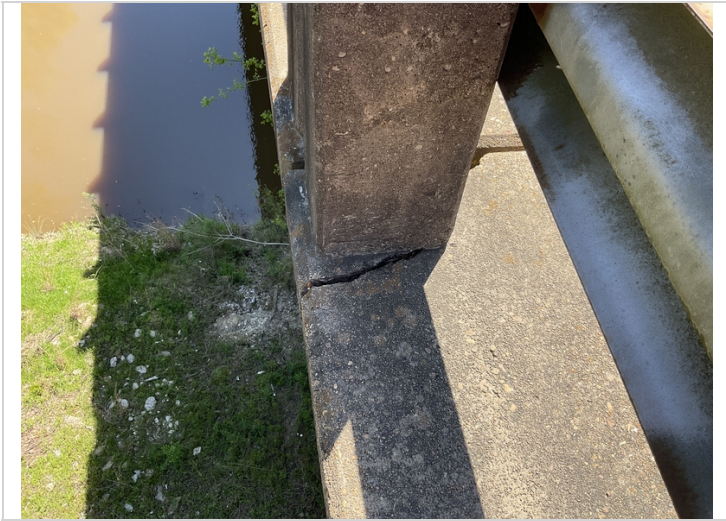
(330) Span 2 RT side is loose							
331	Reinforced Concrete Bridge Railing	LF	484	431	50	3	0
1090	Exposed Rebar	LF	2	0	0	2	0
1130	Cracking (RC and Other)	LF	50	0	50	0	0
7000	Damage	LF	1	0	0	1	0

Bridge railing damage RT side

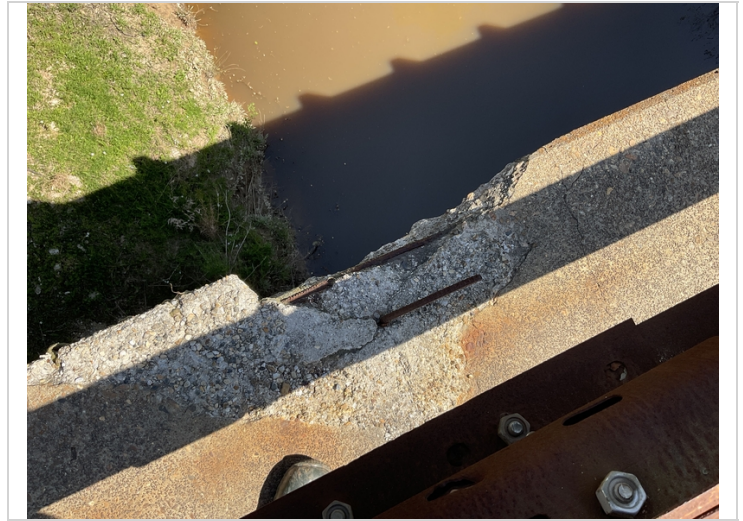
(331) 2' CS3 rebar exposed in span 2. 1' CS3 damage. 50' CS2 cracking

Rebar exposed bridge railing

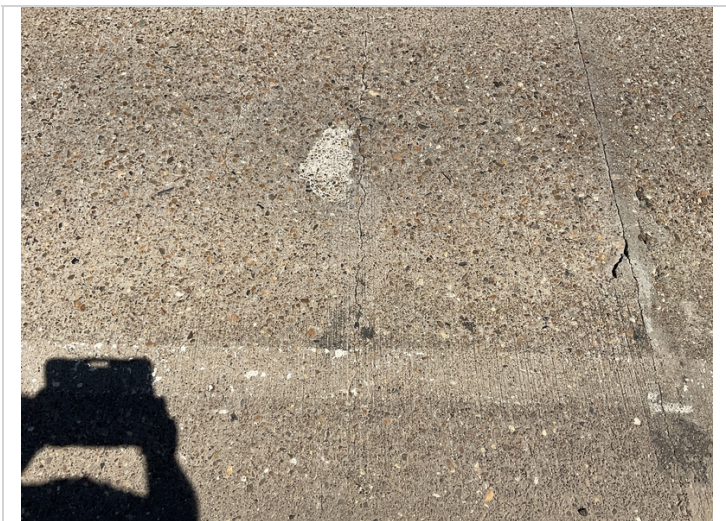
Deck cracking

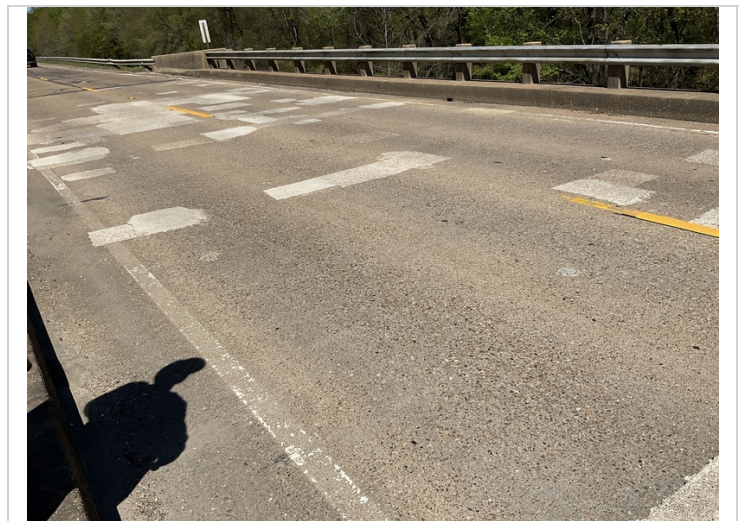
Span 3 patched area

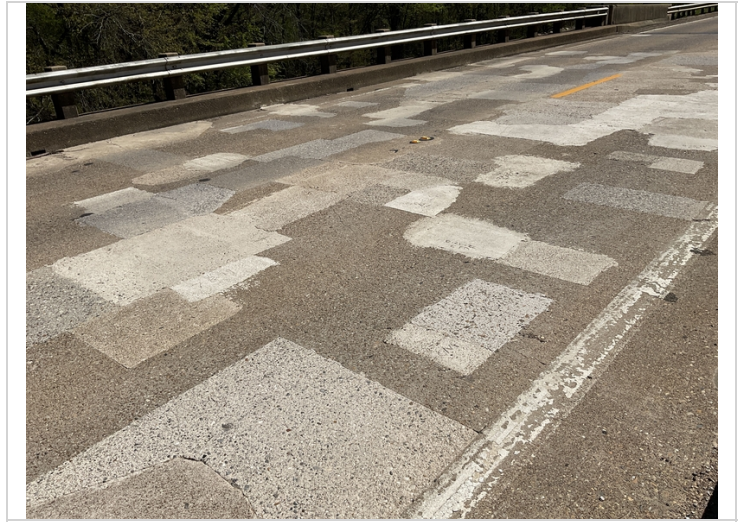
Span 1 patched area

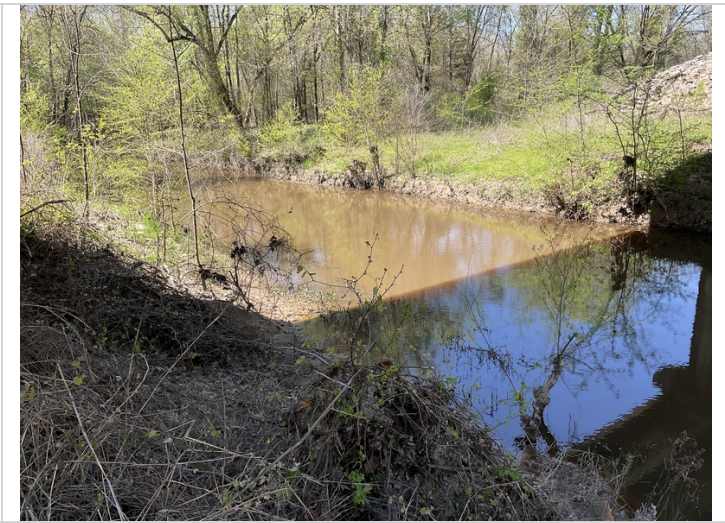
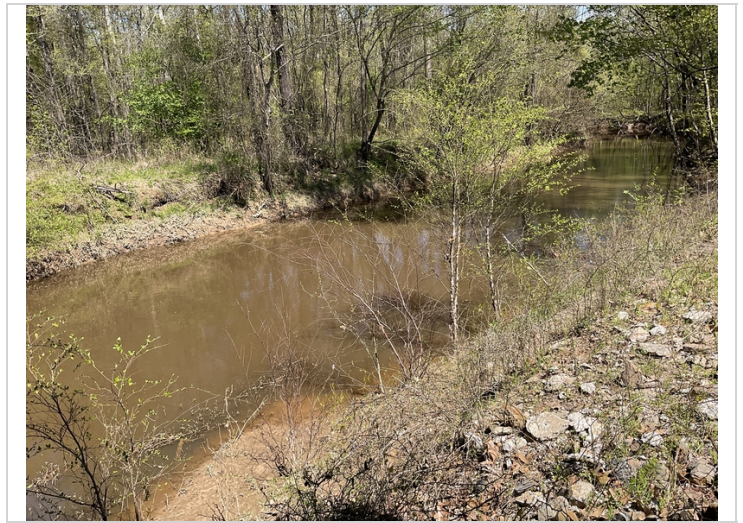
Dropped channel rating from to a 6 this inspection due to bank beginning to slump.

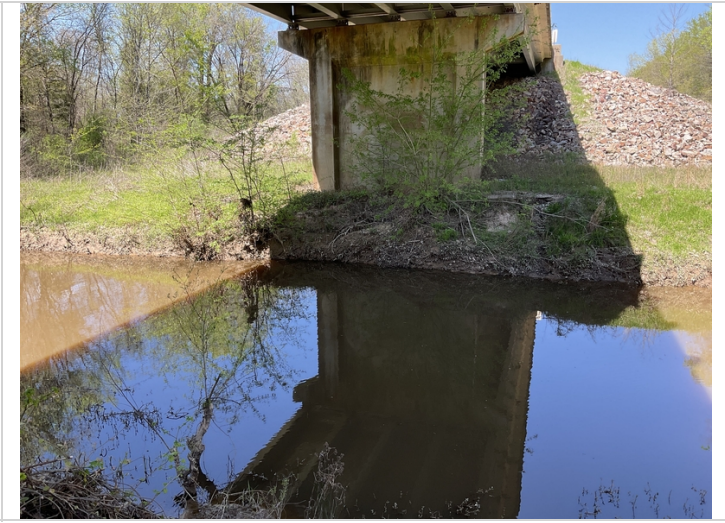
Scour

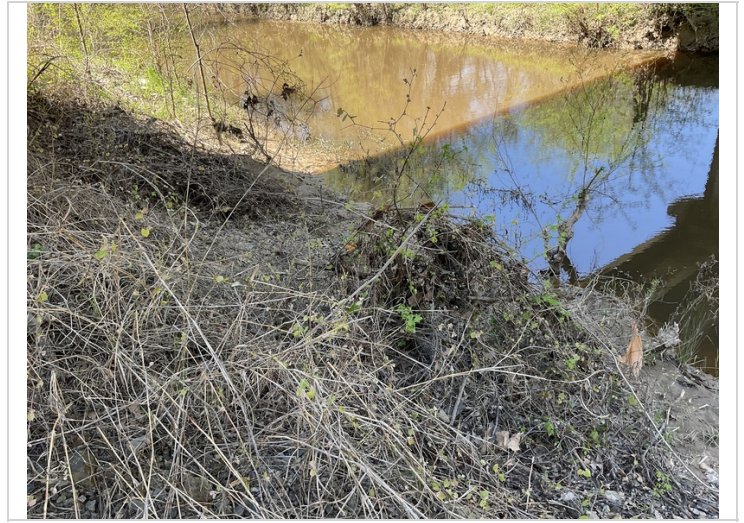
Scour

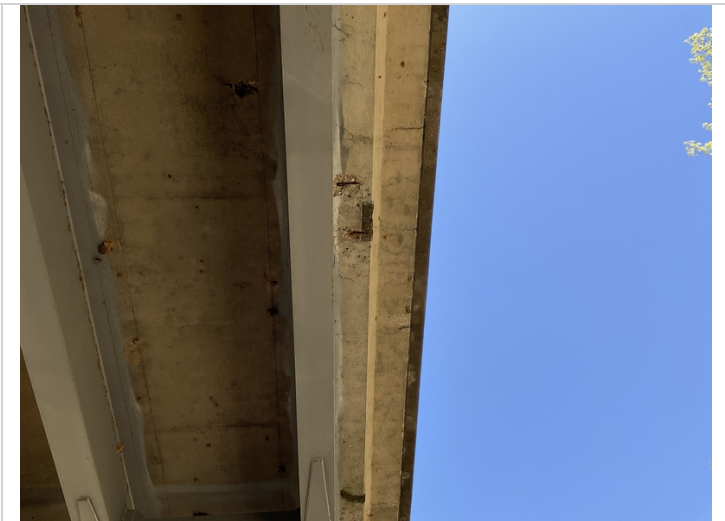
Exposed rebar on overhangs.

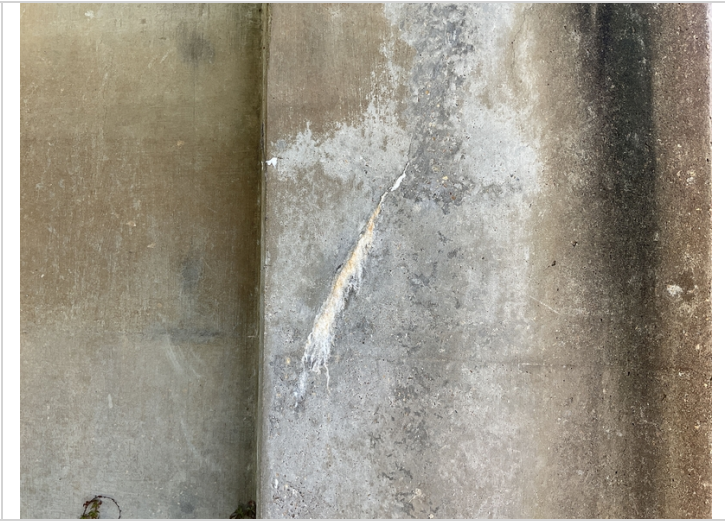
Bent 2 column 1 efflorescence

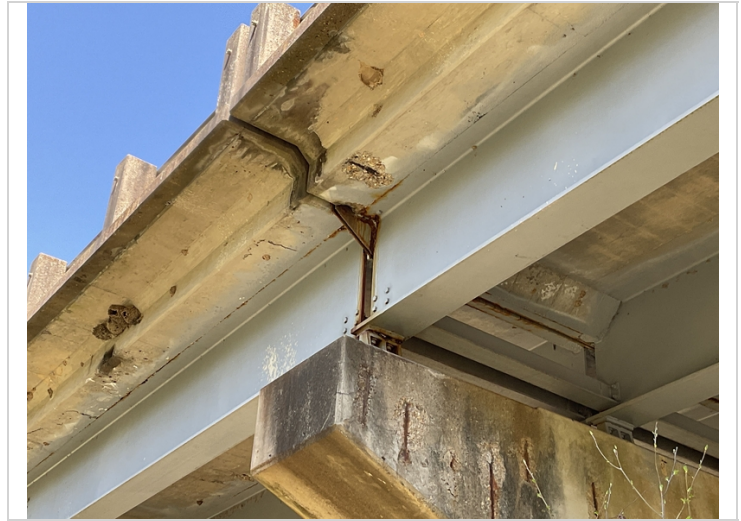
Span 1 corrosion

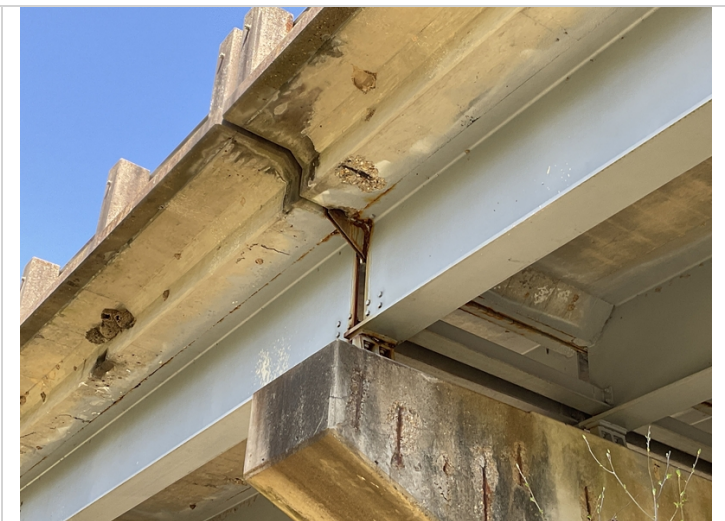
Span 1 corrosion

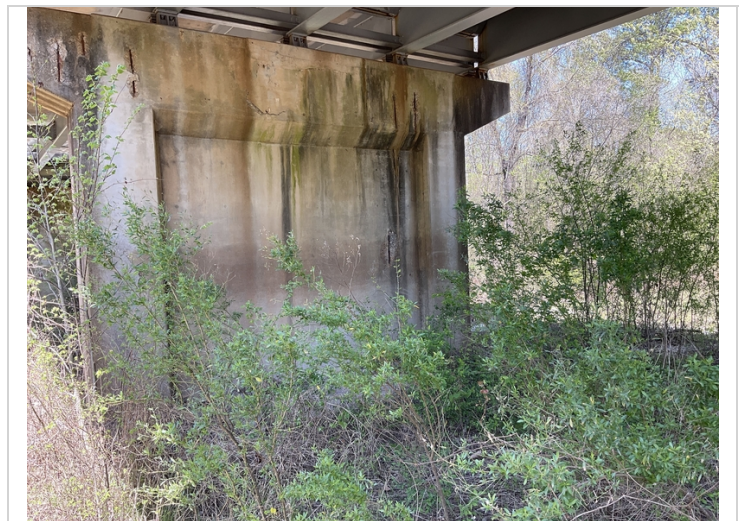
Pier wall at bent 2 rebar exposed

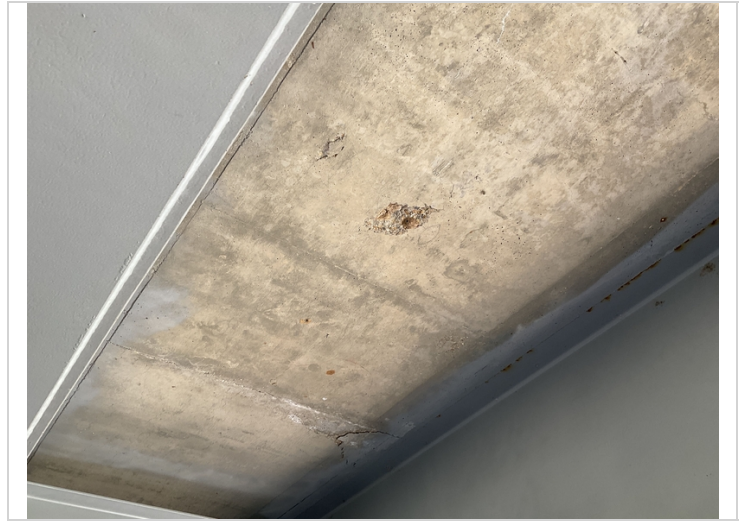
Spalls on underside of deck

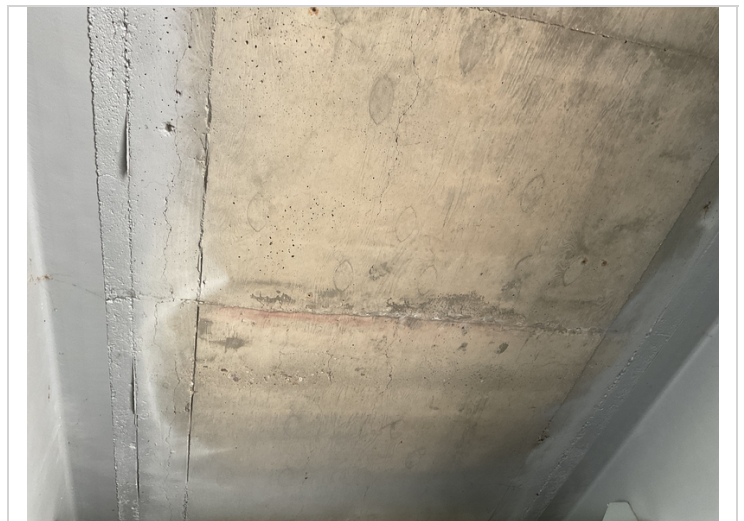
Cracking on underside of deck

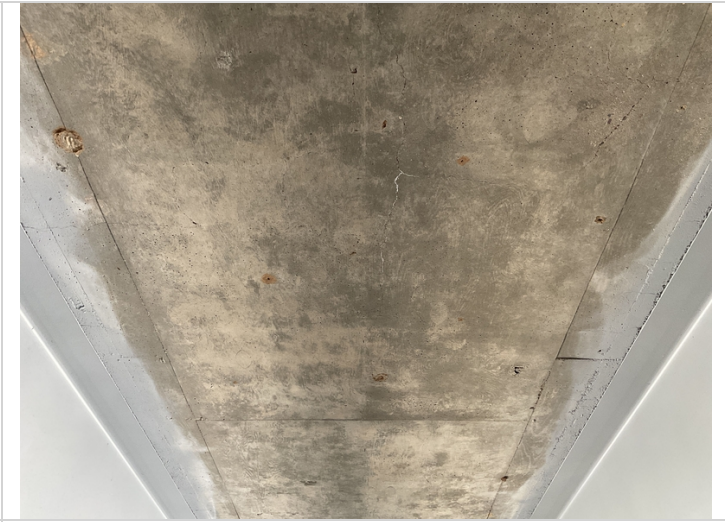
Efflorescence in underside of deck

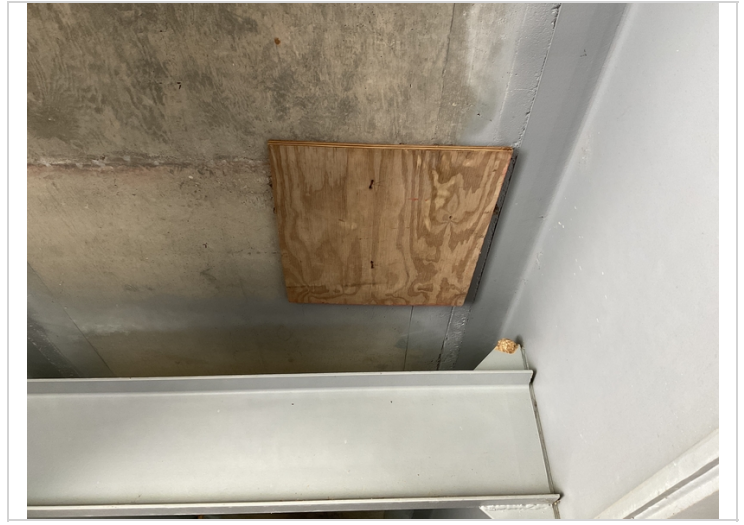
Patched area underside of deck

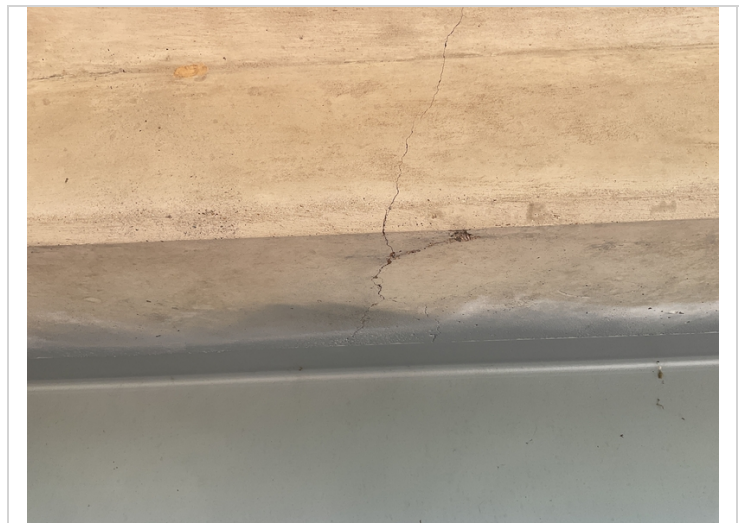
Cracking on underside of deck

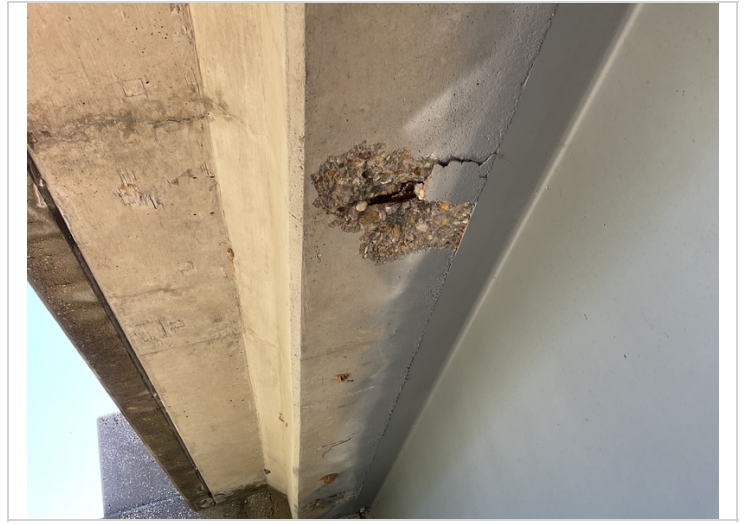
Span 1 underside of deck Rt side rebar exposed

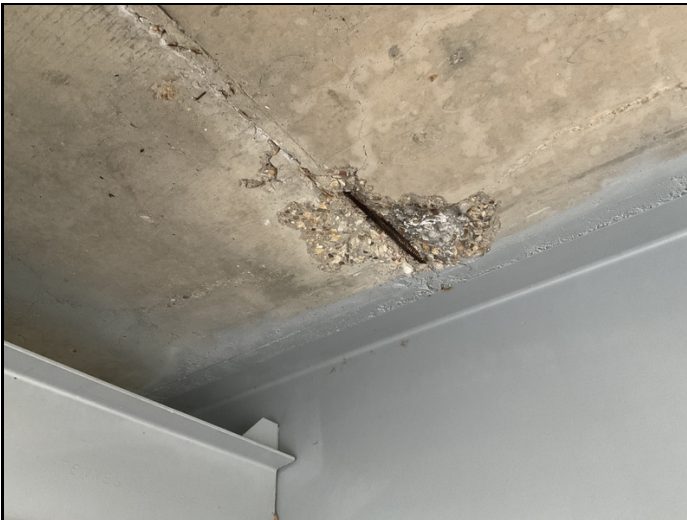
03/2022... over 50 percent of deck is patched some patches are not sound, small spalls and delams on underside of deck at various locations

03/2022... end span spall

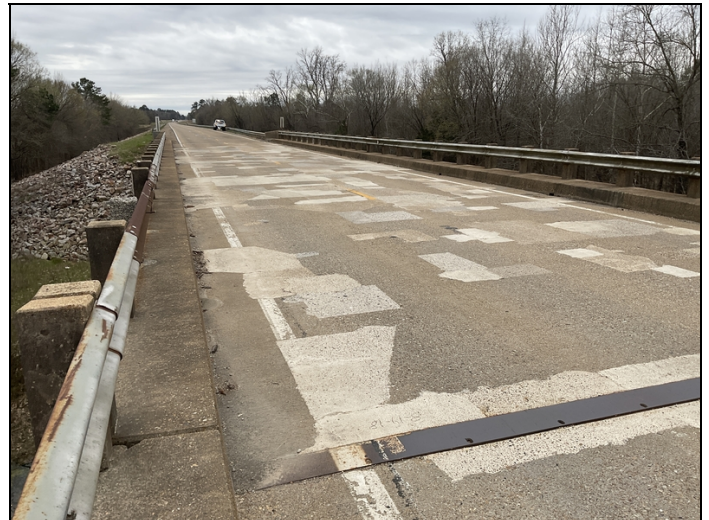
03/2022... typical deck all spans

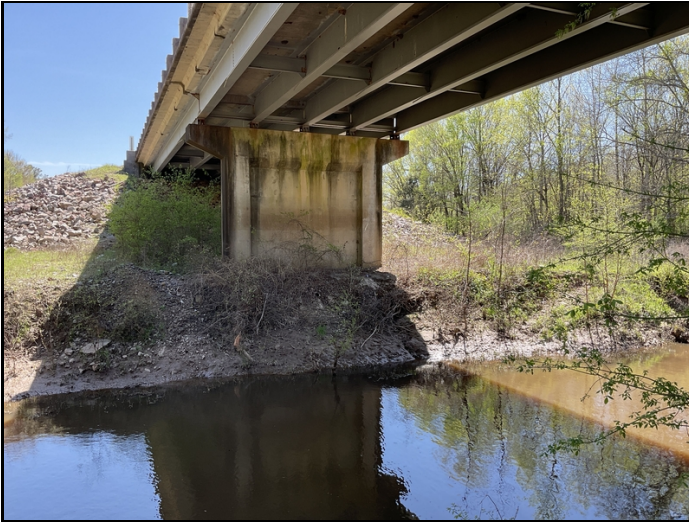
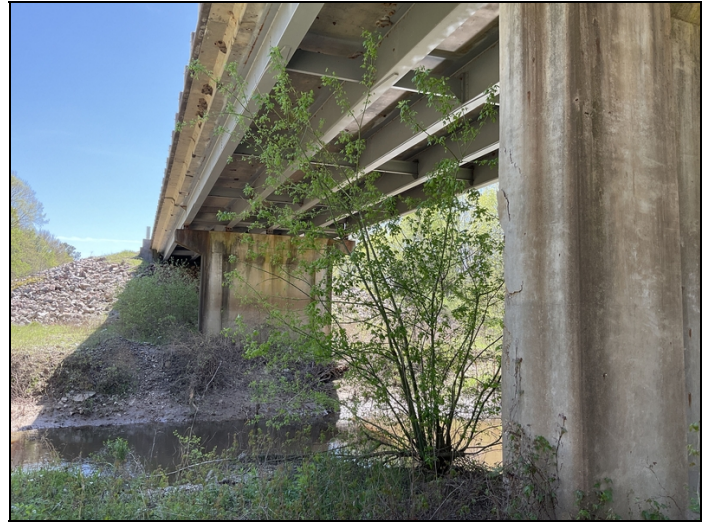
Trees growing under and along both sides of bridge in all spans.

Trees under bridge
