Asset #03674(Routine)

US 71 SEC.04-18.35 over LITTLE RIVER

Location: 2.50 MI N OF WILTON

Team Lead: John King, Inspection Date: 03/21/2022

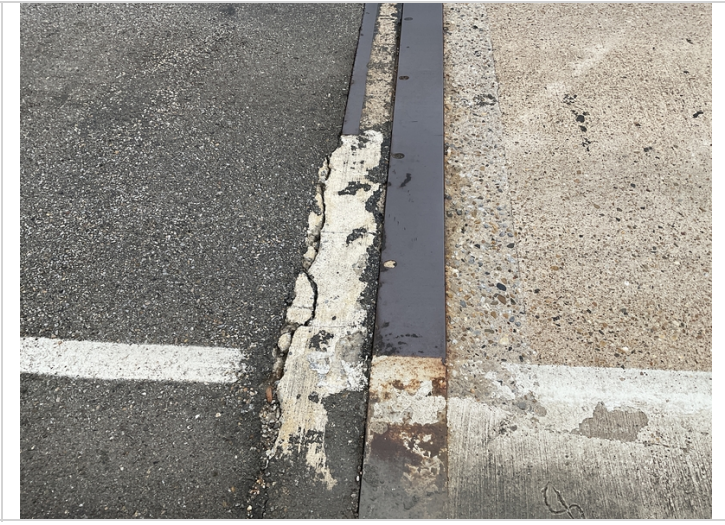
03/2022... Deck photos taken. Patching quantities updated per this inspection... End of bridge Lt side approach is cracking and spalling.

03/2022... end of bridge approach cracked and damaged

03/2022... End of bridge LT side approach needs repaired due to cracking and spalling

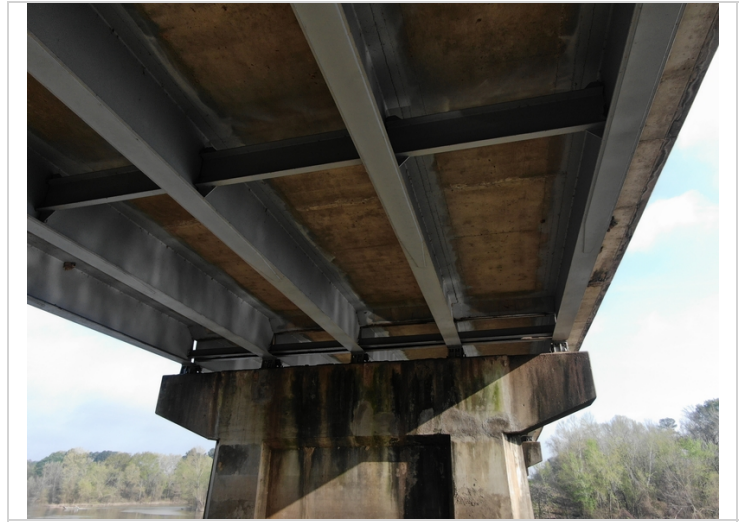
Undersurface span 2

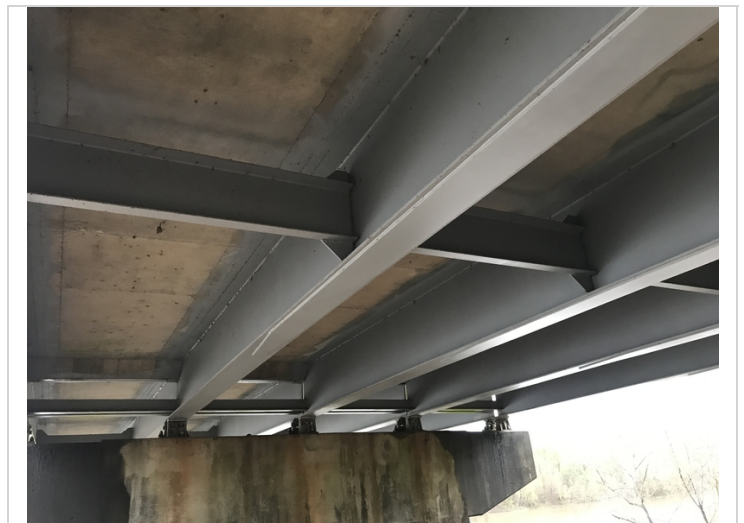
Underside of deck typical all spans

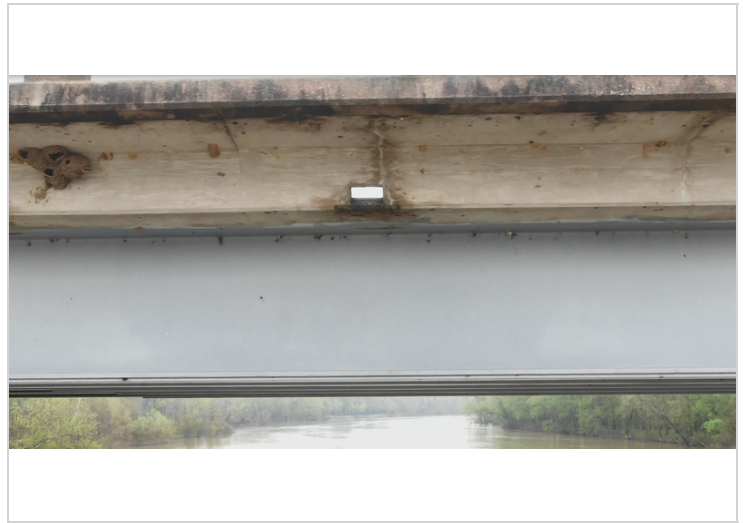
Crack/Delam at gutter

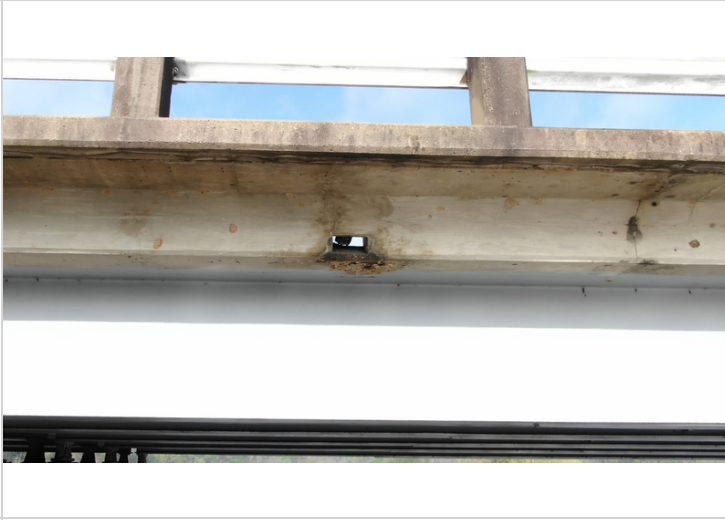
Exposed Bar Downstream Span 3

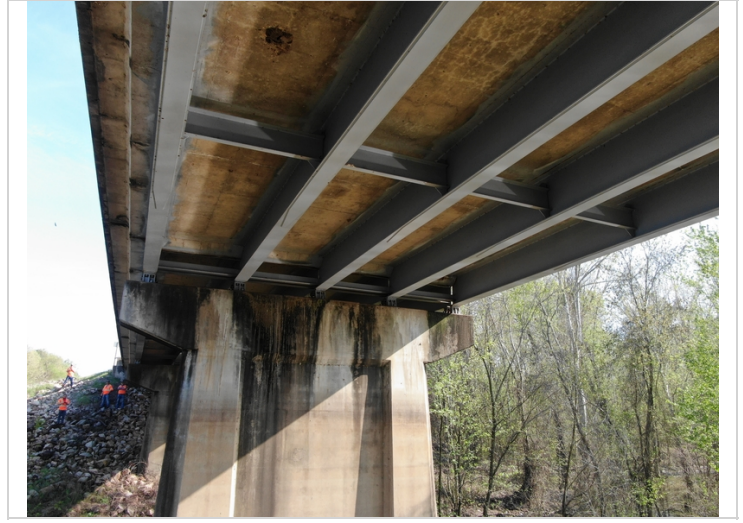
Span 7 Deck crack with Efflorescence

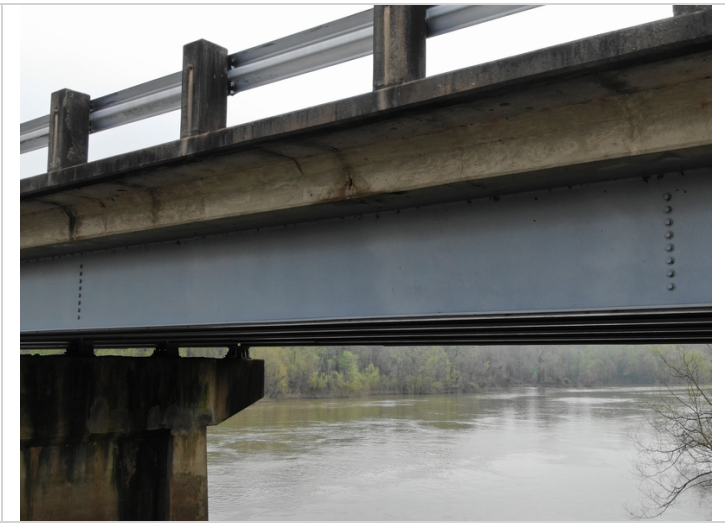
Exposed bar span 2

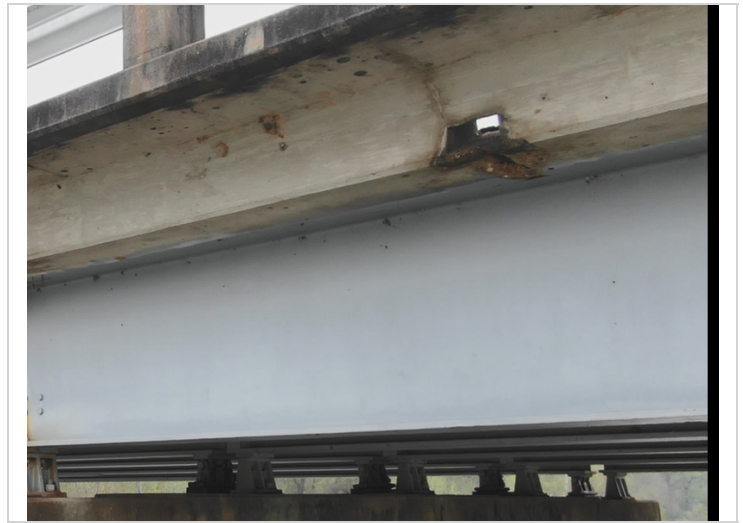
Spall - Exposed Bar

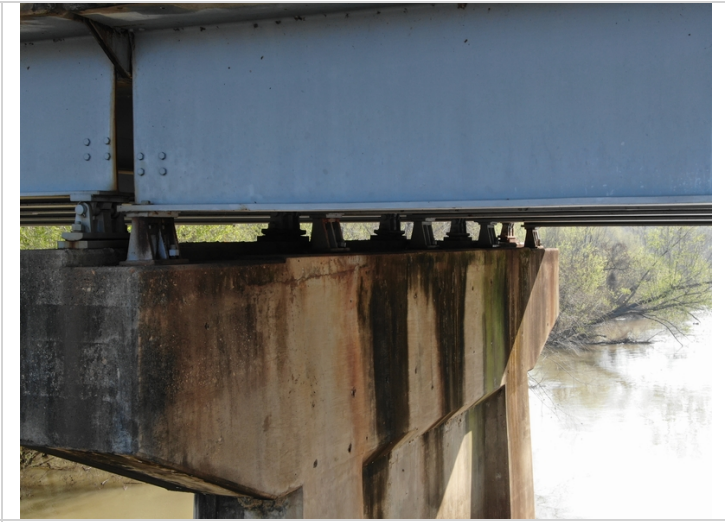
(234) SPALLS AND CRACKS ON CAPS AT BENTS 2, 3, 4, 5, 6, 7, AND 8.							
305	Assembly Joint without Seal	LF	280	280	0	0	0
311	Movable Bearing	EA	45	21	24	0	0
1000	Corrosion	EA	22	0	22	0	0
2210	Movement	EA	2	0	2	0	0

Cracking Bent 7 Cap

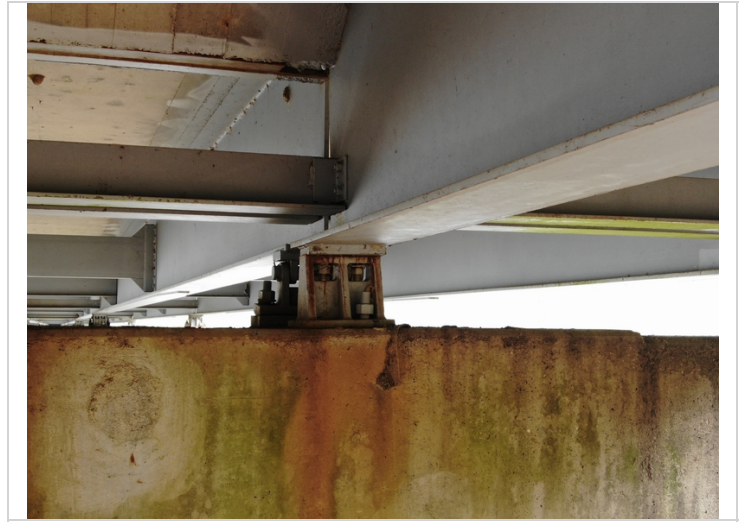
CS2 Corrosion Bearing Bent 6

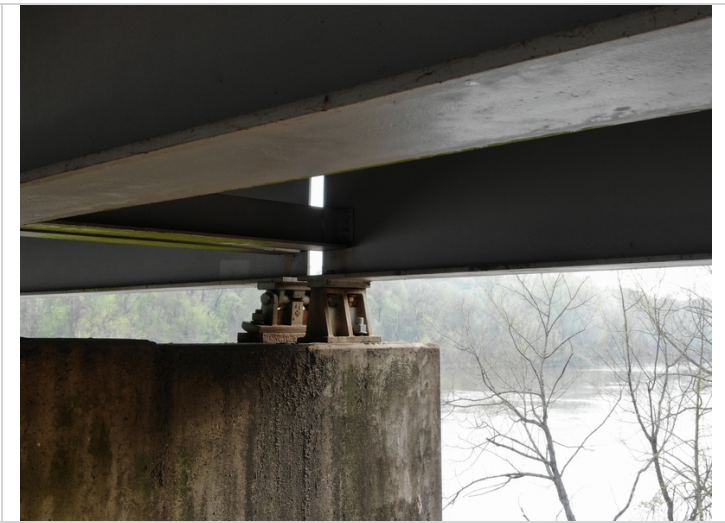
Bearing Position at 65 Degrees

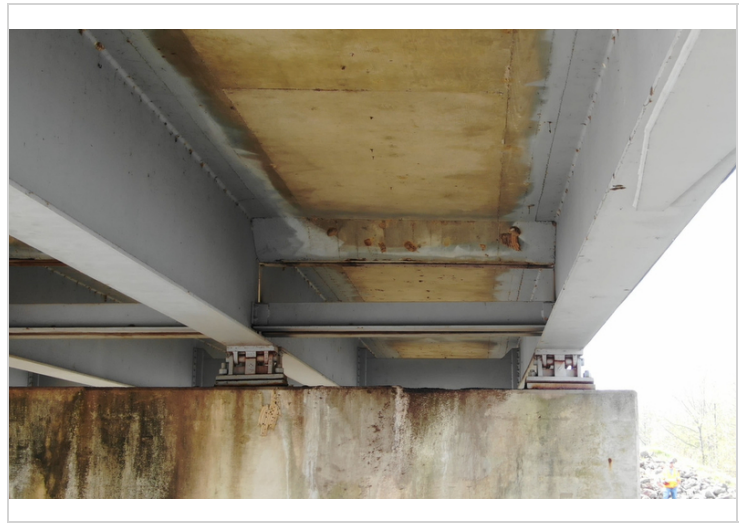
CS2 Corrosion Bearing Bent 3

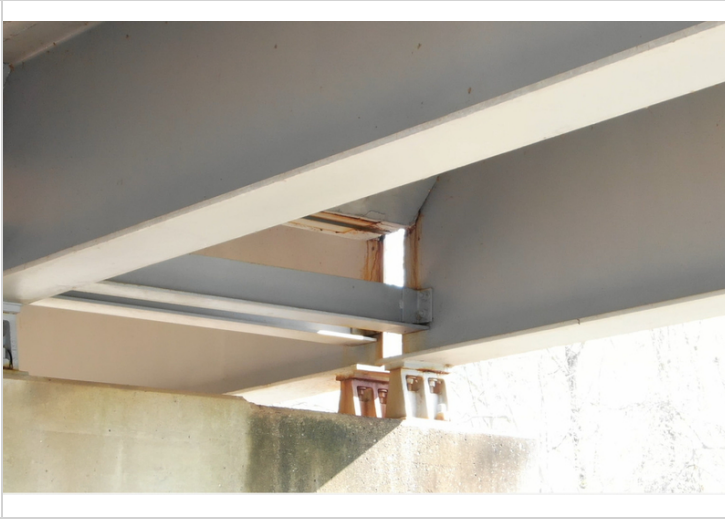
CS2 Corrosion Bent 7

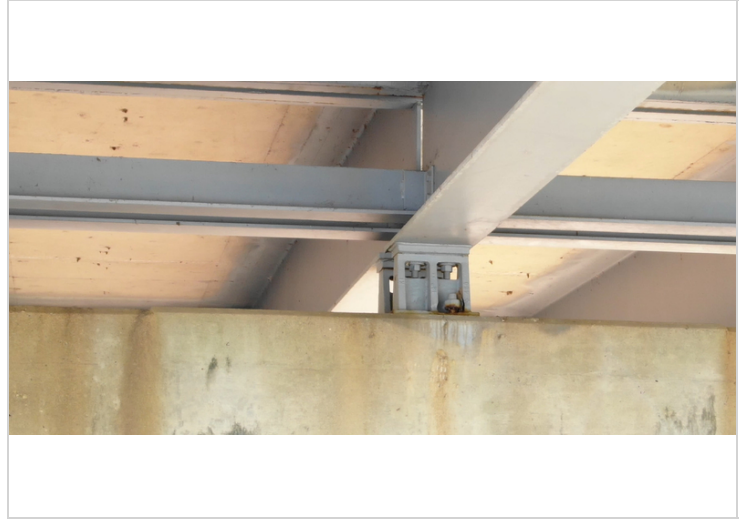
CS3 Corrosion Bearing Bent 9

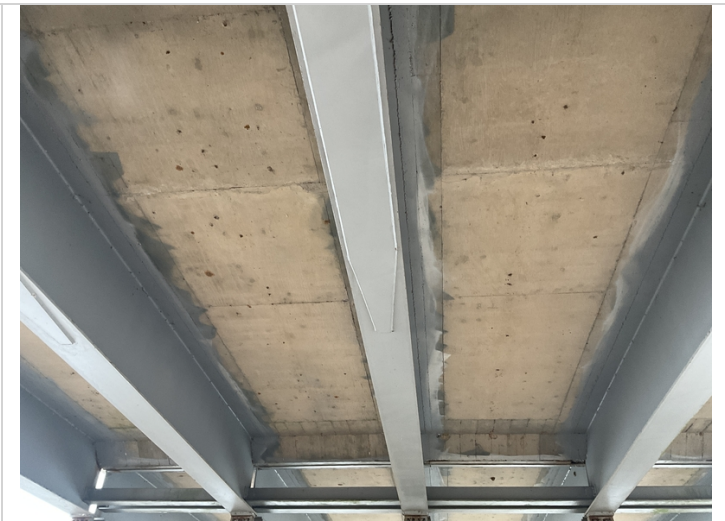
(12) 5709 sqft of deck is patched. 2019 updated patched areas to 5715 sq ft (1090-12) 03/2022... spalls on underside of deck at various locations.							
107	Steel Open Girder/Beam	LF	3010	2967	43	0	0
1000	Corrosion	LF	43	0	43	0	0
515	Steel Protective Coating	SF	24080	24037	0	0	43
3440	Effectiveness (Steel Protective Coatings)	LF	43	0	0	0	43

03/2022... underside of deck typical all spans

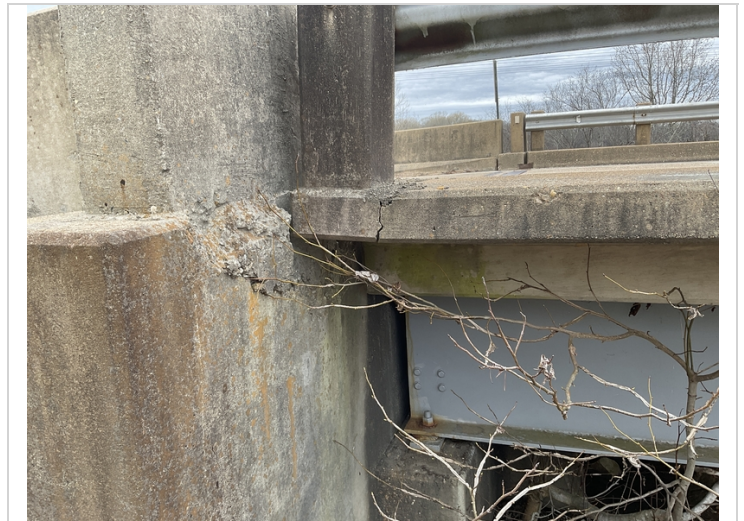
03/2022... spall and crack Rt side beginning of bridge

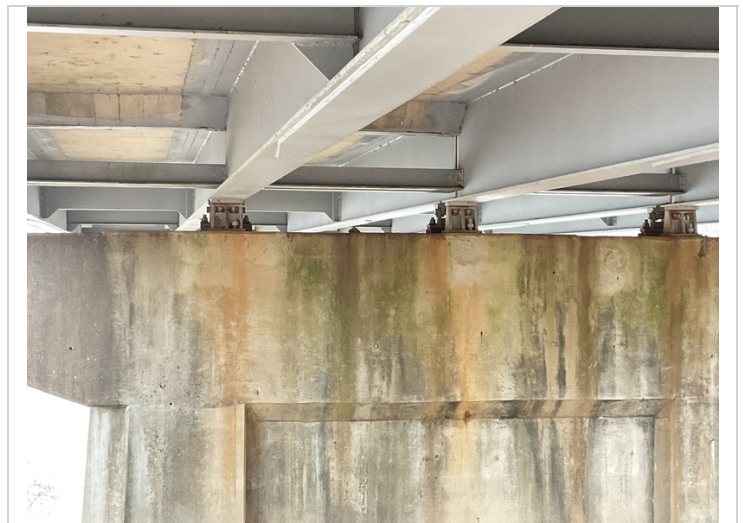
(311) 03/2022... anchor bolts are backing out or not tightened at various locations							
313	Fixed Bearing	EA	45	21	22	2	0
1000	Corrosion	EA	24	0	22	2	0

03/2022... anchor bolts are backing out or not tightened at various locations

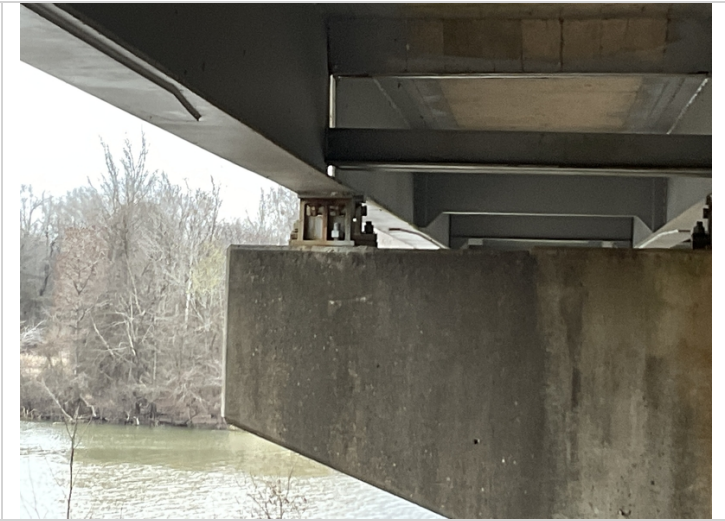
(313) 03/2022... anchor bolts are backing out or not tightened at various locations							
330	Metal Bridge Railing	LF	1204.3	1204.3	0	0	0

03/2022... anchor bolts are backing out or not tightened at various locations

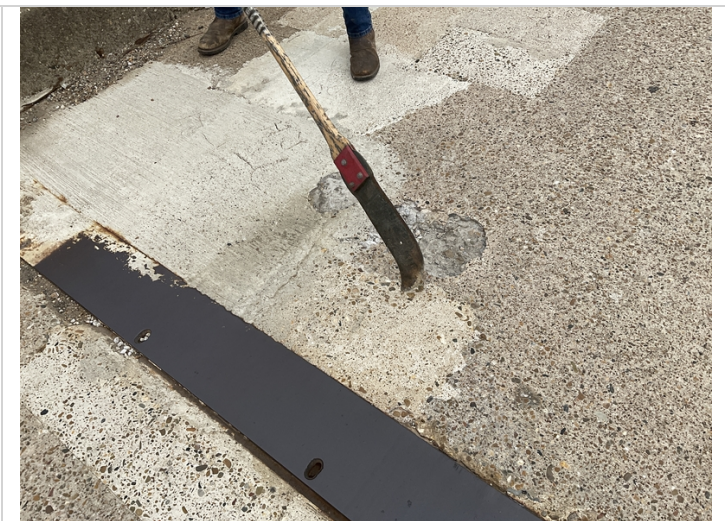
03/2022... LT side span 6 existing patch spalling

03/2022... Span 6 LT side existing patch starting to spall and various locations on deck are hollow... found Delams in various locations on deck

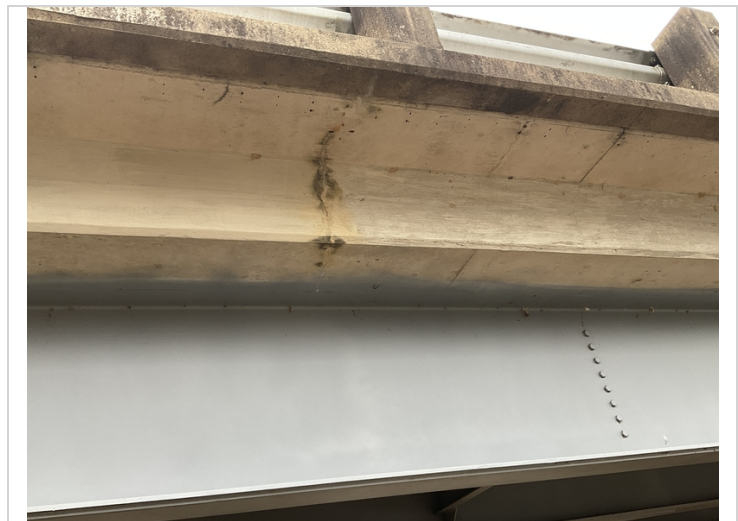
03/2022... cracking on overhangs various locations

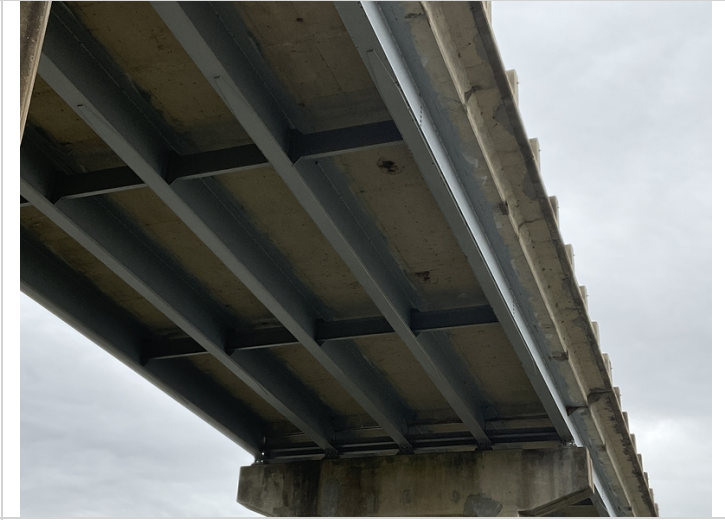
03/2022... span 7 Rt side spalls... spalls at various locations
on bridge

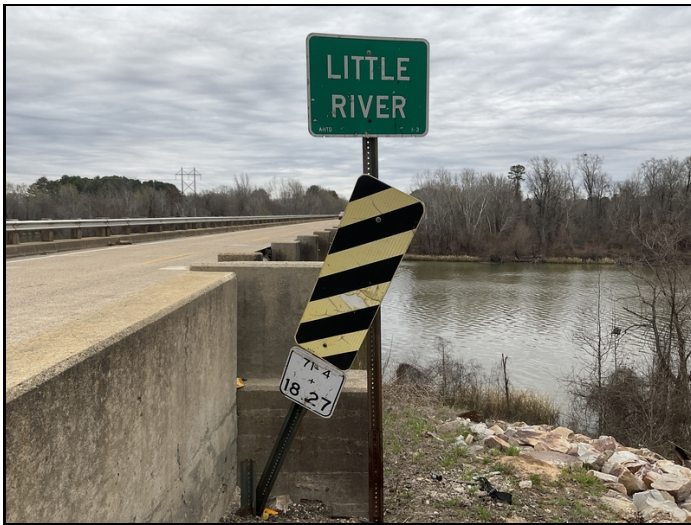
Rt side of bridge log mile sign damaged

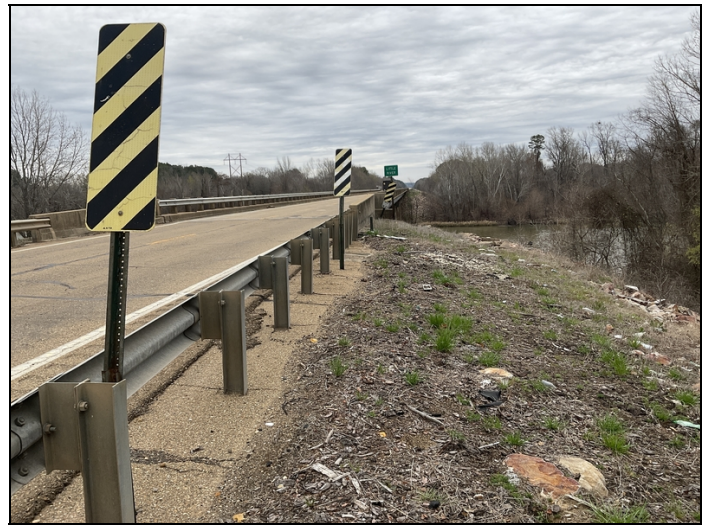
Rt side of bridge OM-3 signs damaged

Rt side of bridge OM3 signs damaged

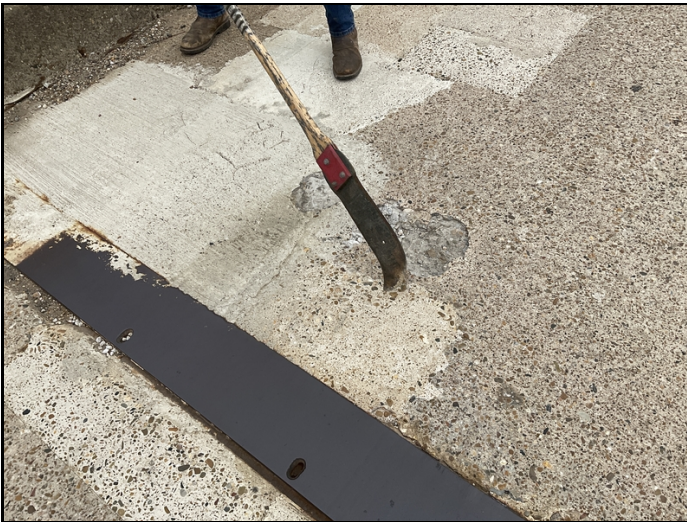
03/2022... LT side span 6 existing patch spalling

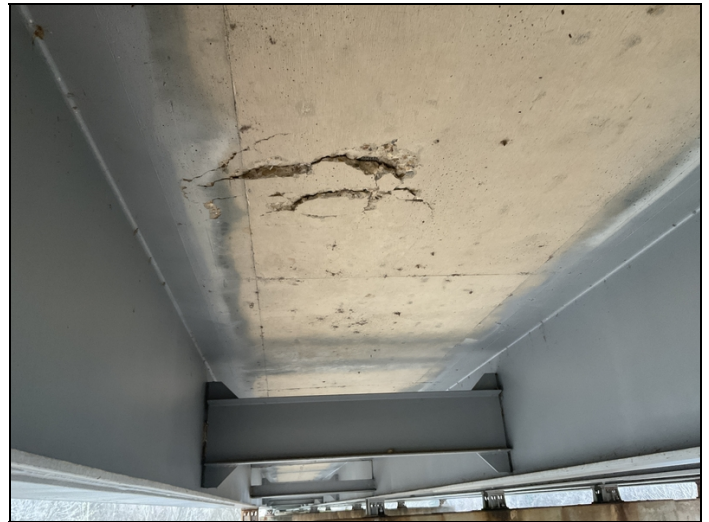
03/2022... Rt side last span delam

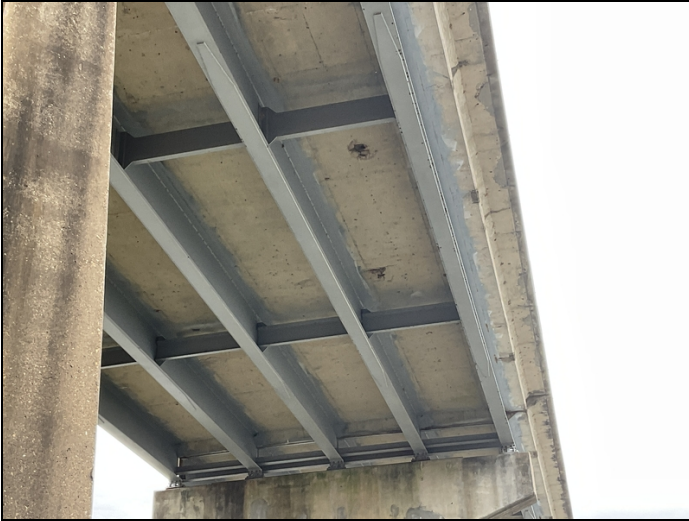
03/2022... LT side span 7 spalls

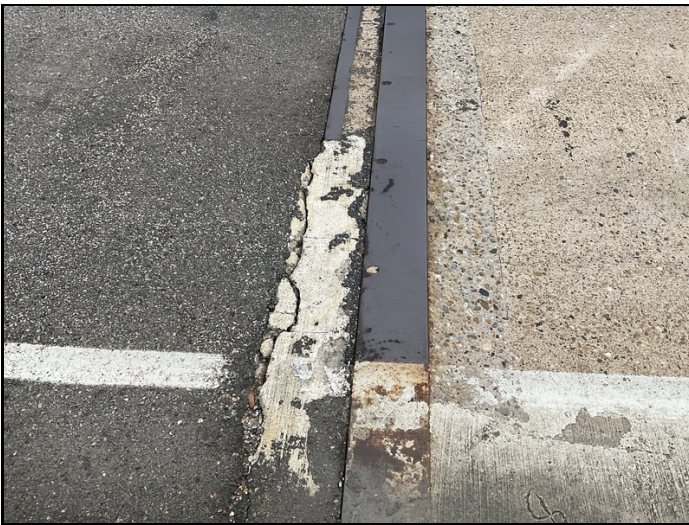
03/2022... End of bridge approach cracked and damaged
