Asset #01321 (Routine, Underwater type 2)
US 71-SEC.05-11.46 over BIG BELLVILLE CREEK

Location: 1.5 MI S JCT. S.H24 & 371

Team Lead: Charlie Rogers, Inspection Date: 02/16/2022

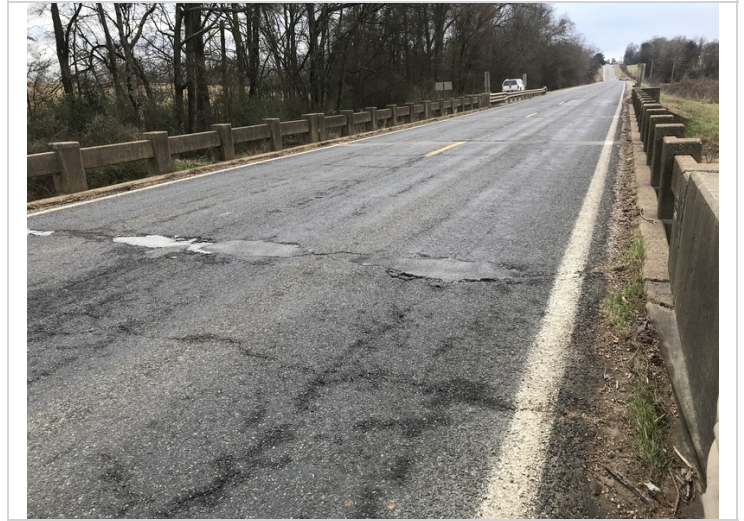
All joints covered with asphalt

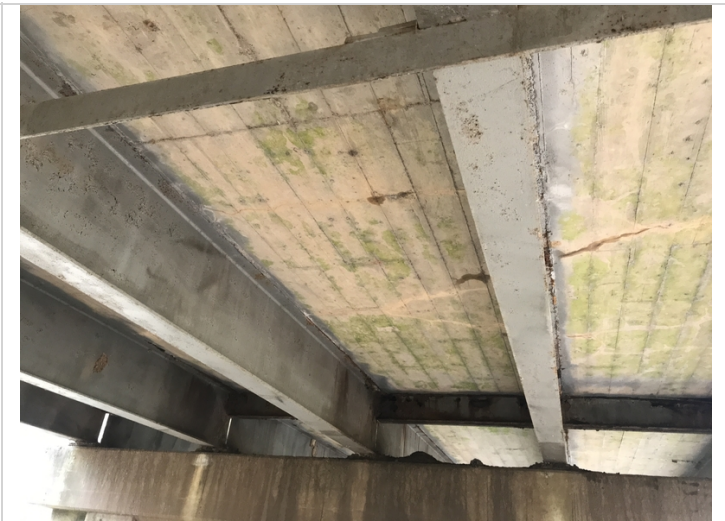
Comment: 02/20/2018...AL, SS, DECK PHOTOS TAKEN. LITTLE OR NO CHANGE IN CONDITION...2/16/2022...Cracking in bottom of deck in various locations leaking water down onto beams causing corrosion. Spalls and rebar exposed on bottom side of deck, efflorescence with rust staining and regular cracking in various locations...

Underside of deck typical all spans 2/2022

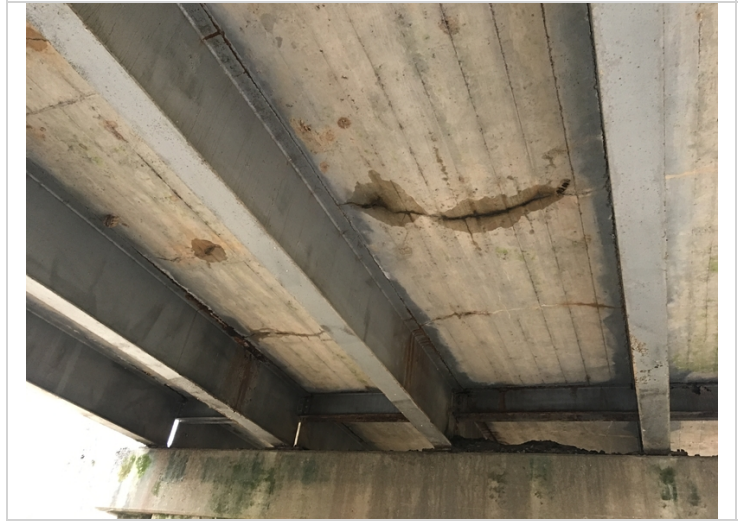
Rust staining

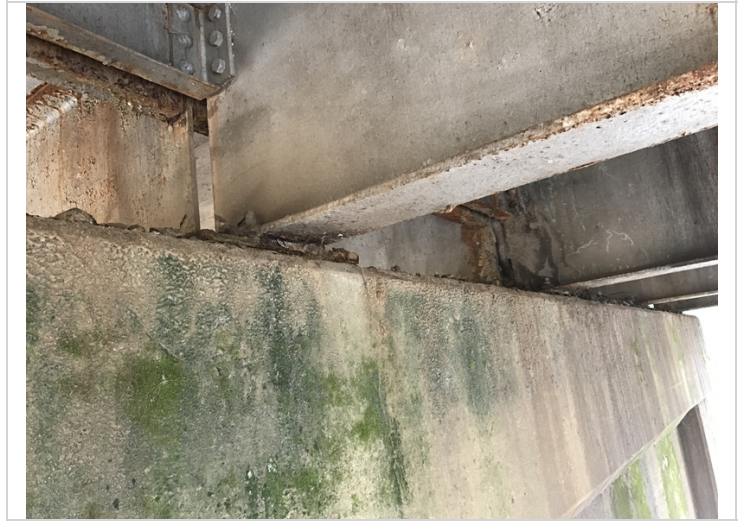
Comment: Raised super to a 5 fair due to Repairs made to beams, see photos and drawings. Still some initial section loss in critical areas -----2/16/2022...Steel diaphragm's at bents #1 and #2 are rusted with holes in diaphragm's. Corrosion with some section loss in various locations of beams and beam ends...

Various beam ends have section loss

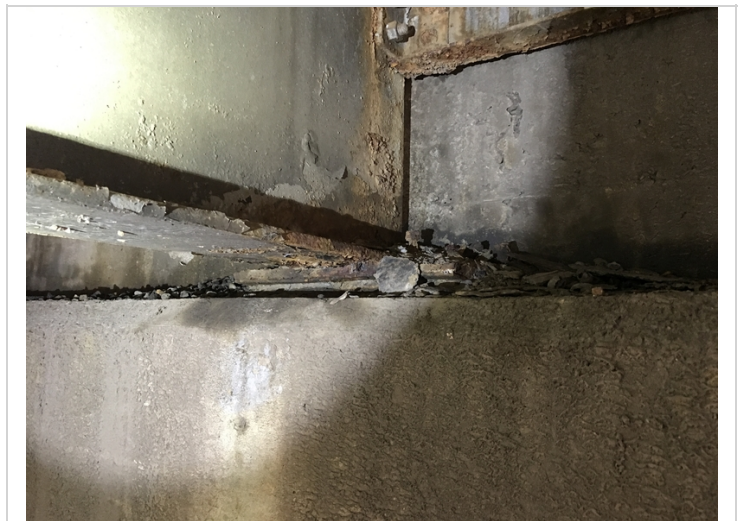
Fixed bearings have heavy pack rust

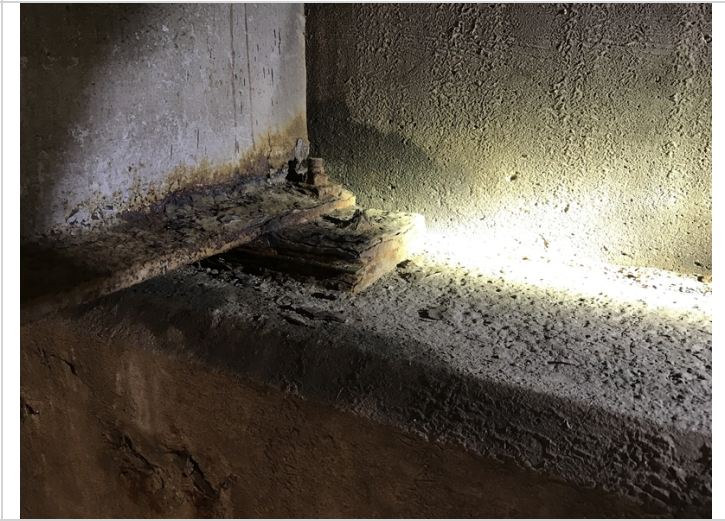
Heavy pack rust

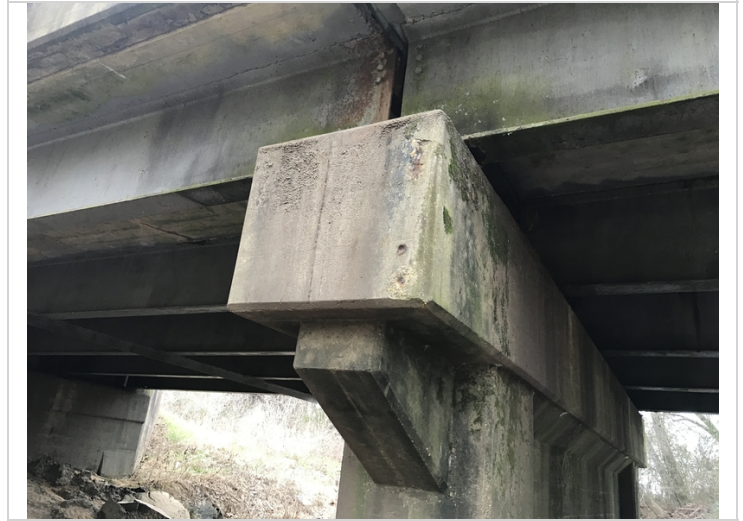
Bent 2

Large amounts of debris sitting on top of caps, beam ends, and bearings causing corrosion.

Type of Work: (Inactive) (Inactive) 1 - Clean

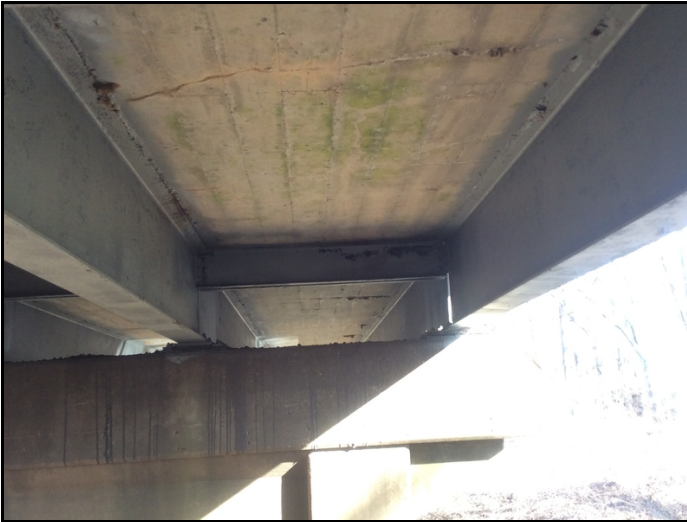
Bent 2 bay 4 diaphragm

Steel diaphragm's at bents #1 and #2 are rusted with holes in diaphragm's.

Type of Work: Repair (General)
