Asset #01869(Routine, Underwater type 2)

US 71 SEC.05-11.27 over LITTLE BELLVILLE CREEK

Location: 1.4 M S OF LOCKESBURG

Team Lead: Charlie Rogers, Inspection Date: 02/16/2022

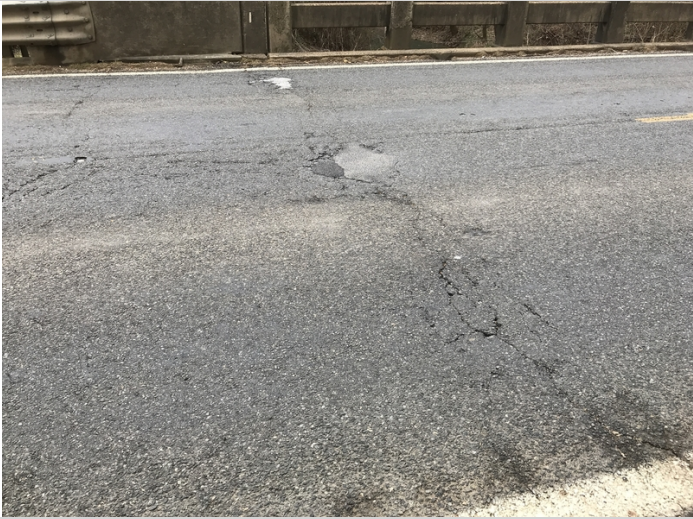
All joints are covered with asphalt

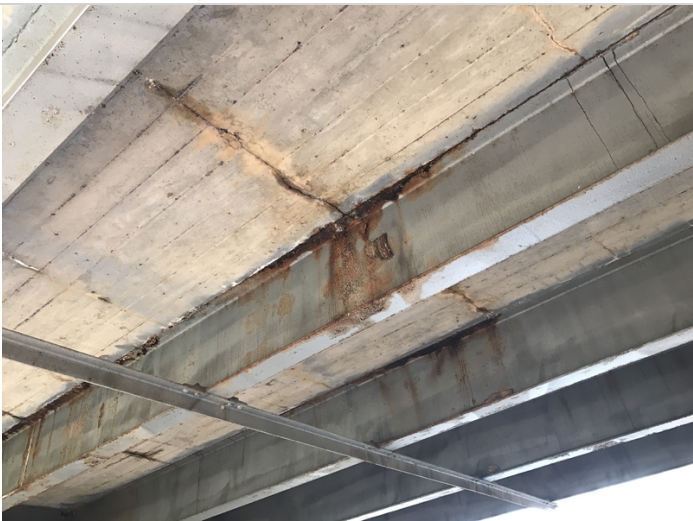
02/20/2018...AL, SS, DECK PHOTOS TAKEN. LITTLE OR NO CHANGE IN CONDITION...2/16/2022...Deck has large cracking, efflorescence with rust staining, and efflorescence on bottom side of deck. Exposed rebar near bent 3 abutment in bottom of deck. Dropped deck to a 5...

Underside of deck typical all spans 2/2022

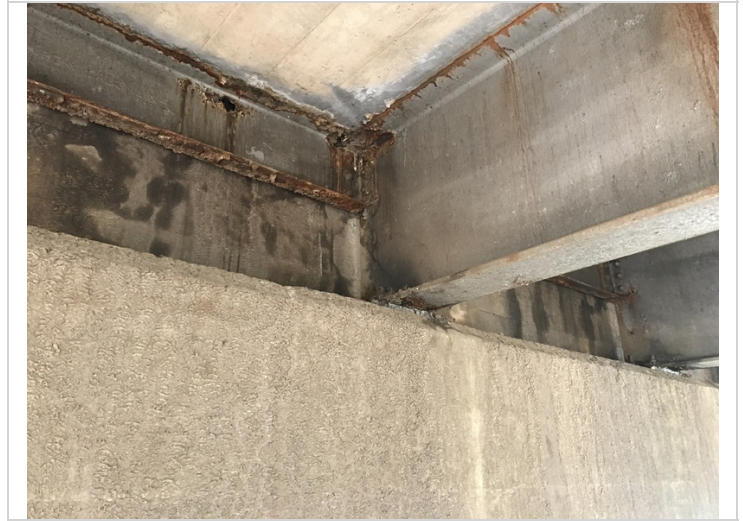
Raised super to a 5 fair due to repairs made to beams; see drawings -----2/16/2022... Corrosion with section loss on various beam ends. Corrosion in various locations of beams. All bearings have corrosion with heavy section loss. Various diaphragms at bents 1 and 2 have section loss holes...

Various beam ends have section loss

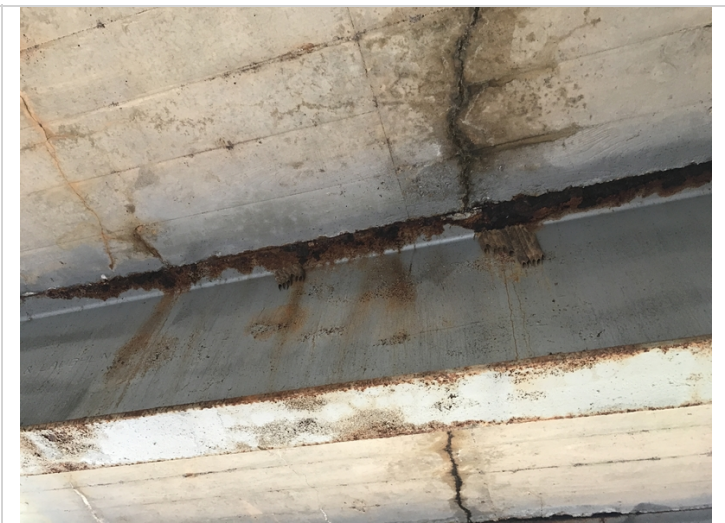
Corrosion on beams

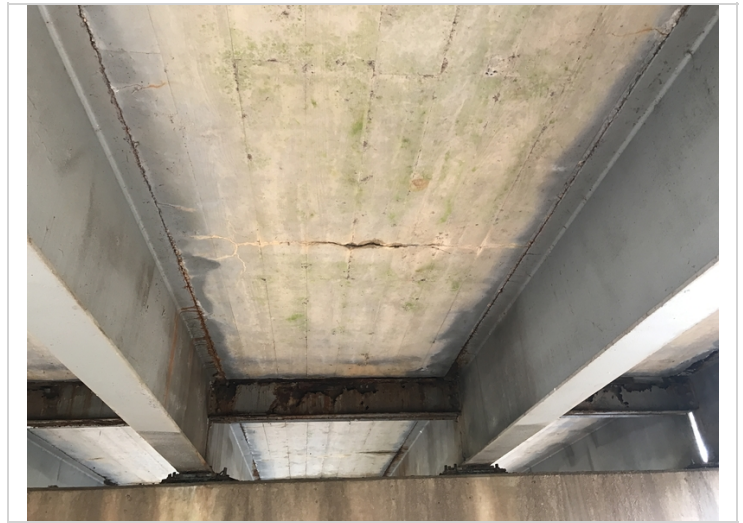
Rust staining

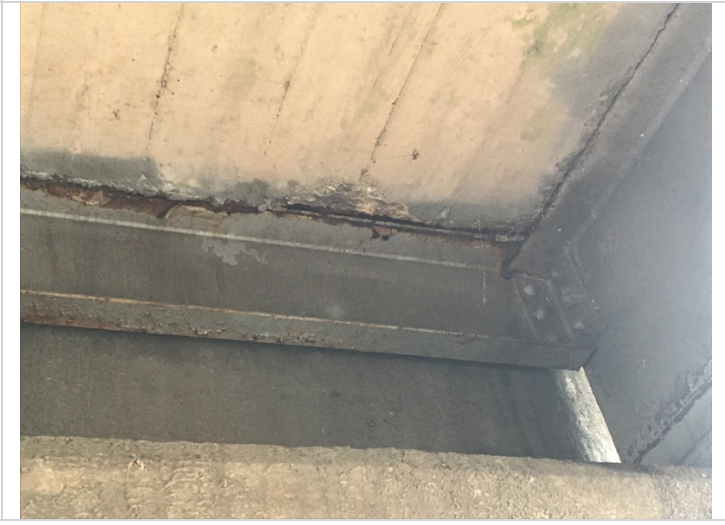
Bent 3

2/16/2022...Small delam on bent 3 abutment, rebar exposed on bent 2 column...

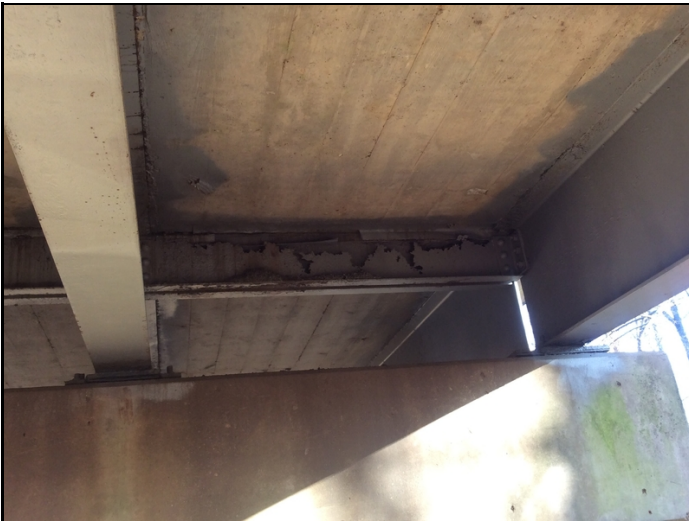
STEEL DIAPHRAGMS BENT 2 SECTION LOSS AND HOLES IN DIAPHRAGMS...2/16/2022...Bent 1 also has holes in diaphragms per this inspection...

Bent 2 bay 4 diaphragm.

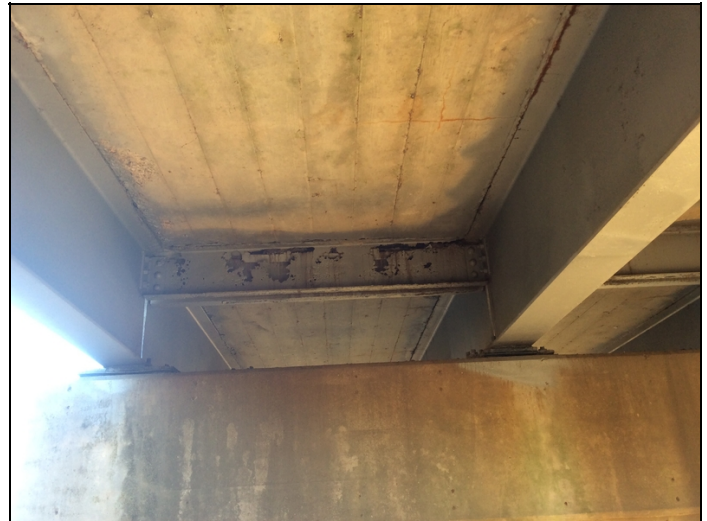
Bent 2 bay 1 diaphragm
