Asset #06620(Routine)

US 71 SEC. 07-6.08 over K .C. R/R

Location: 6.7 MI N JCT US 70 & 71

Team Lead: Charlie Rogers, Inspection Date: 09/13/2021

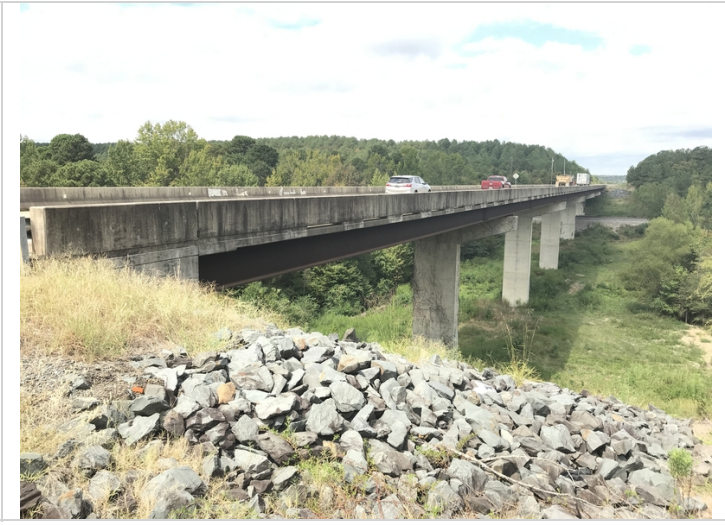
Elevation 9/2021

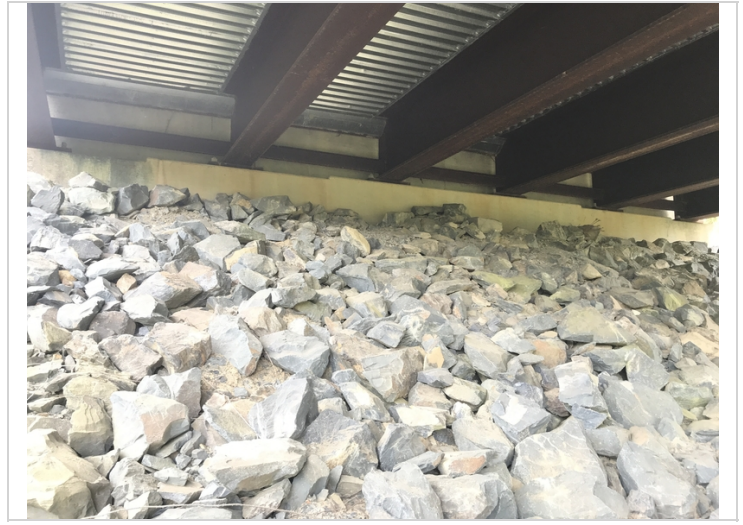
Bent 1 abutment

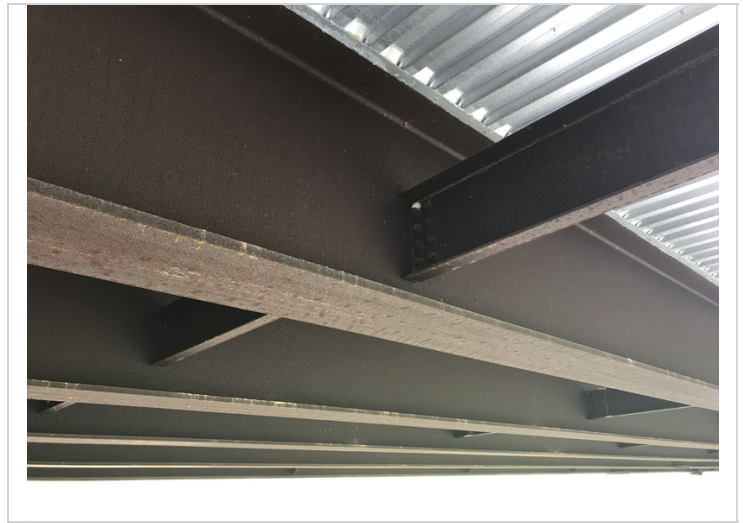
Paint: weathering steel

Weathering steel beams

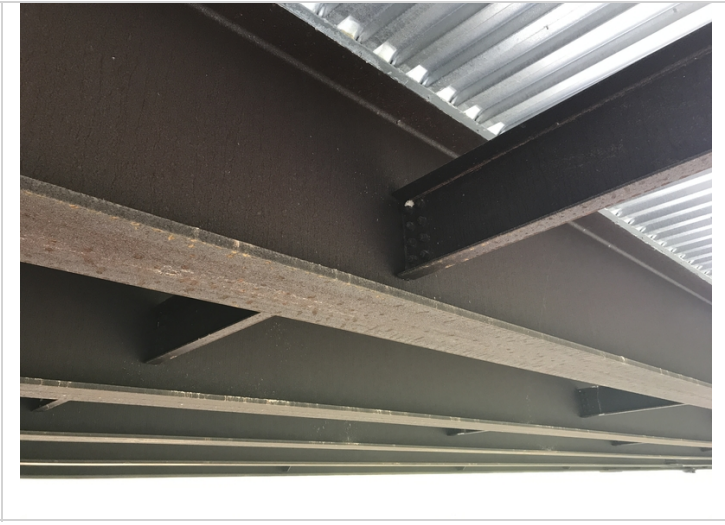
Weathering steel beams

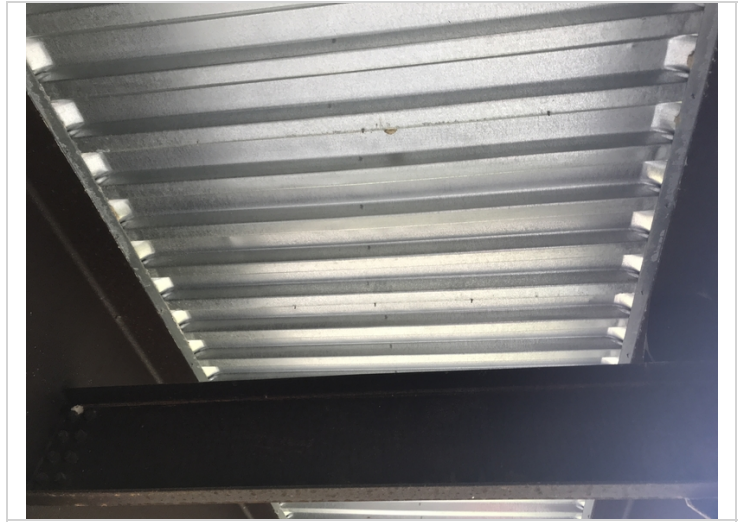
Stay in place forms

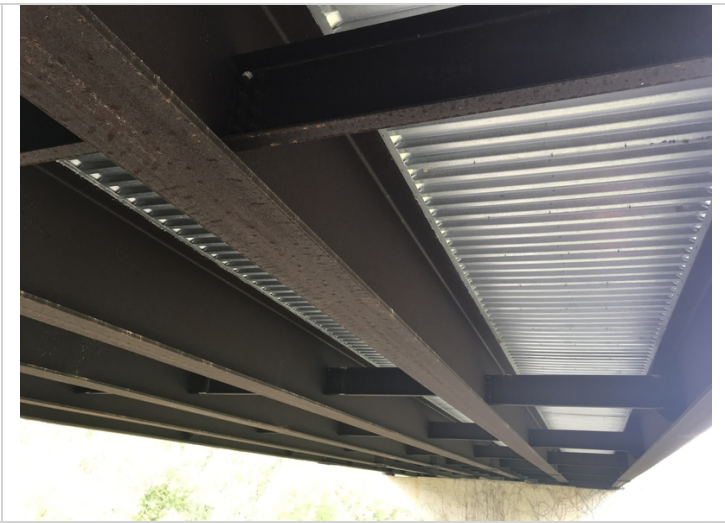
Underside of deck typical all spans

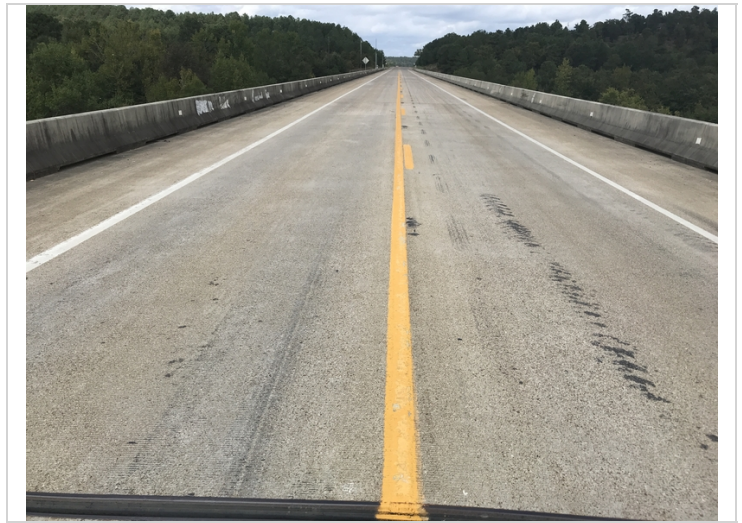
Wearing Surface: Sealable cracks various locations...9/13/2021...Deck cracking in all spans, some spalling on parapet  
walls...

Deck 9/2021

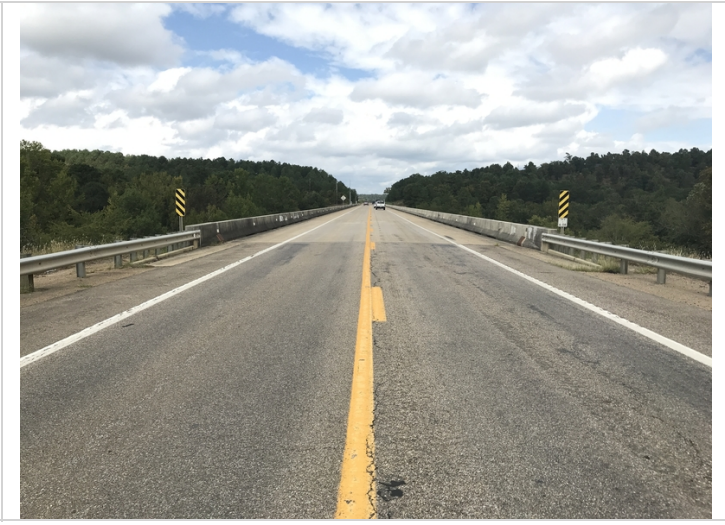
Alignment 9/2021

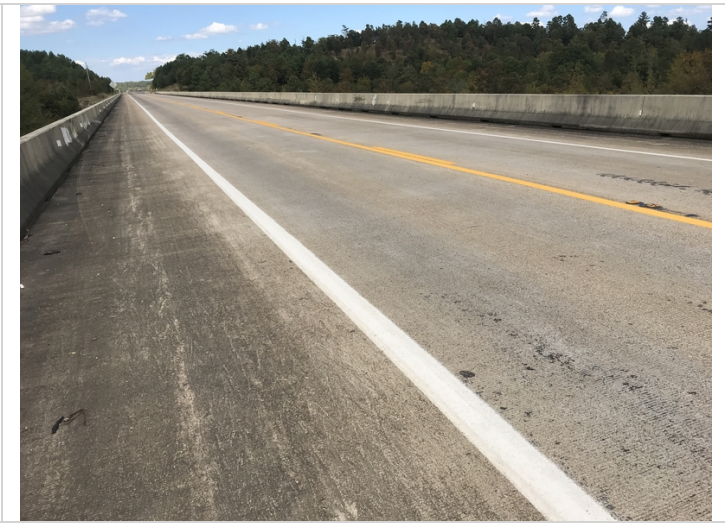
Deck photo Span #1

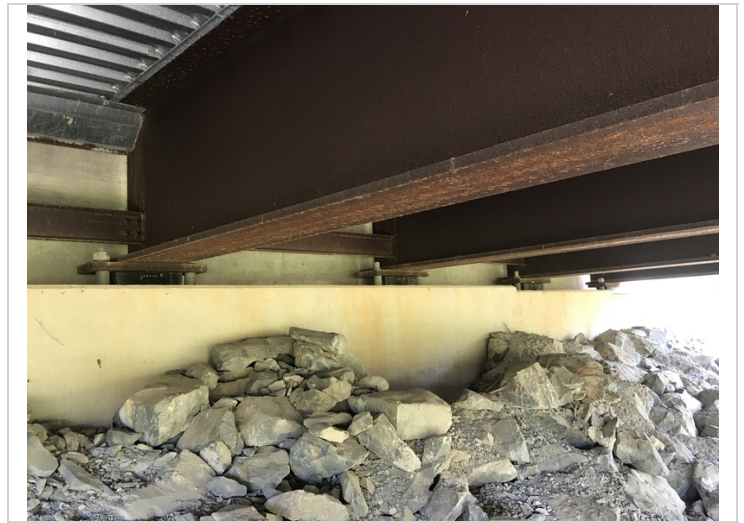
Comment: Other: Bearings - 8 Very Good

Bearings

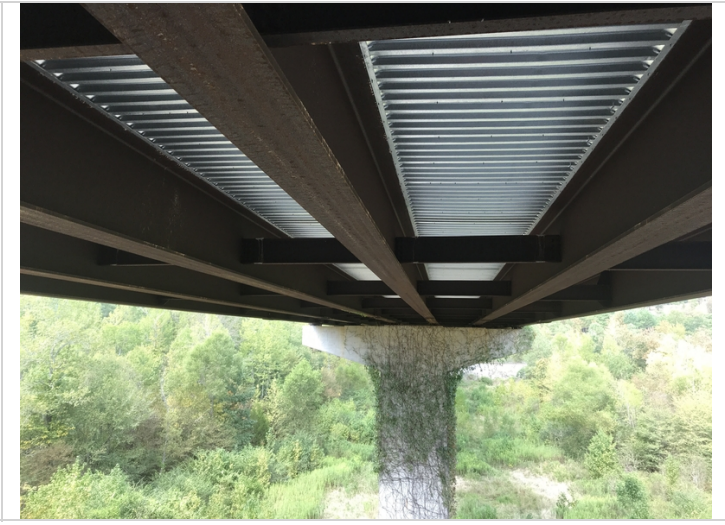
Under photo

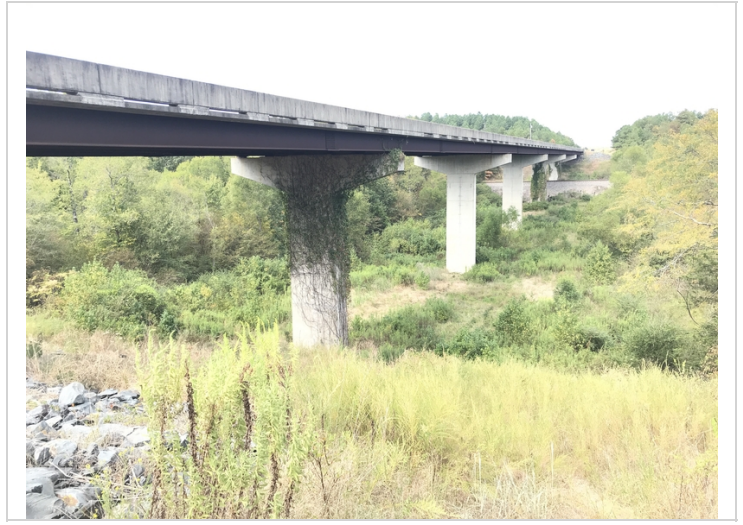
Vines on bents #2 and #5 and #6

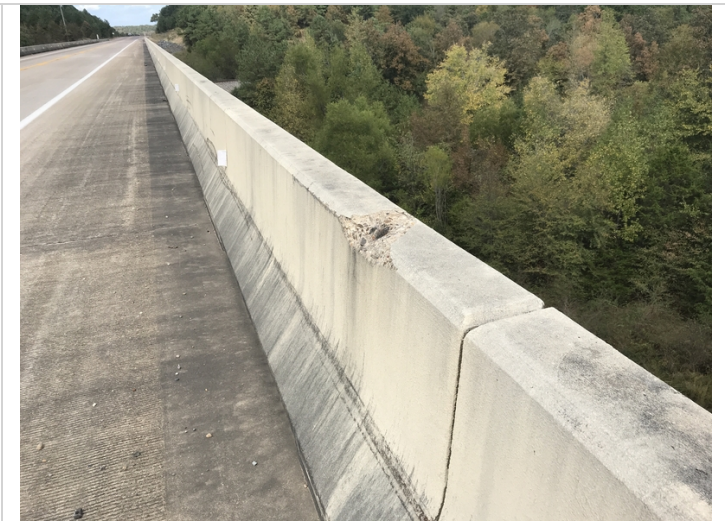
Spall Span #2 Parapet rail

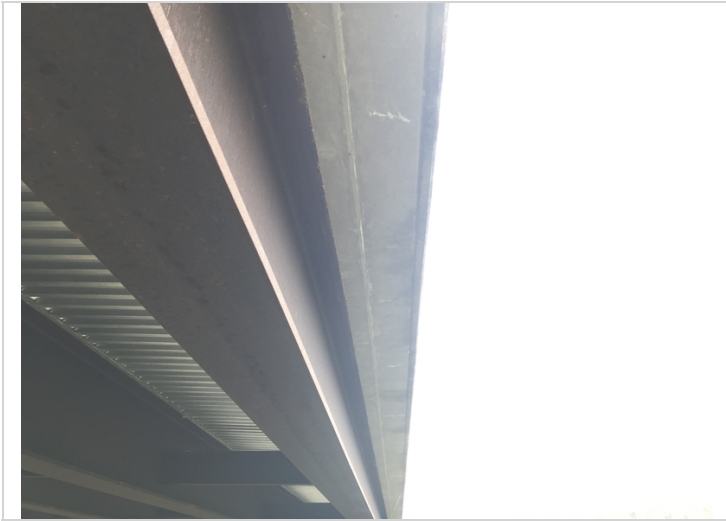
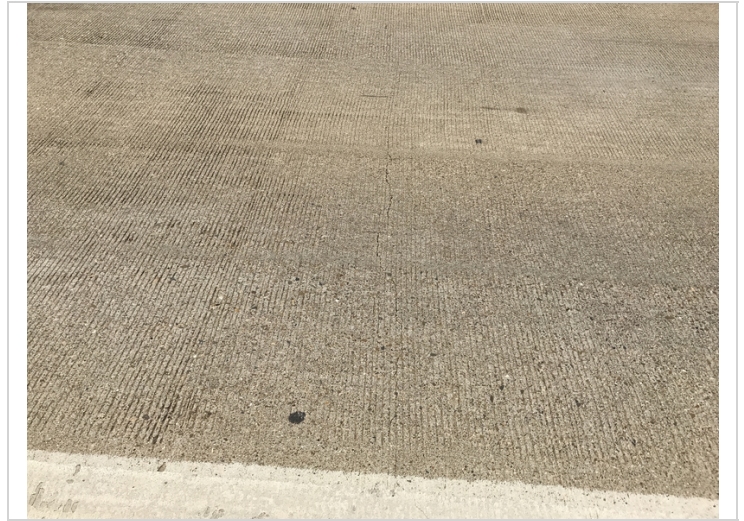
ELEMENTS	DESCRIPTION	UNITS	TOTAL				
				CS1	CS2	CS3	CS4
12	Reinforced Concrete Deck	SF	33127	25706	7421	0	0
1080	Delamination/Spall/Patched Area	SF	1	0	1	0	0
1120	Efflorescence/Rust Staining	SF	200	0	200	0	0
1130	Cracking (RC and Other)	SF	7220	0	7220	0	0
(12) 1080- pop out in deck span 2 north bound lane							
1130- cond 2 moderate unsealed cracking in deck various locations

Efflorescence in both overhangs

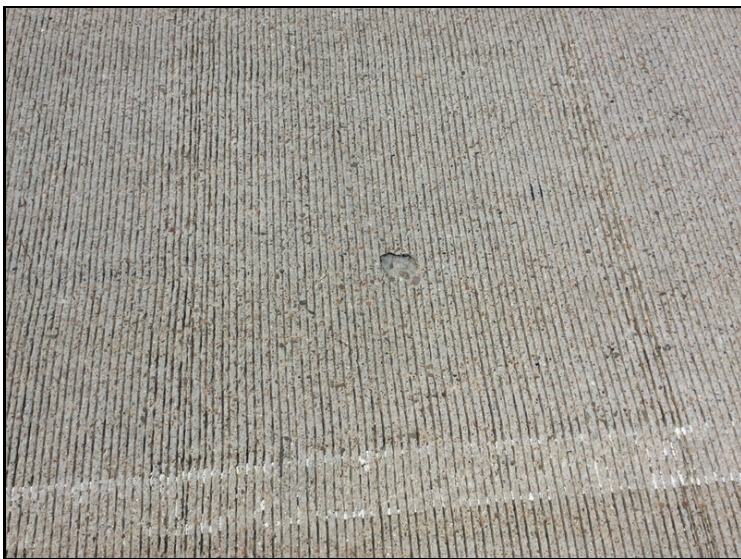
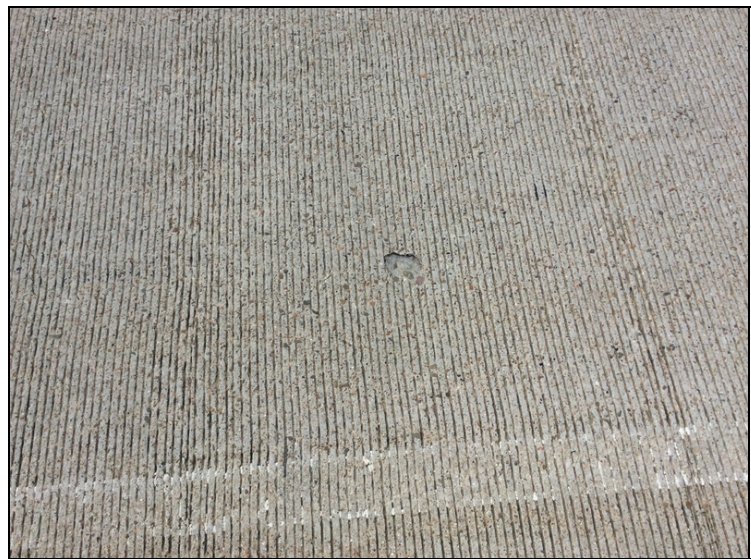
Small pop out in deck north bound lane span 2

Pop out in deck span 2 north bound lane

**Date Reported:** 09/29/2015  
**Priority:** (Inactive) (Inactive) G - General/ Preventive maintenance  
**Type of Work:** Repair (General)  
**Status:** Monitor  
**Component:**

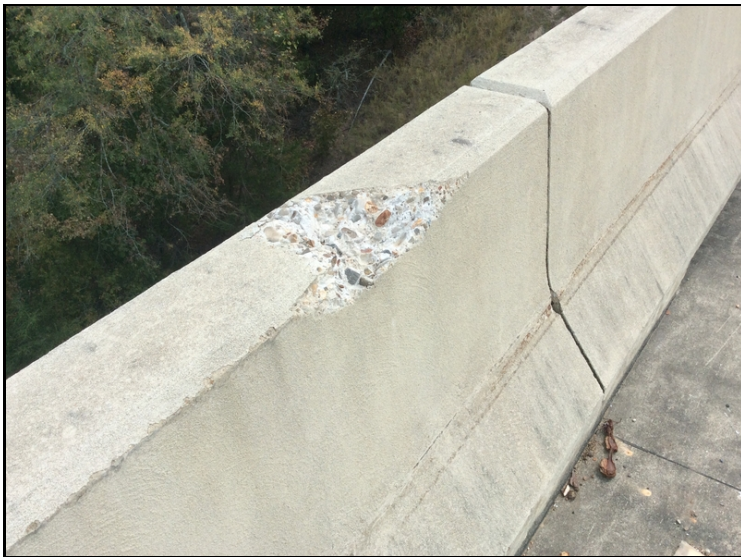
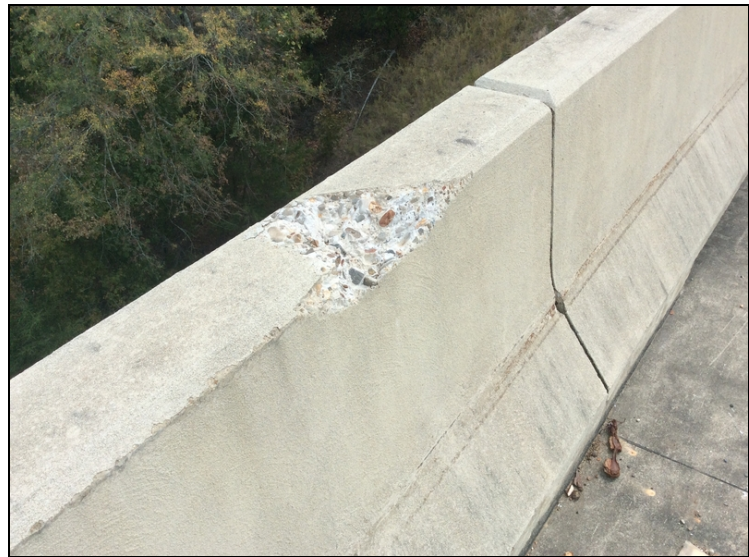
Spall in parapet rail span 2 right and left side

Parapet rail spall span 2 right side

**Date Reported:** 09/29/2015  
**Priority:** (Inactive) (Inactive) G - General/ Preventive maintenance  
**Type of Work:** Repair (General)  
**Status:** Monitor  
**Component:**
