Asset #06332(Routine, Underwater type 2)

US 278-5-11.89 over SO FK OZAN CREEK

Team Lead: Charlie Rogers, Inspection Date: 01/11/2022

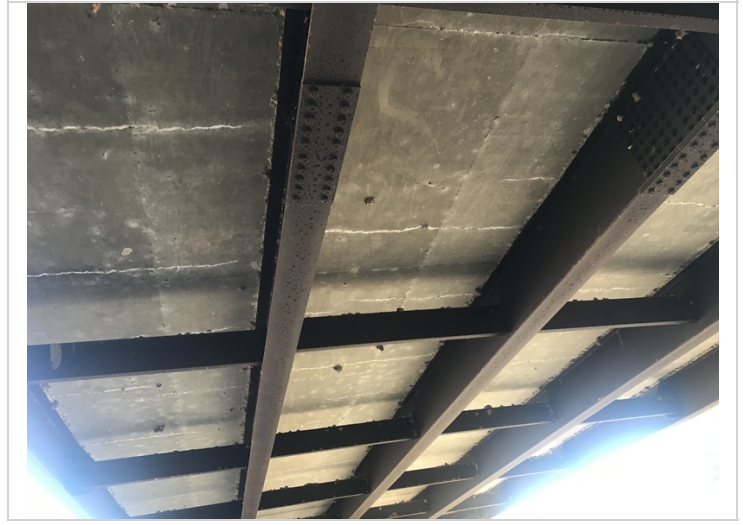
(12) 1120--EFFLORESCENCE ON BOTTOM OF DECK SOME IN ALL SPANS. 1130--DECK CRACK IN ALL SPANS NOT SEALABLE AT THIS TIME VERY SMALL CRACKS.							
107	Steel Open Girder/Beam	LF	750	750	0	0	0
515	Steel Protective Coating	SF	5707	5707	0	0	0

Bottom of deck

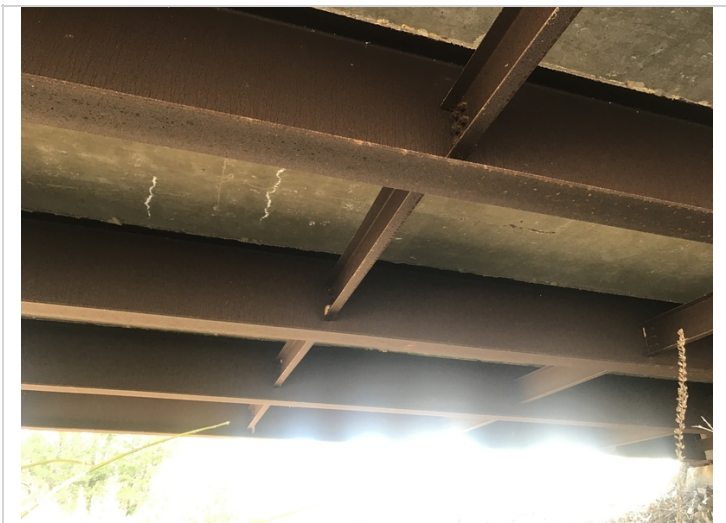
Weathering steel beams

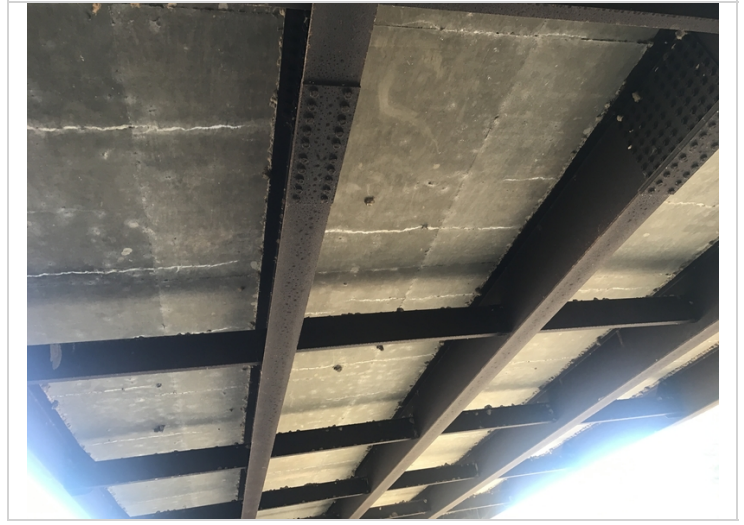
Bottom of deck typical all spans
