Asset #02928(Routine)

SH 355 - 01-1.37 over BRUSHY CREEK

Location: 1.3 MI SE MINERAL SPRINGS

Team Lead: John King, Inspection Date: 04/07/2022

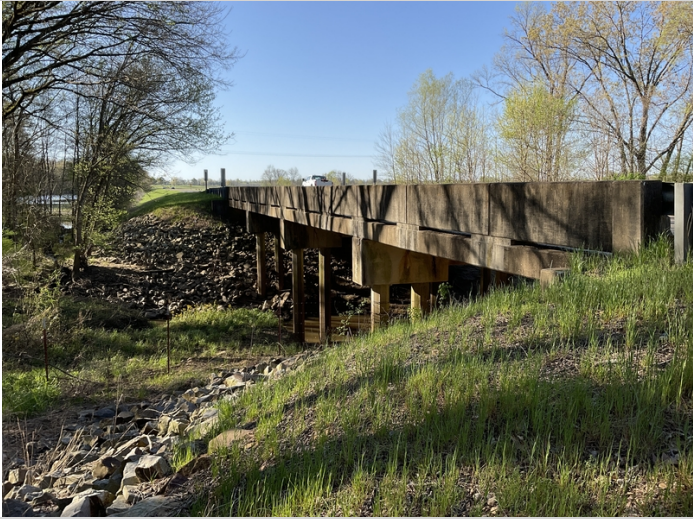
04/2022... elevation

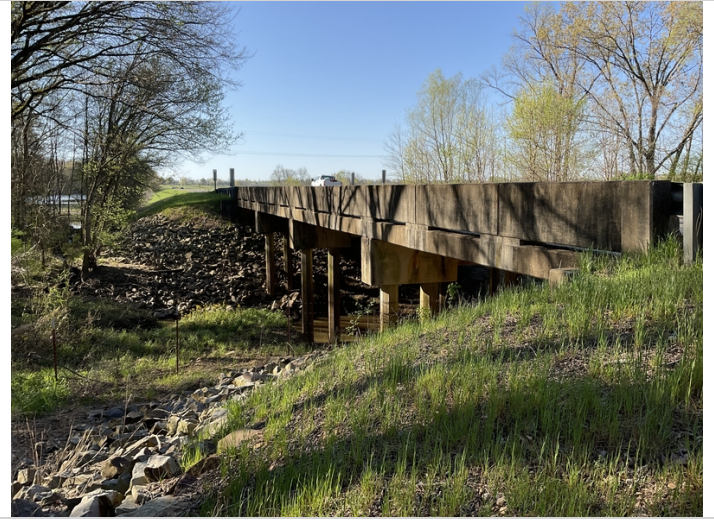
04/2022... elevation

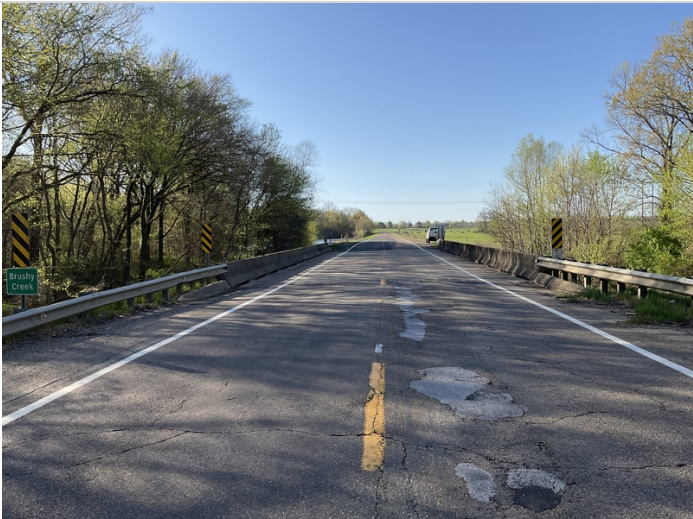
04/2022... alignment

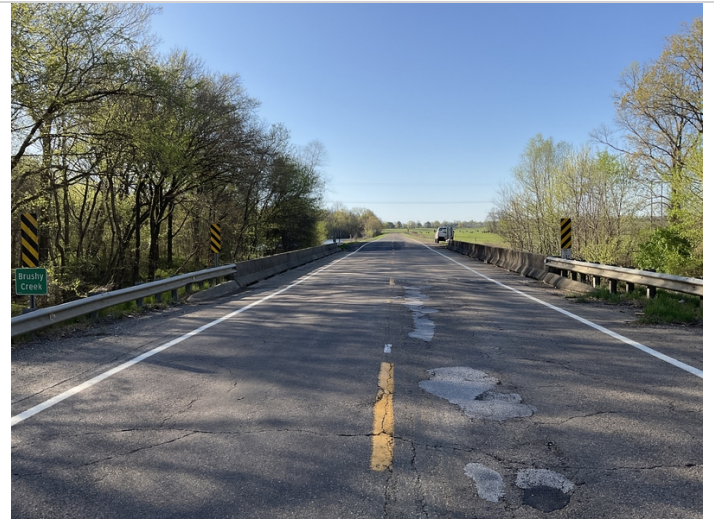
04/2022... alignment

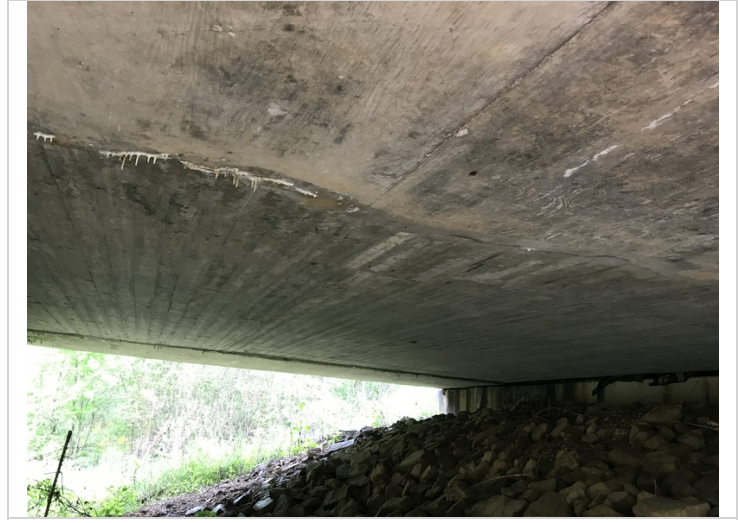
Underside of deck typical all spans

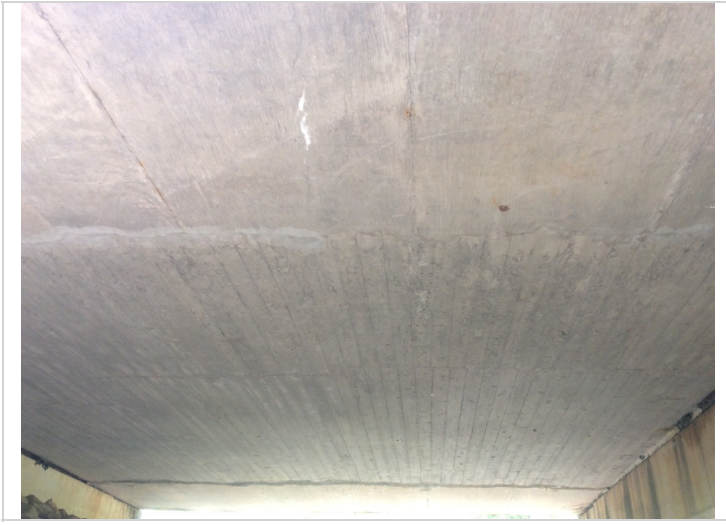
BOTTOM OF DECK TYPICAL ALL SPANS.

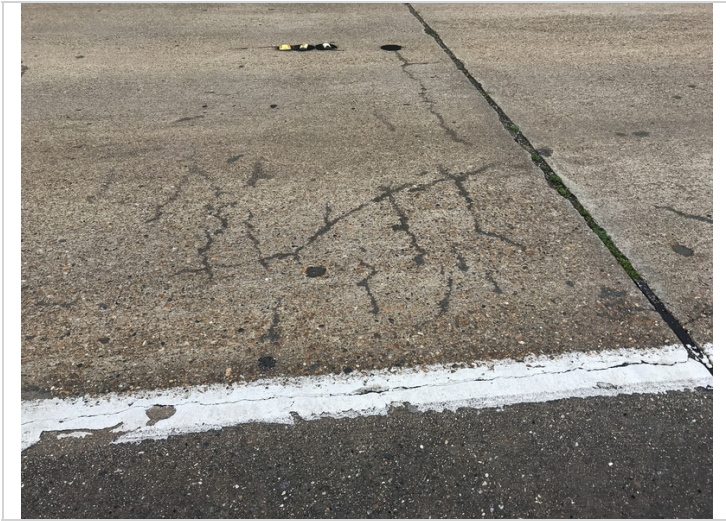
Sealed deck cracks

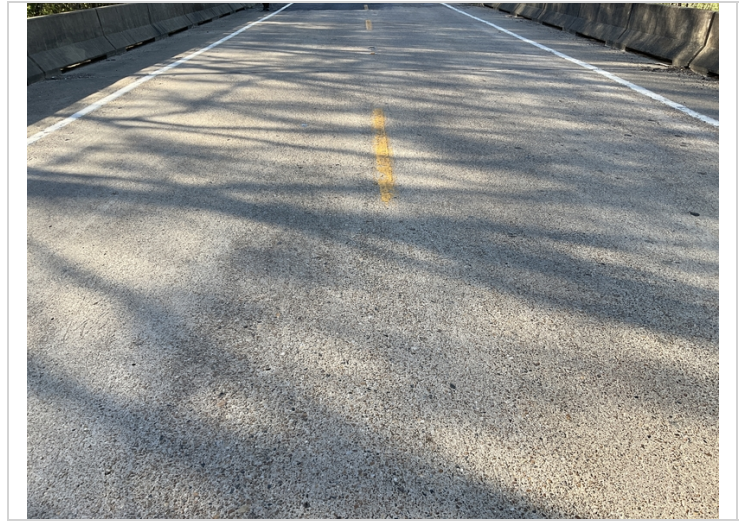
04/2022... deck photo typical all span

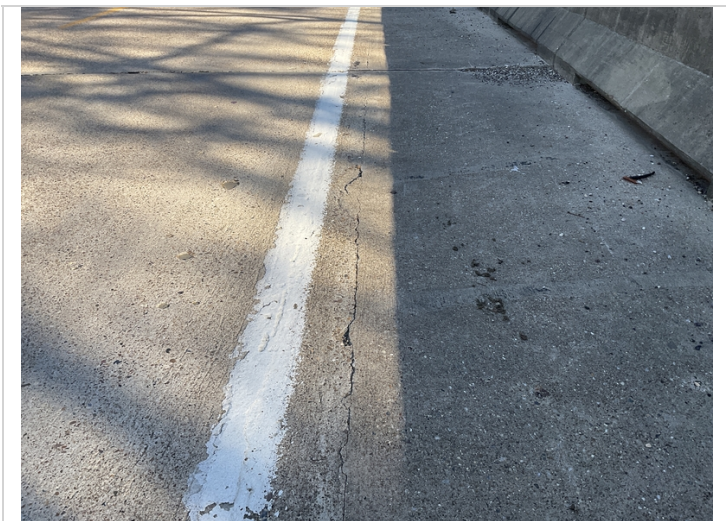
04/2022... deck cracking running entire length of bridge both sides

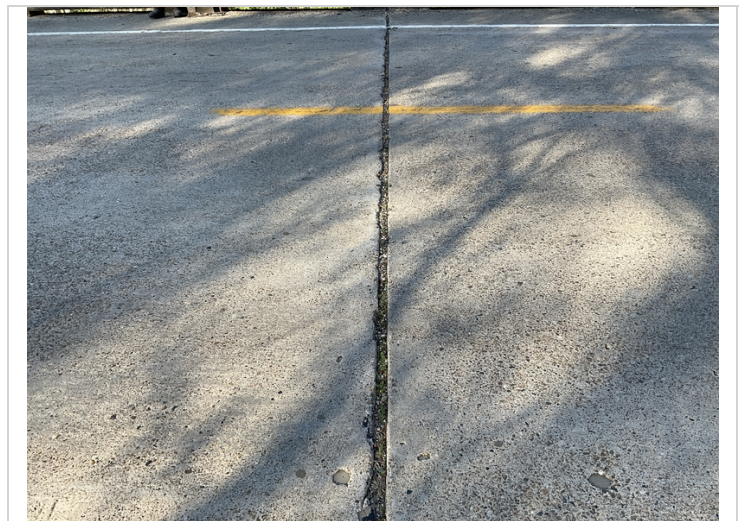
Joints: NEED RESEALED

04/2022... joint photo typical all spans

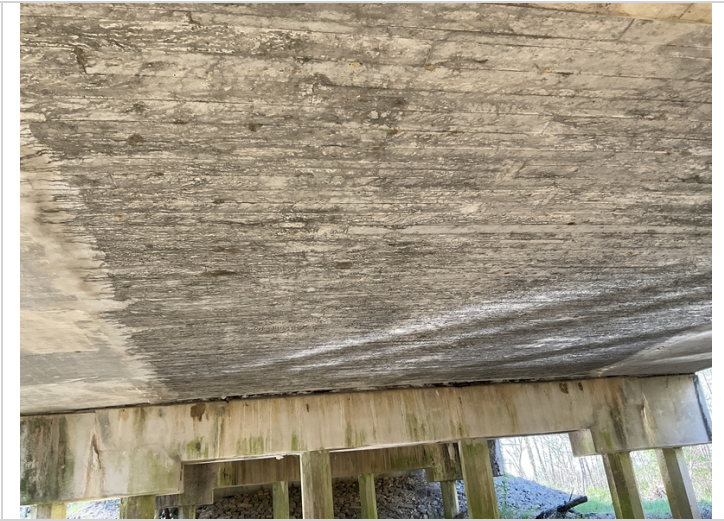
Underside of Deck: SLAB CONSTRUCTION JOINTS WHERE DECK WAS WIDENED LONGITUDINAL CRACKS WITH EFFLORESENCE LEAKAGE AT CONSTRUCTION JOINTS.....4/7/2020...Dropped deck to a 6 due to cracking, efflorescence, delams on top and bottom of deck....04/2022... little to no change in condition per this inspection

04/2022... underside of deck typical all spans

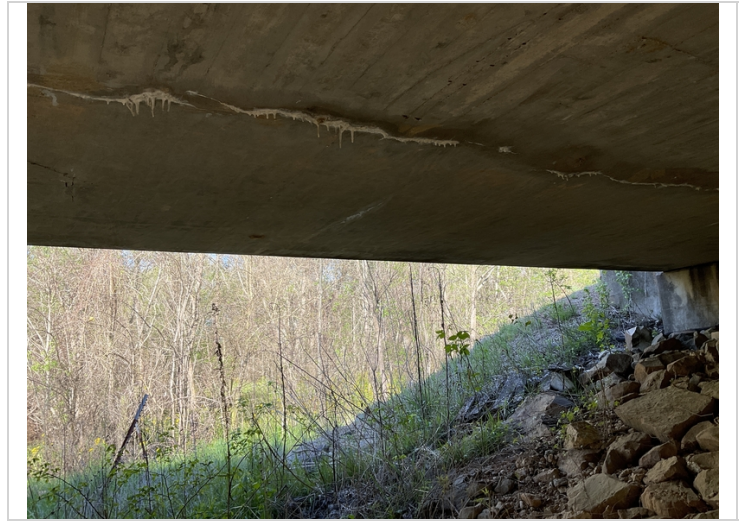
04/2022.. joints leaking along longitudinal crack with efflorescence

CONSTRUCTION JOINTS WHERE DECK WAS WIDENED
LONGITUDINAL CRACKS WITH EFFLORESCENCE LEAKAGE
AT CONSTRUCTION JOINTS.

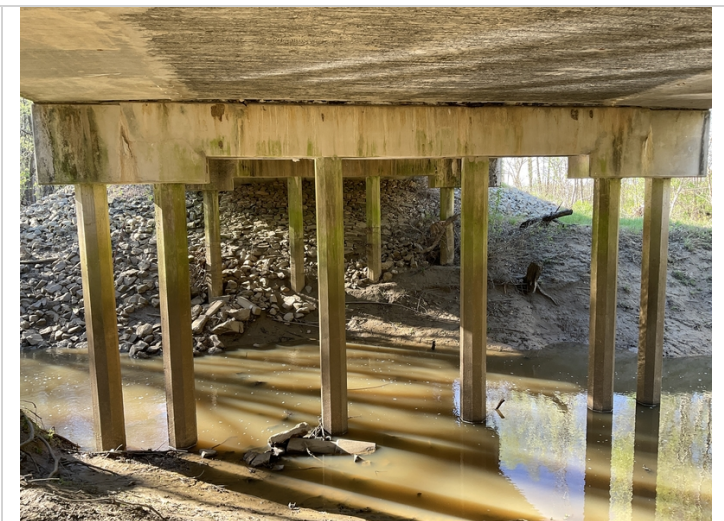
04/2022.. concrete caps and piles

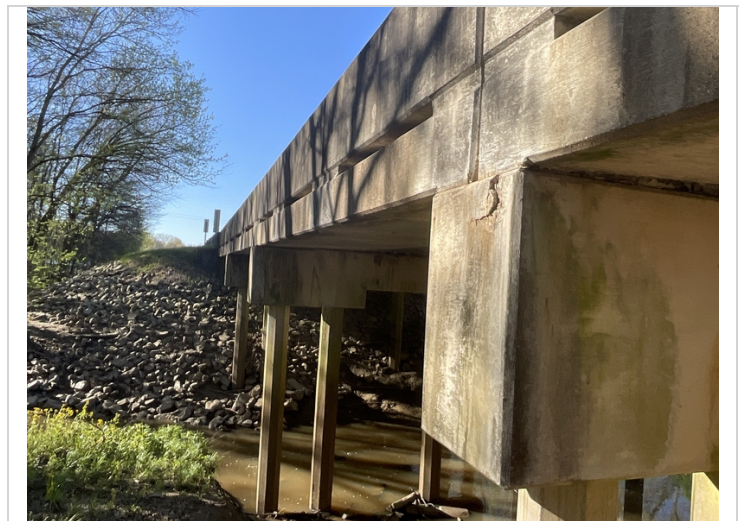
Pier Cap: BENTS 2,3,4 spalls,rebar exposed

04/2022... spalls in caps at various. Locations

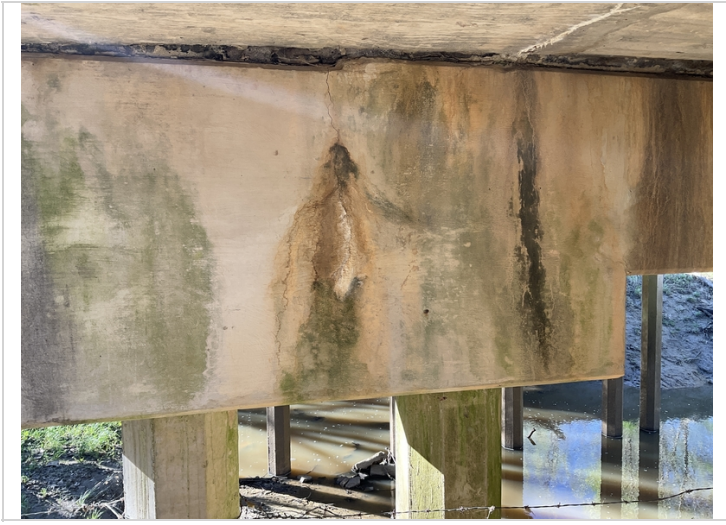
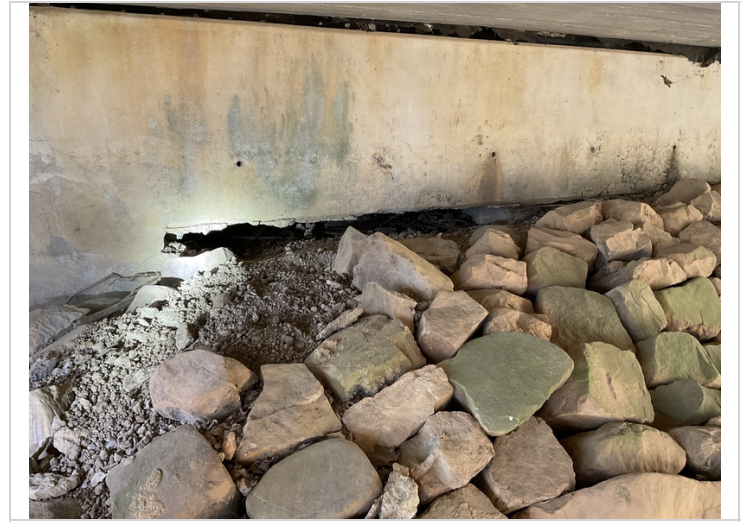
04/2022... efflorescence and cracking on caps various locations

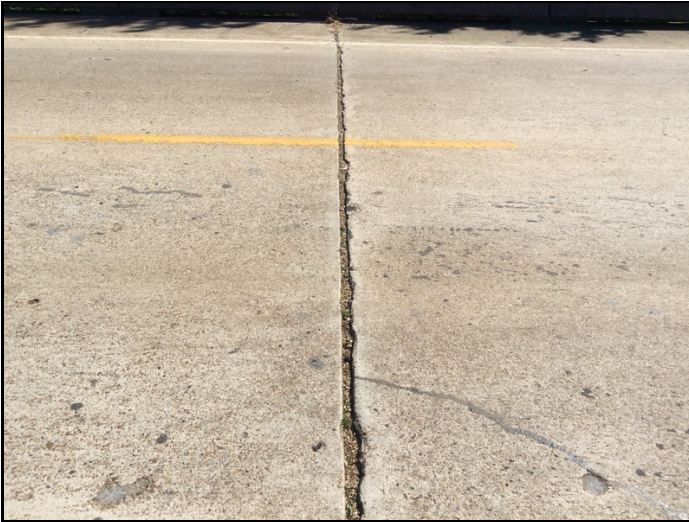
CONSTRUCTION JOINTS AT BENTS 2, 3, AND 4, JOINTS NEED TO BE CLEANED OUT.

CONSTRUCTION JOINTS AT BENTS 2, 3, AND 4
JOINTS NEED TO BE CLEANED OUT AND NEW D-200
ADDED

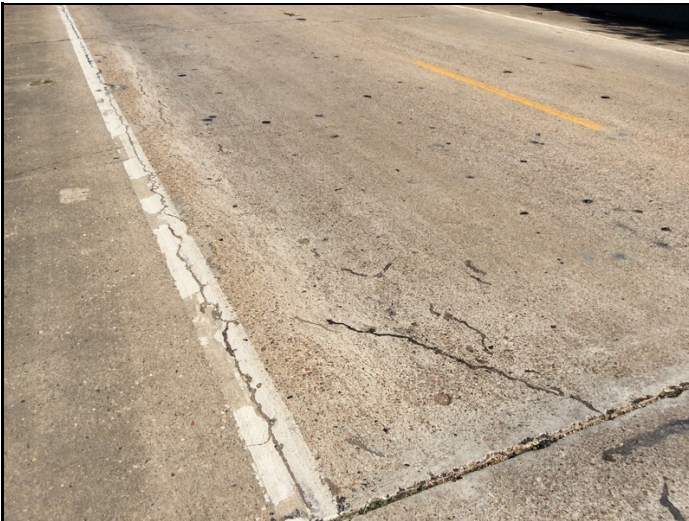
CONSTRUCTION JOINTS WHERE DECK WAS
WIDENED
LONGITUDINAL CRACKS WITH EFFLORESCENCE
LEAKAGE
AT CONSTRUCTION JOINTS.

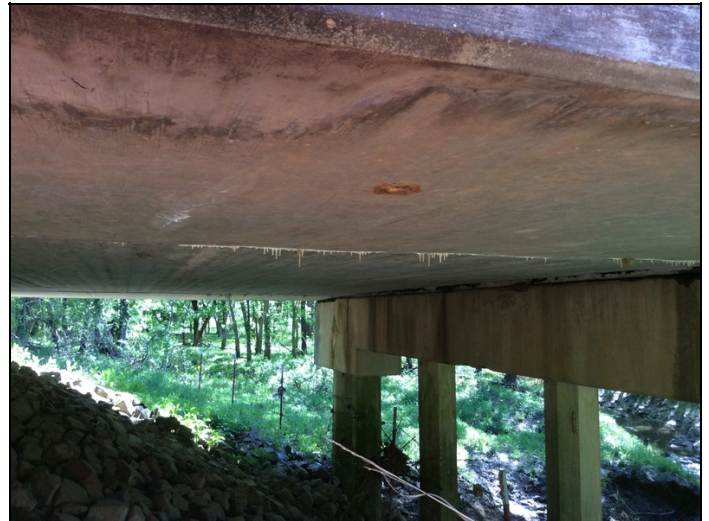
CONSTRUCTION JOINTS WHERE DECK WAS
WIDENED
LONGITUDINAL CRACKS WITH EFFLORESCENCE
LEAKAGE
AT CONSTRUCTION JOINTS.

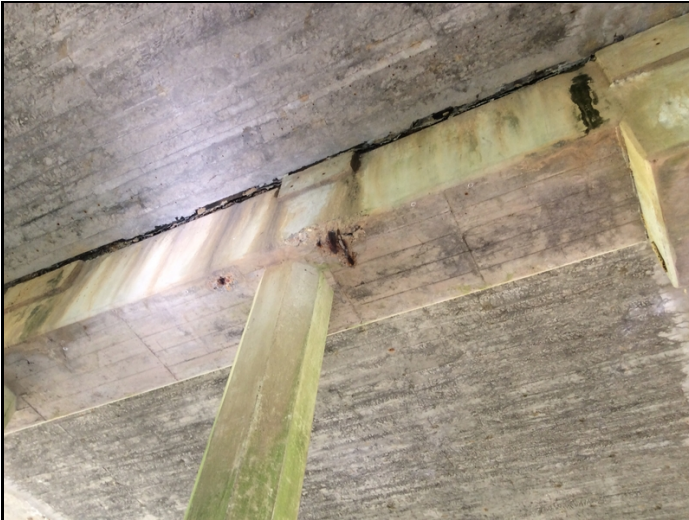
BENT 3 BOTTOM OF CAP HAS MINOR SPALLS WITH REBAR EXPOSED

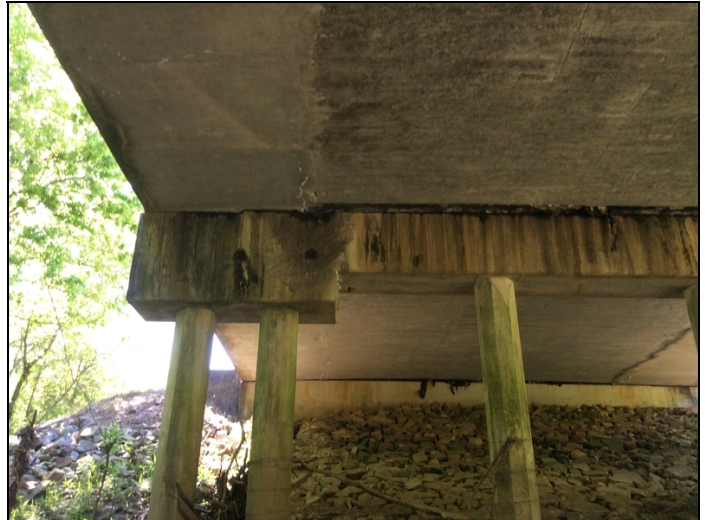
BENT 4 CAP HAS A LARGE SPALL AND SMALL SPALL WITH REBAR EXPOSED

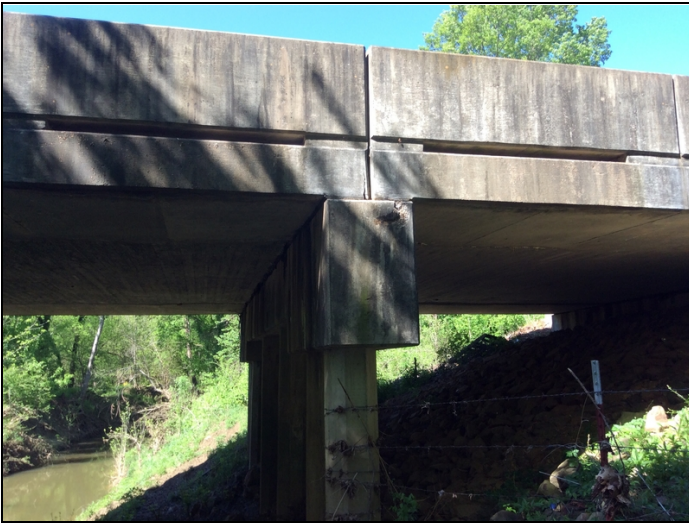
End cap BT 2 small spall

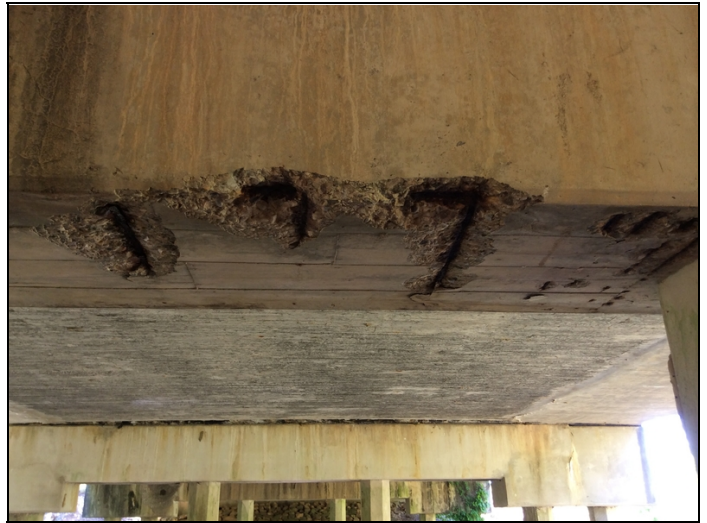
CONCRETE CAPS
BENT 2 BOTTOM OF CAP HAS SEVERAL SPALLS
WITH REBAR EXPOSED

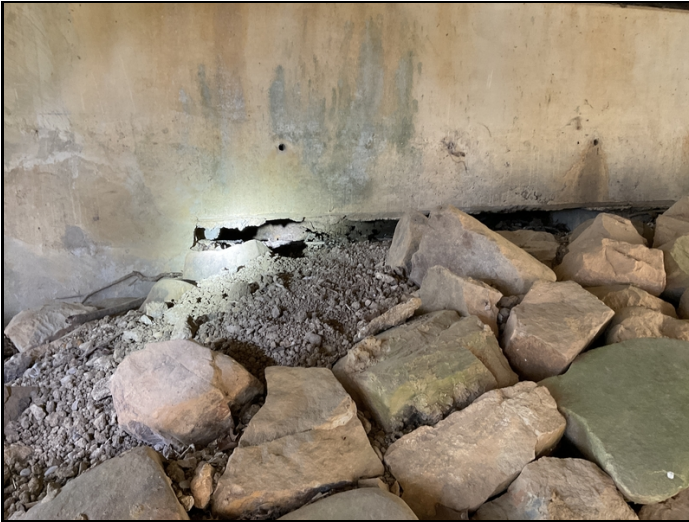
Hole under End Bent LT side approximately 5 ft. under cap

Hole under End Bent LT side

Type of Work: Repair (General)
