Asset #03040(Routine)

SH 355 - 02- 3.16 over YELLOW CREEK

Location: 3.3 MI. S.E. OF SARATOGA

Team Lead: Jared Kegley, Inspection Date: 09/27/2022

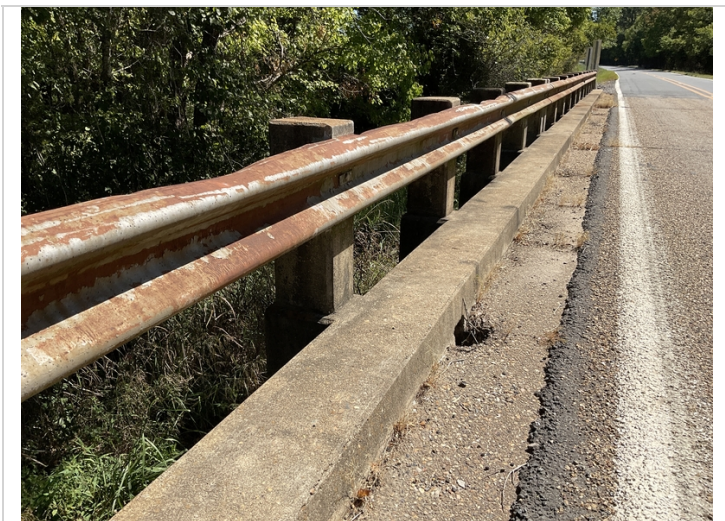
(301) 120' of joints is covered in asphalt with asphalt cracking above joints							
330	Metal Bridge Railing	LF	224	0	224	0	0
1000	Corrosion	LF	224	0	224	0	0

(330) Guard rail heavy rust needs re painted							
331	Reinforced Concrete Bridge Railing	LF	224	219	5	0	0
1080	Delamination/Spall/Patched Area	LF	5	0	5	0	0
(1080-331) Concrete bridge railing has minor spalling on both RT and LT side of bridge.

Corrosion on metal bridge railing

Guard rail needs painted heavy rust both right and left sides

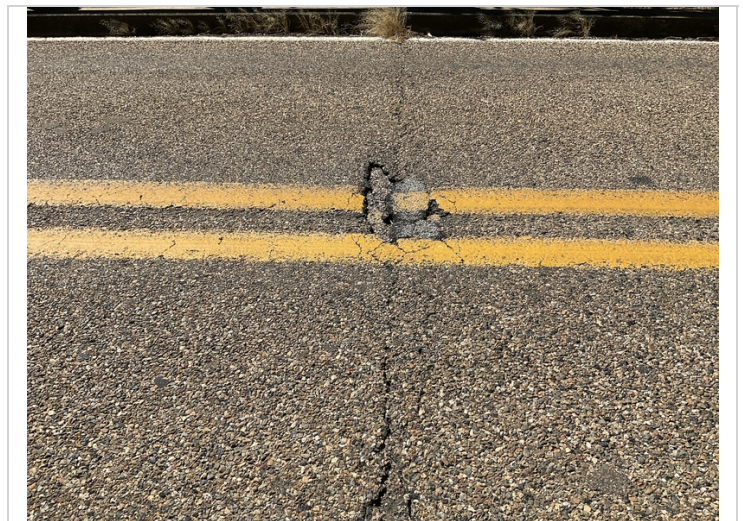
Asphalt Wearing Surface covering bridge deck. Potholes have formed in wearing surface along all joint lines of bridge. Cracking throughout wearing surface in all spans. Concrete bridge railing has minor spalling on both RT and LT side of bridge. Spall in span 3 LT side underside of deck near drain. Deck is rated a 7 per this inspection.

Potholes on asphalt wearing surface at all joint lines.

Potholes in Asphalt Wearing Surface along all joint lines need patched.

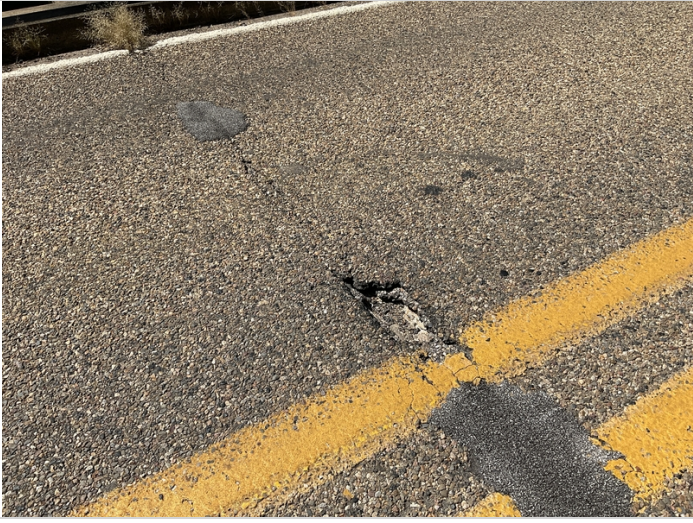
Potholes on asphalt wearing surface at all joint lines.

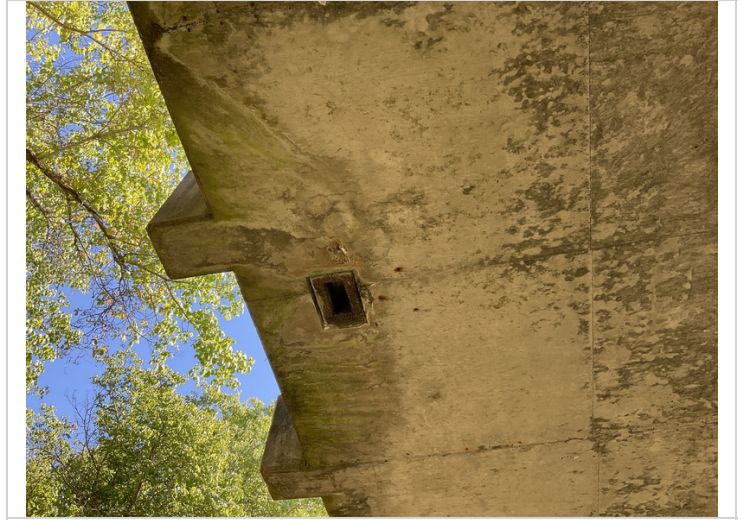
Spall in span 3 LT side underside of deck near drain. Superstructure is rated a 7 per this inspection.

Spall in span 3 LT side underside of deck

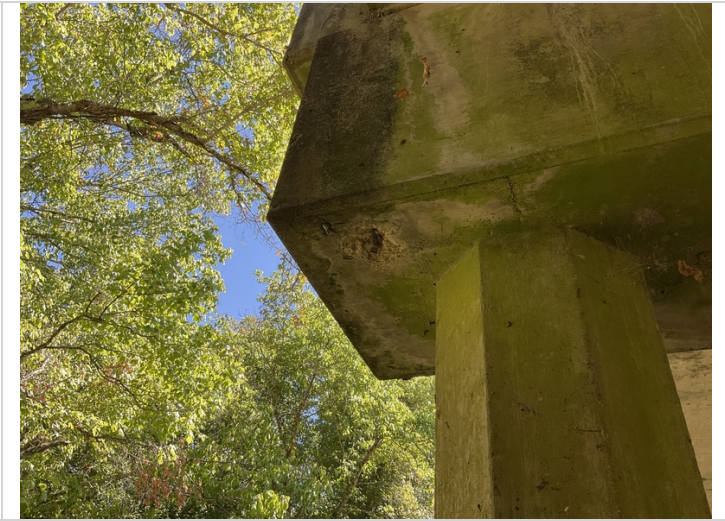
Bent 3 has 1' of exposed rebar on LT side of cap. Bent 2 has a 1' spall on RT side of cap. Substructure is rated a 7 per this inspection.

Bent 3 exposed rebar LT side of cap

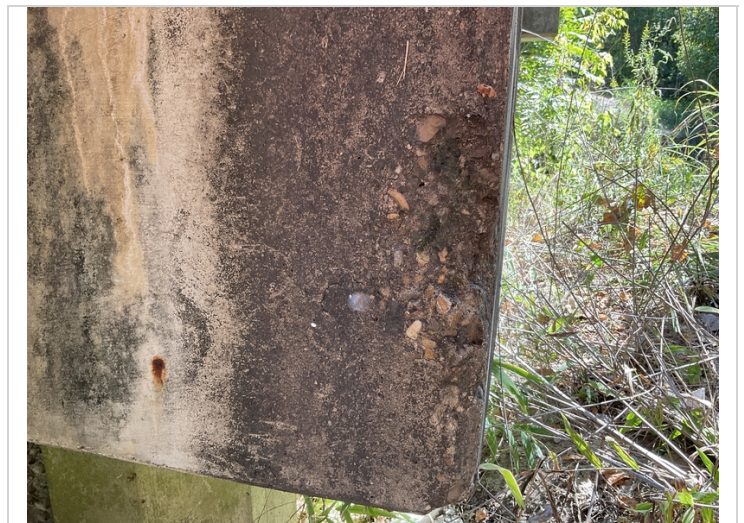
Bent 2 spall on cap RT side

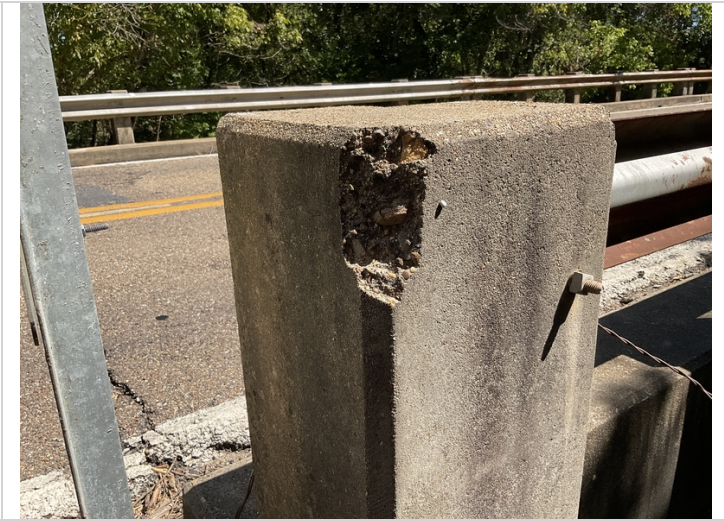
RT side beginning of bridge spall on concrete bridge railing

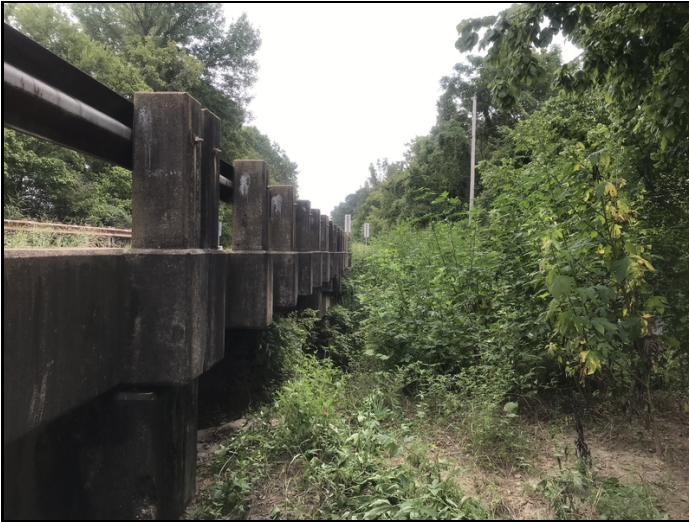
Vegetation needs sprayed along side of bridge

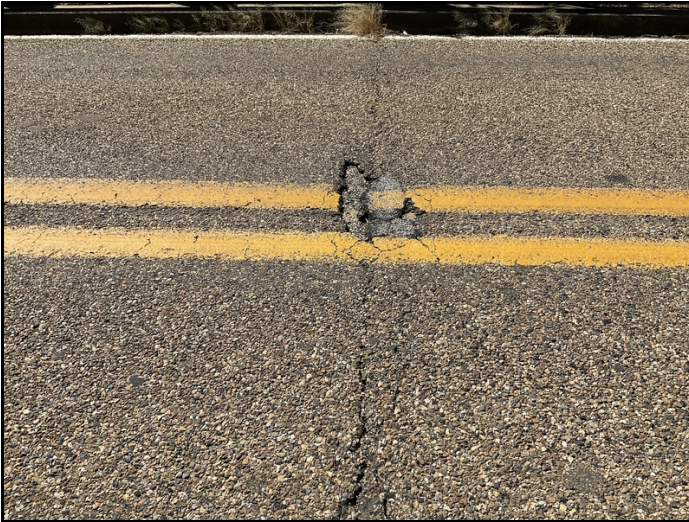
Potholes on asphalt wearing surface at all joint lines.

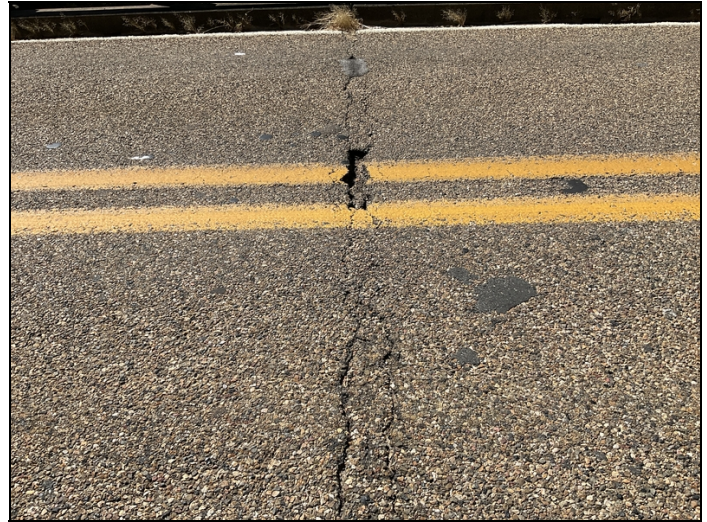
Potholes on asphalt wearing surface at all joint lines.

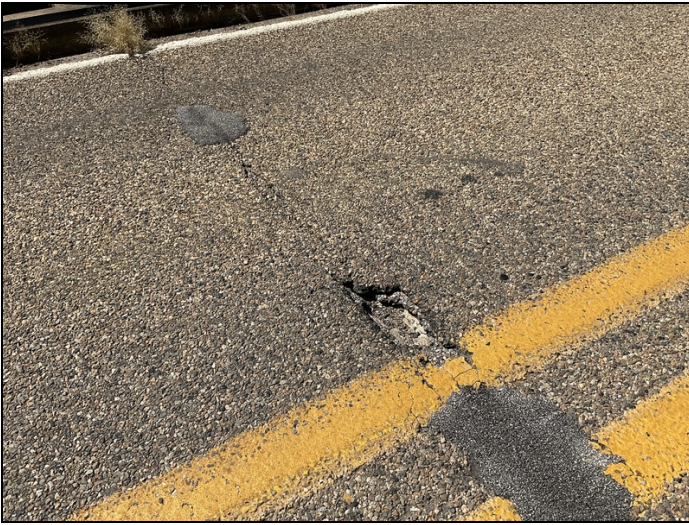
Potholes on asphalt wearing surface at all joint lines.

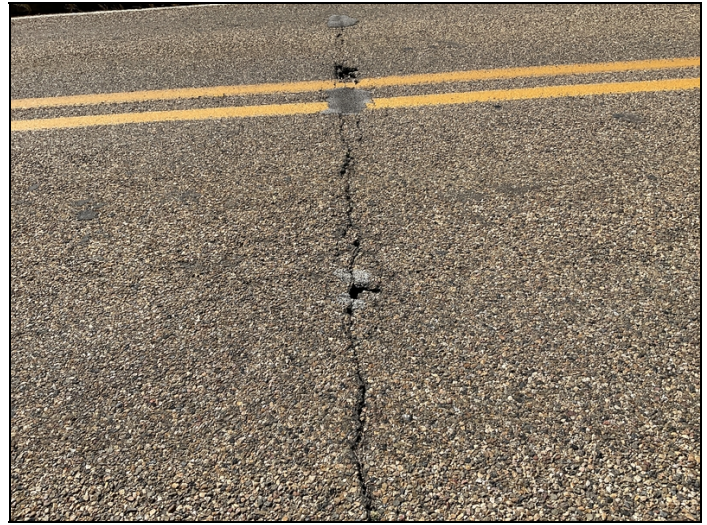
Potholes on asphalt wearing surface at all joint lines.
