Asset #06049(Routine, Underwater type 2)

SH 355 - 01 - 1.25 over MINE CREEK

Location: 1.25 MI SE MINERAL SPRING

Team Lead: Jared Kegley, Inspection Date: 08/11/2022

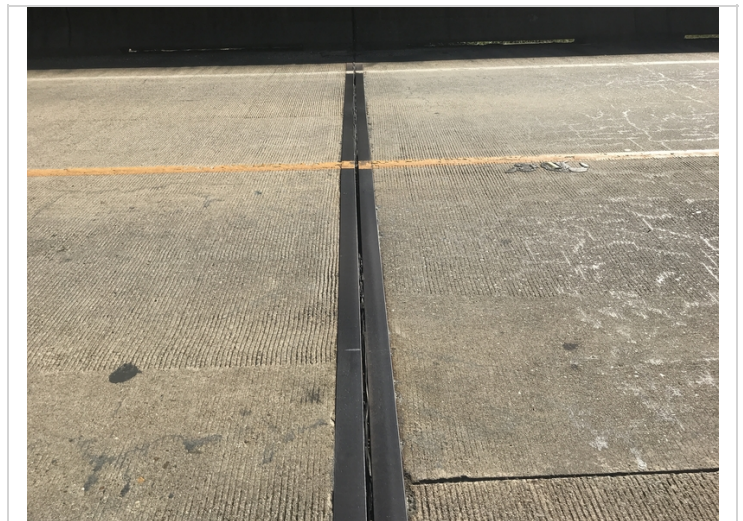
Joint material missing at bent bent #3 and #4 #5

JOINT MATERIAL AT ALL BENTS NEED REPLACED

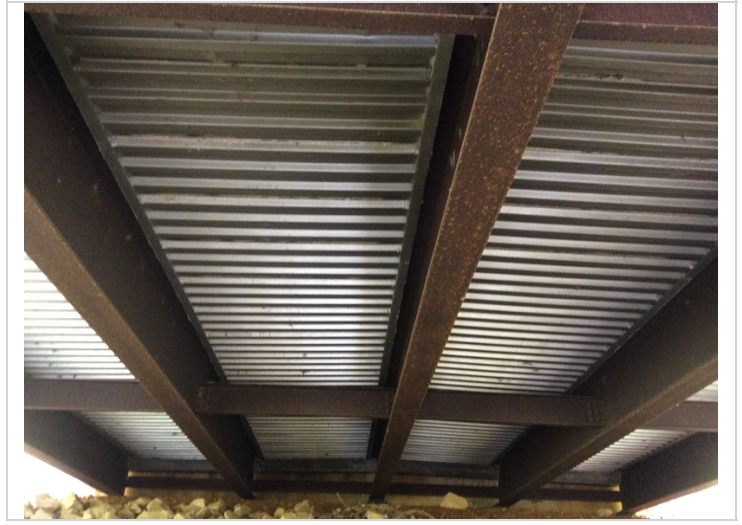
Underside of deck typical all spans

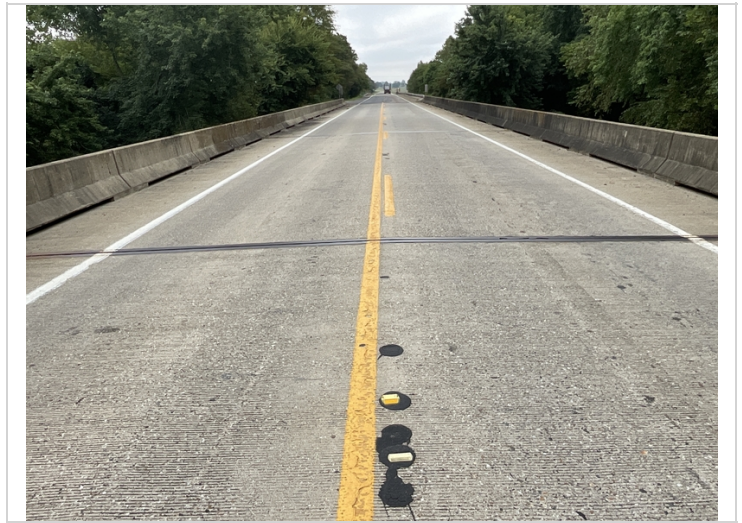
8/2022... deck photo typical of all spans

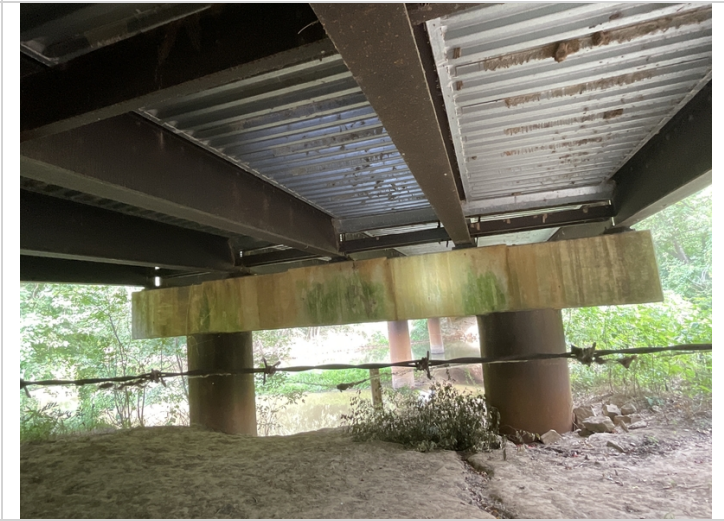
8/2022... Underside of deck typical of all spans

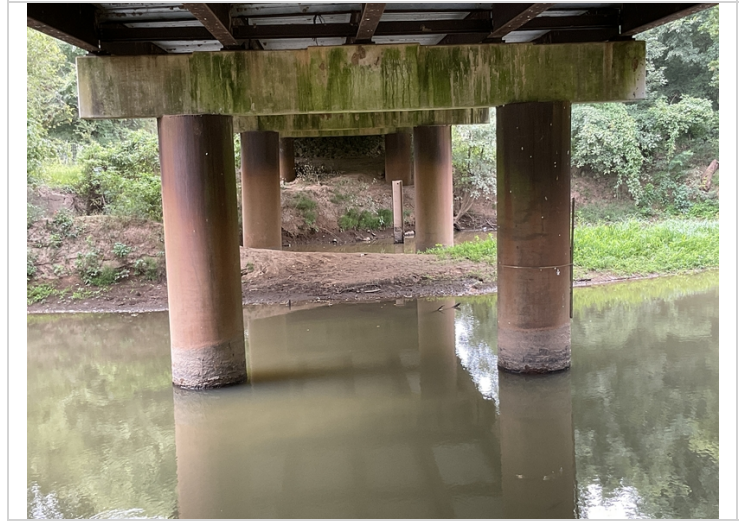
8/2022... Typical bent photo

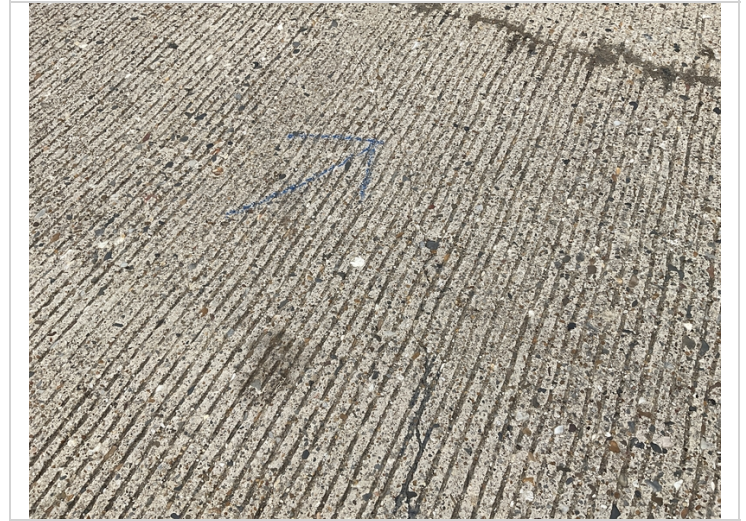
CS2 cracking in various locations of deck

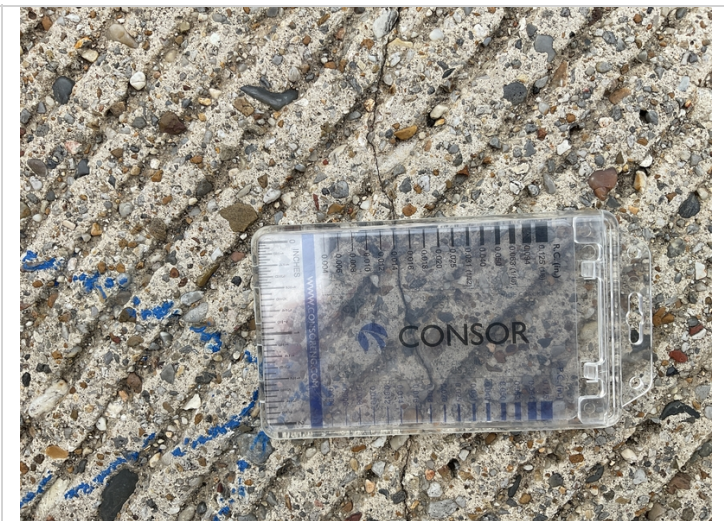
CS2 cracking in various locations of deck

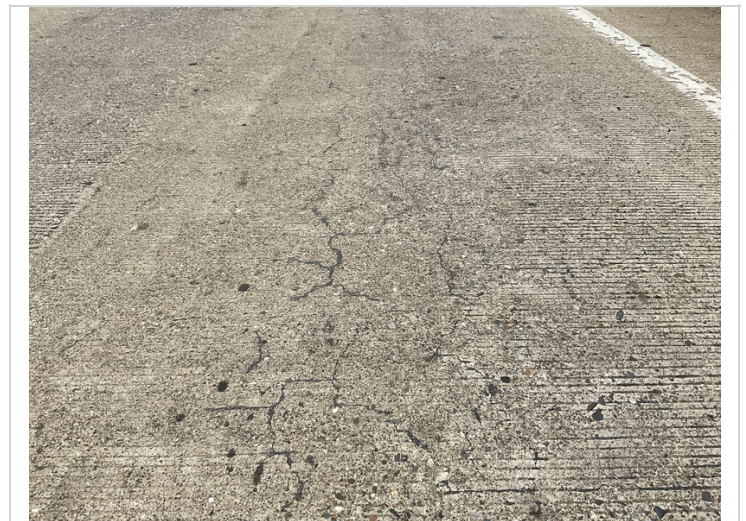
CS2 cracking in various locations of deck

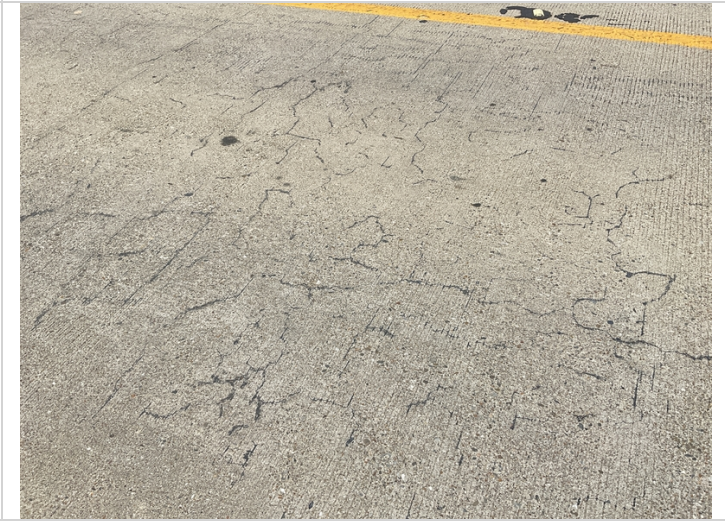
Some cracks in deck have been sealed in the past

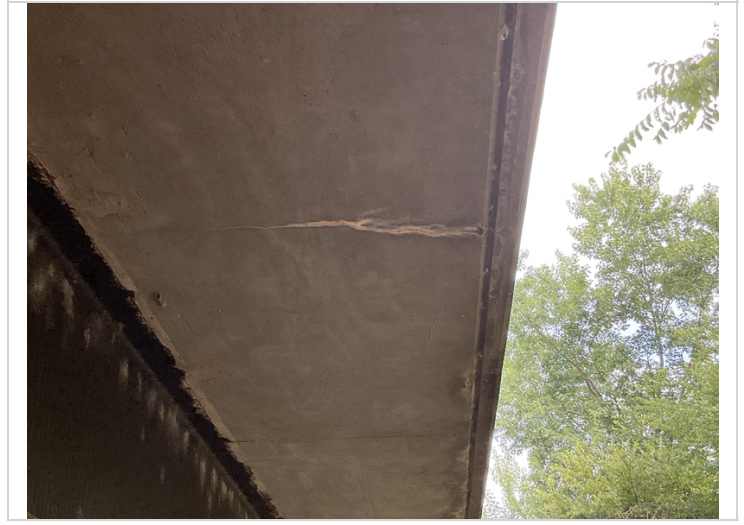
Efflorescence on overhangs various locations

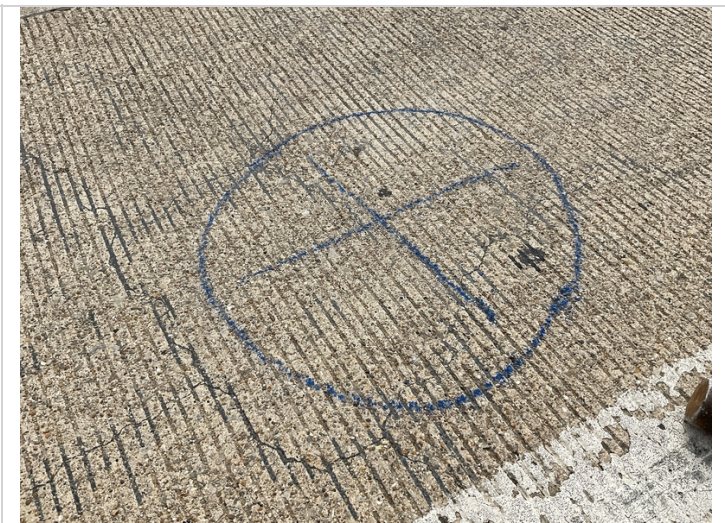
Span 4 RT side Delam. Southbound Lane near Bt 5

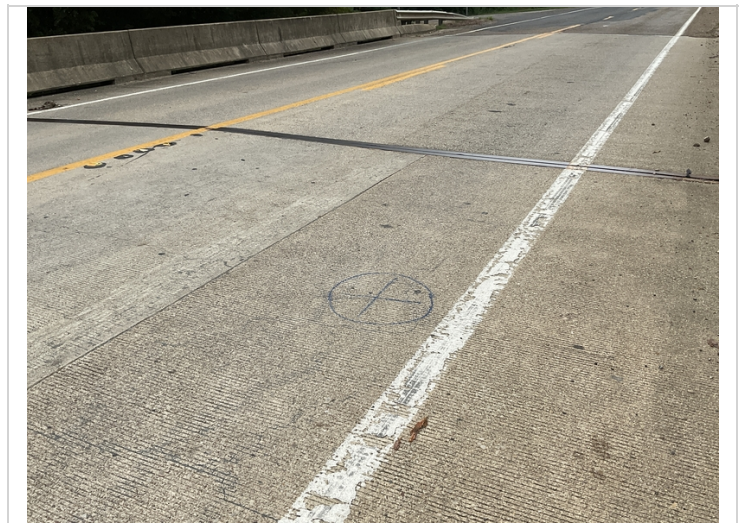
Span 4 RT side Delam. Southbound Lane near Bt 5

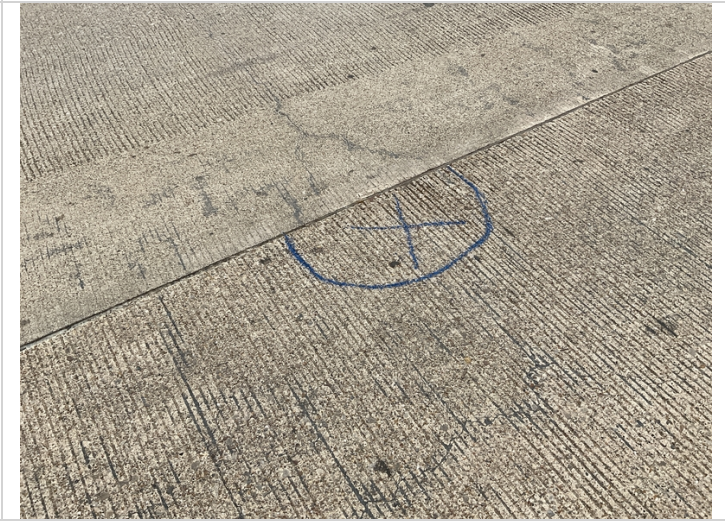
Span 4 RT side Delam. Southbound lane mid span

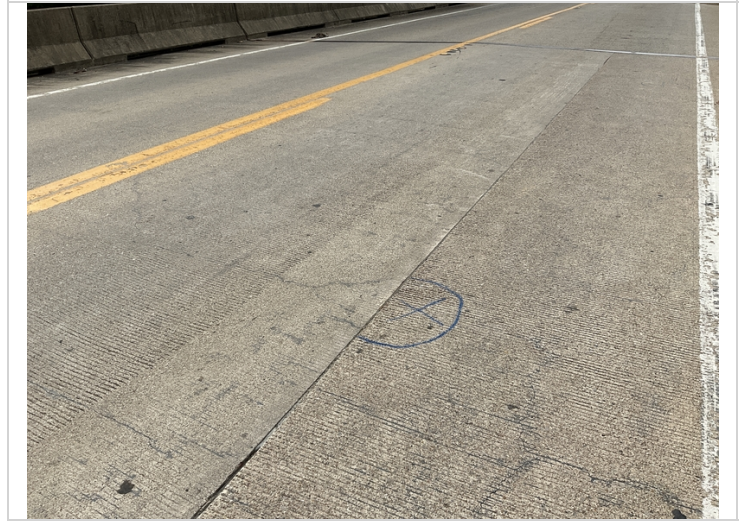
Span 4 RT side Delam. Southbound lane mid span

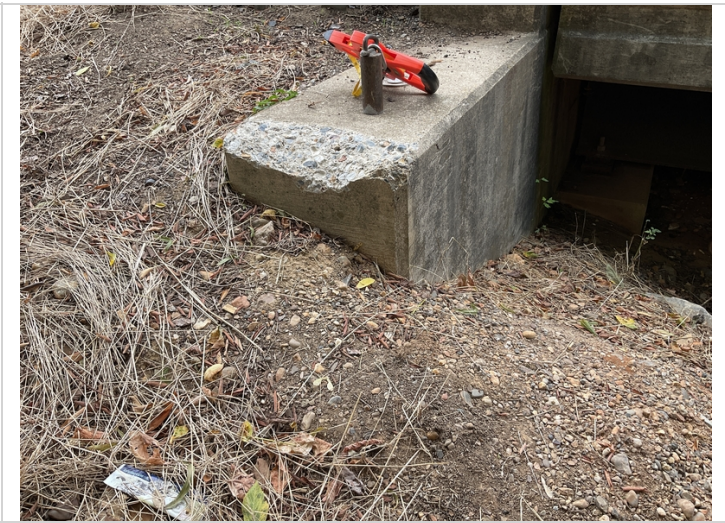
8/11/2022... Drilled shaft with R.C. Caps. Bent 5 has various spalls with rebar exposed on underside of cap. End of bridge LT side abutment spall. Dropped Substructure to a "7" due to rebar exposed on caps

Bent 6 Abutment LT Side Spall

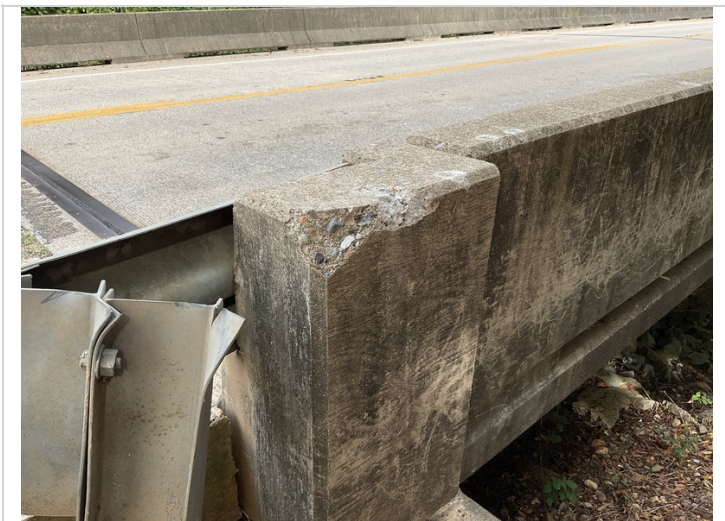
ELEMENTS	DESCRIPTION	UNITS	TOTAL	CS1	CS2	CS3	CS4
(1080-331) End of bridge LT side spall

End of bridge LT side spill

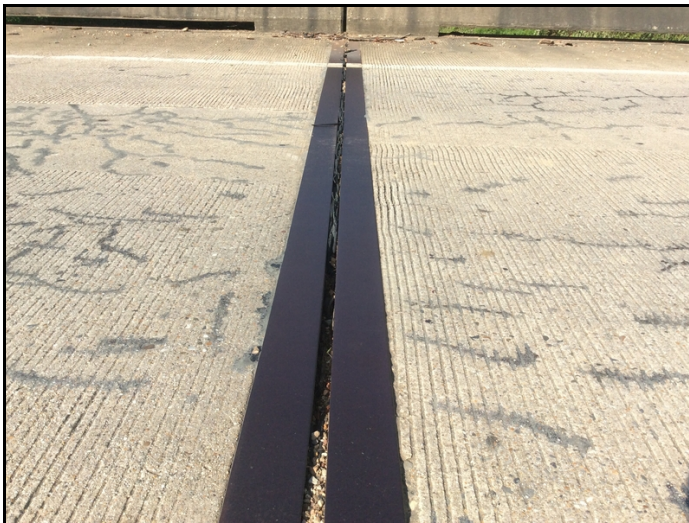
(300) ALL JOINT SEALS ARE LEAKING IN VARIOUS LOCATIONS							
(2310-300) All joint seal is leaking. ALL Bents							
311	Movable Bearing	EA	20	20	0	0	0
313	Fixed Bearing	EA	20	20	0	0	0
331	Reinforced Concrete Bridge Railing	LF	504	503	1	0	0
1080	Delamination/Spall/Patched Area	LF	1	0	1	0	0

JOINT MATERIAL AT ALL BENTS NEED REPLACED

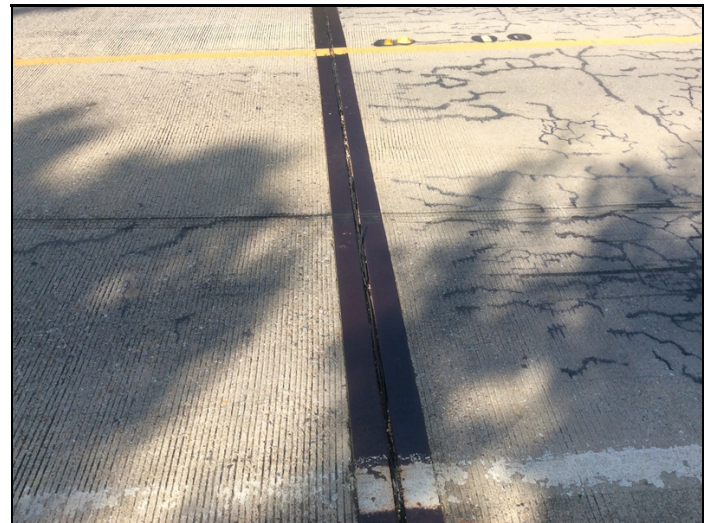
JOINT MATERIAL AT ALL BENTS NEED REPLACED

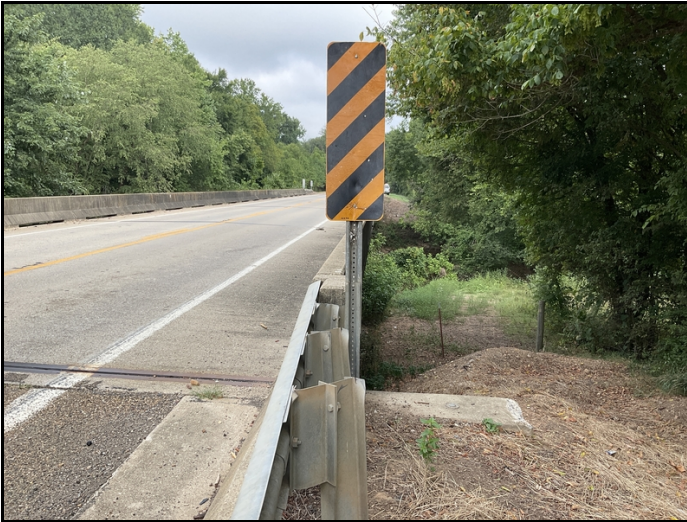
Missing Log Mile Sign End of Bridge LT Side.

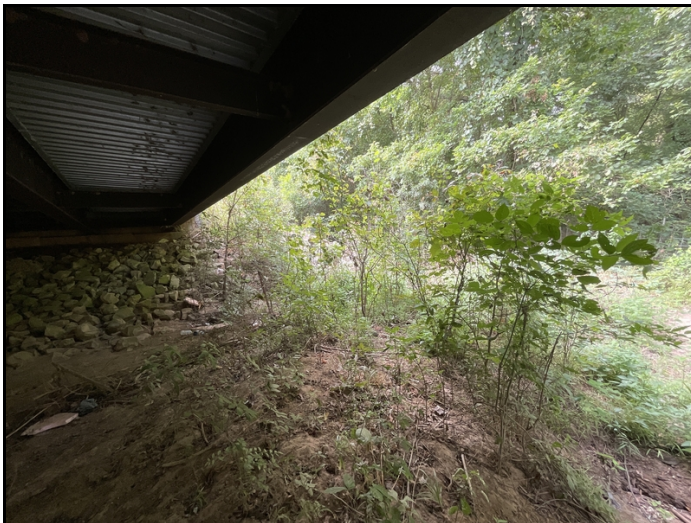
Trees and vegetation at end of bridge need removed

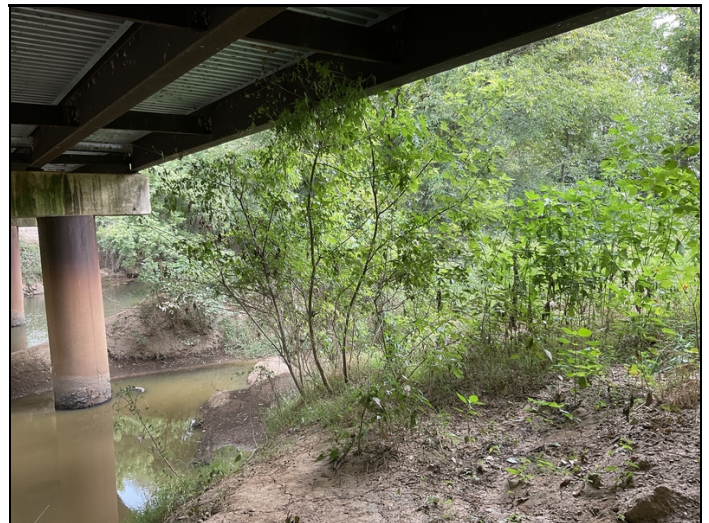
Trees and vegetation at end of bridge need removed
