Asset #A2926(Routine, Underwater type 2)
SH 355 - 01- 7.42 over PLUM CREEK RELIEF
Location: 2.41 MI N HEMPSTEAD CO

Team Lead: John King, Inspection Date: 04/12/2022

General Observation

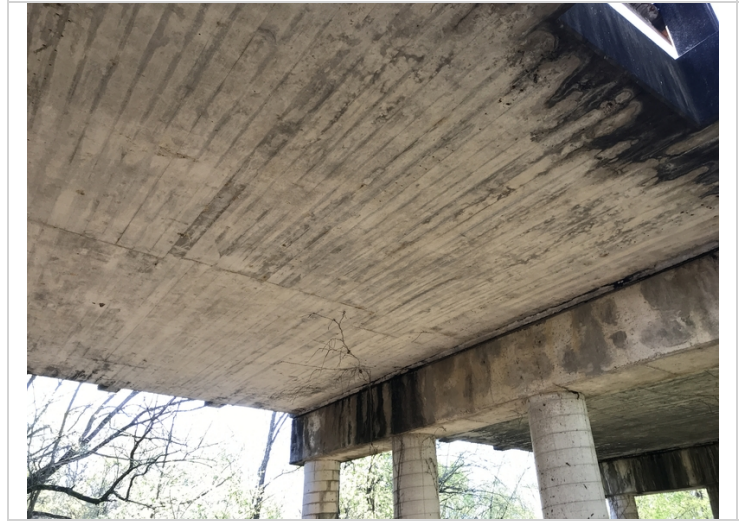
Underside of deck typical all spans

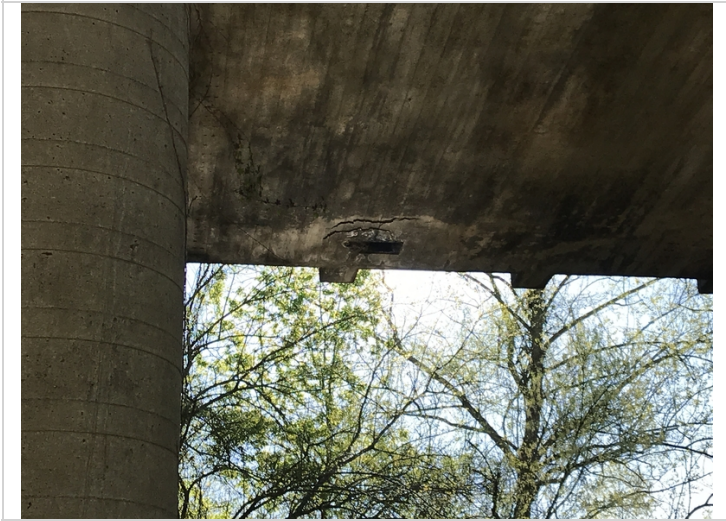
(38) 4 INCH ASPHALT WEARING SURFACE, Small spalls bottom deck rebar exposed span 5. (1080-38) 4/1/2020... Delam at drain span 4 LT side... (510-38) 04/22 bridge has a asphalt over concrete deck. asphalt is cracking in various locations... (3220-510-38) 04/2022... cracking in deck typical all spans4 INCH ASPHALT WEARING SURFACE,							
205	Reinforced Concrete Column	EA	24	20	2	2	0
1090	Exposed Rebar	EA	2	0	0	2	0
1130	Cracking (RC and Other)	EA	2	0	2	0	0

Delam at drain span 4 LT side

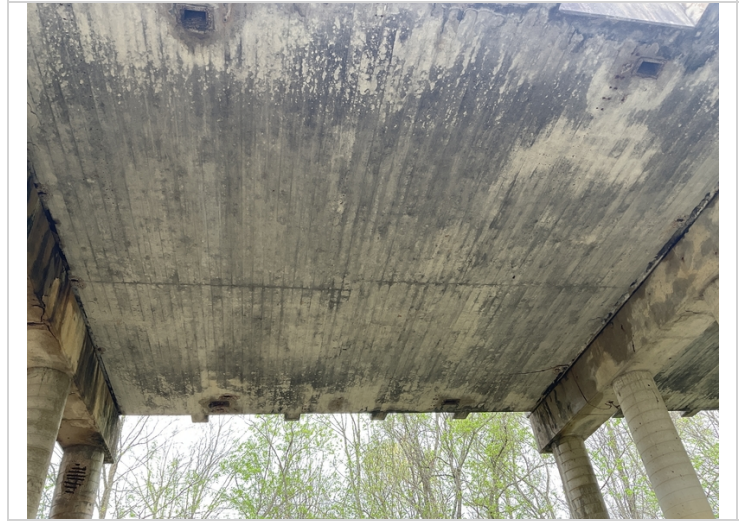
04/2022... underside of deck typical of all spans

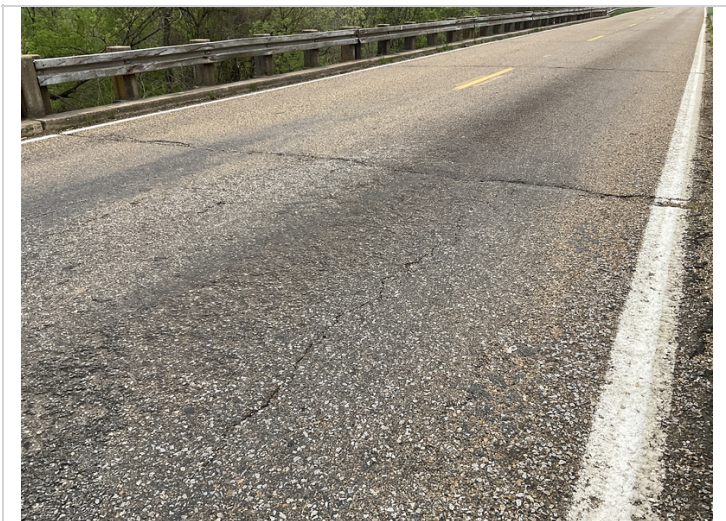
04/2022.. typical photo of deck all spans

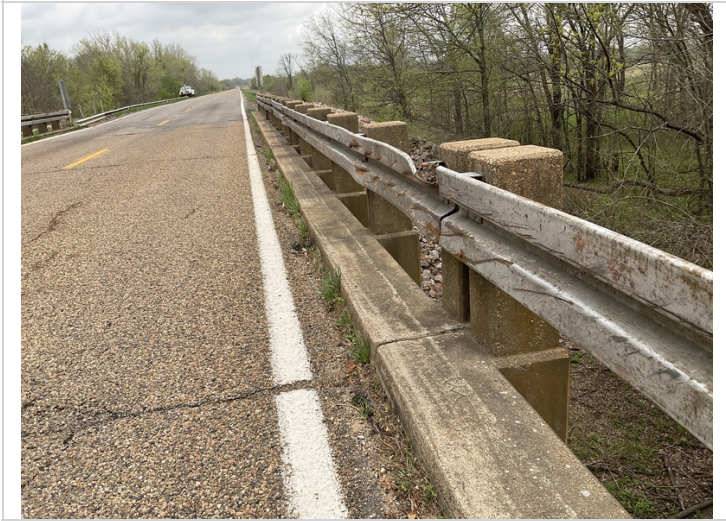
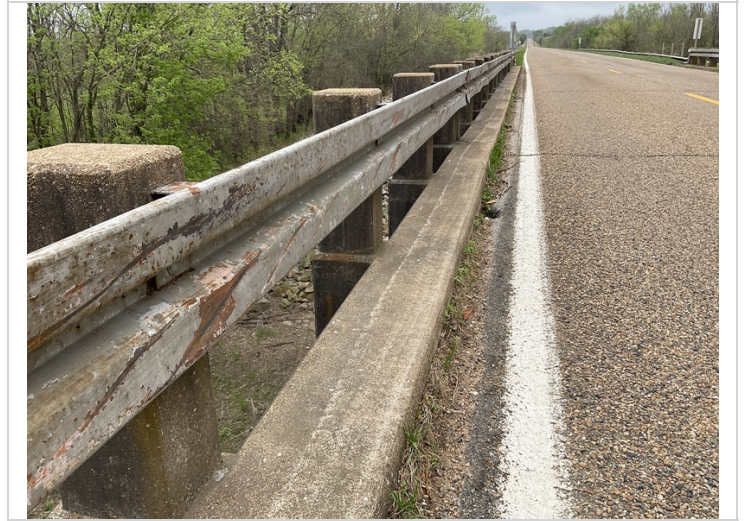
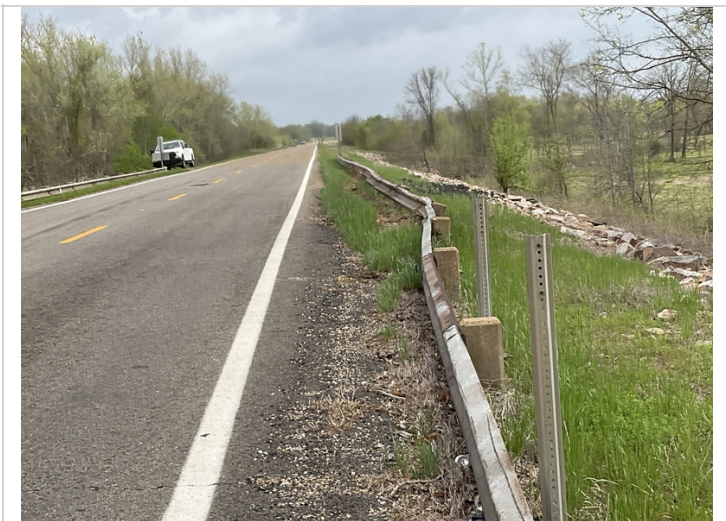
(330) CONCRETE END POST BENT 1 RIGHT & LEFT SIDE HAS A POST THAT IS BROKEN AT THE BASE FROM COLLISION DAMAGE WITH REBAR EXPOSED. SPAN 2 POST # 4 ON THE LEFT SIDE HAS A POST BROKEN FROM COLLISION DAMAGE. . steel bridge rail need painted also... (7000-330) LT side metal bridge railing damage entire length of bridge							
331	Reinforced Concrete Bridge Railing	LF	392	364	28	0	0
7000	Damage	LF	28	0	28	0	0

LT side metal bridge railing damage entire length of bridge

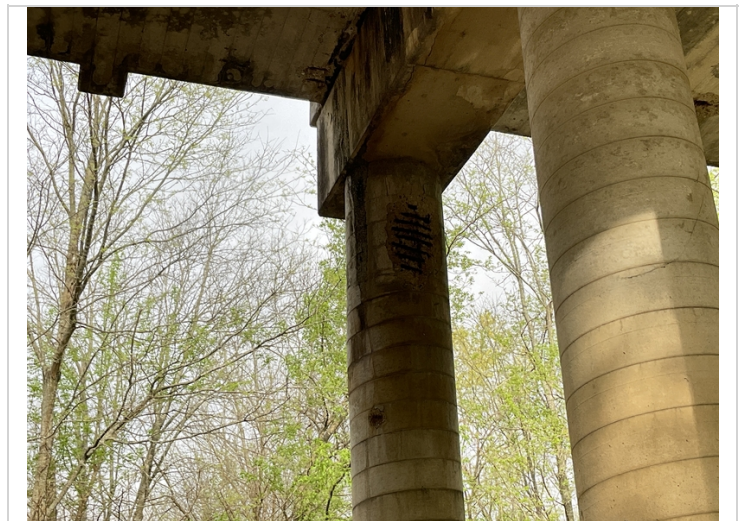
04/2022... cracks in cap and columns at bent 6. Bent 6 column 4 has spall with rebar exposed

Exposed rebar on bent 6 column 4

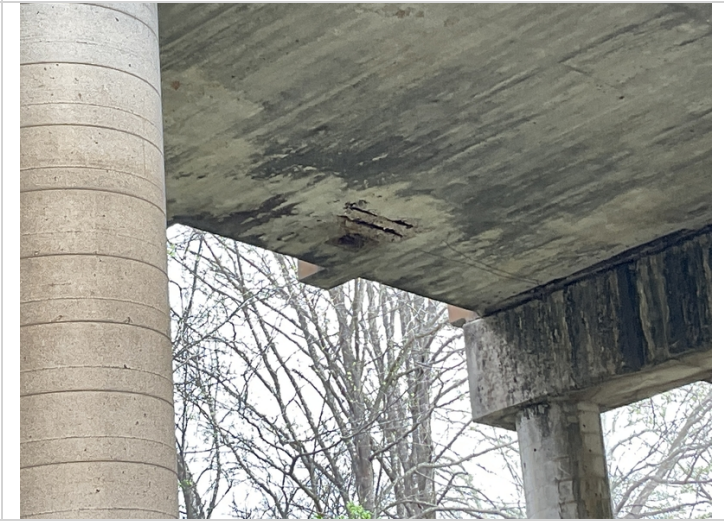
Underside of Deck: Small spalls span 5 with rebar exposed

Exposed rebar on underside of deck various locations

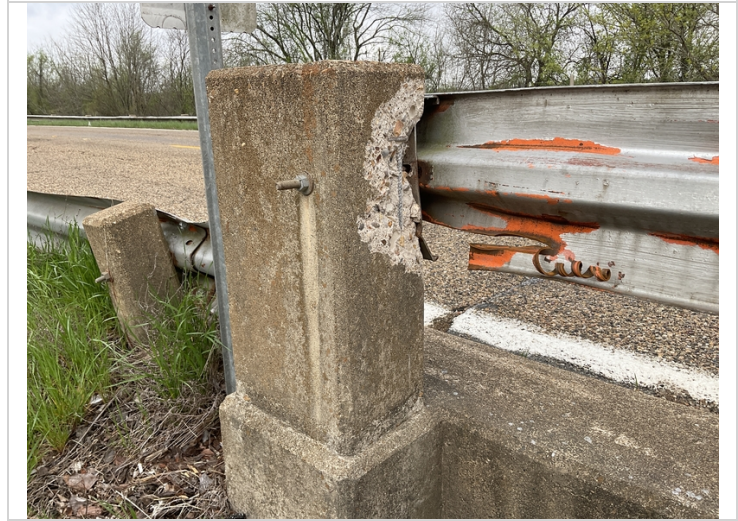
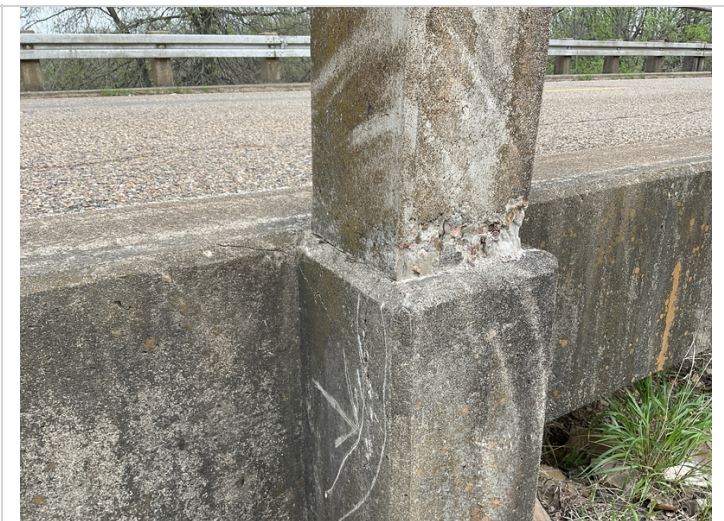
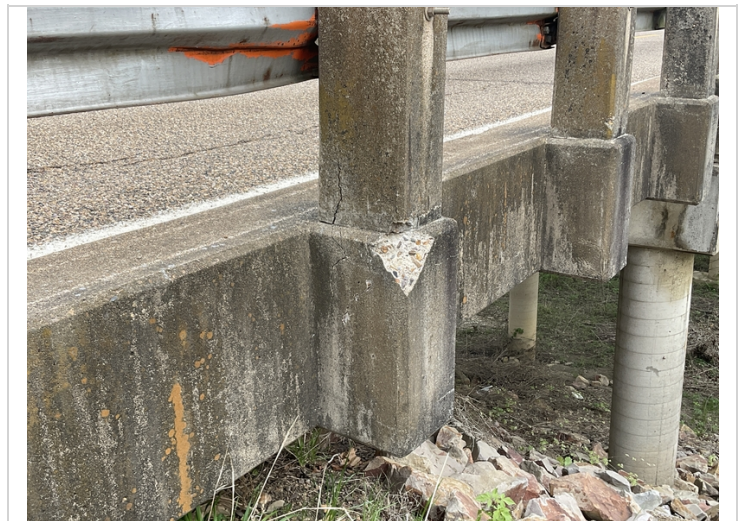
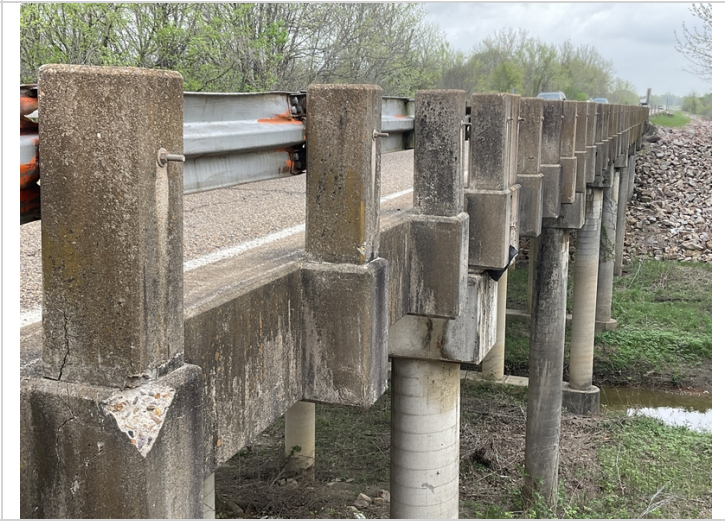
ELEMENTS	DESCRIPTION	UNITS	TOTAL	CS1	CS2	CS3	CS4
(7000-331) 04/2022...	Damage to concrete bridge railing, entire last span on LT side

04/2022... Damage to concrete bridge railing, entire last span on LT side

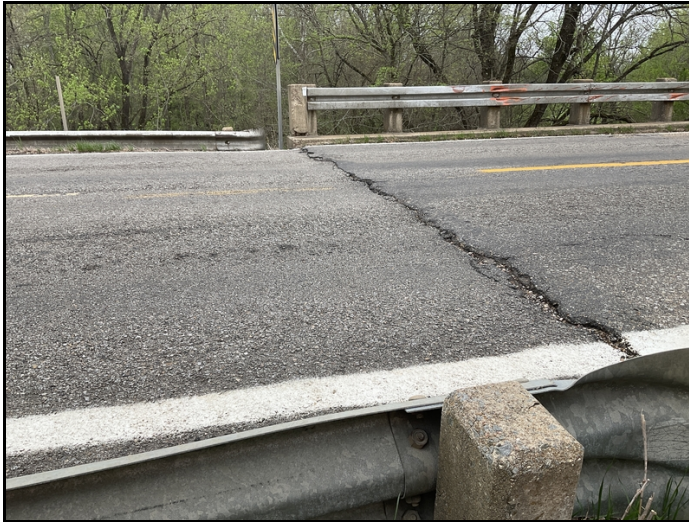
Sediment at approach roadway causing impact both beginning and end of bridge

Sediment at approach roadway causing impact to beginning of bridge

Type of Work: Repair (General)

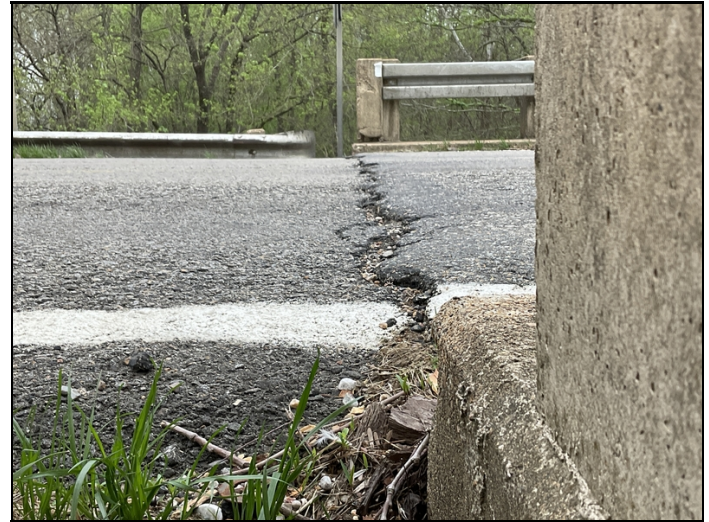
Sediment at approach roadway causing impact to bridge

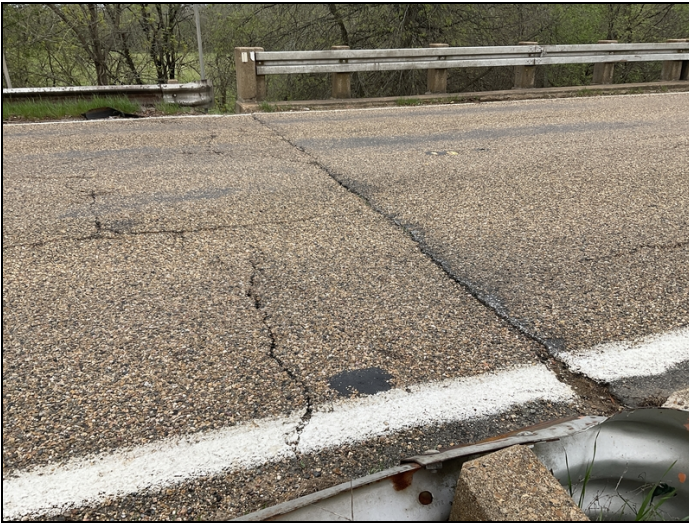
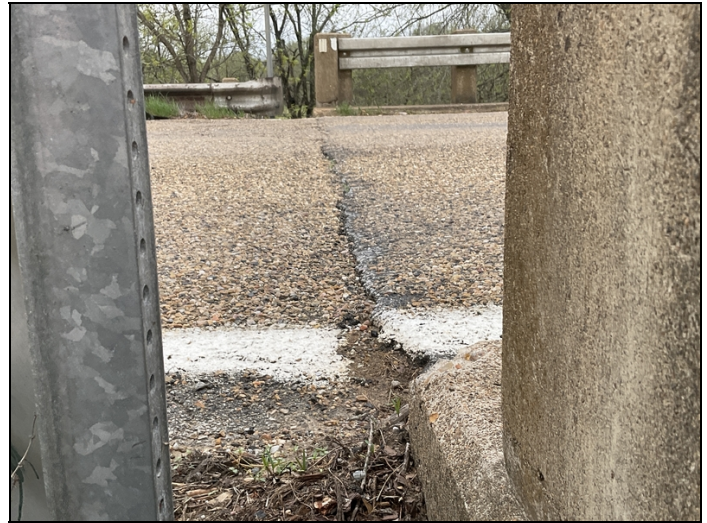
Sediment at approach roadway causing impact to end of bridge

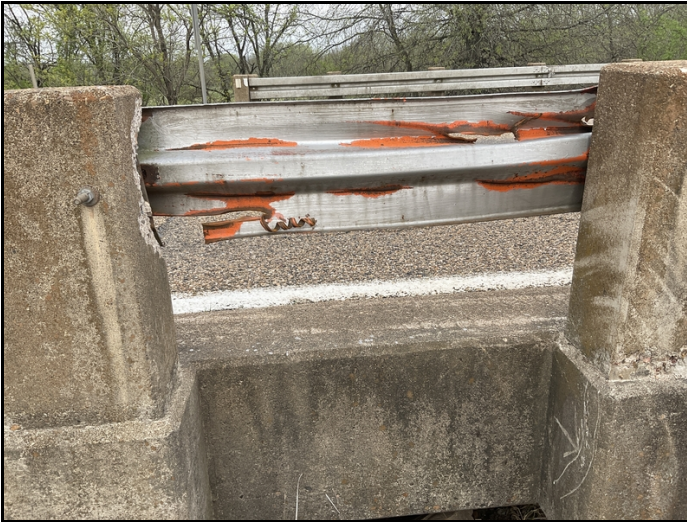
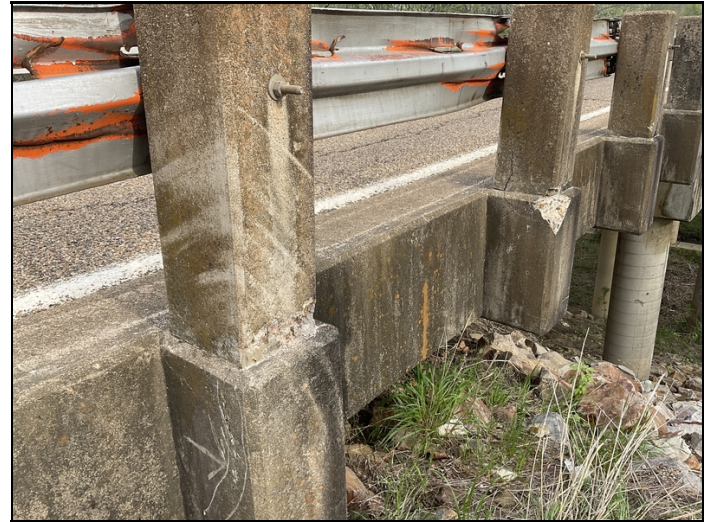
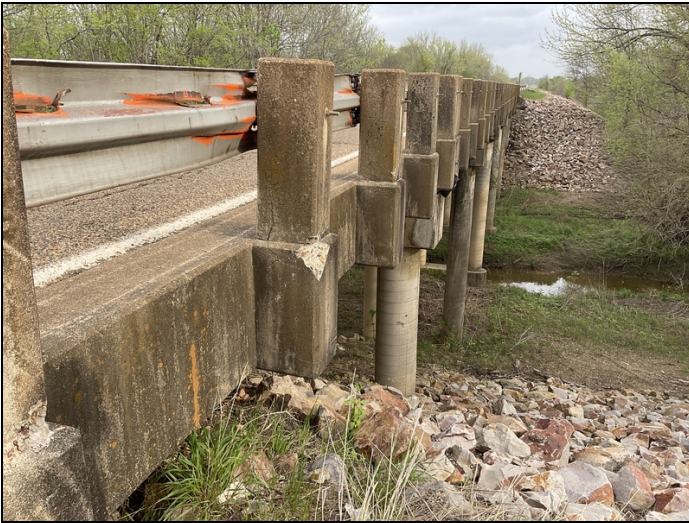
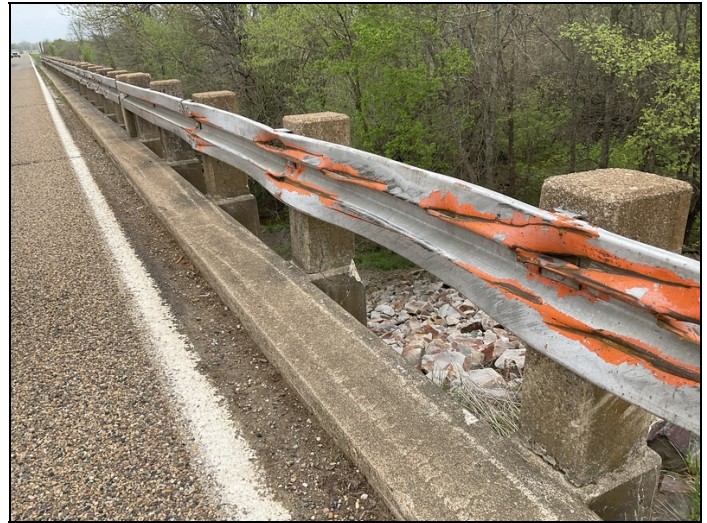
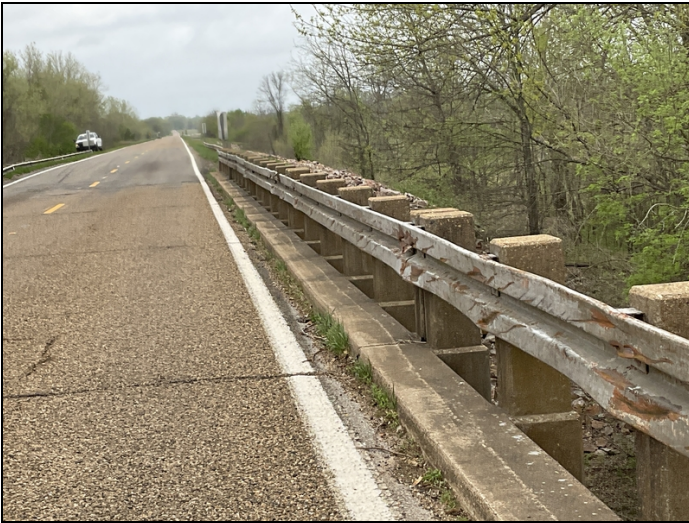
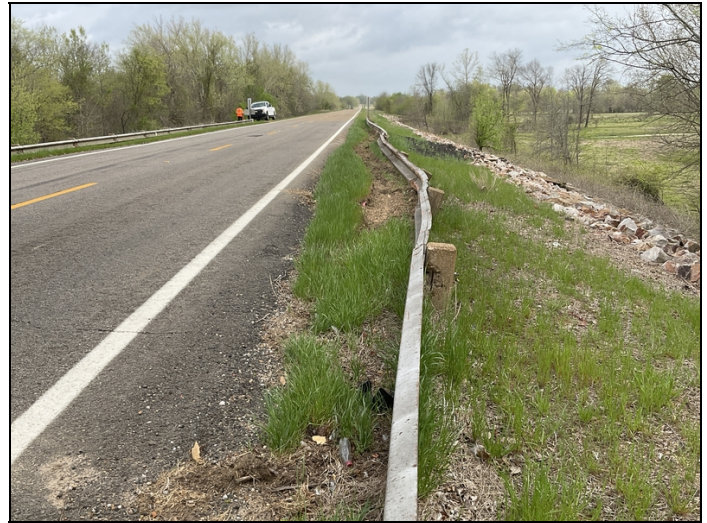
04/2022... damage to metal bridge railing and guardrail on LT side of bridge. Entire length

Type of Work: Repair (General)

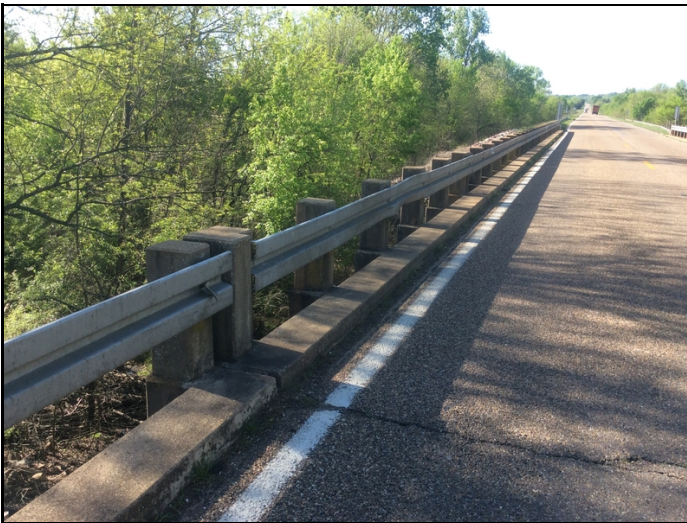
Span 2 left side guard rail damaged

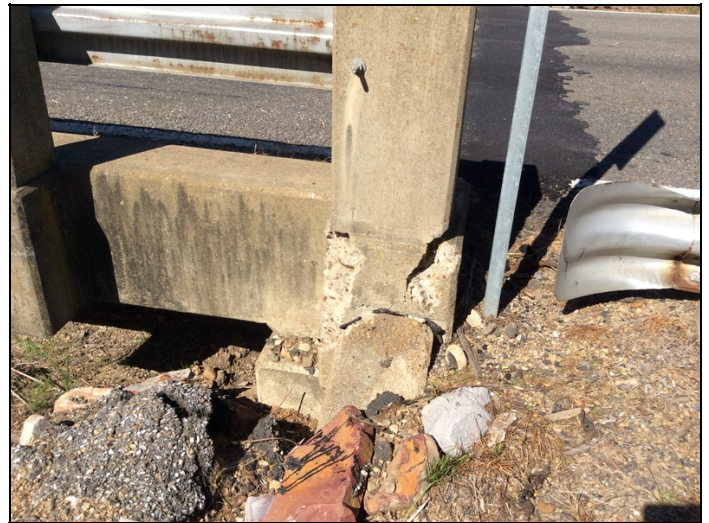
CONCRETE END POST
BENT 1 RIGHT & LEFT SIDE HAS A POST THAT IS
BROKEN AT THE BASE
FROM COLLISION DAMAGE WITH REBAR EXPOSED.

SPAN 2 POST # 4 ON THE LEFT SIDE HAS A POST
BROKEN FROM
COLLISION DAMAGE.

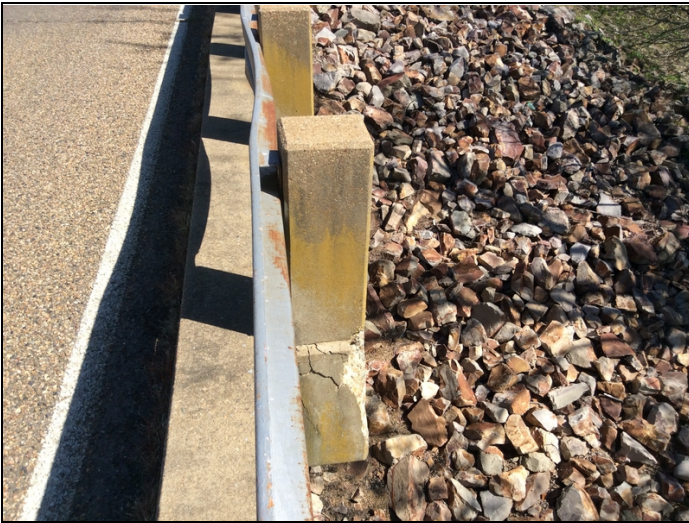
Span 2 left side post crack

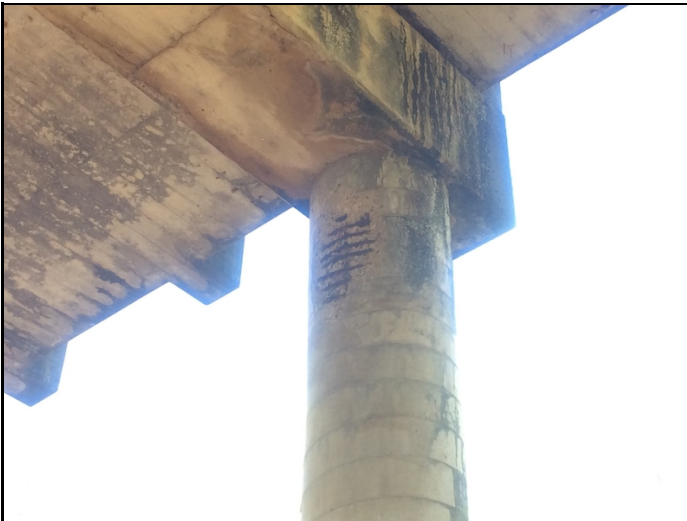
Column 4 bent 6

CONCRETE COLUMN #4 AT BENT #6
MINOR SPALL WITH REBAR EXPOSED APPROX. 1'X1'
NUMBER LT TO RT WITH LOG MILES. Column 1 at bent 6 has cracking

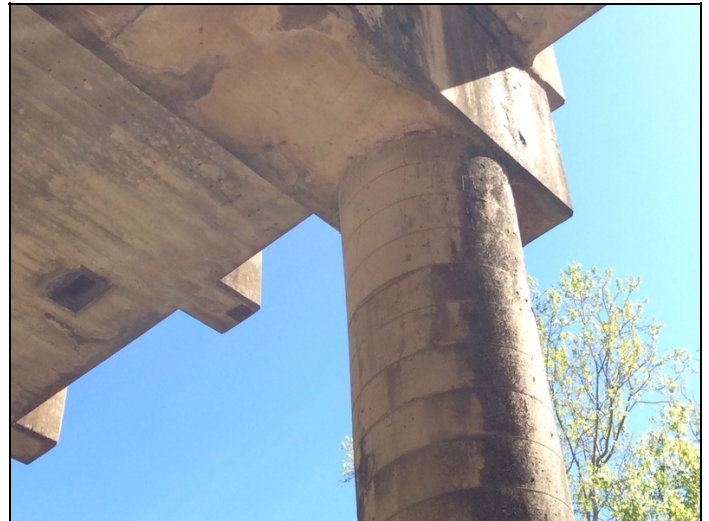
Bent 6 column 1 small crack at top of column

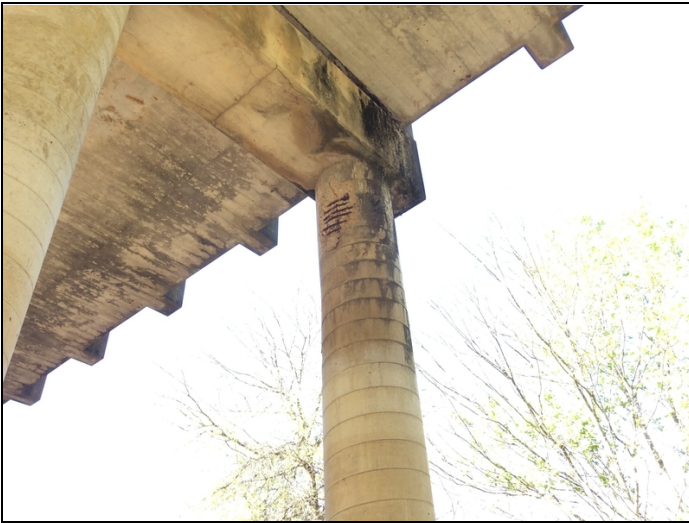
CONCRETE COLUMN #4 AT BENT #6
MINOR SPALL WITH REBAR EXPOSED APPROX. 1'X1'
NUMBER LT TO RT WITH LOG MILES.

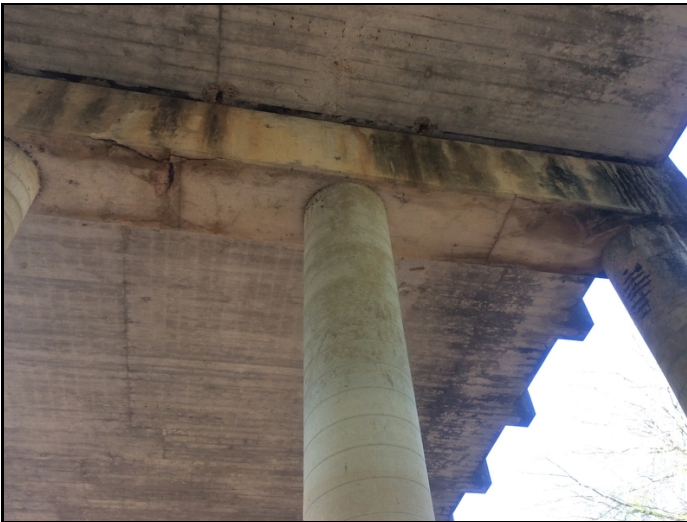
Bent 6 cap and column 4. Cracking and spall with rebar exposed

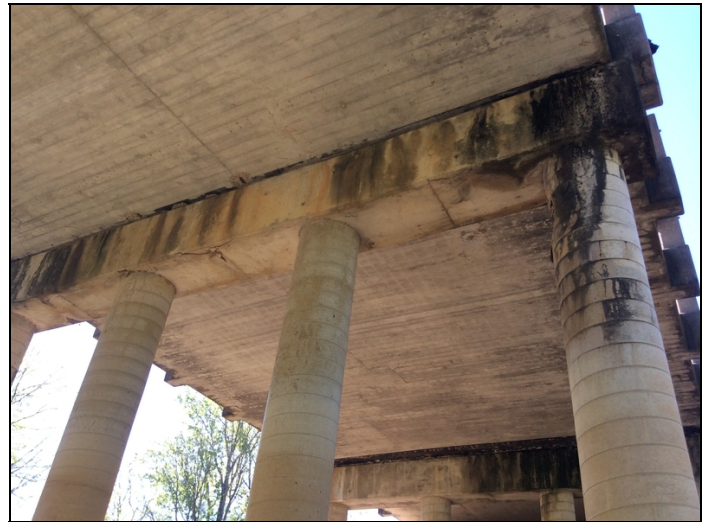
(234) 1130---CAP AT BT 6 HAS NUMEROUS CRACKS IN BOTTOM OF CAP.							
301	Pourable Joint Seal	LF	133	0	0	133	0
2350	Debris Impaction	LF	133	0	0	133	0
(301) 04/22 all joints have asphalt over them and asphalt is cracking on all joints.							
330	Metal Bridge Railing	LF	392	0	196	196	0
1000	Corrosion	LF	196	0	196	0	0
7000	Damage	LF	196	0	0	196	0

CAP @ BENT #6 HAS NUMEROUS CRACKS IN
BOTTOM AREA OF CAP.
