Asset #A2927 (Routine, Underwater type 2)

SH 355 - 01- 7.15 over PLUM CREEK

Location: 2.68 MI N HEMPSTEAD CO

Team Lead: John King, Inspection Date: 04/12/2022

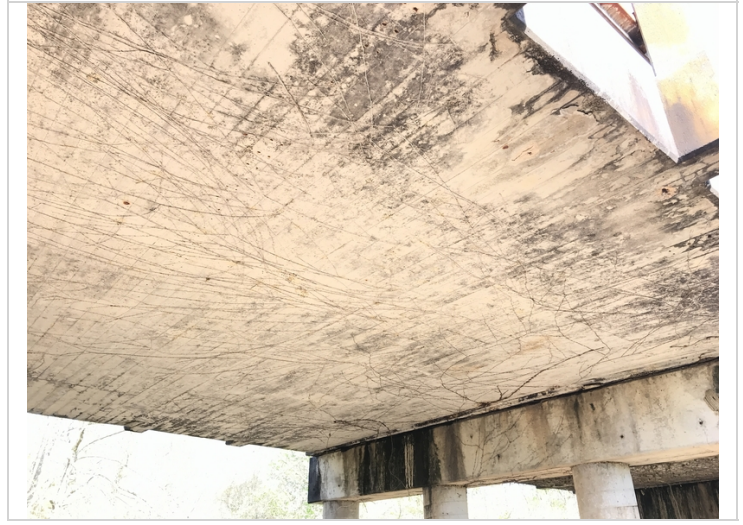
Underside of deck typical all spans

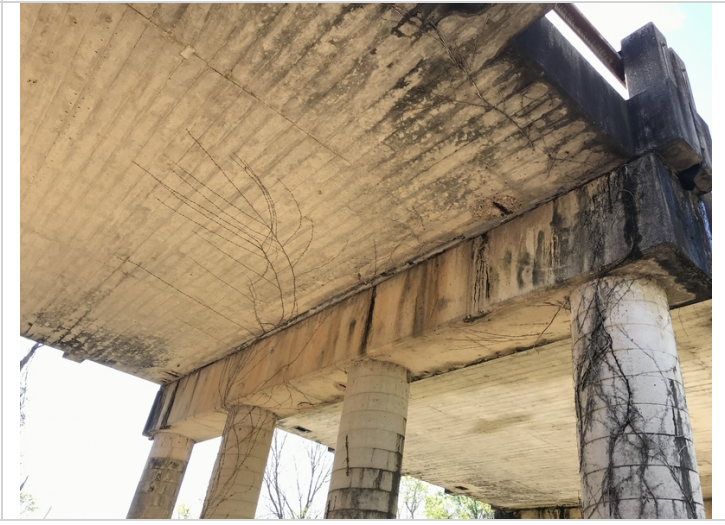
Rebar exposed span 2

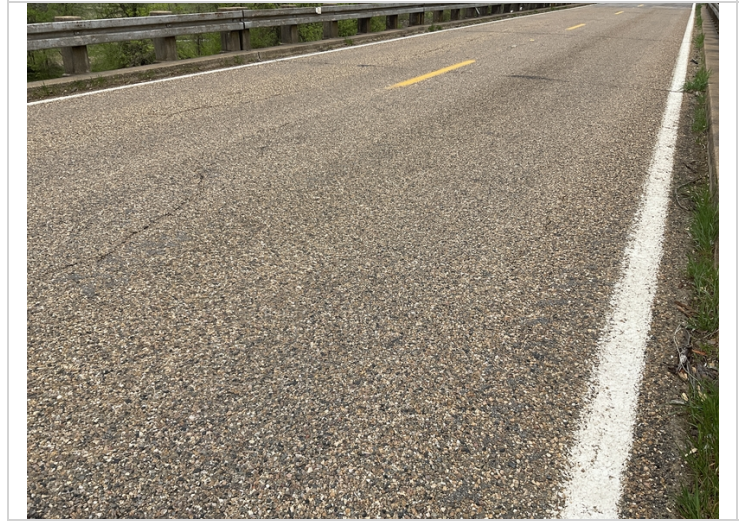
04/2022... typical deck photo all spans

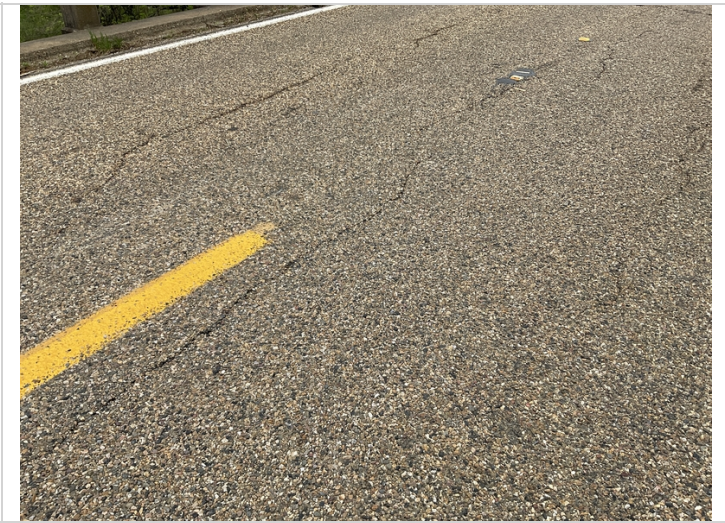
Cracking throughout deck various locations

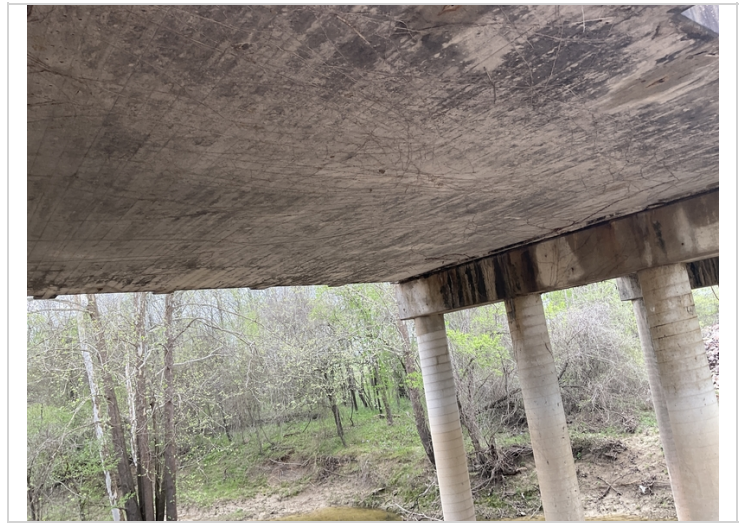
04/2022... Underside of deck typical of all spans

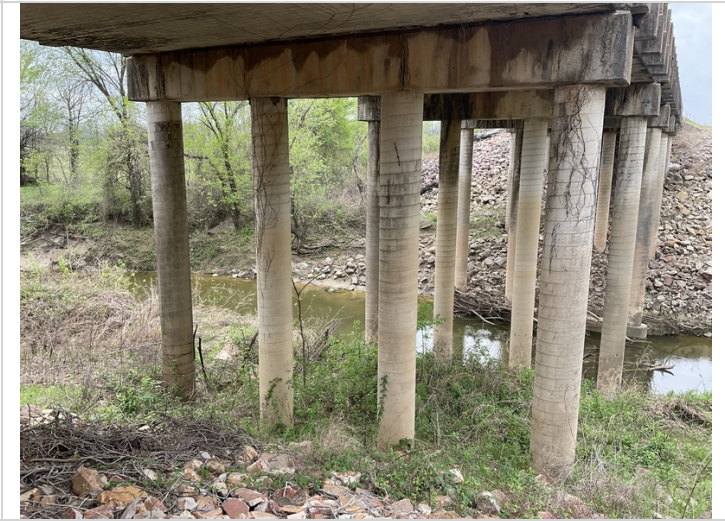
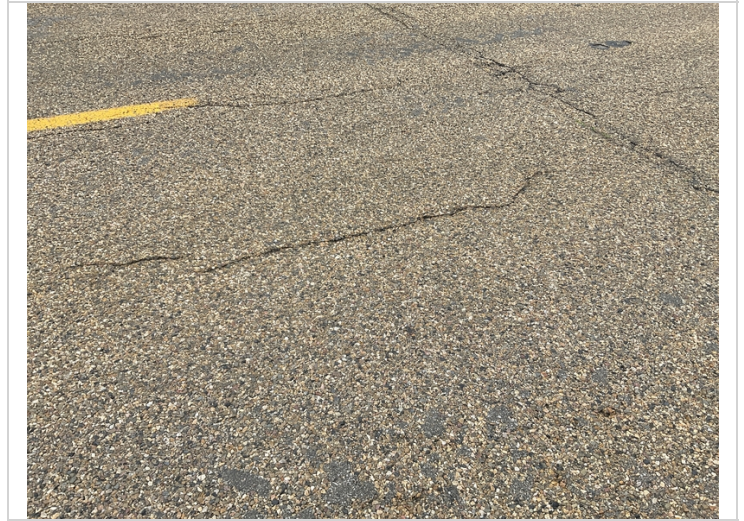
Cracking throughout deck various locations

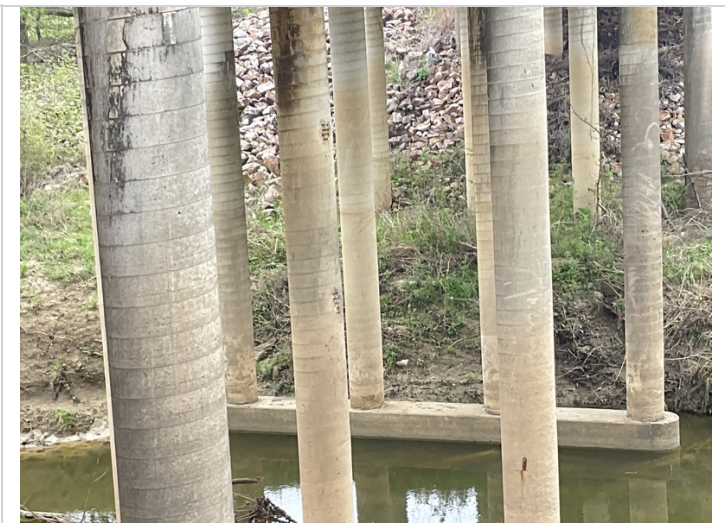
(205) CONCRETE COLUMN AT BENT #5, COLUMN #2							
(NUMBERED LEFT TO RIGHT) MINOR SPALLS WITH REBAR EXPOSED							
(1090-205) Bent 5 column 2 spalls with exposed rebar							
215	Reinforced Concrete Abutment	LF	97	97	0	0	0
234	Reinforced Concrete Pier Cap	LF	118	115	2	1	0
1080	Delamination/Spall/Patched Area	LF	2	0	2	0	0
1090	Exposed Rebar	LF	1	0	0	1	0
301	Pourable Joint Seal	LF	156	0	0	156	0
2350	Debris Impaction	LF	156	0	0	156	0
(2350-301) Asphalt over joints not allowing them to move properly. All joints are leaking on underside of deck							
330	Metal Bridge Railing	LF	392	0	392	0	0
1000	Corrosion	LF	392	0	392	0	0
(1000-330) Corrosion and paint loss on both metal railings on bridge							
331	Reinforced Concrete Bridge Railing	LF	784	784	0	0	0

Bent 5 column 2 spalls with exposed rebar

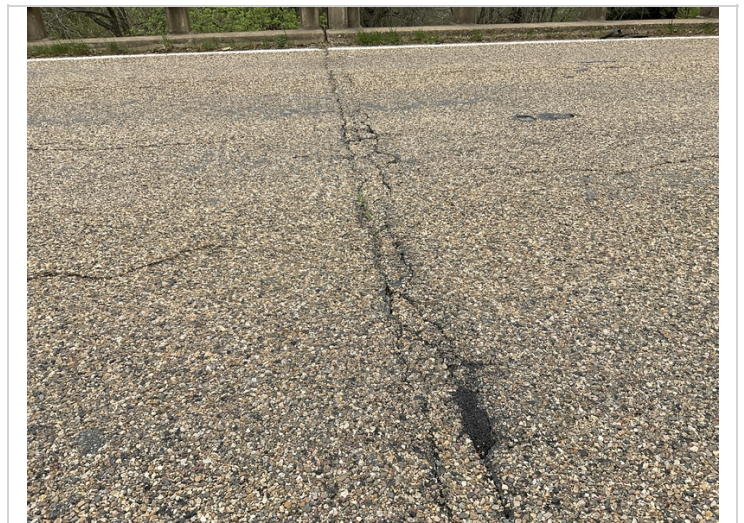
Asphalt over joints not allowing them to move properly

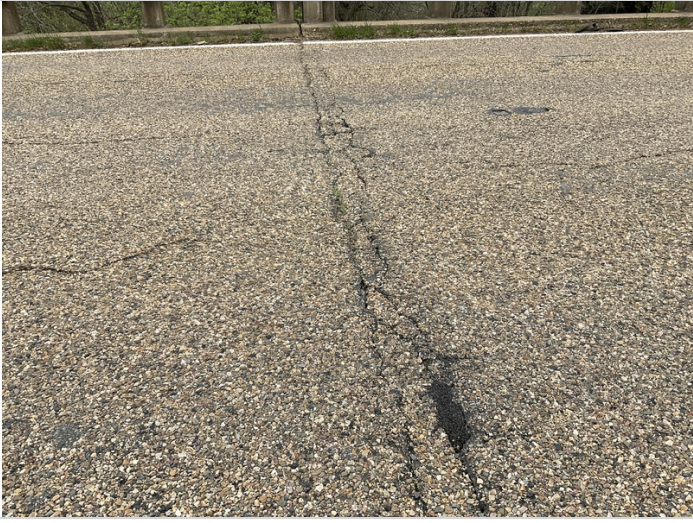
Asphalt over joints not allowing them to move properly

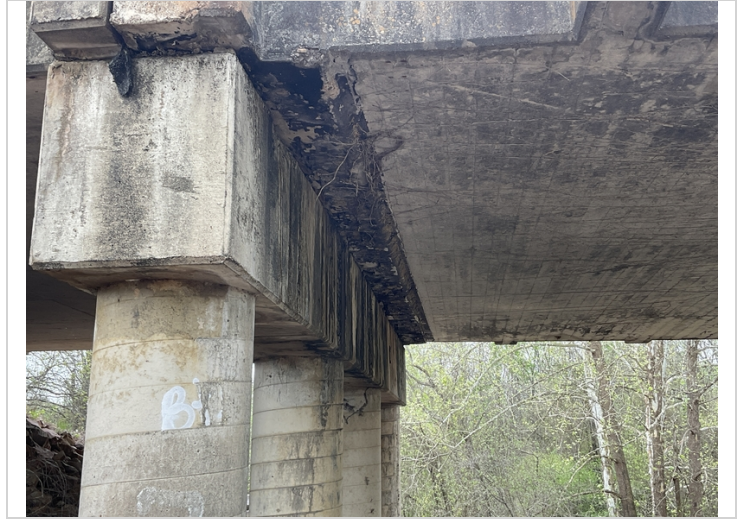
Underside of deck joints leaking

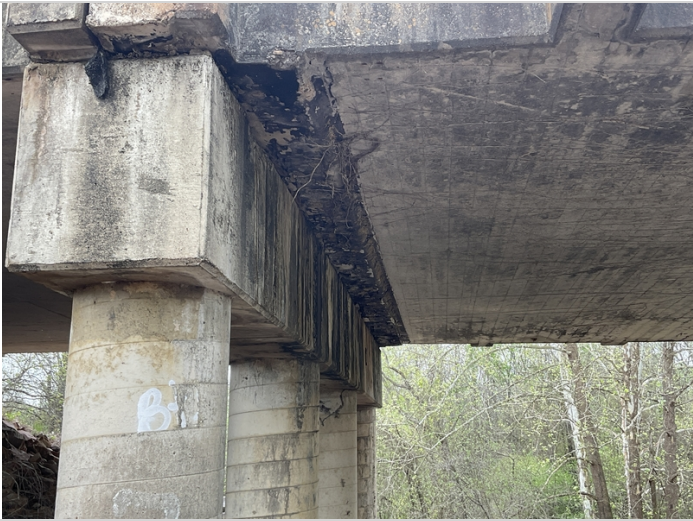
Underside of deck joints leaking

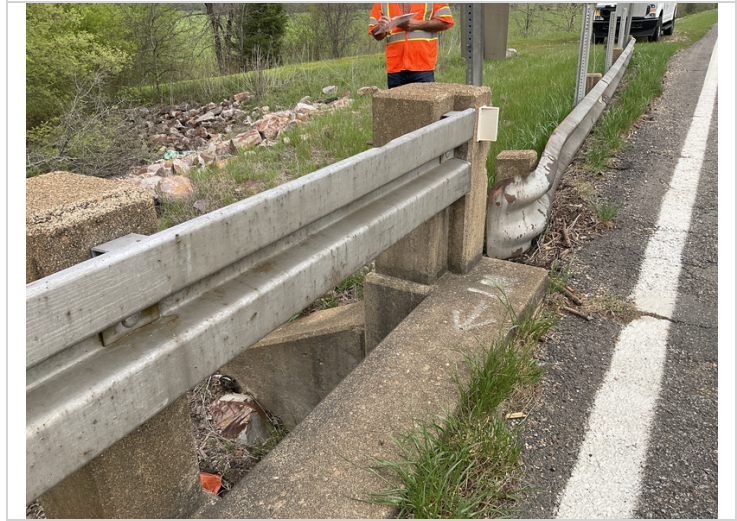
Corrosion and paint loss on both metal railings on bridge

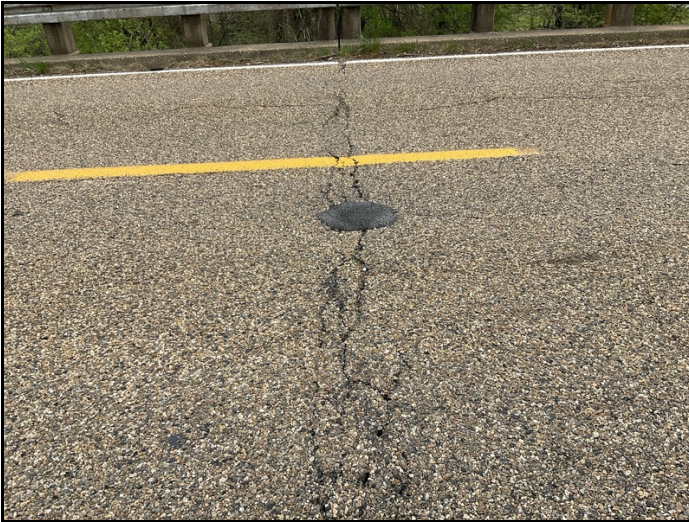
All joints on deck have asphalt overlay not allowing them to move properly

Type of Work: Repair (General)

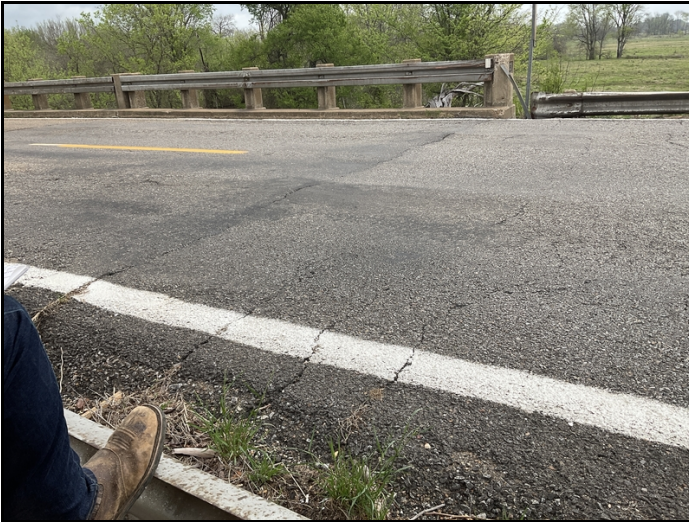
Both approach's at bridge ends have debris impacting joints not allowing them to move properly.

End of bridge debris impacting

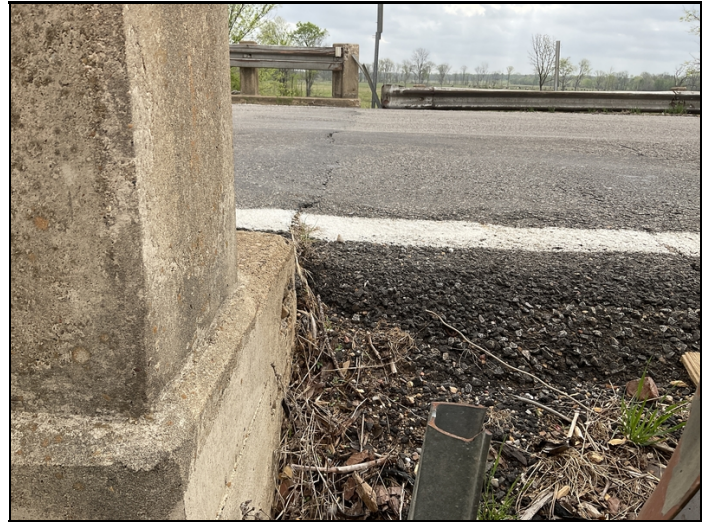
End of bridge debris impacting

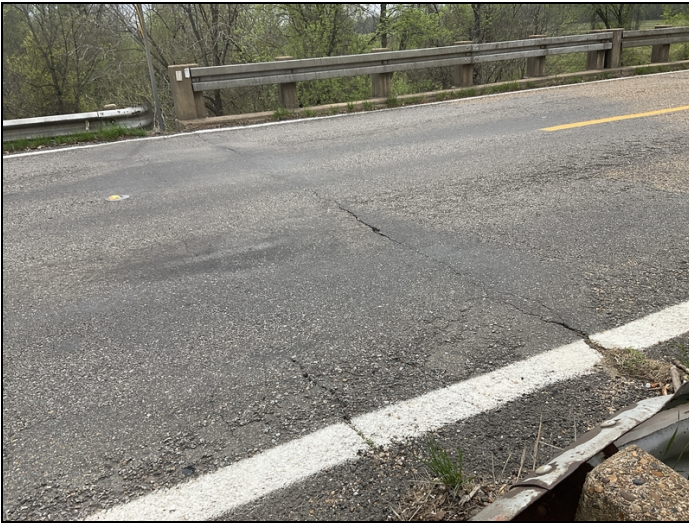
Beginning of bridge debris impacting

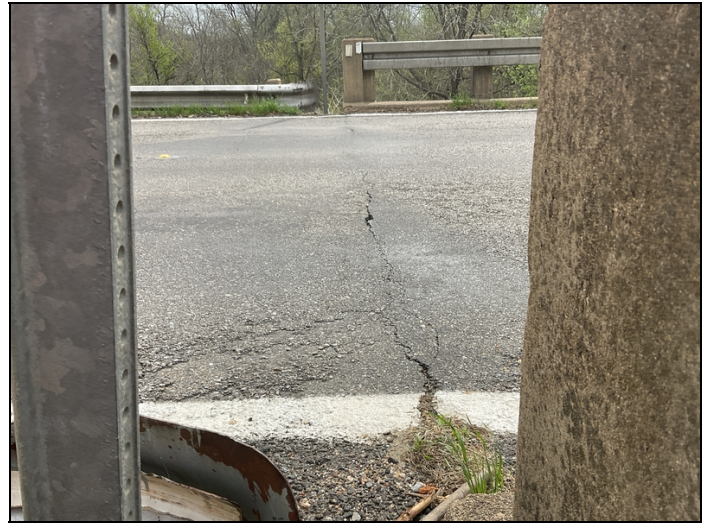
Beginning of bridge debris impacting

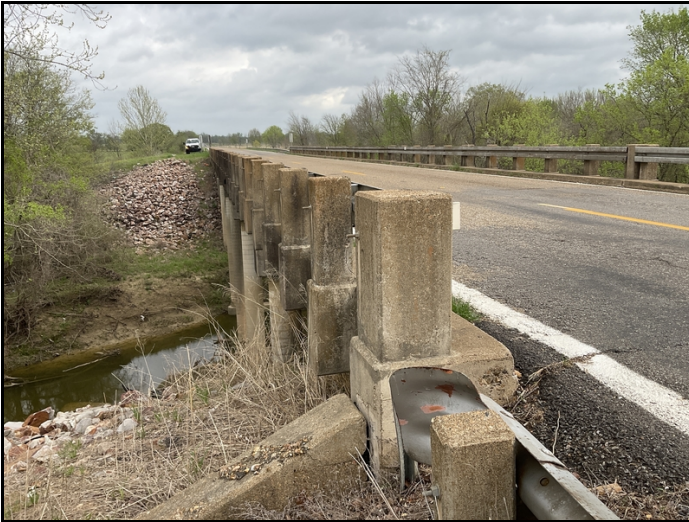
Rt side end of bridge flareboard is missing

Type of Work: Replace (General)

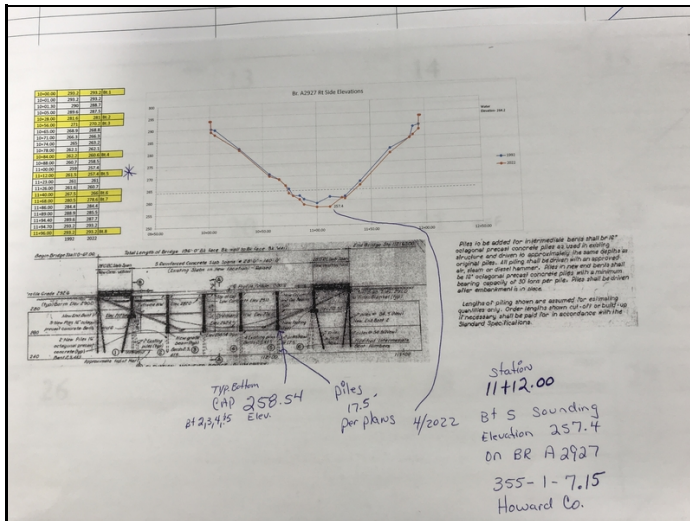
sounding were taken 04/2022 and bottom of pile cap per plan elevation is 258.54 at station 11+12.00 sounding show elevation of ground line at 257.4 this is at bottom of concrete cap. note that sub cap has 17.5 ft of piles under cap. lowered item 61 channel from 7 good to 6 satisfactory due to erosion.

2022 Sounding Sheet lowered channel from 7 good to 6 satisfactory due to erosion.

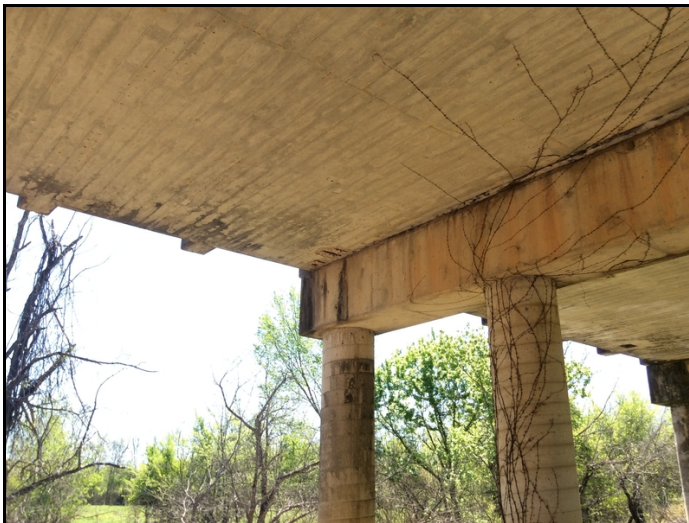
BOTTOM OF CONCRETE DECK
SPAN #2 HAS A 1'X1' SPALL W/REBAR EXPOSED.

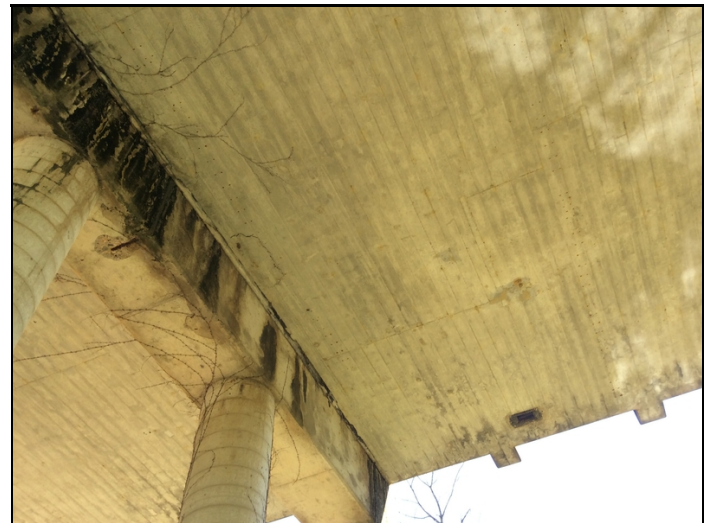
SPAN 3 DELAM BOTTOM DECK AT BT 3 16'X16'
CENTER BRIDGE.

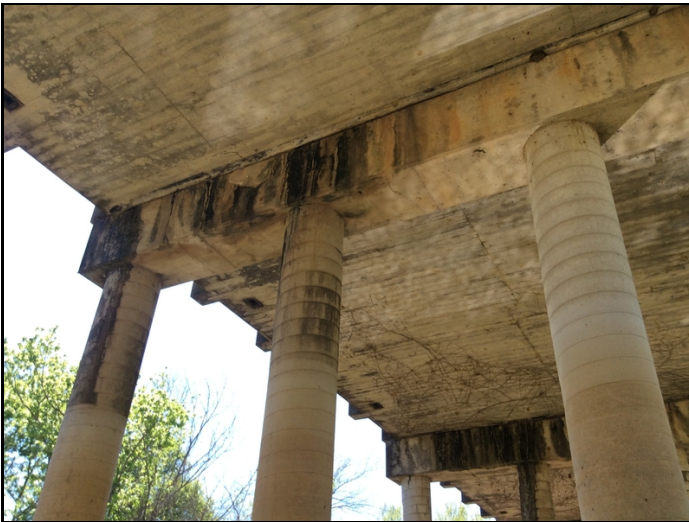
CONCRETE CAP AT BENT #4, NORTH FACE
18"X24" DELAMINATION ON CAP BETWEEN
COLUMNS 1 and 2

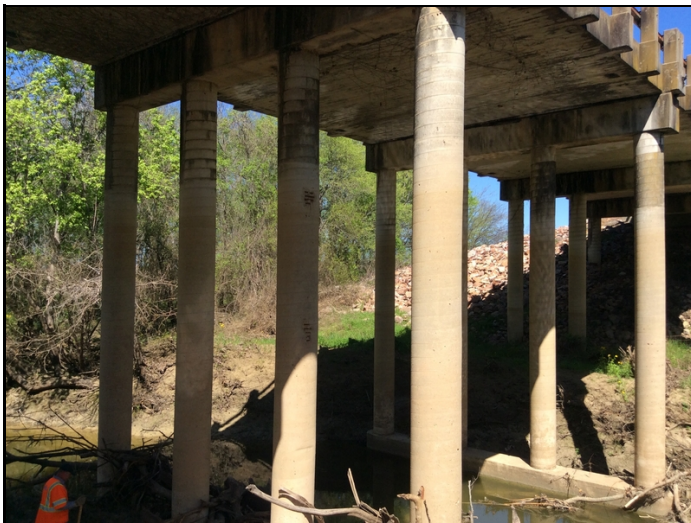
CONCRETE COLUMN AT BENT #5, COLUMN #2
(NUMBERED LEFT TO RIGHT)
MINOR SPALLS WITH REBAR EXPOSED
