Asset #05527 (Routine, Underwater type 2)

US 278- 04- 1.63 over SANDY BRANCH

Team Lead: John King, Inspection Date: 04/11/2022

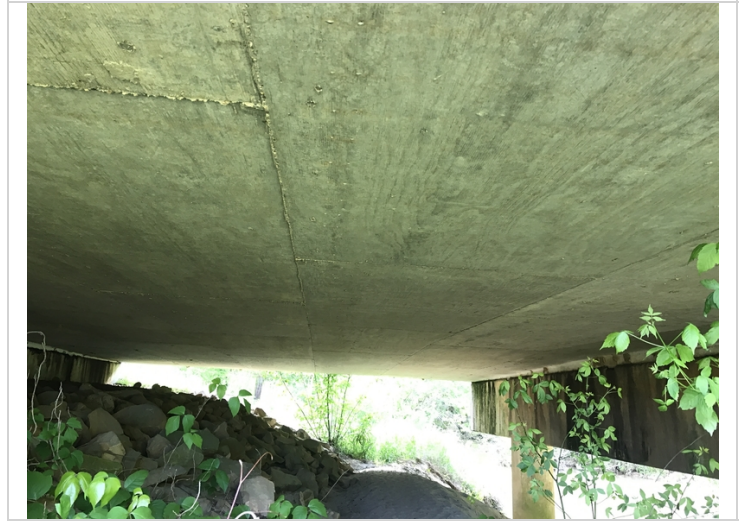
Underside of deck typical all spans

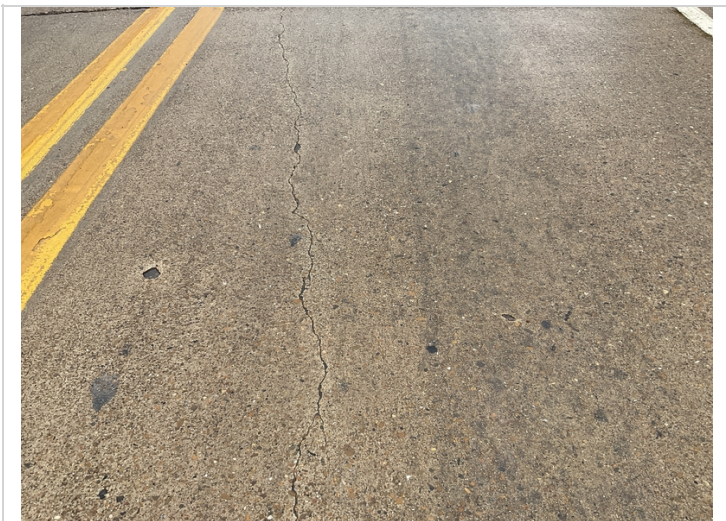
04/11/2018. AL,SS,OTHER PHOTO TAKEN. APPROACH SLAB BEGINNING AND END OF BRIDGE HAVE CRACKS IN THEM.

04/2022.. concrete approach slab has cracks both sides of bridge

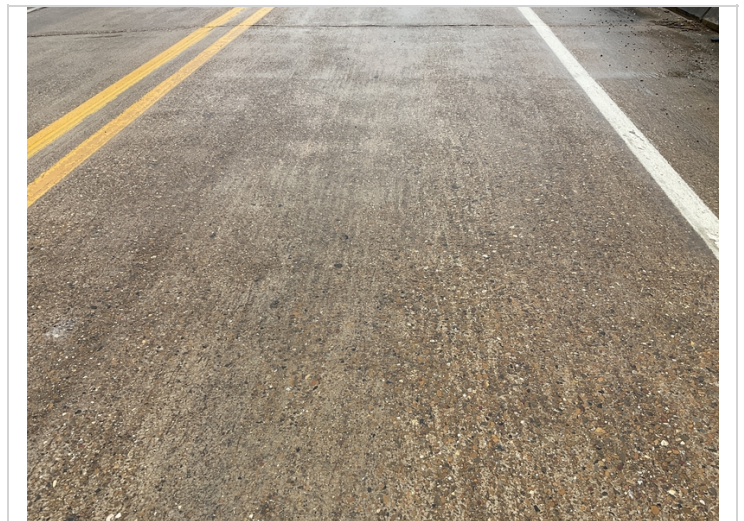
04/2022.. typical deck photo all spans

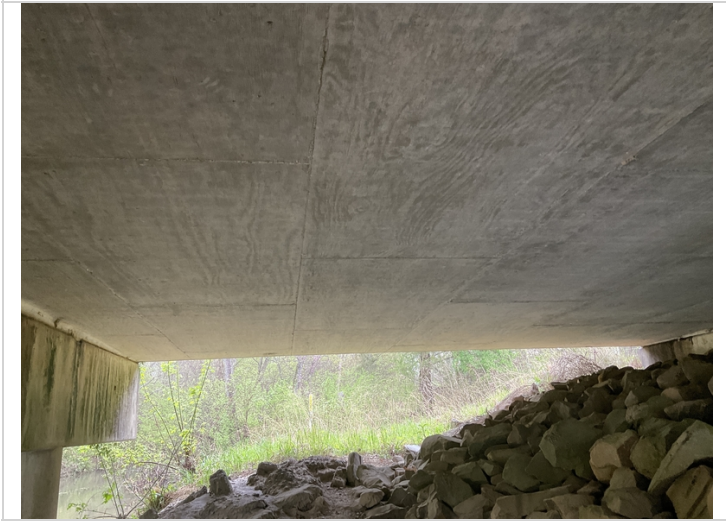
04/2022... underside of deck typical all spans

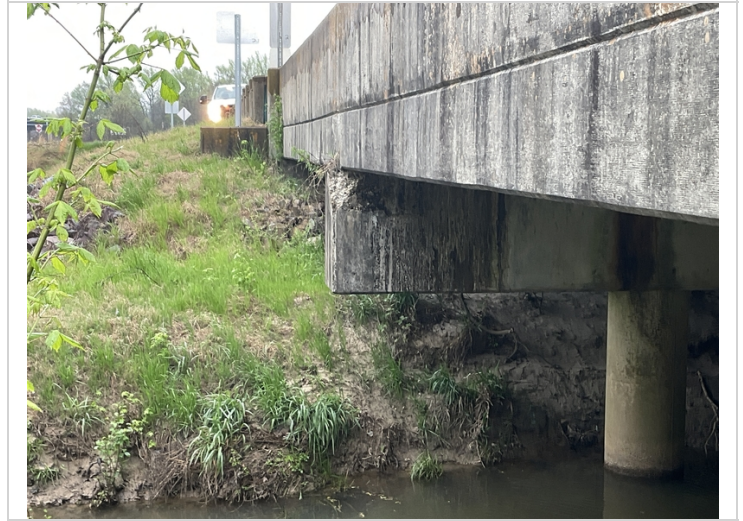
04/2022. Bent 2 Rt and Lt side of cap are spalled with rebar exposed. Little to no change per this inspection.

Bent 2 spall

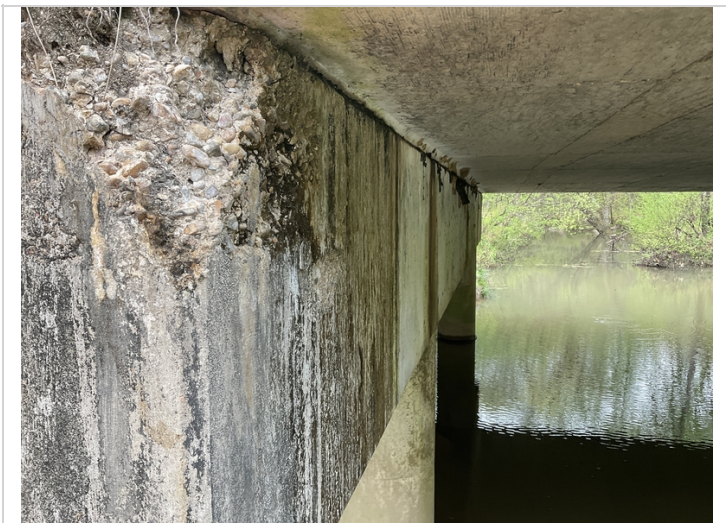
Bent 2 spall

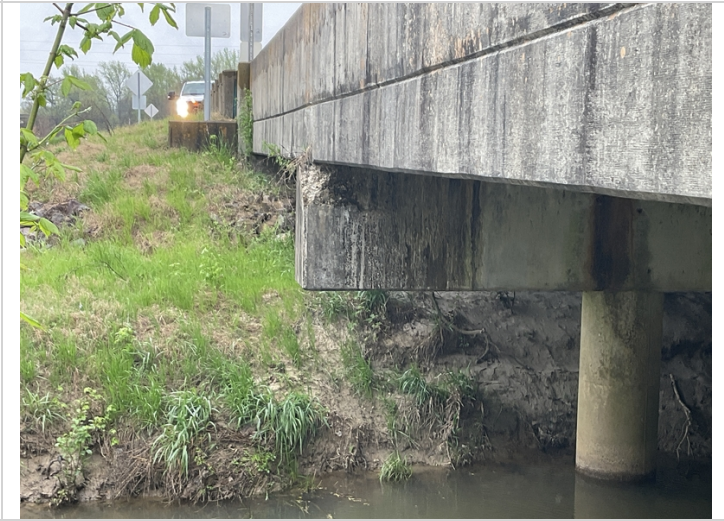
ELEMENTS	DESCRIPTION	UNITS	TOTAL	CS1	CS2	CS3	CS4
205	Reinforced Concrete Column	EA	4	4	0	0	0
215	Reinforced Concrete Abutment	LF	86	86	0	0	0
234	Reinforced Concrete Pier Cap	LF	148	144	2	2	0
1080	Delamination/Spall/Patched Area	LF	2	0	2	0	0
1090	Exposed Rebar	LF	2	0	0	2	0
(234) Small spall bent 2 right side, left side spall with rebar exposed

Rt side cap at bent 2 spall

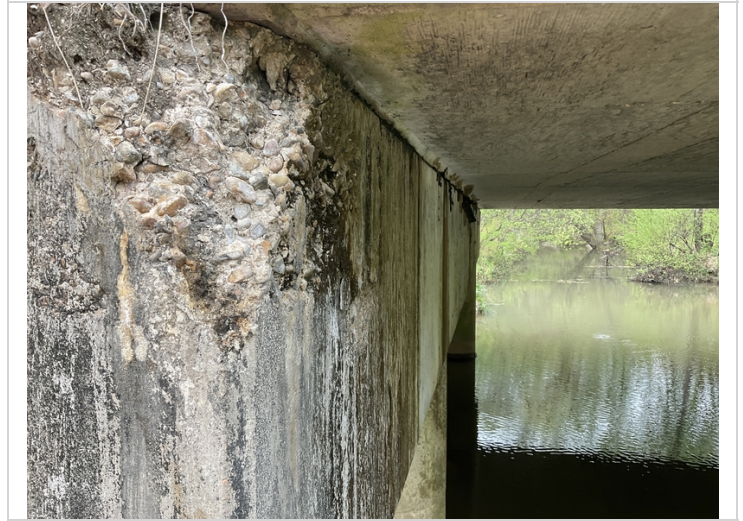
Rt side bent 2 spall

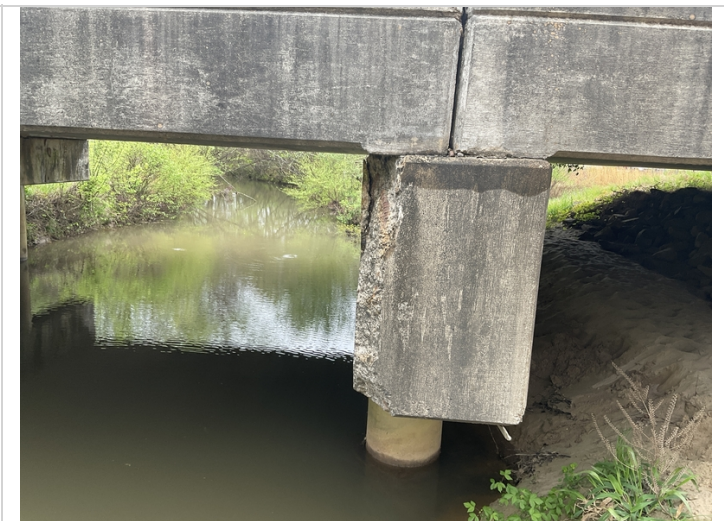
LT side spall with rebar exposed

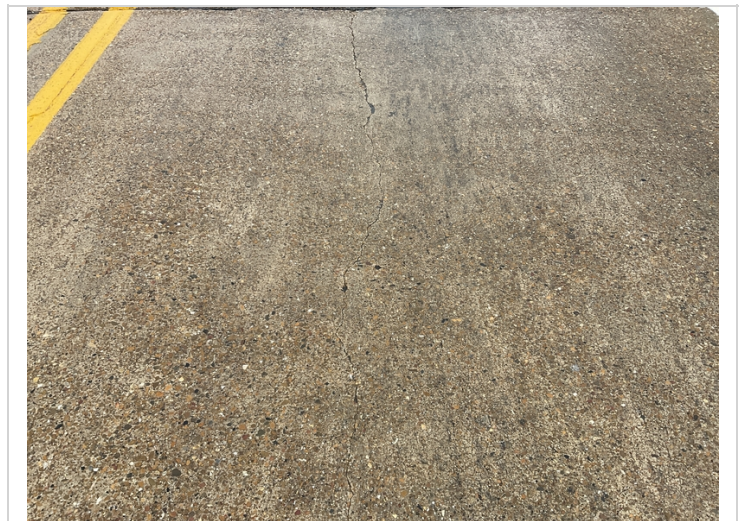
Concrete approach slab cracking both sides of bridge

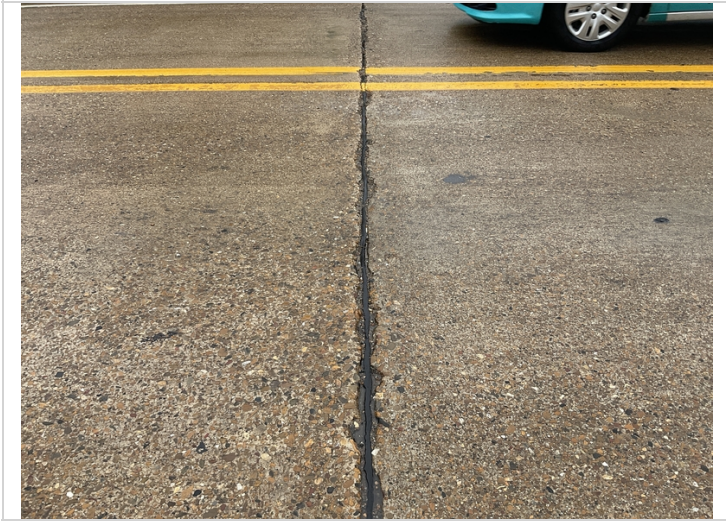
04/2022.. typical joint photo all spans

04/2022.. joints need cleaned and resealed
