Bridge 06413 Inspection Report

Asset #06413(Routine, Underwater type 2)

US 278- 03- 0.68 over HOLLY CREEK

Team Lead: Jared Kegley Inspection Date: 04/01/2024

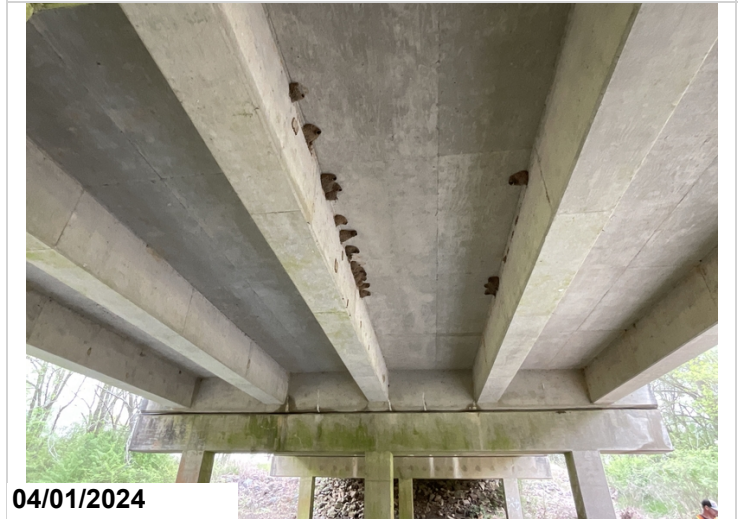
Undersurface, Typical of all spans

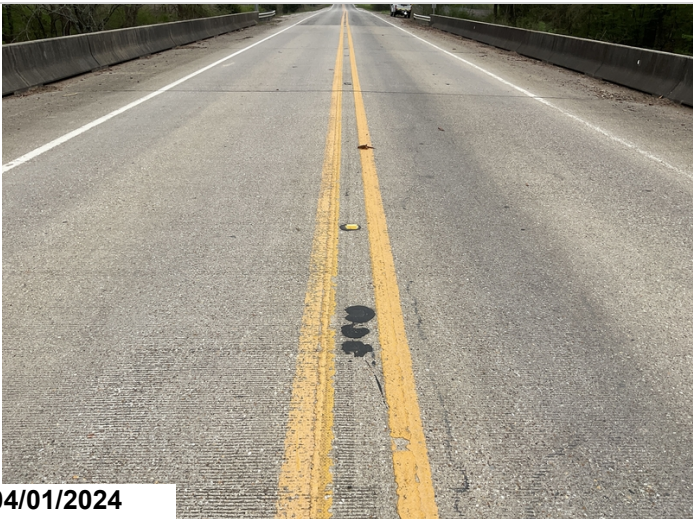
Deck, Typical of all spans

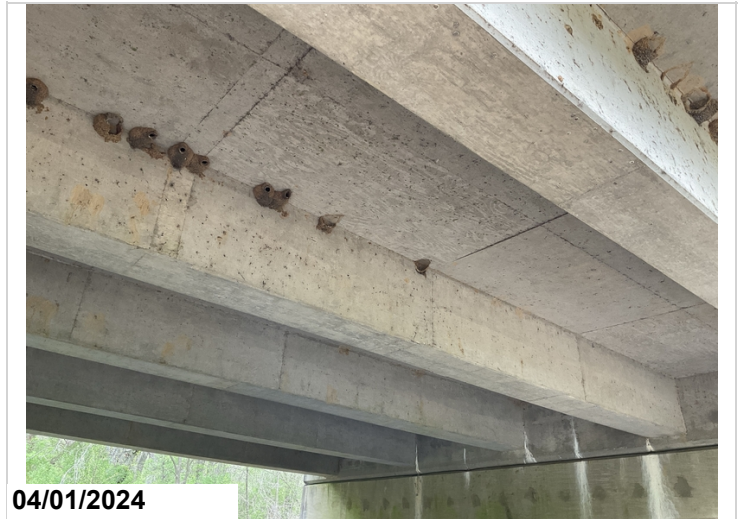
Superstructure rating is a 7 this inspection due to minor cracking that is found throughout all concrete tee beams in various locations of all spans.

Concrete t-beams, Typical of all spans

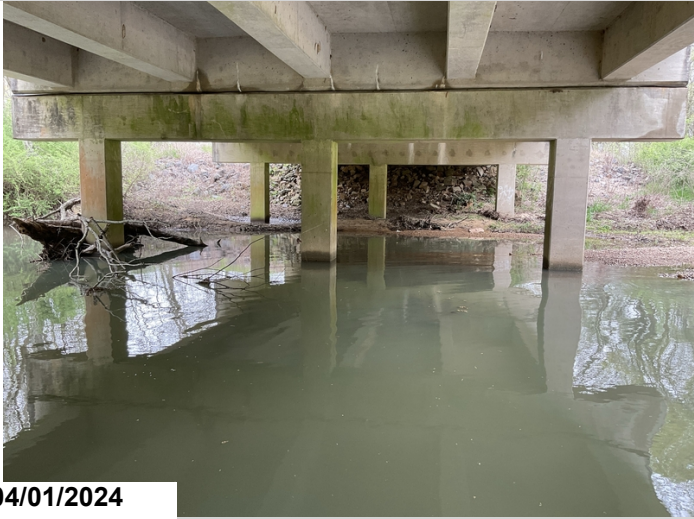
Bent photo, Typical of bents 2, 3, & 4

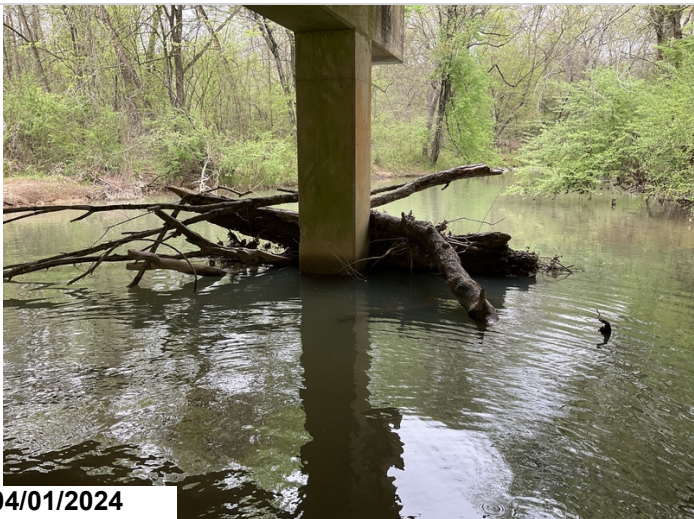
Logs and debris against bent 3 column 1.

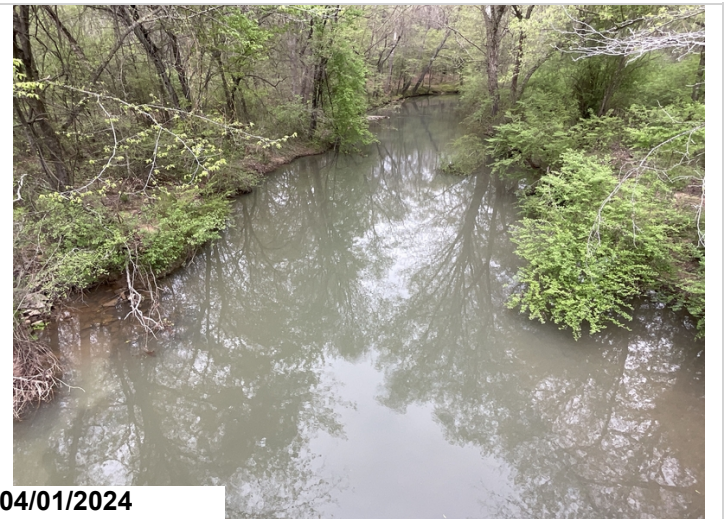
Channel rating is an 8 this inspection due to both the up and downstream sides of the bridge being well vegetated and in stable condition. Soundings taken this inspection and linked to report and asset files.

Upstream channel

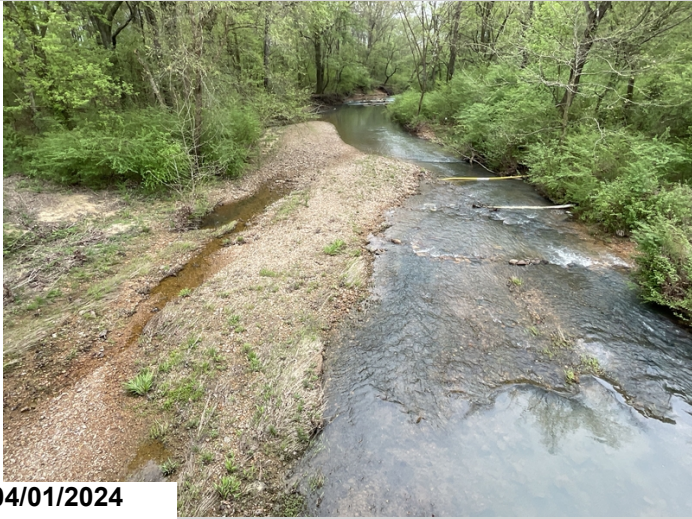
Downstream channel

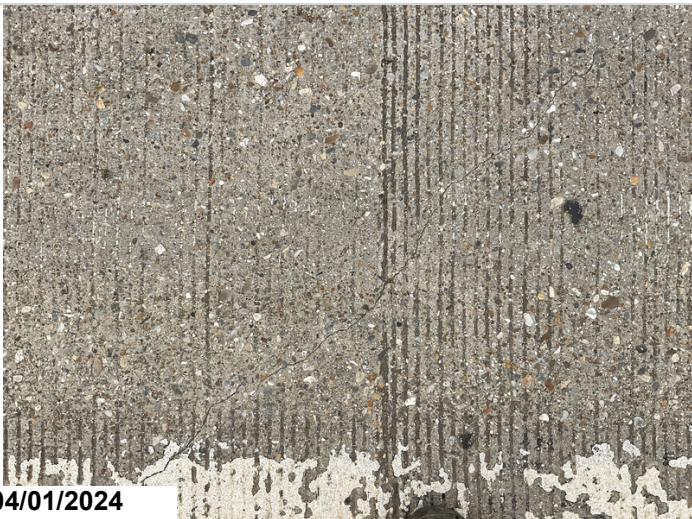
Sealable deck cracking is present in various locations throughout all spans.

Sealable deck cracking, Typical in various locations throughout all spans

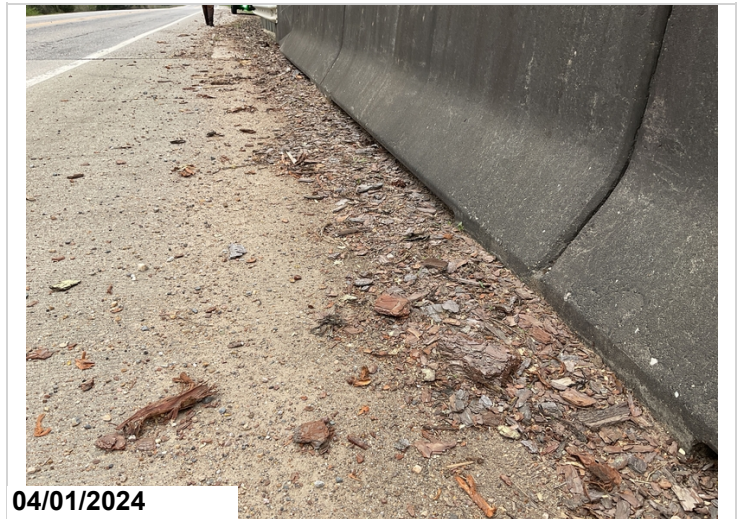
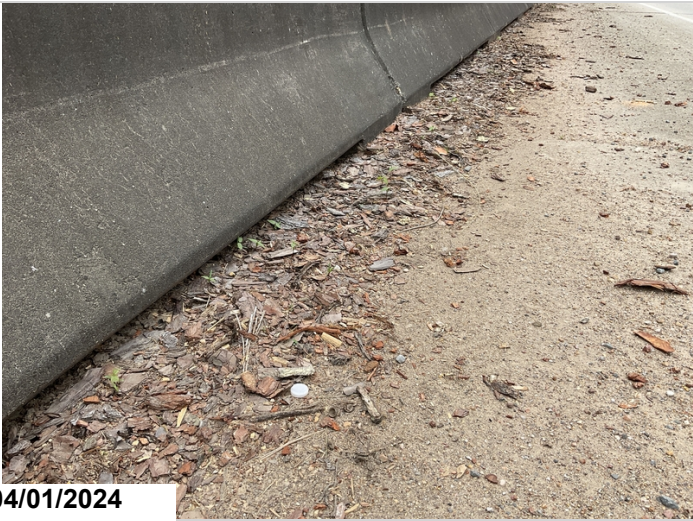
Deck washing is needed. Both the right and left gutter lines have debris that is blocking the deck drains.

Deck washing needed, Both right and left sides of bridge deck have debris blocking drains, Typical in all spans

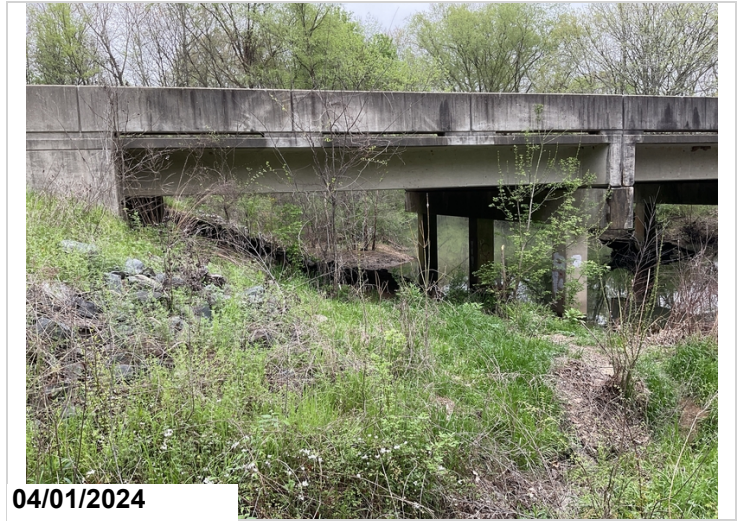
Trees and vegetation need removed at all four corners of the bridge.

Span 1, Right side, Trees and vegetation need removed

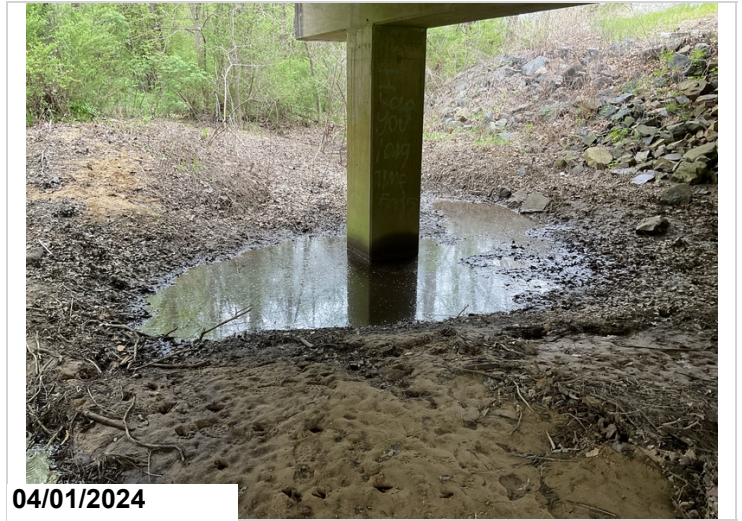
The scour rating is a 6 this inspection due to isolated moderate scour that is found to intermediate bents 2, 3, and 4.

Bent 4 column 1 scour

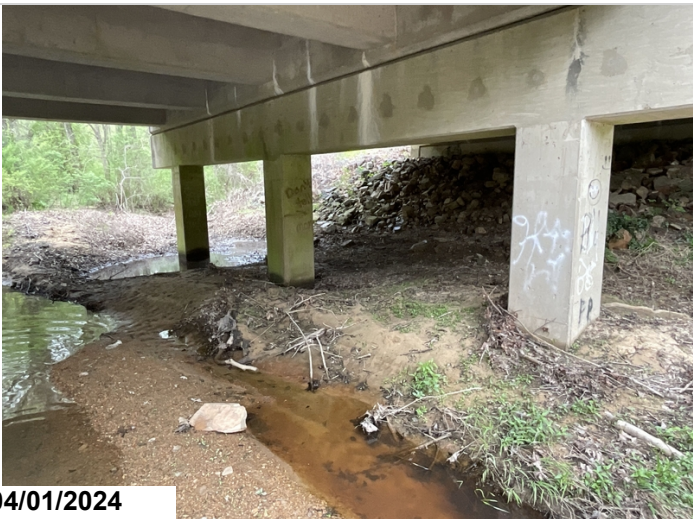
Bent 4 scour

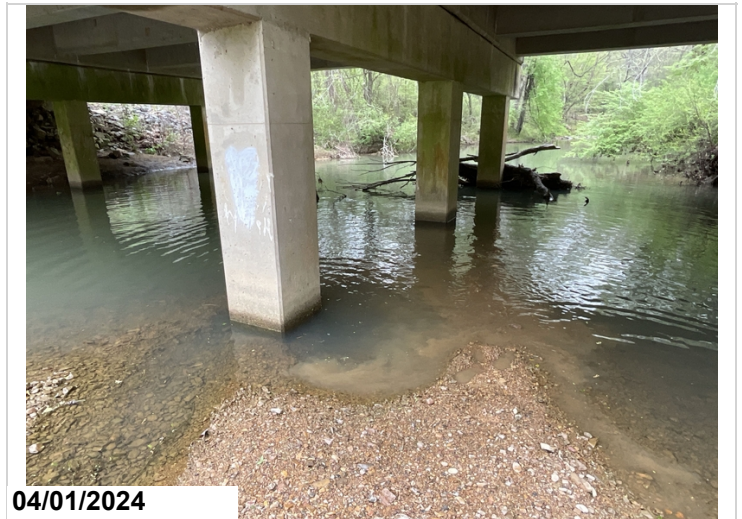
Bent 3 scour

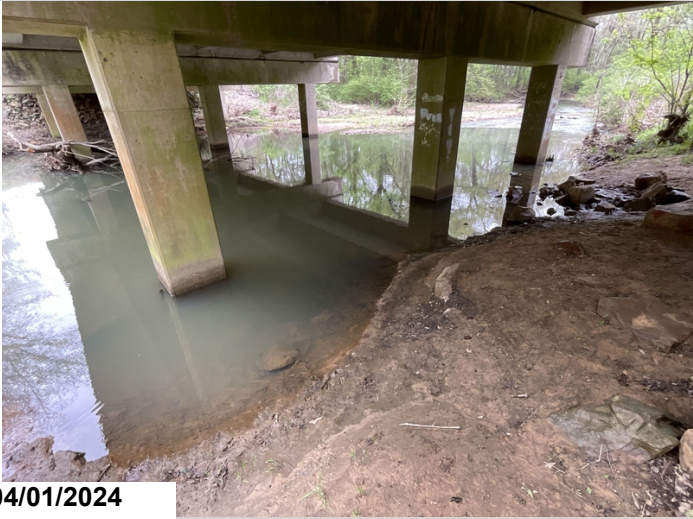
Bent 2 scour

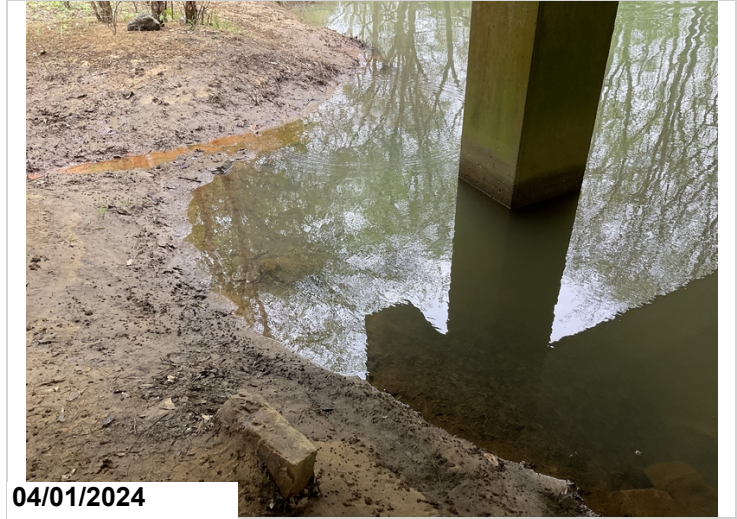
Bent 2 column 1scour

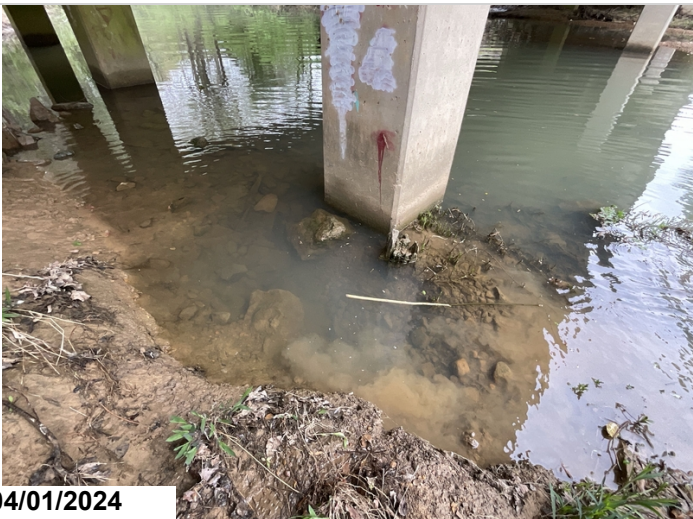
Bent 2 column 3 scour

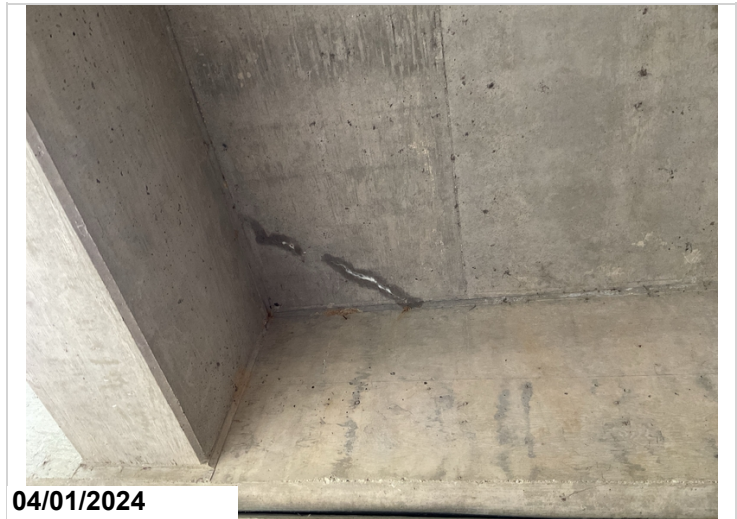
Span 4, Bay 4, Efflorescence to undersurface of deck, CS2

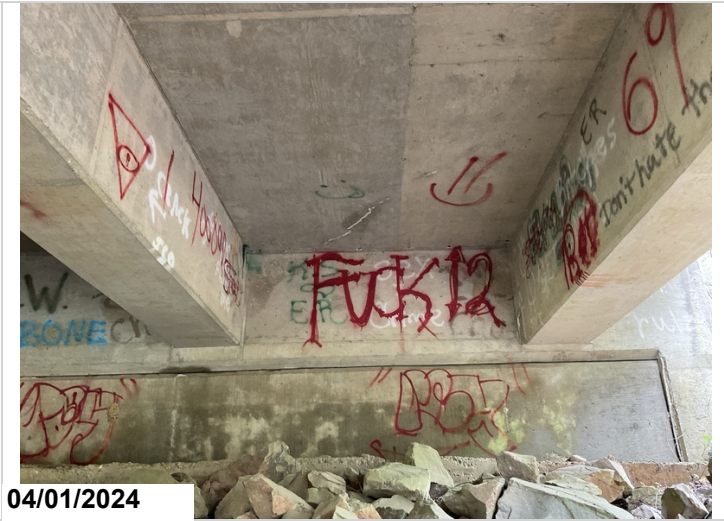
Span 1, Bay 1, Efflorescence to undersurface of deck, CS2

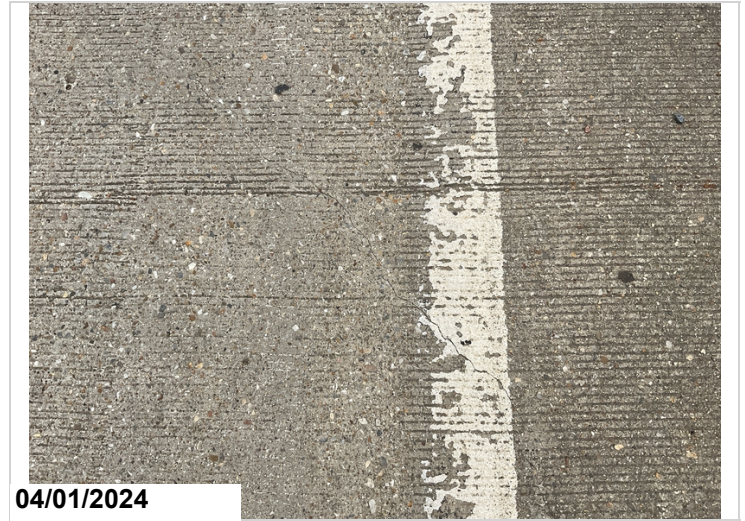
(16) Deck cracking is present in various locations of the concrete deck in all spans. Some deck cracking has been sealed prior to this inspection, CS2. Efflorescence is found to the undersurface of the bridge deck in various locations in all spans, CS2.							
110	Reinforced Concrete Open Girder/Beam	LF	700	650	50	0	0
1130	Cracking (RC and Other)	LF	50	0	50	0	0

Span 4, Rt side, Deck cracking, Typical of all spans, CS2

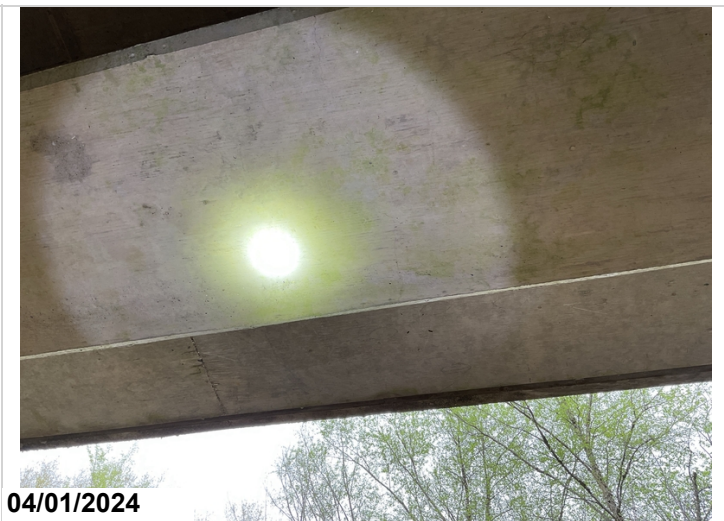
(110) Minor cracking is found in the concrete tee beams in various locations throughout all spans. The minor hairline cracks measure 0.005" and are unsealed, CS2. Efflorescence is found to the concrete diaphragms between all beams at all bents.							
205	Reinforced Concrete Column	EA	9	8	1	0	0
1080	Delamination/Spall/Patched Area	EA	1	0	1	0	0

Span 1, Beam 1, Minor hairline cracking that is unsealed,
CS2

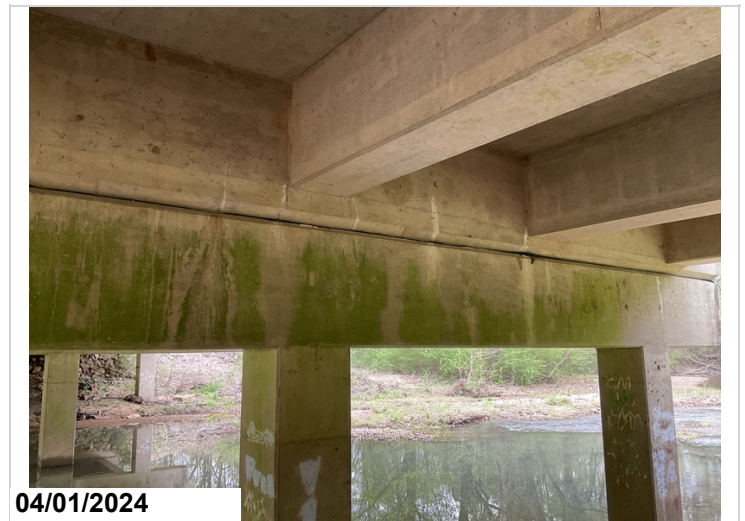
Majority of efflorescence is on concrete diaphragm between
beams at bents
Efflorescence is found on the concrete diaphragms between
beams at all bents.

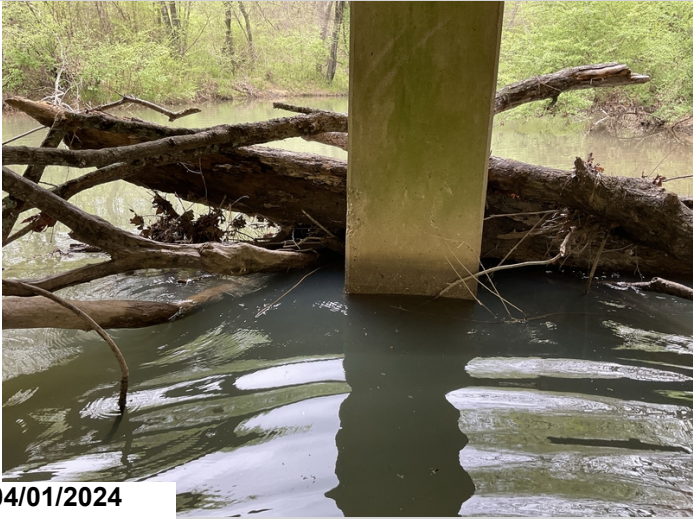
Dropped the substructure rating to a 7 this inspection due to cracking with efflorescence on concrete caps at intermediate bents as well as a spall on bent 3 column 1.

(205) Minor spalling is found to column 1 at bent 3, CS2.							
215	Reinforced Concrete Abutment	LF	132	132	0	0	0
234	Reinforced Concrete Pier Cap	LF	215	212	3	0	0
1120	Efflorescence/Rust Staining	LF	3	0	3	0	0

Bent 3, Column 1 spill, CS2.

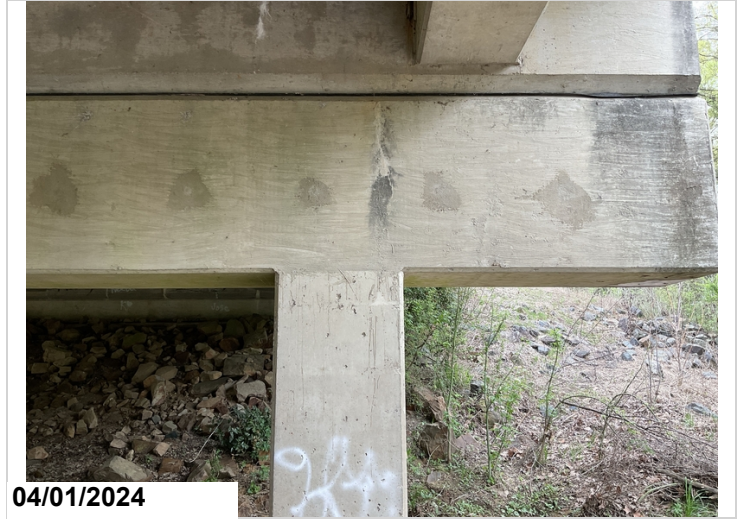
(234) Intermediate bents 2 and 4 have various locations of minor efflorescence on the concrete caps, CS2.							
301	Pourable Joint Seal	LF	130	0	0	130	0
2320	Seal Adhesion	LF	78	0	0	78	0
2350	Debris Impaction	LF	52	0	0	52	0

Bent 4, Looking ahead, Efflorescence to right side of cap above column 3. CS2

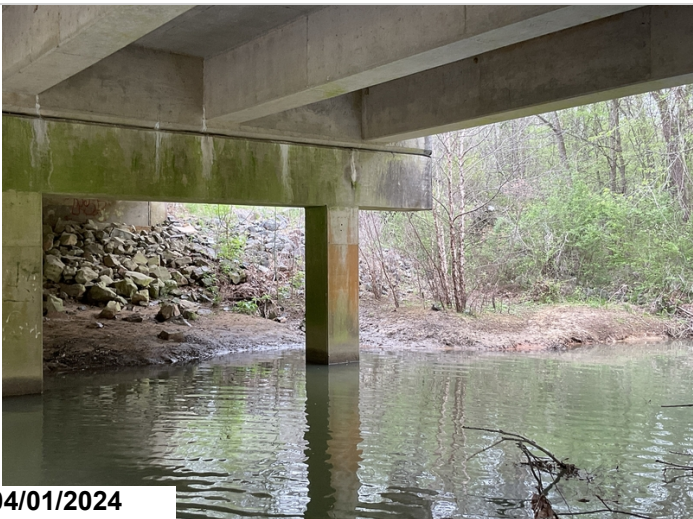
Bent 2, Looking back, Efflorescence to left side of cap above column 1. CS2

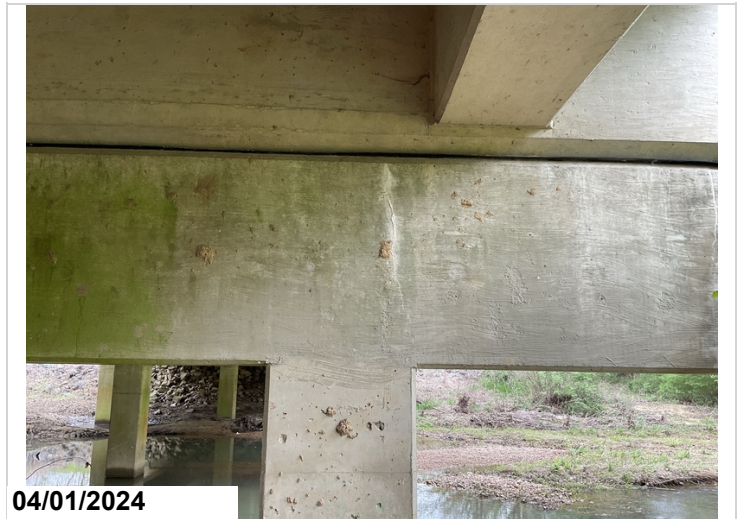
Bent 2, Looking ahead, Efflorescence to right side of cap above column 3. CS2

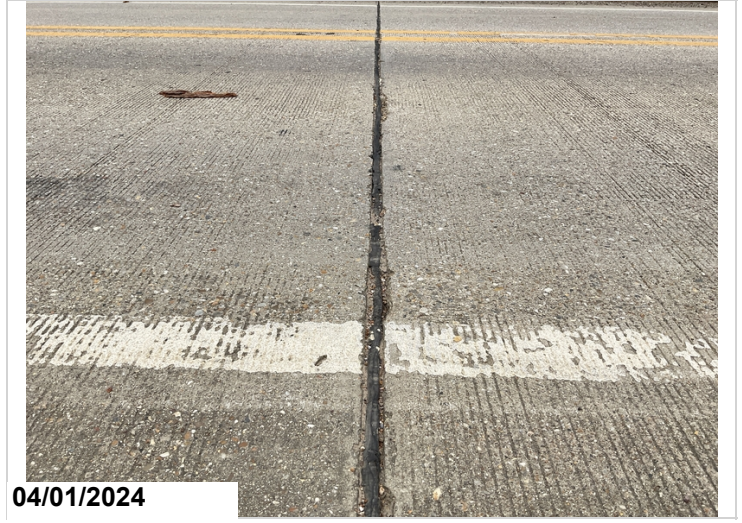
Bent 4, Loss of seal adhesion, Typical of bents 2, 3, and 4.
CS3

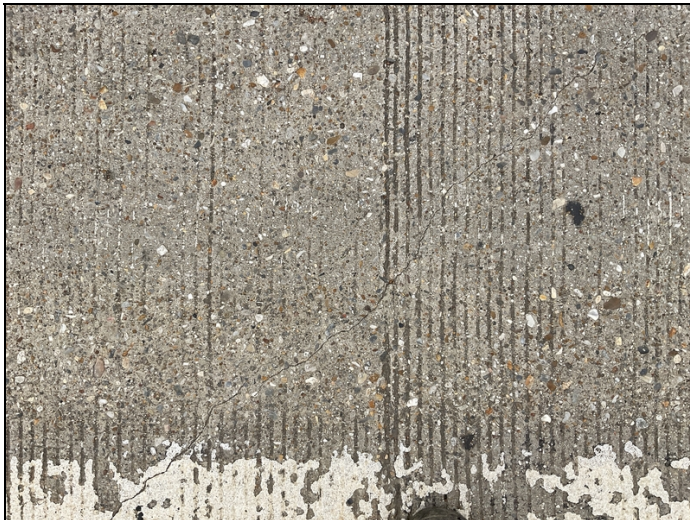
Sealable deck cracking is present in various locations throughout all spans.

Sealable deck cracking, Typical in various locations throughout all spans

A-54 - Sealable Deck Cracks (Yes)

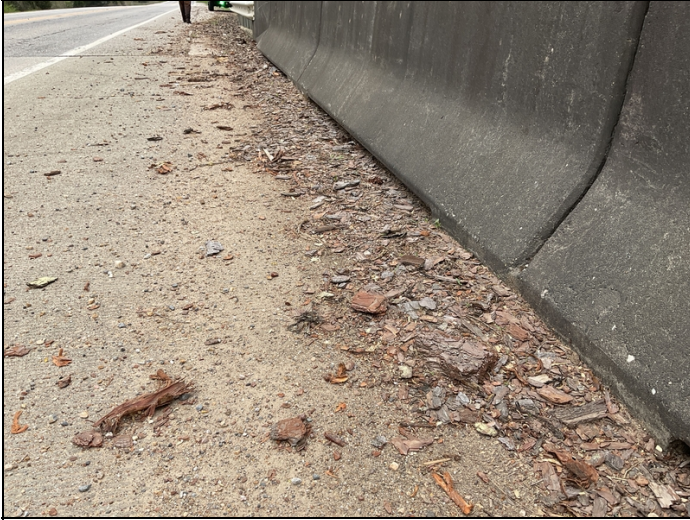
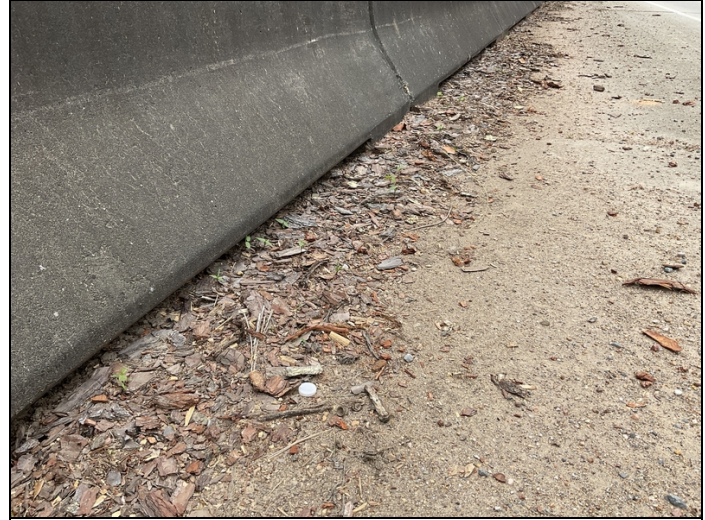
Deck washing is needed. Both the right and left gutter lines have debris that is blocking the deck drains.

Deck washing needed, Both right and left sides of bridge deck have debris blocking drains, Typical in all spans

A-55 - Deck Washing Needed (Yes)

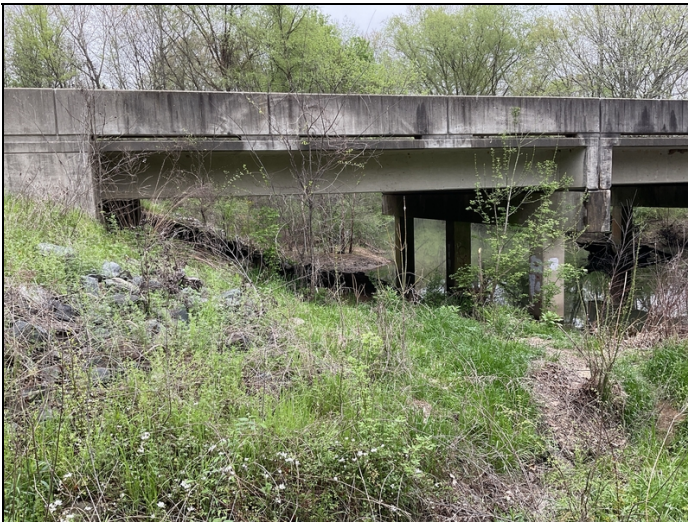
Trees and vegetation need removed at all four corners of the bridge.

Span 1, Right side, Trees and vegetation need removed

A-64 - Vegetation Removal Requested (Yes)
