Bridge 06414 Inspection Report

(4) Place Code	0
(6) Features Intersected	LITTLE HOLLY CREEK
(7) Facility Carried	US 278- 03 - 3.84
(9) Location	3.50 MI SE OF DIERKS
(11) Mile Point	3.84 mi

Team Lead: Roger Hawthorne, Inspection Date: 12/13/2022

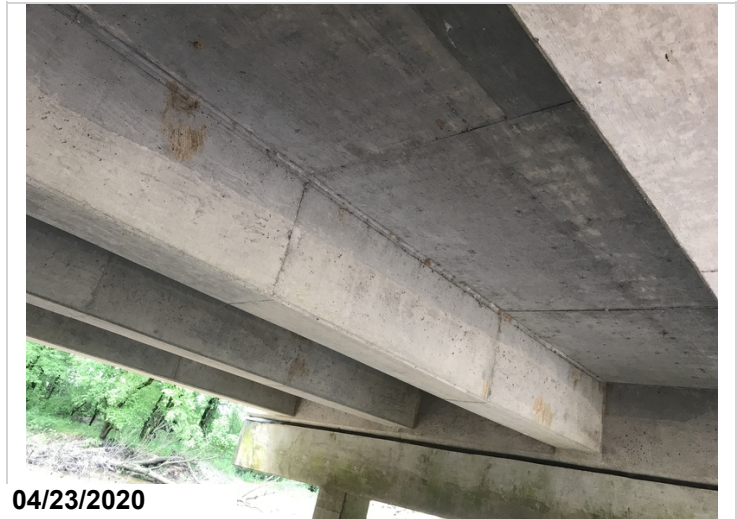
04/23/2020

Underside of deck typical all spans

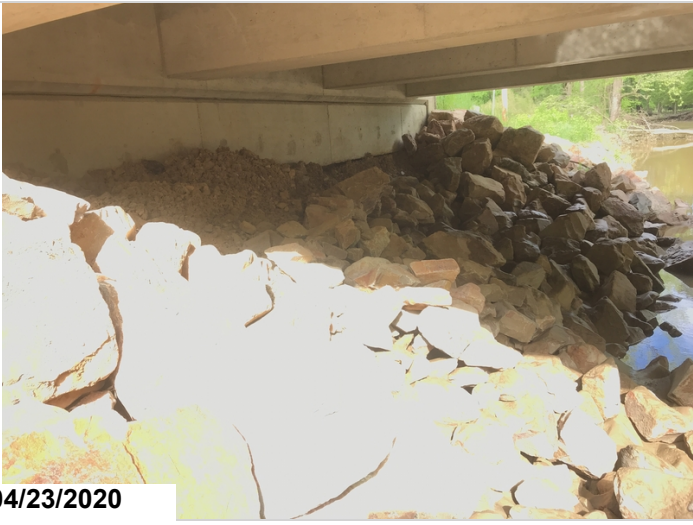
Bent 4 riprap starting to slide into channel, riprap was placed in 2019 from flooding.

Sand and cement mix in bags placed around abutment per Howard County Area Maintenance Supervisor Jim Bob Lamb

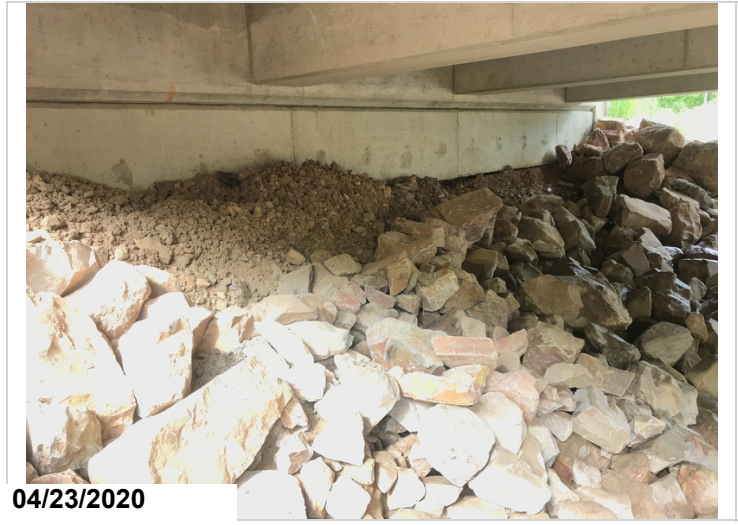
Bent 4 riprap starting to slide into channel, riprap was placed in 2019 from flooding.

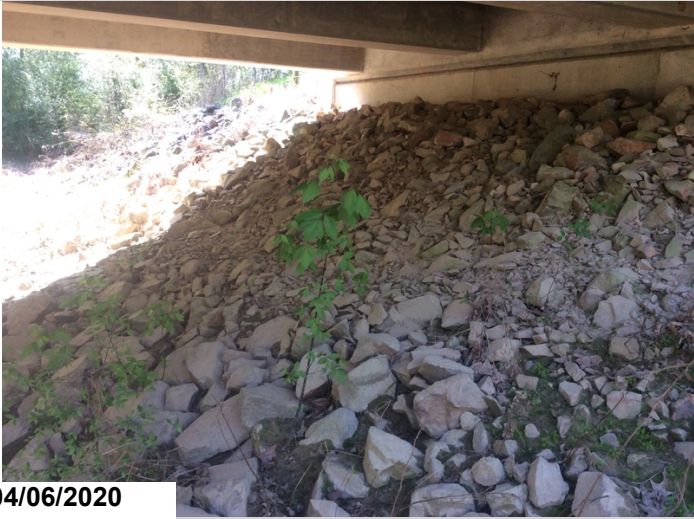
Slope protection at bent 2 end

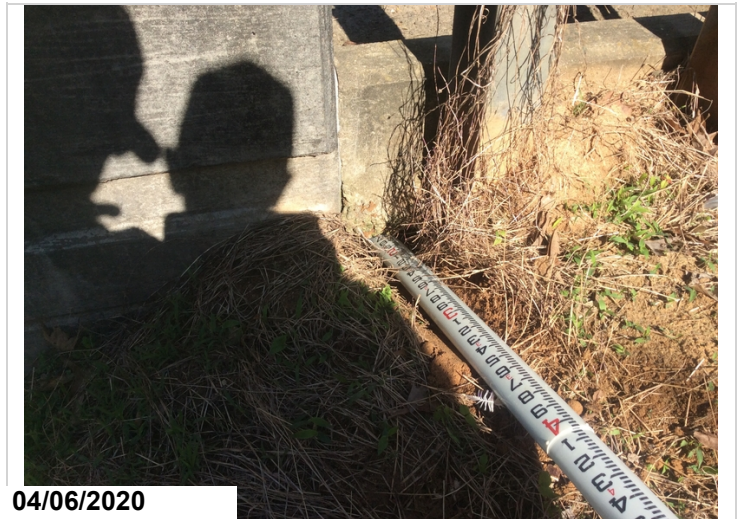
2 ft erosion left side behind back wall beginning of bridge

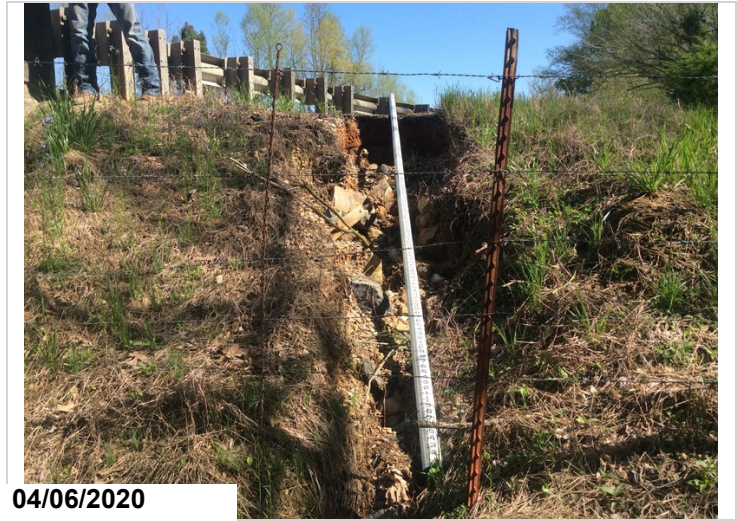
EROSION BEGINNING OF BRIDGE LEFT SIDE. 13 ft.

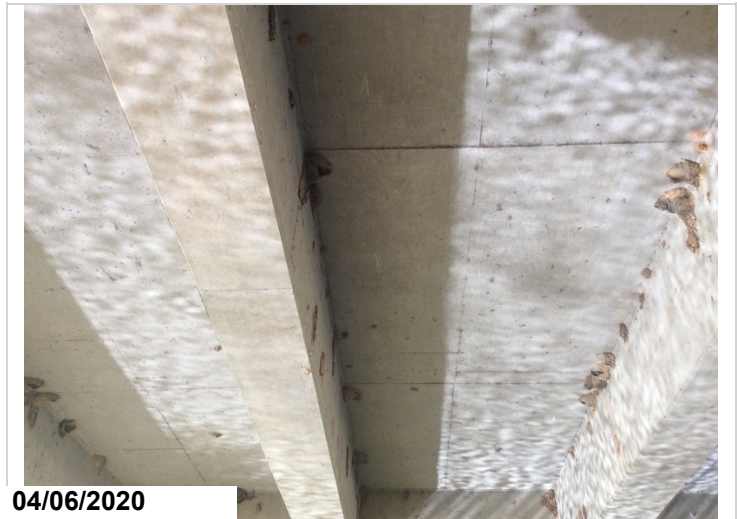
BOTTOM OF DECK TYPICAL ALL SPANS

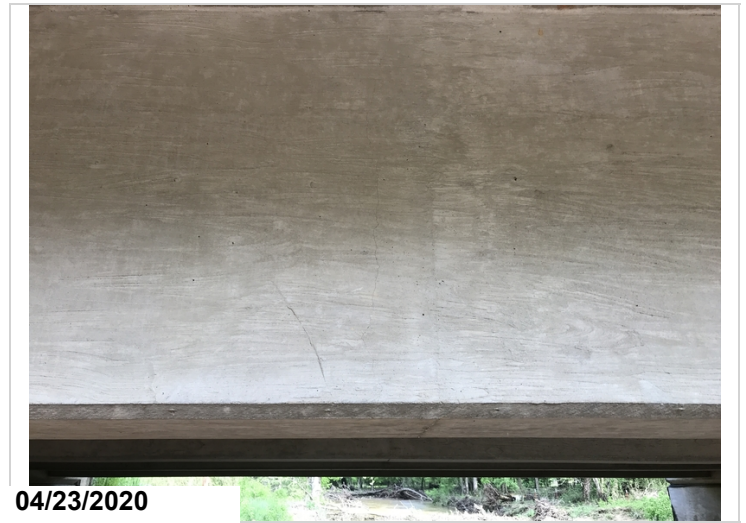
Hairline cracks

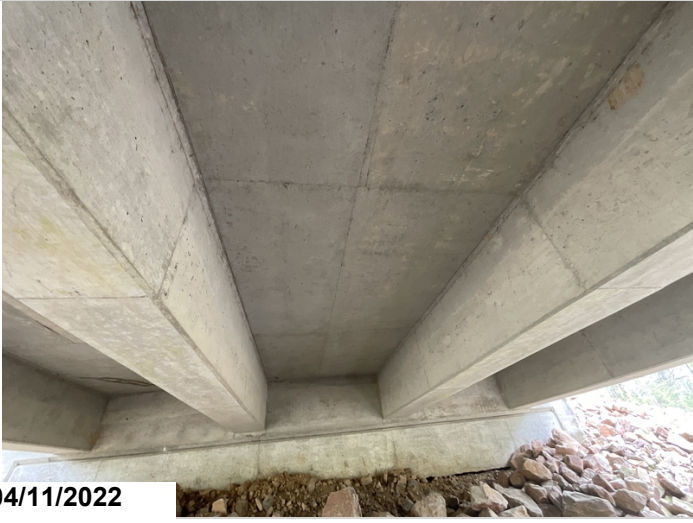
04/22 typical bottom of deck

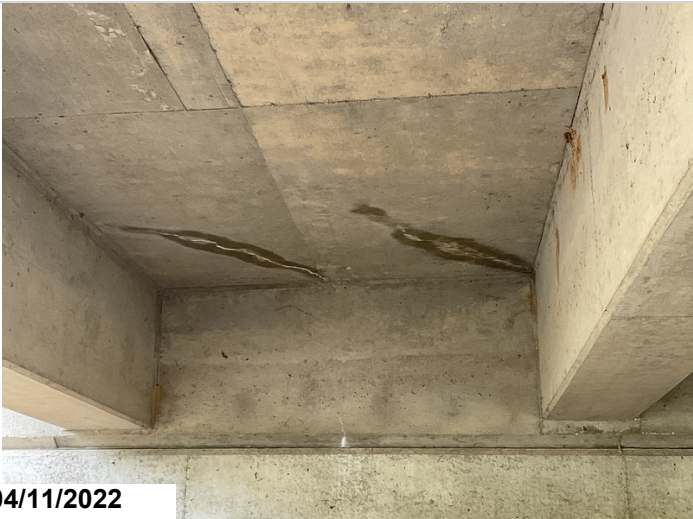
Joints: Seal Adhesion bad typ. All joints. Underside of Deck: Efflorescence bottom side deck at abutment. Wearing Surface: Small deck cracks....

04/22 efflorescence photo

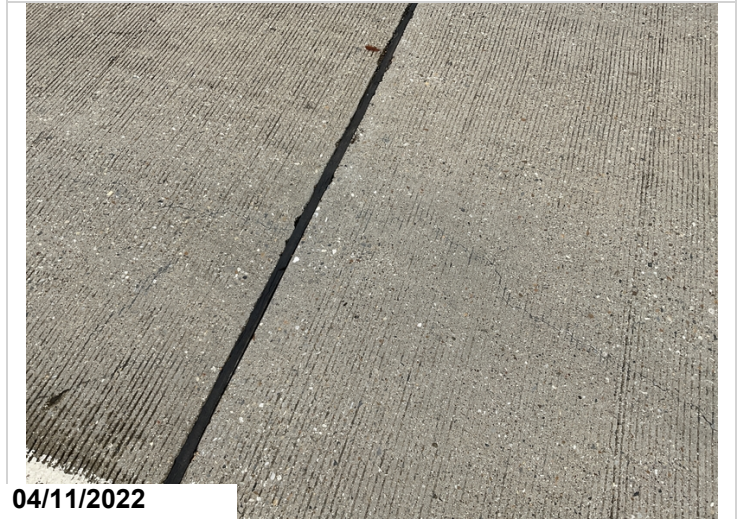
04/22 cracking in top of deck
