## Bridge 06415 Inspection Report

Asset #06415(POA Scour Assessment Evaluation)

US 278- 03- 6.63 over MESSER CREEK

Team Lead: Anahi Mendez Inspection Date: 01/06/2025

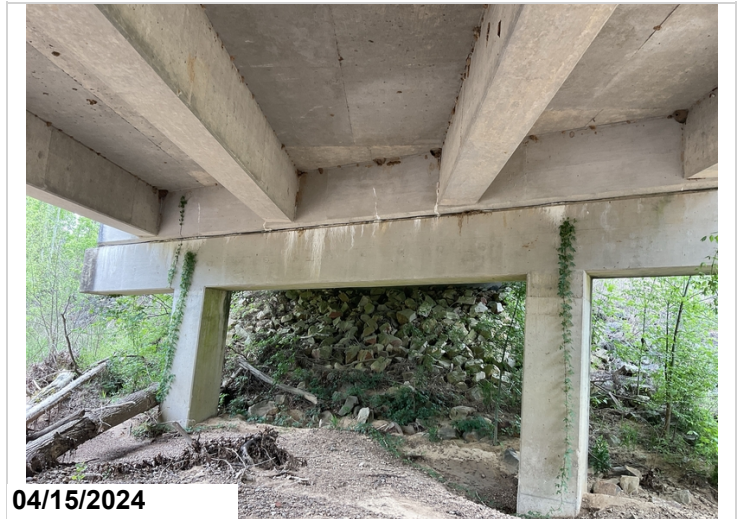
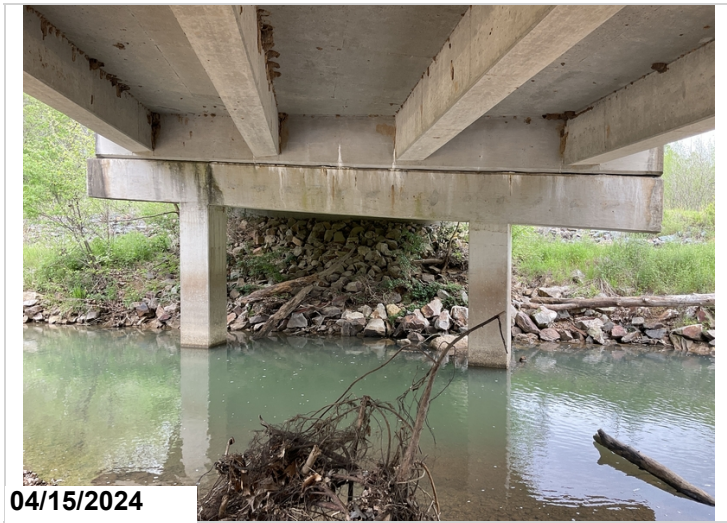
Superstructure rating is a 7 this inspection due to minor defects to the concrete tee beams. The concrete diaphragms above all end bents and intermediate bents have cracking with efflorescence throughout various locations.

Cracking with efflorescence to concrete diaphragm at all bents

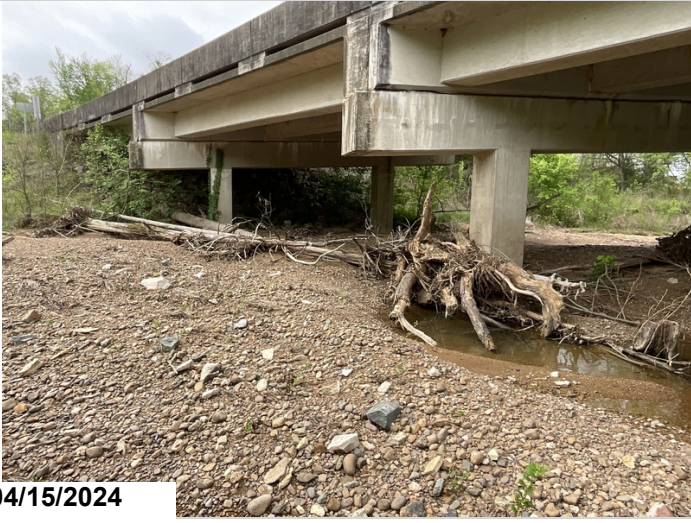
Log jam is located on the upstream side of intermediate bents 2 & 3.

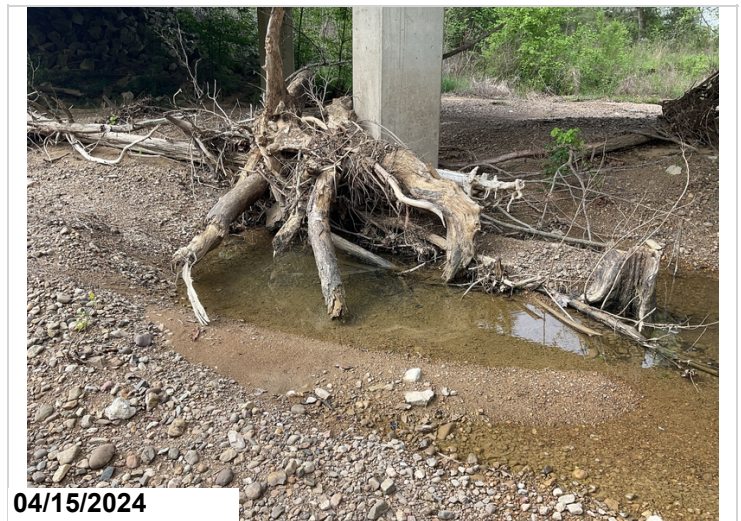
Scour rating is a 6 this inspection due to isolated moderate scour being found around intermediate bents 2 and 3.

Bent 3, Column 1 scour from log jam.

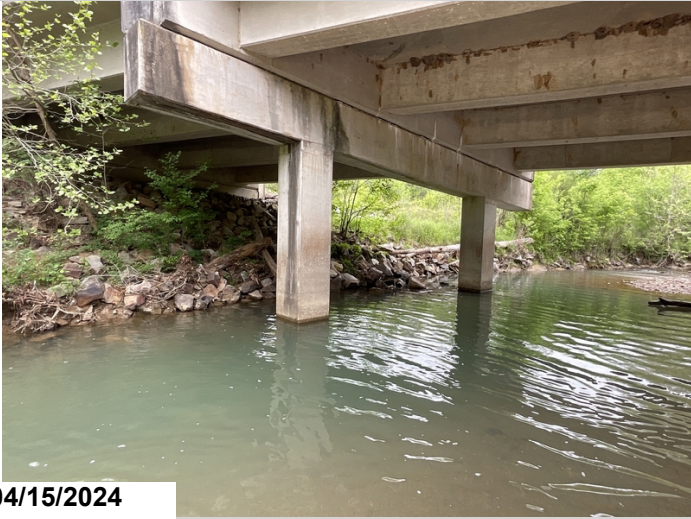
**61 - Channel/Channel Protection** (6 - Bank is beginning to slump. River control devices and embankment protection have widespread minor damage. There is minor stream bed movement evident. Debris is restricting the channel slightly.)  
Channel rating is a 6 this inspection due to evident streambank movement as well as a large log jam that is restricting the channel flow at intermediate bents 2 & 3. Soundings taken this inspection and linked to asset and report files. Channel profile of bent 2 RT side is showing that the top of the footing is now exposed.

Scour assessment is being requested do to recent findings during the latest channel profile is showing the top of the footing at bent 2 RT side is now exposed.

Bent 2 scour.

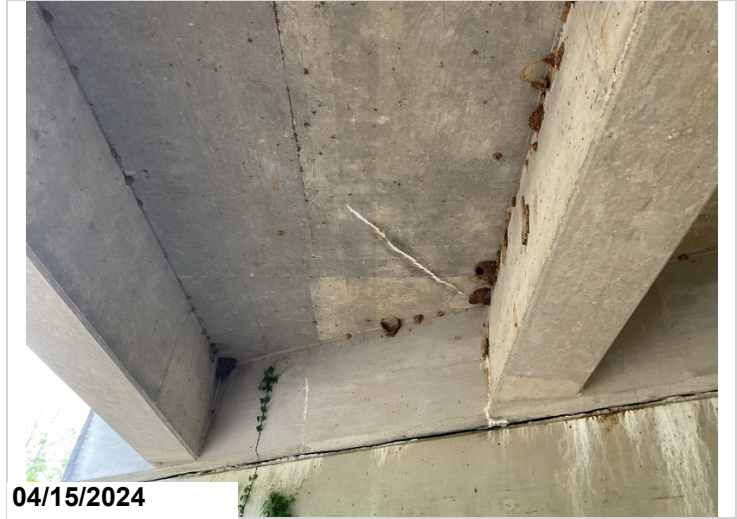
Deck rating is a 6 this inspection due to deck cracking throughout all spans. The undersurface of the concrete bridge deck has various locations of cracking with efflorescence throughout all spans.

Span 3, Bay 1, cracking with efflorescence to undersurface, CS2.

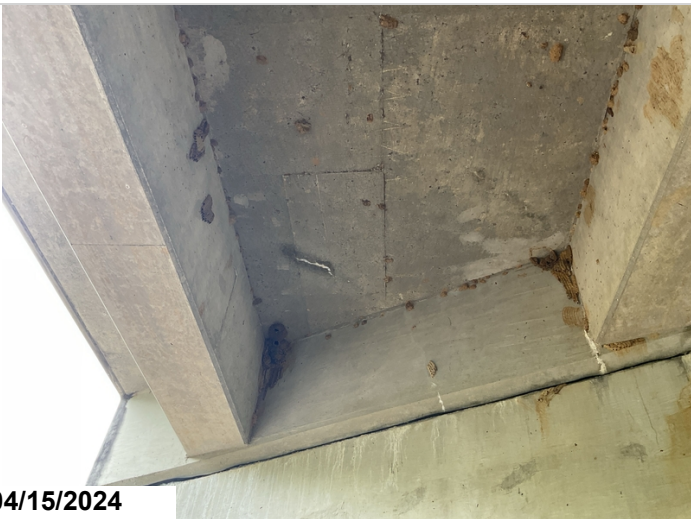
Span 2, Bay 1, cracking with efflorescence to undersurface, CS2.

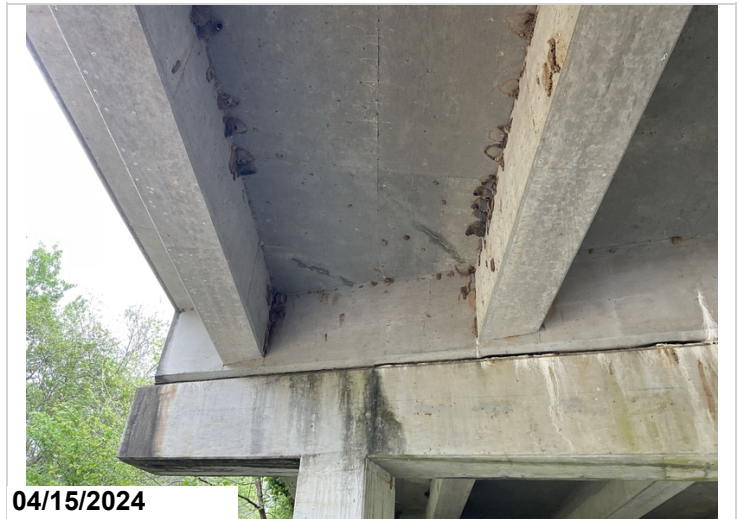
Span 2, Bay 3, cracking with efflorescence to undersurface, CS2.

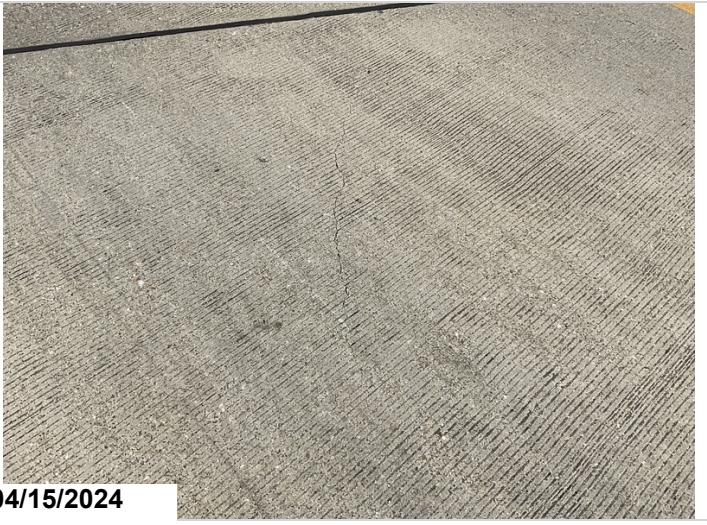
(16) Deck cracking is found in various locations throughout all spans, CS2. Cracking with efflorescence is located throughout all spans on the undersurface and overhangs of the concrete bridge deck, CS2.							
110	Reinforced Concrete Open Girder/Beam	LF	560	560	0	0	0
205	Reinforced Concrete Column	EA	6	6	0	0	0
215	Reinforced Concrete Abutment	LF	135	135	0	0	0
234	Reinforced Concrete Pier Cap	LF	205	204	1	0	0
1080	Delamination/Spall/Patched Area	LF	1	0	1	0	0

Span 3, Right side, Deck cracking, CS2.

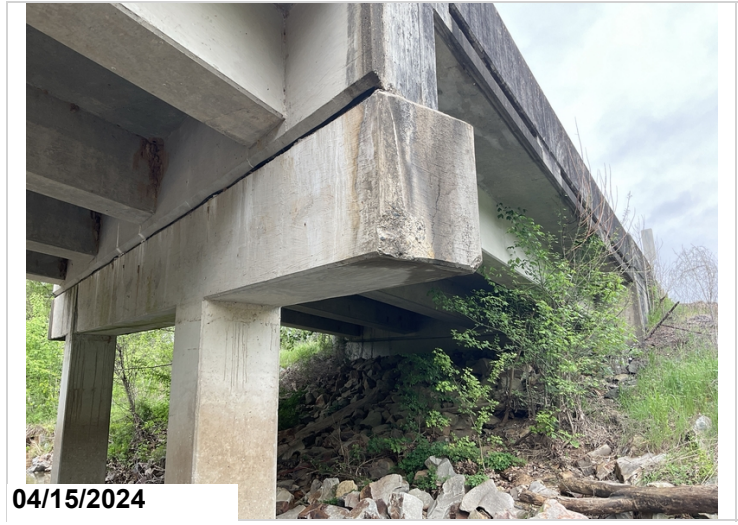
Substructure rating is a 7 this inspection due to a minor spall that is located to the left side of the bent 2 concrete cap.

(234) Bent 2, Looking back, Spalling to left side of cap, CS2							
301	Pourable Joint Seal	LF	160	90	50	20	0
2320	Seal Adhesion	LF	70	0	50	20	0
(301) Bent 2, Left side, Loss of seal adhesion, CS3. Bent 3, Right side, Loss of seal adhesion, CS2.							
331	Reinforced Concrete Bridge Railing	LF	280	280	0	0	0

Bent 2, Looking back, Spalling to left side of cap, CS2

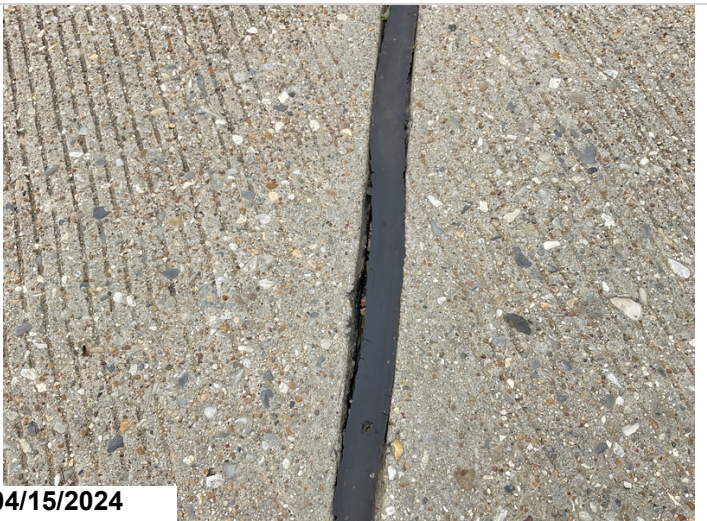
Bent 2, Left side, Loss of seal adhesion, CS3

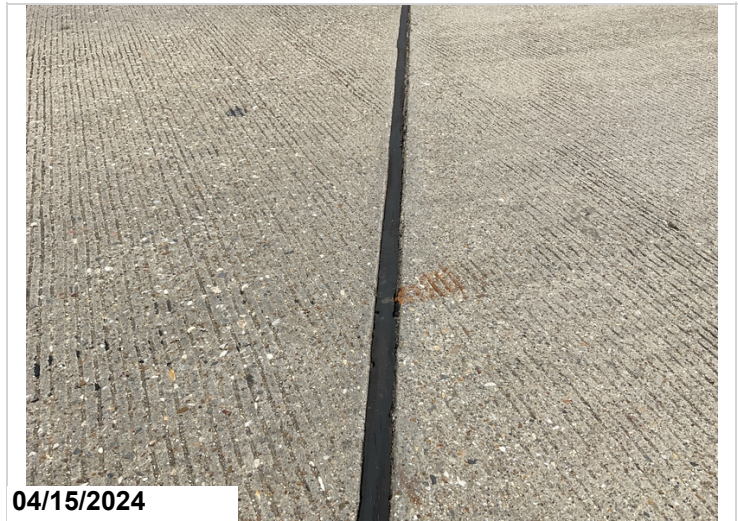
Bent 2, Left side, Loss of seal adhesion, CS2

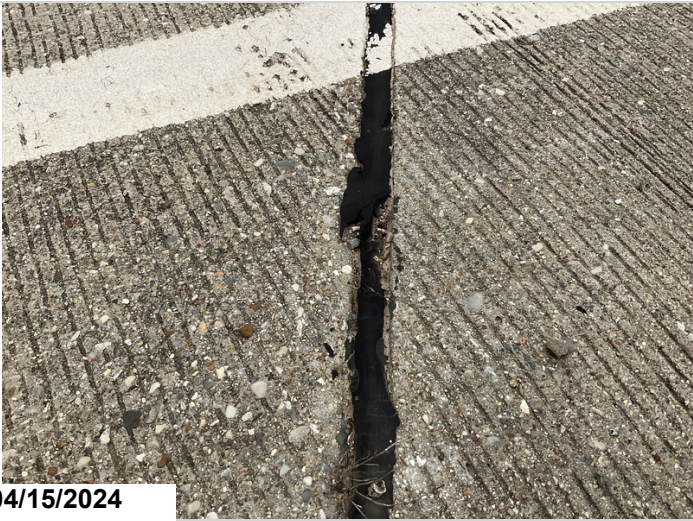
Bent 3, Right side, Loss of seal adhesion, CS2

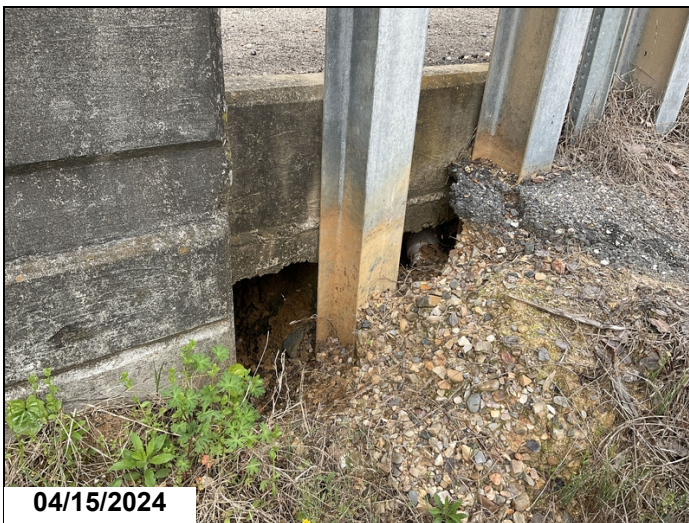
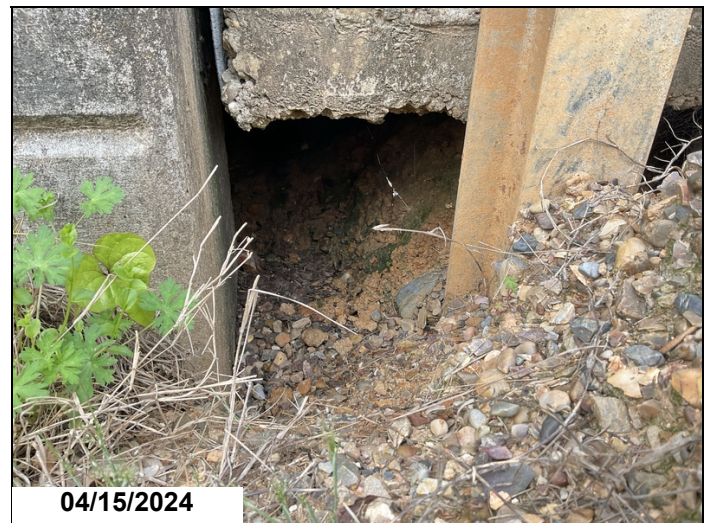
04/15/2024

Erosion under LT shoulder at Bent 1 bridge end, approx. 3 ft wide X 1 ft deep

04/11/2022 - Erosion is still under LT shoulder at bent 1 bridge end, reopened maintenance need.

2024. Updated photo of the erosion under the left side of the beginning of bridge.

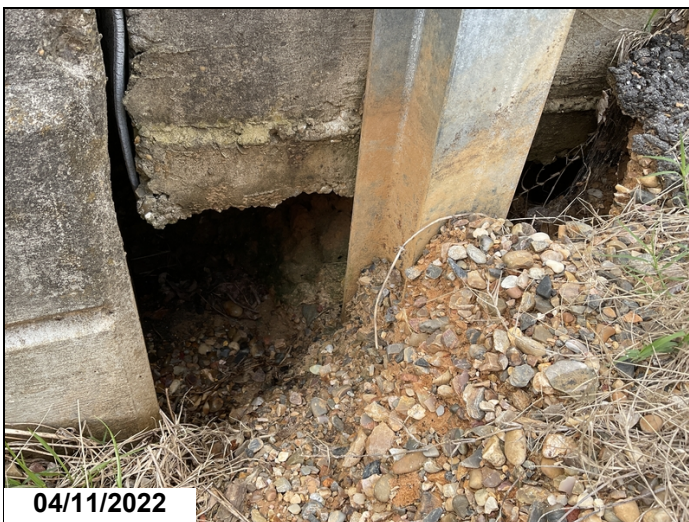
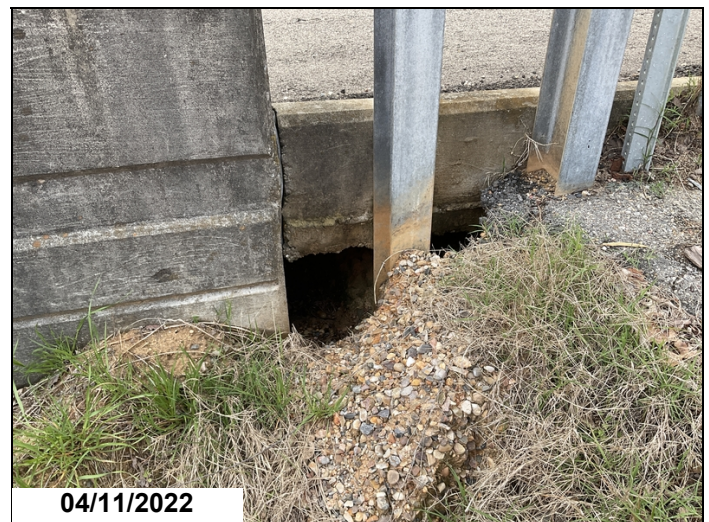
04/11/2022

04/2022... erosion LT side bent 1

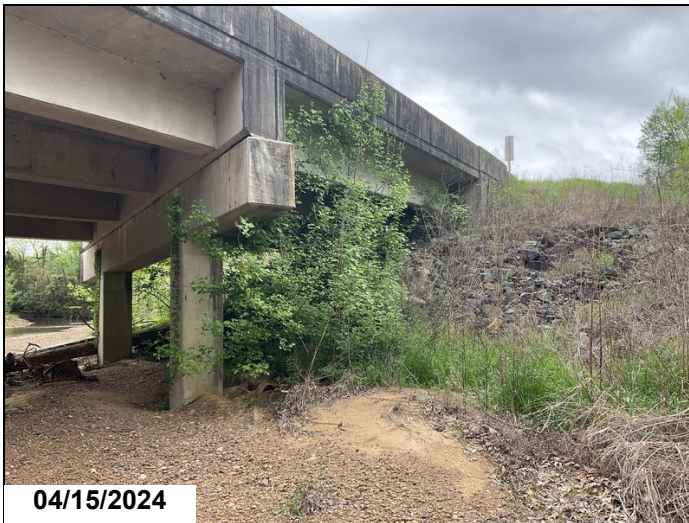
Trees and vegetation are growing over the bridge railing in various locations of bridge.

End of bridge, Right side, Trees and vegetation growing over bridge railing.

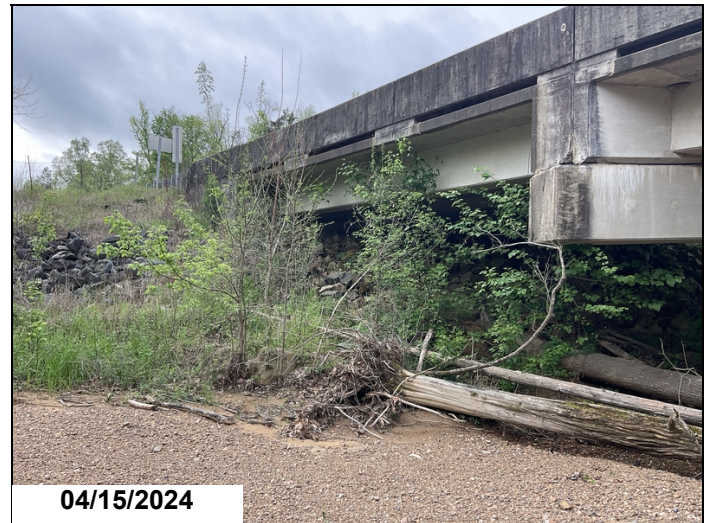
End of bridge, Left side, Trees and vegetation growing over bridge railing.

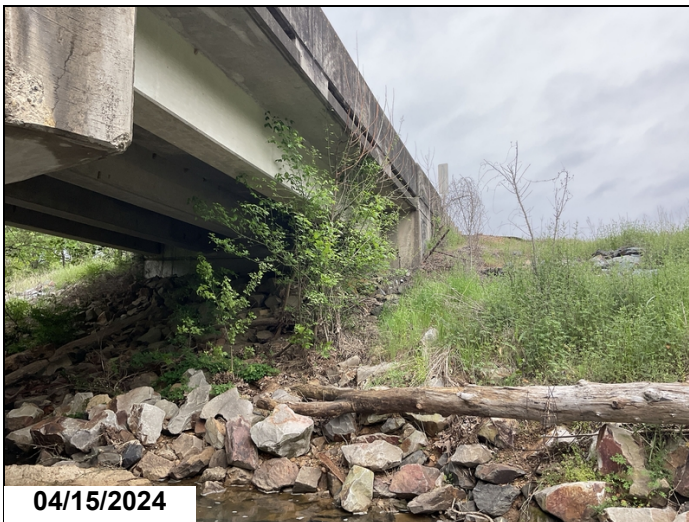
Beginning of bridge, Left side, Trees and vegetation growing over bridge railing.

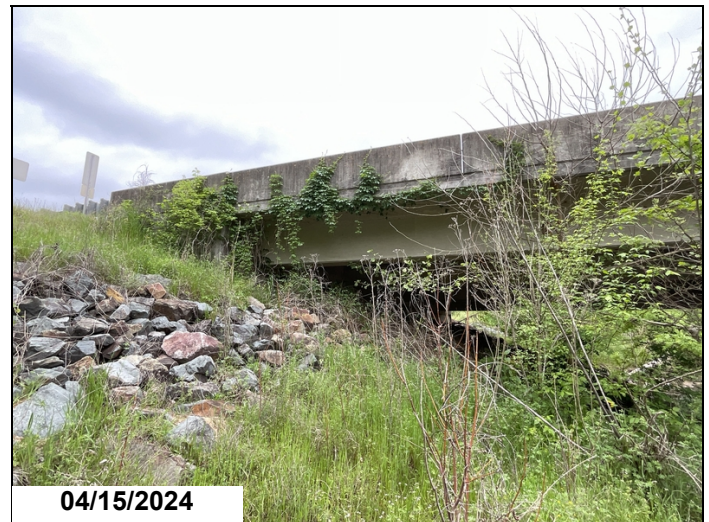
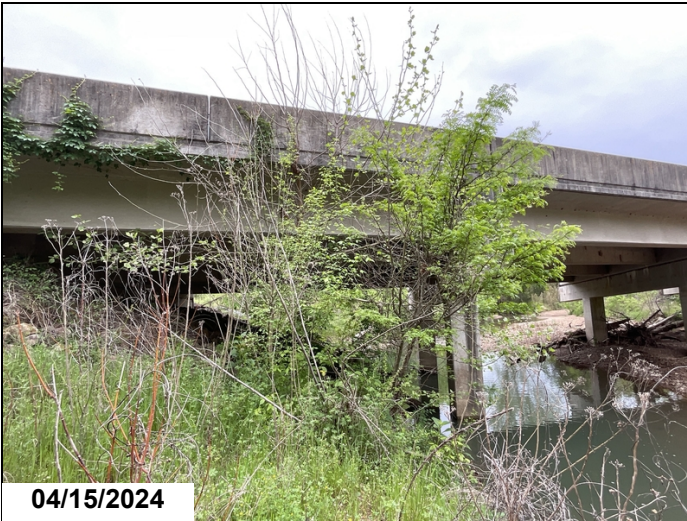
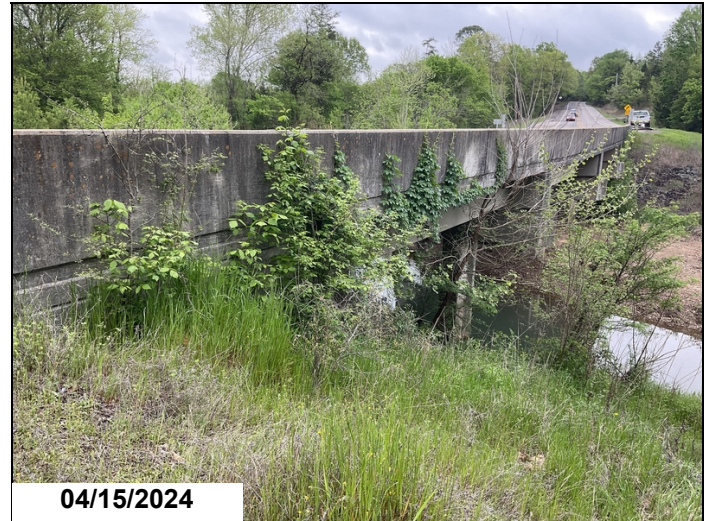
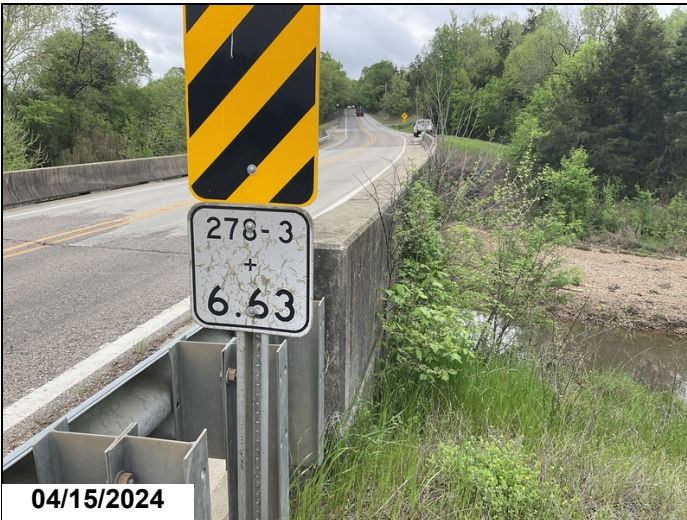
Beginning of bridge, Right side, Trees and vegetation growing over bridge railing.

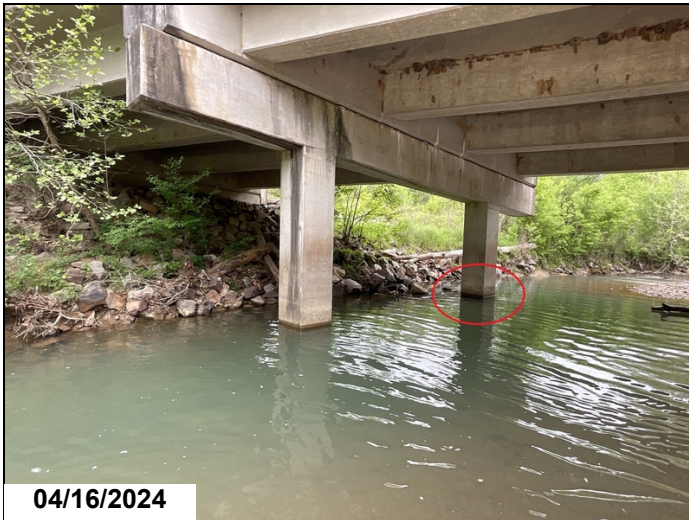
Channel profile of bent 2 RT side is showing that the top of the footing is now exposed and within 1'-10" of undermining, footing is 2'-6" thick.

Scour area around bent 3, column 1.

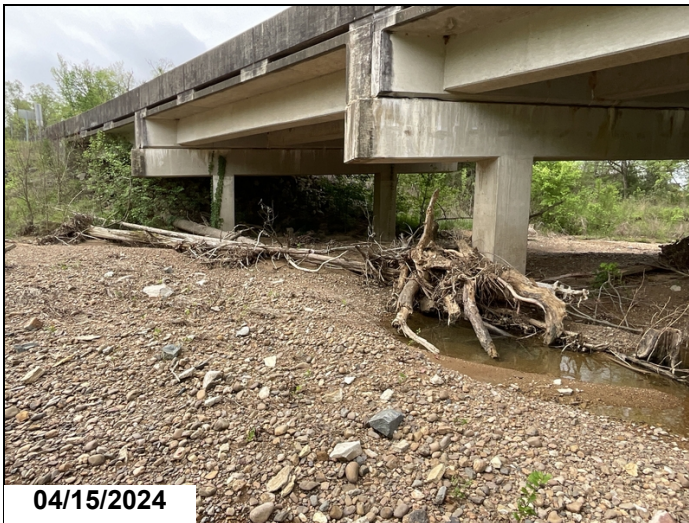
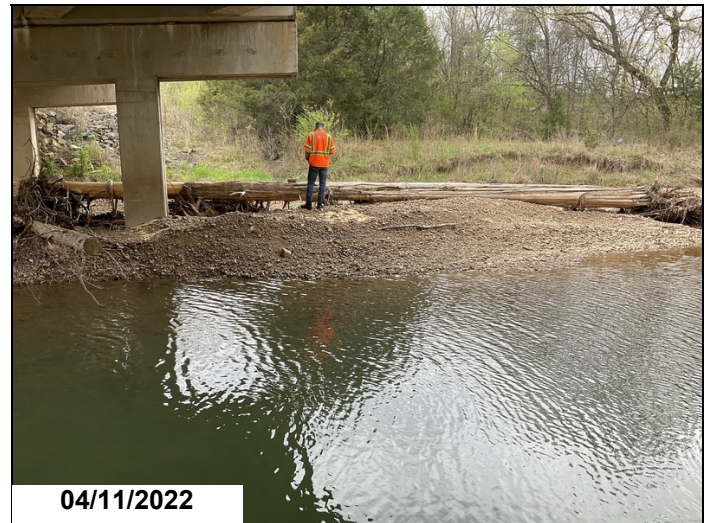
Large tree at Bent 2 needs removed from channel.

4/15/2024. Updated photo of log jam
