Bridge 06930 Inspection Report

HWY 32 - 02- 16.79 over HWY 71 & U.P. R/R

Location: 16.80 MI. E. OF 32&41 INT

Team Lead: Jonathan Gonzalez Inspection Date: 09/05/2025

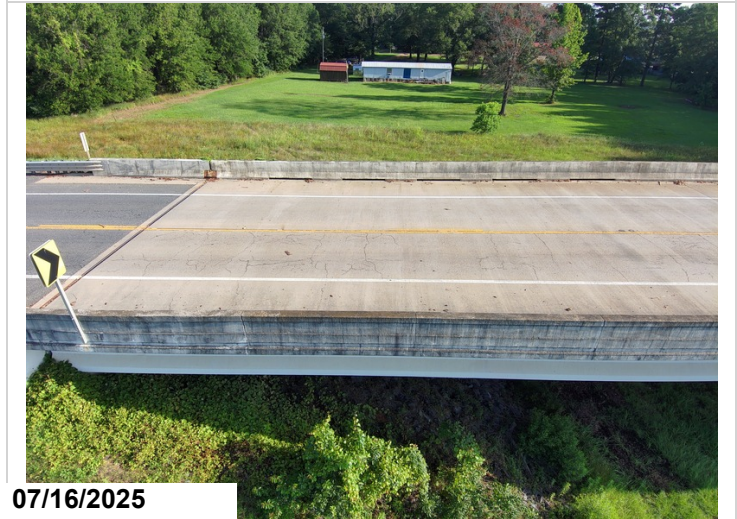
Cracks along the topside of the deck have been sealed.

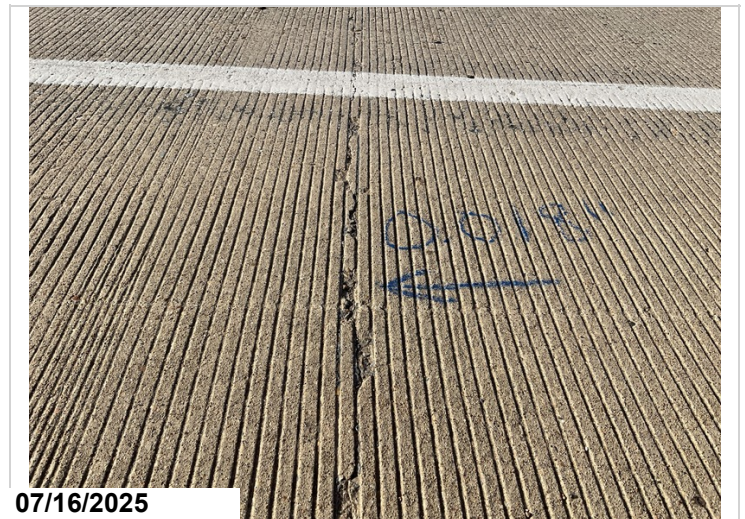
The approach spans and main spans have cracking in various locations throughout the topside of the deck.

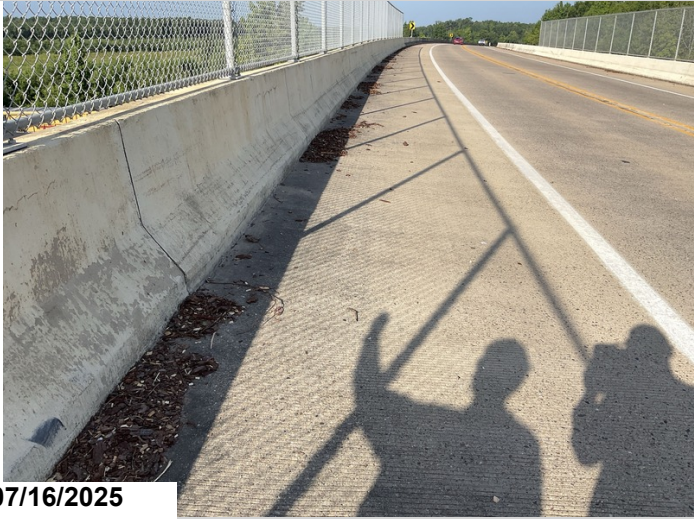
The left and right sides of the gutter lines have debris buildup. Note: The debris buildup is tree bark due to excessive amounts of large trucks.

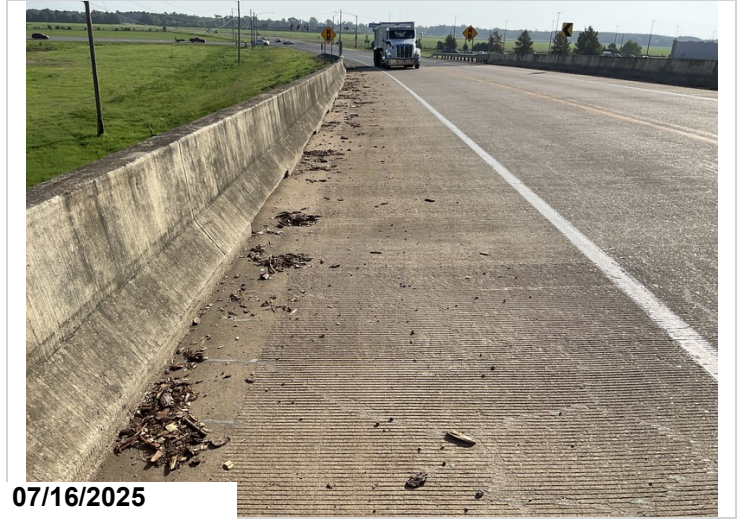
The left and right sides of the gutter lines have debris buildup. Note: The debris buildup is tree bark due to excessive amounts of large trucks.

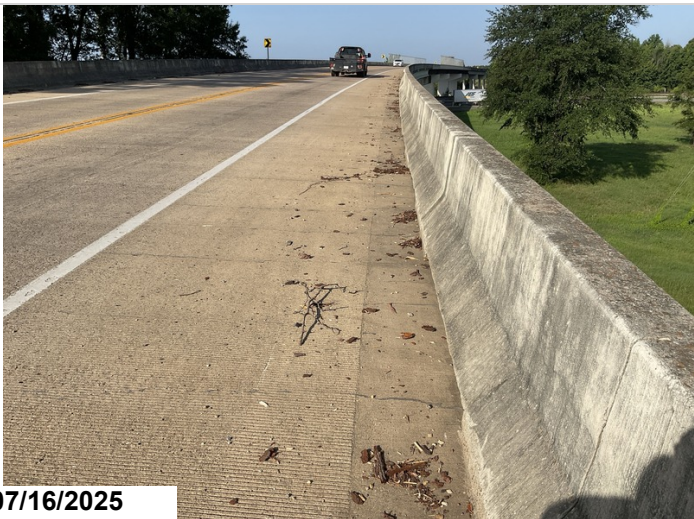
The left and right sides of the gutter lines have debris buildup. Note: The debris buildup is tree bark due to excessive amounts of large trucks.

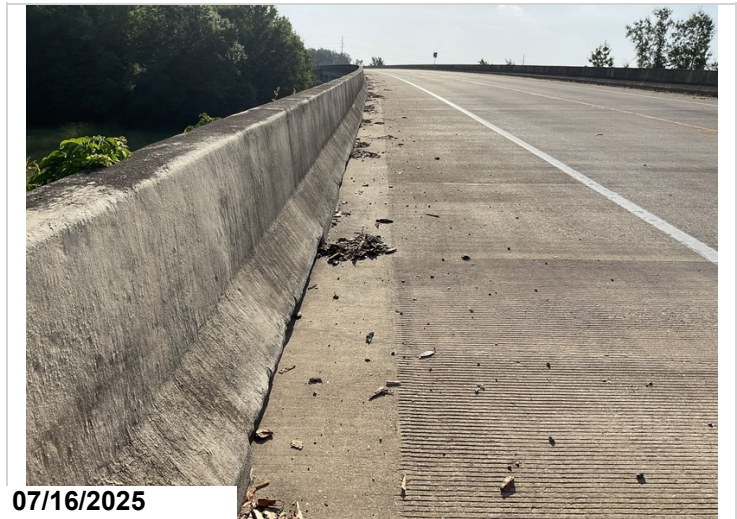
The left and right sides of the gutter lines have debris buildup. Note: The debris buildup is tree bark due to excessive amounts of large trucks.

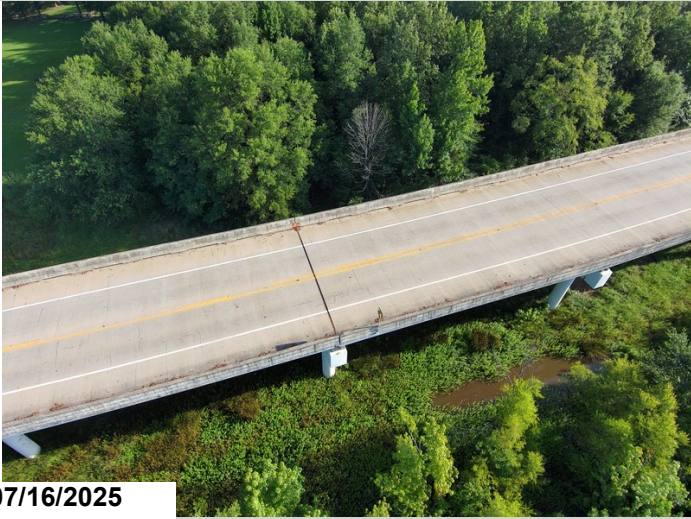
The topside of the deck has cracking in various locations.

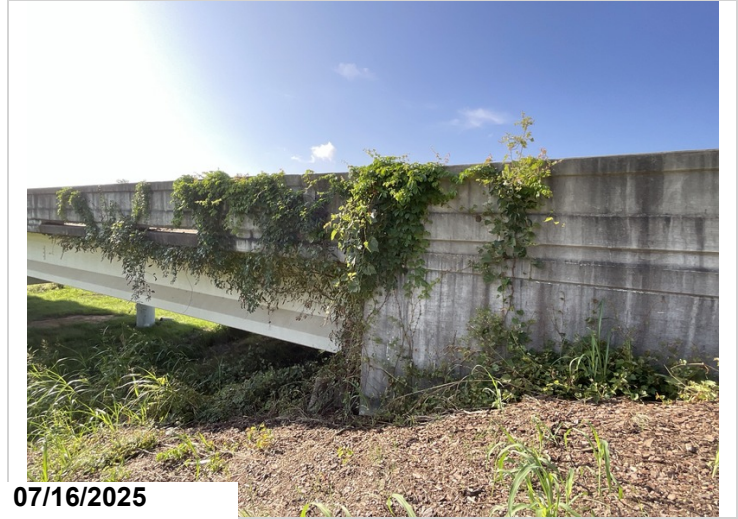
There is an excessive amount of vine growth on the left and right sides of the bridge.

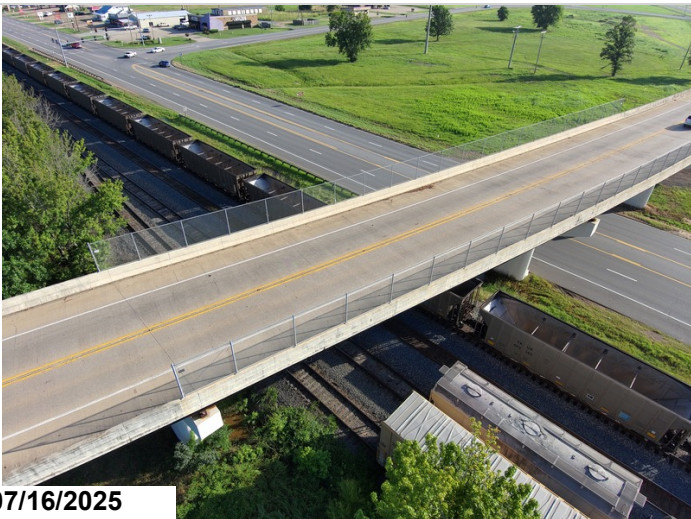
The fence is screwed onto the parapet wall in the main spans over the track.

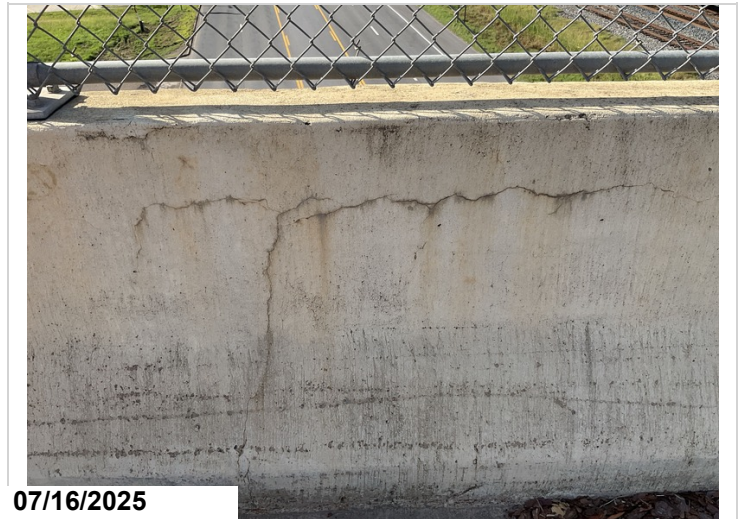
The bridge railing is rated a 6 this inspection due to minor cracking in various locations throughout the left and right side bridge railing.

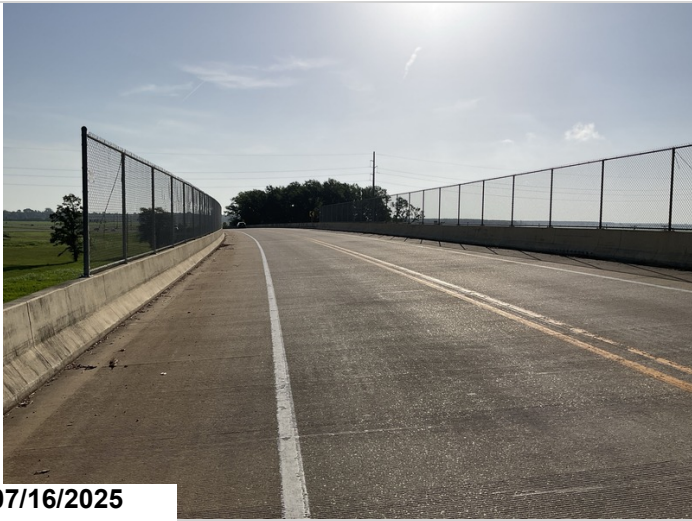
Fence is mounted to parapet wall.

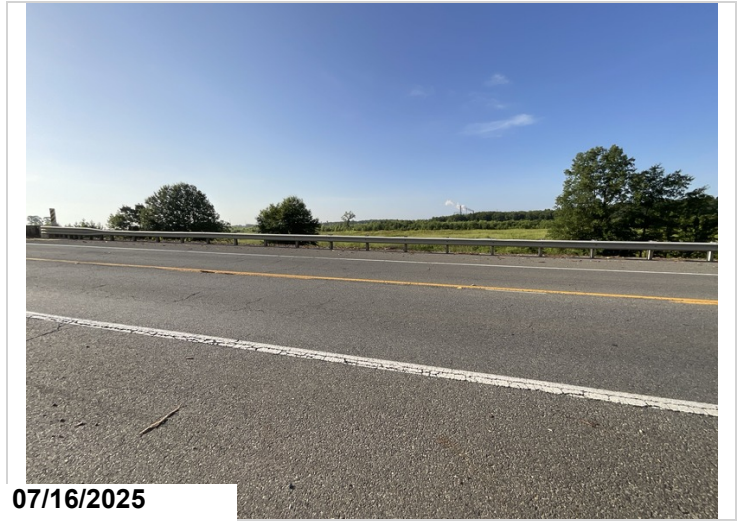
The bridge railing transition is rated a 6 this inspection due to minor damage in various locations.

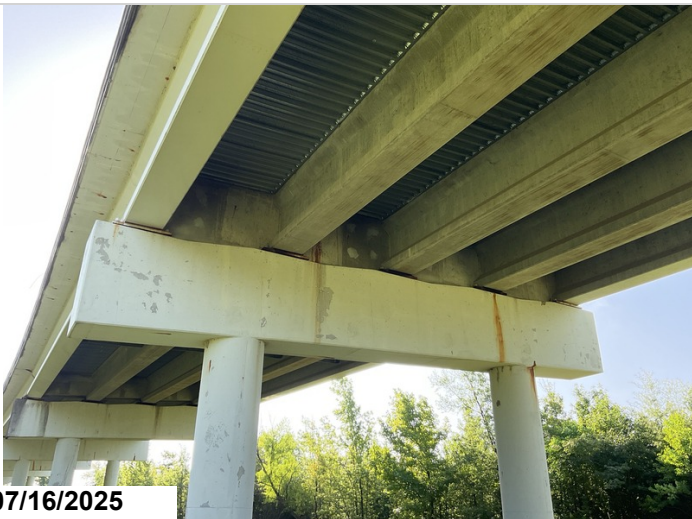
The bridge bearings are rated a 6 this inspection due to various bearings starting to rust.

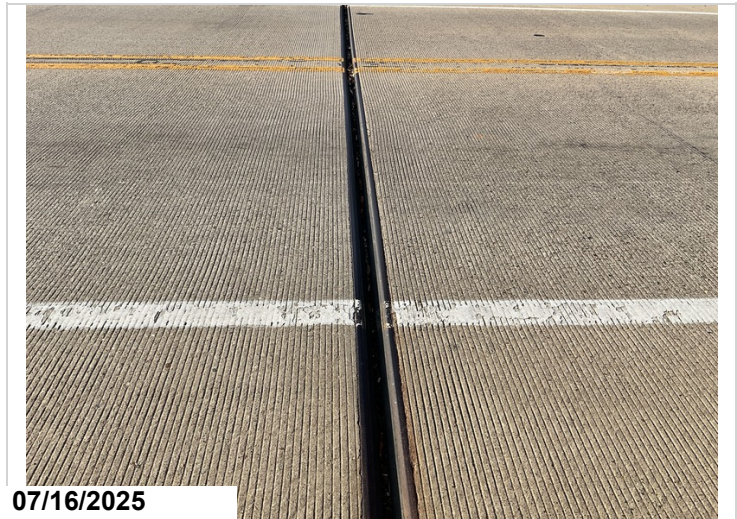
The bridge joints are rated a 6 this inspection due to there being debris impaction in various locations.

The bridge joints are rated a 6 this inspection due to there being debris impact in various locations.

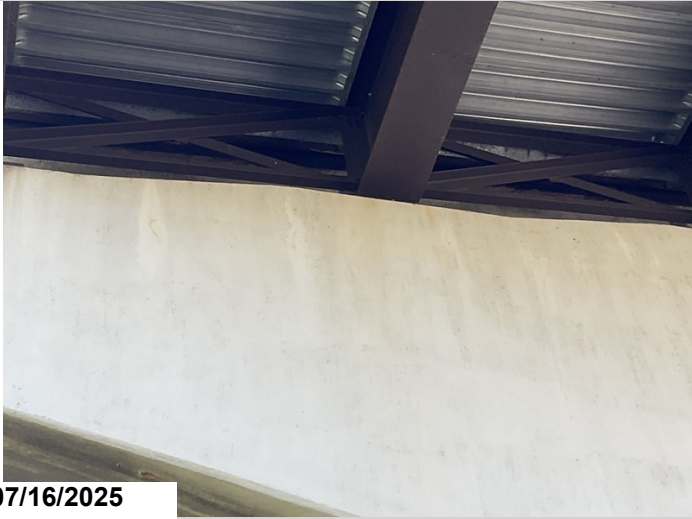
Cracking in the concrete piers in various locations, CS2.

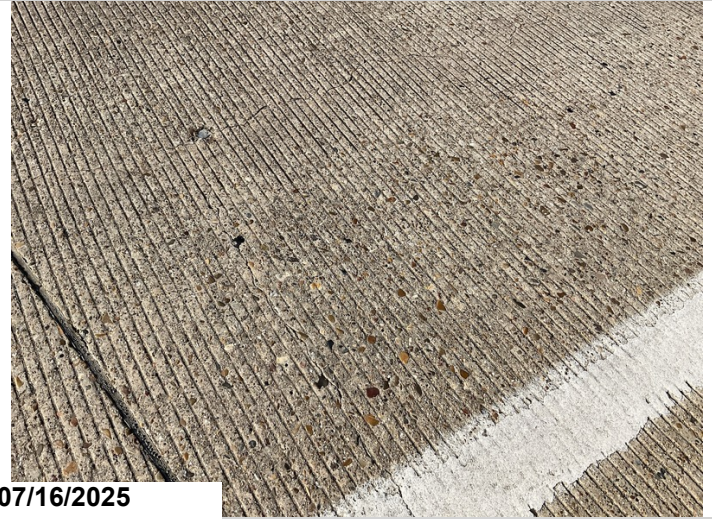
There is minor cracking throughout the main spans in various locations, .020", CS2.

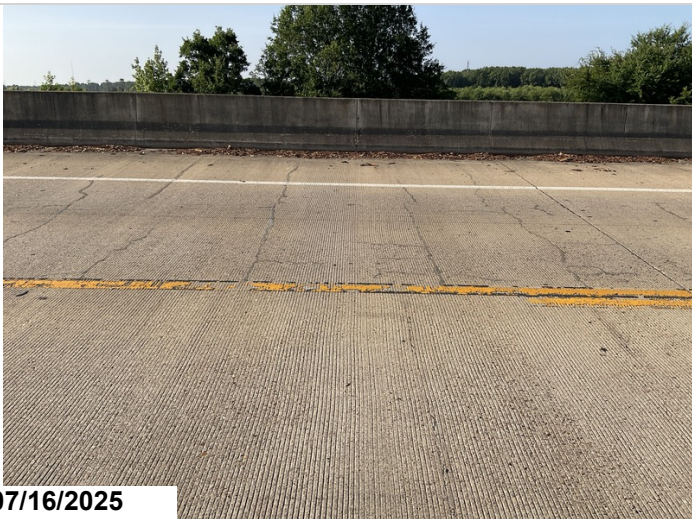
Various cracks along the main spans and approach spans have been sealed.

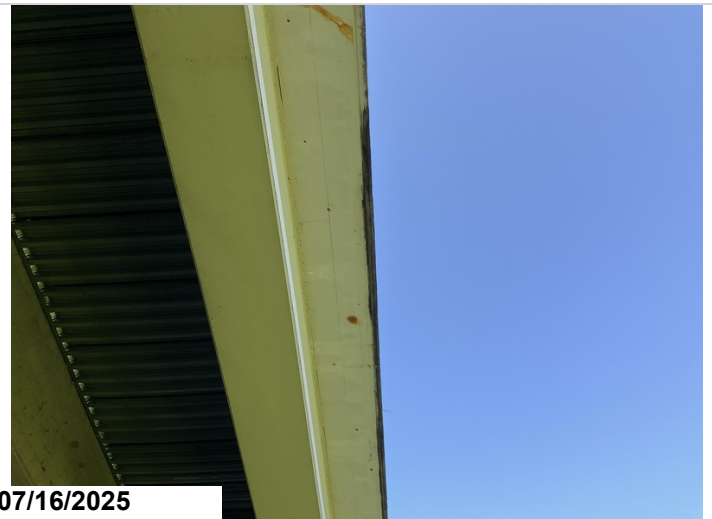
The left and right side concrete overhangs have cracking with efflorescence in various locations, CS2.

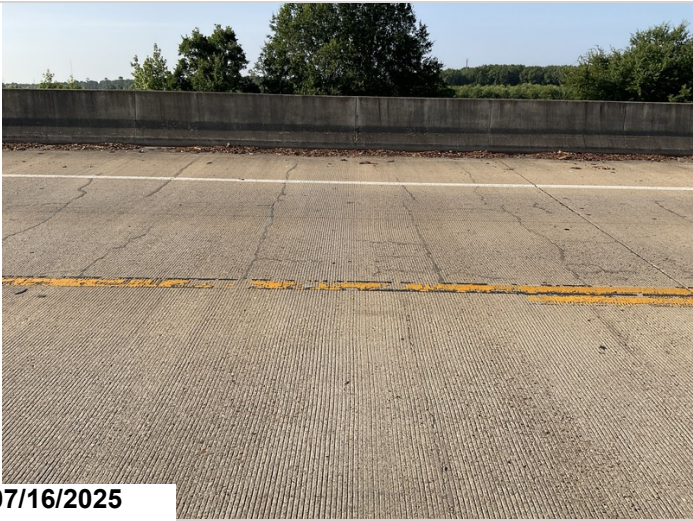
Various cracks along the main spans and approach spans have been sealed.

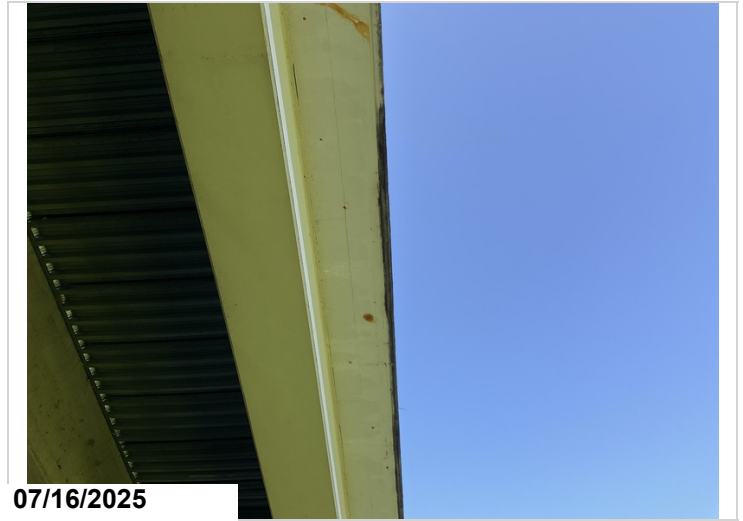
The left and right side concrete overhangs have cracking with efflorescence in various locations, CS2.

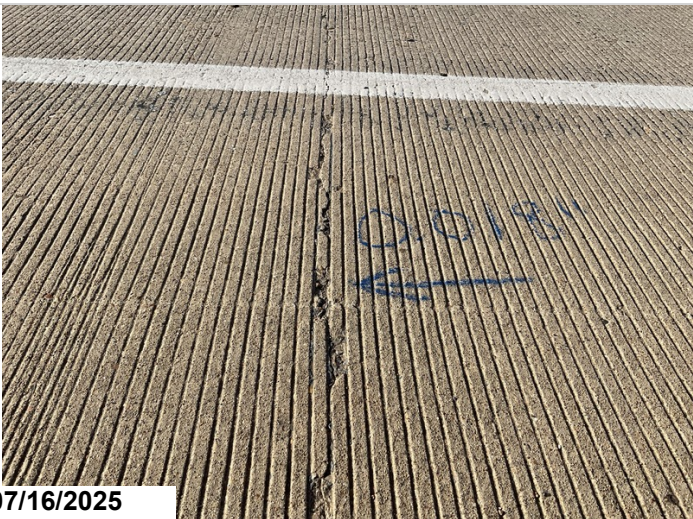
The approach slab has of cracking in various locations, CS2.

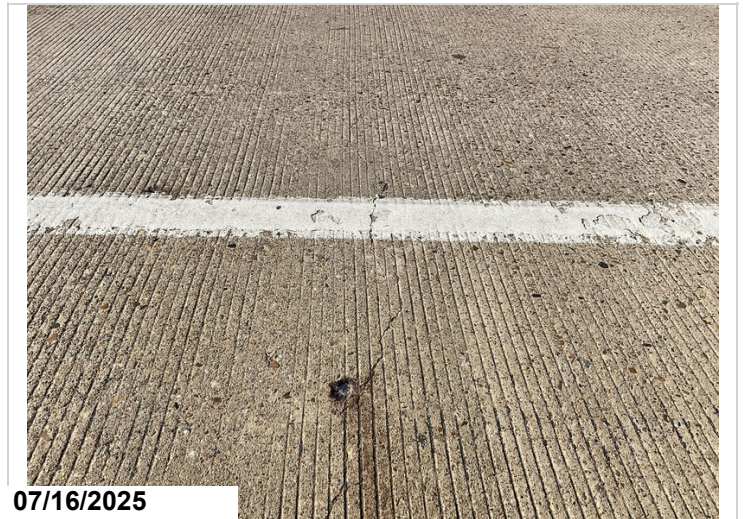
The approach slab has of cracking in various locations, CS2.

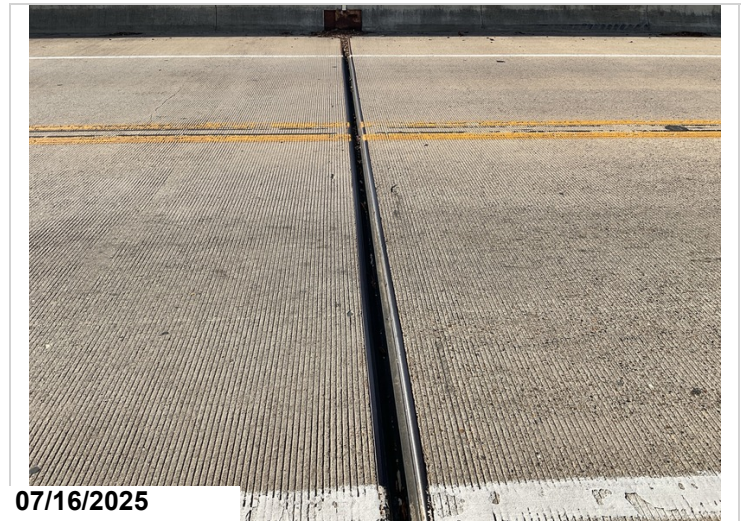
Bent 13 joints, main span, 30' of debris impaction, CS2.

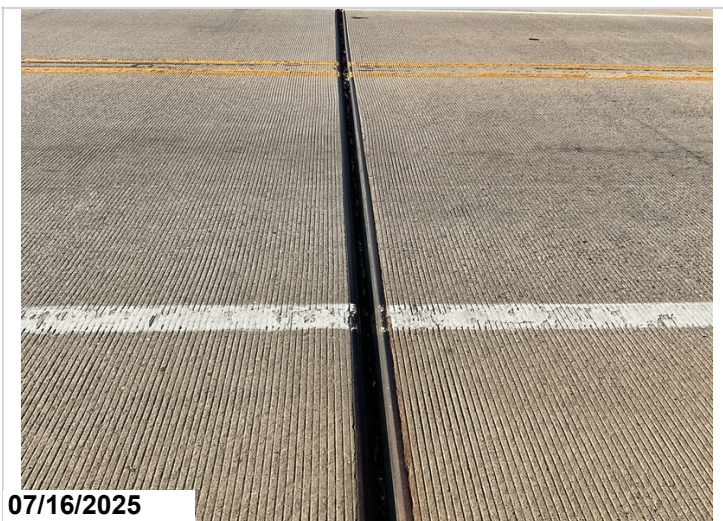
Bent 9 joint, main span, 30' of debris impaction, CS2.

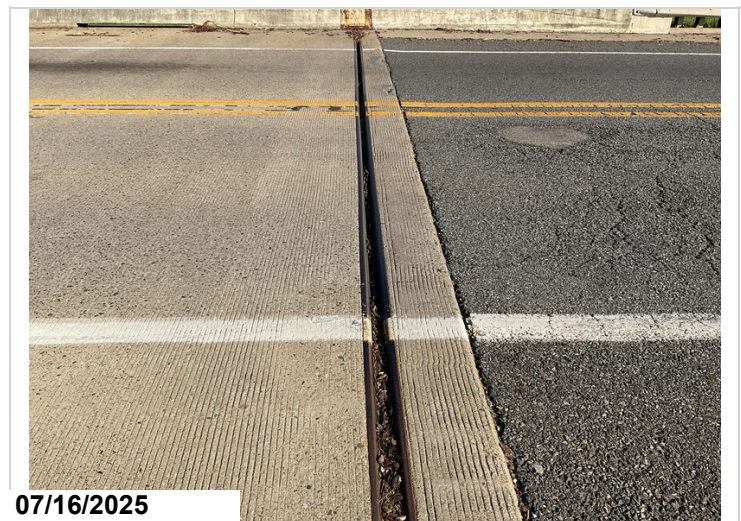
Bent 21 joint, approach span, debris impaction, CS2.

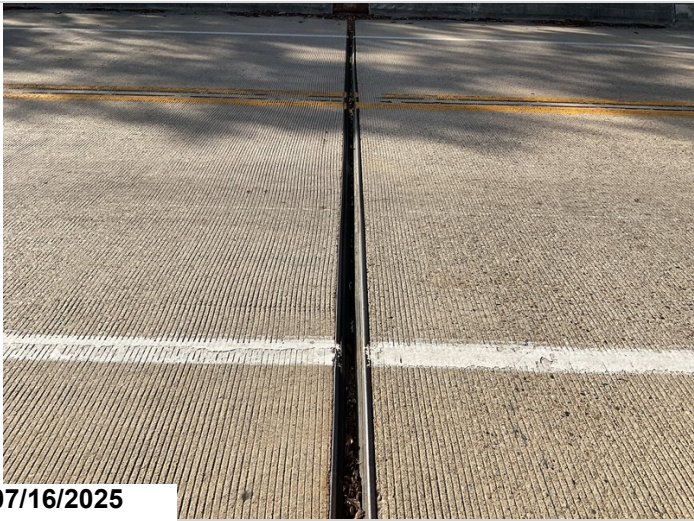
Bent 17 joint, approach span, debris impactation, CS2.

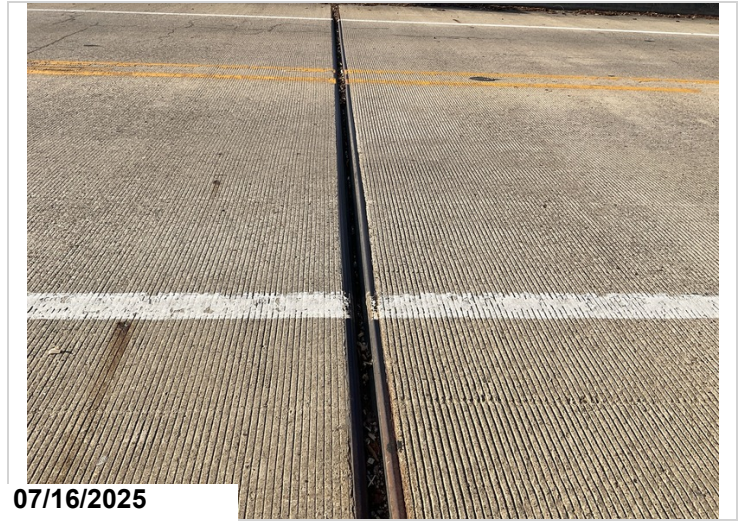
Bent 5 joint, approach slab, debris impactation, CS2.

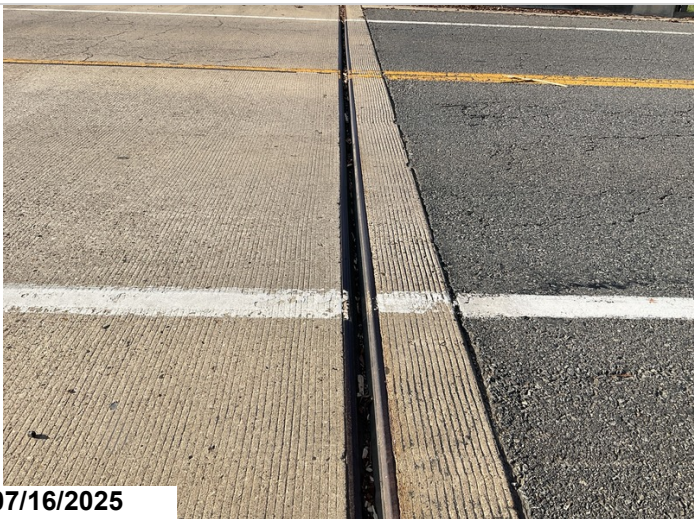
Bent 1 approach joint, debris impactation, CS2.

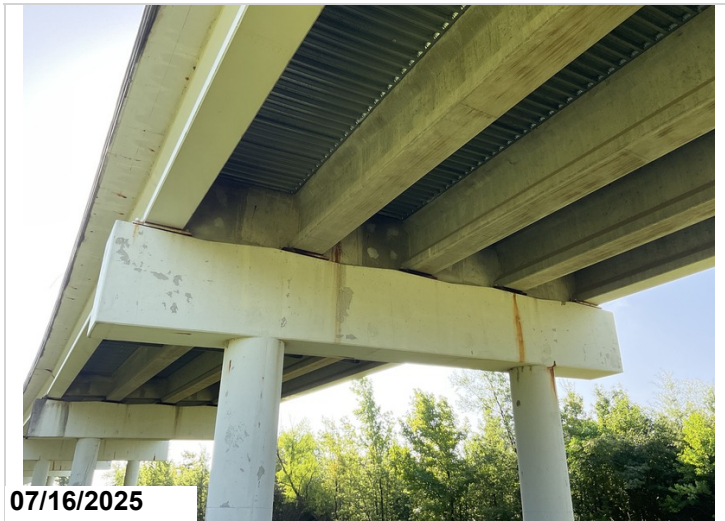
Various bearings are starting to rust, CS2.

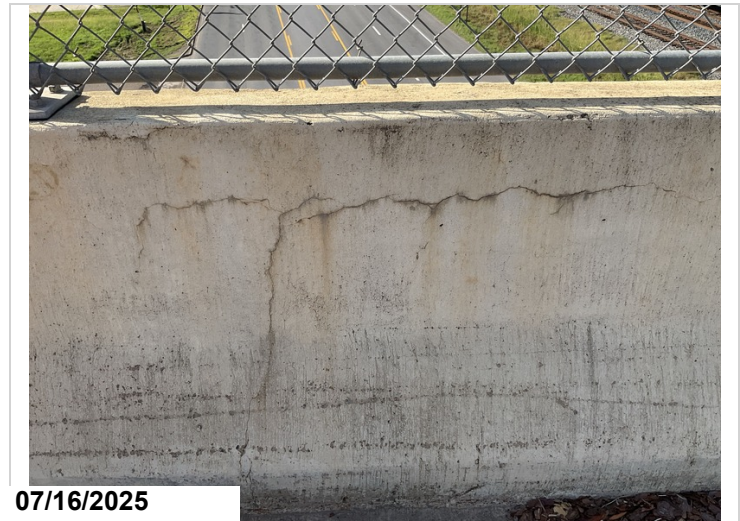
Concrete bridge railing, left and right sides, main spans, cracking in various locations, CS2.

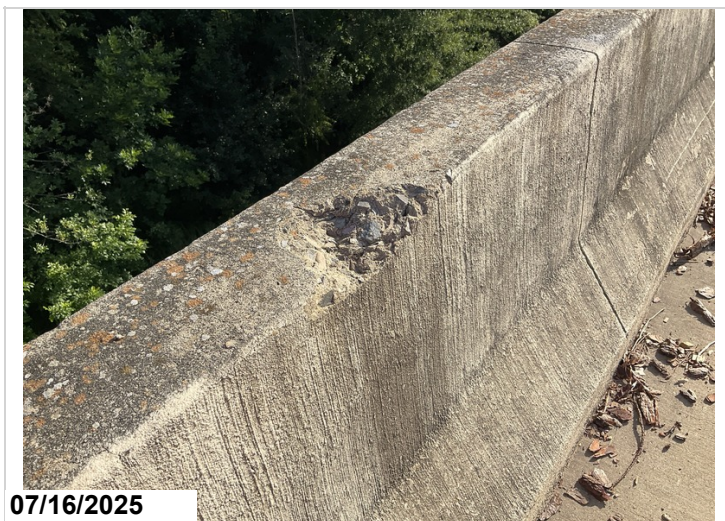
Left side, bridge railing, 1' of spalling, CS2.

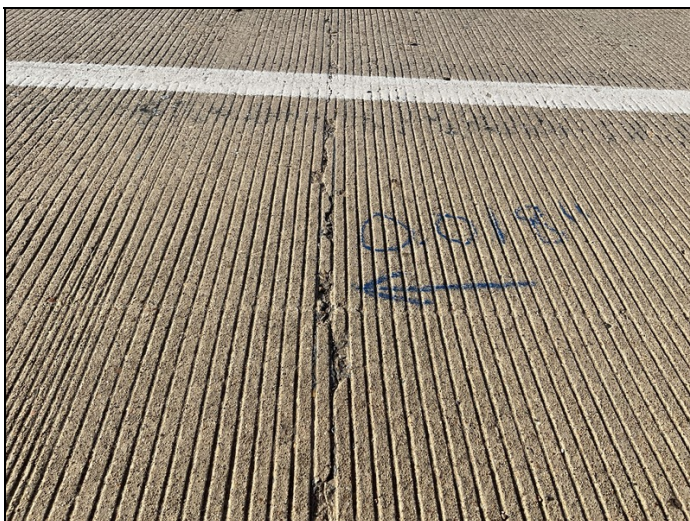
A-54 - Sealable Deck Cracks (Yes)

The approach spans and main spans have cracking in various locations throughout the topside of the deck.

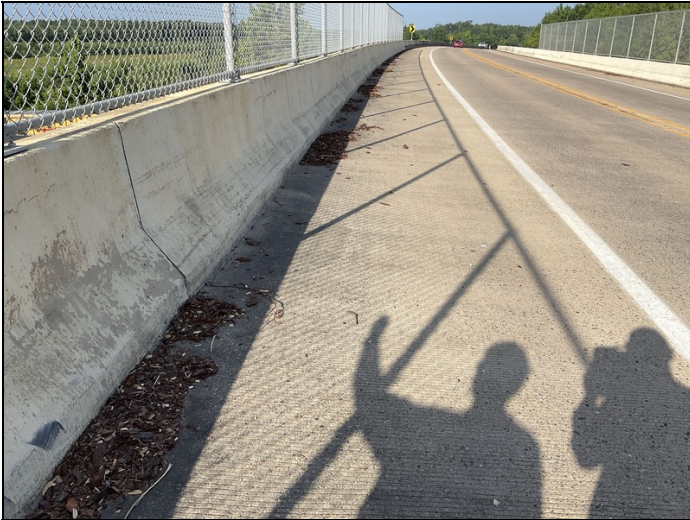
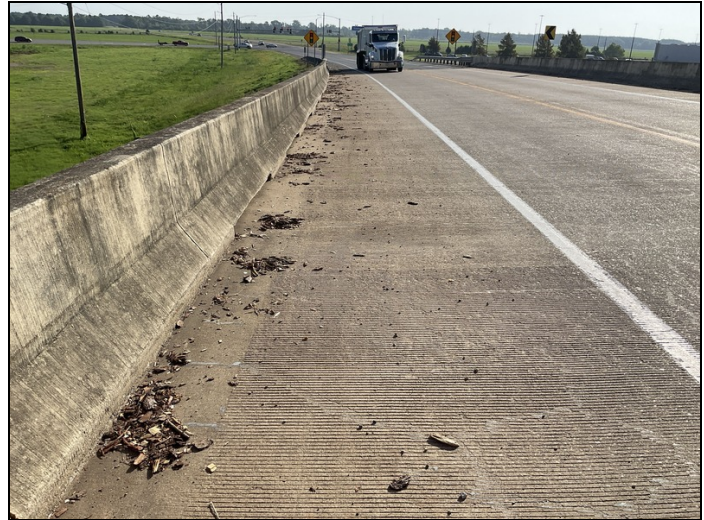
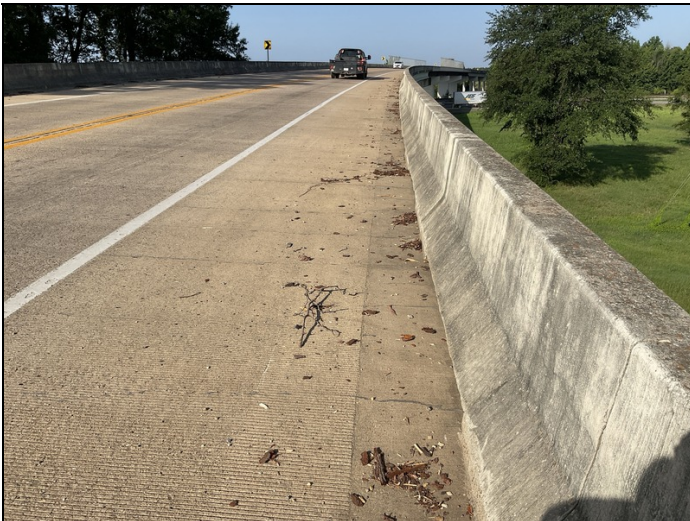
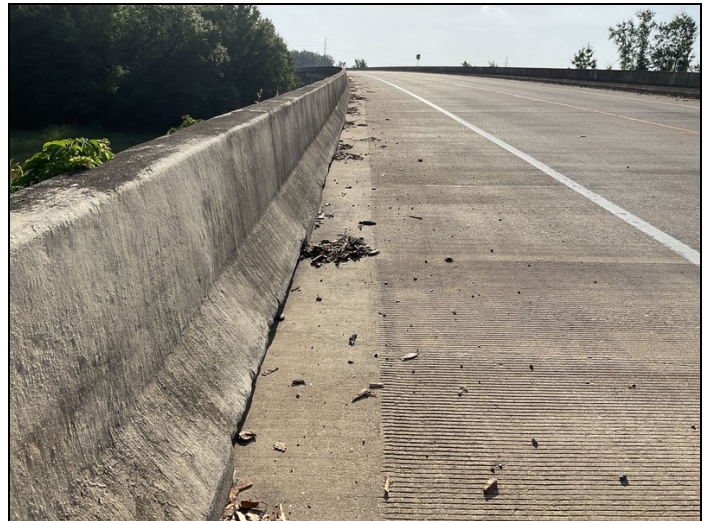
A-55 - Deck Washing Needed (Yes)

The left and right sides of the gutter lines have debris buildup. Note: The debris buildup is tree bark due to excessive amounts of large trucks.

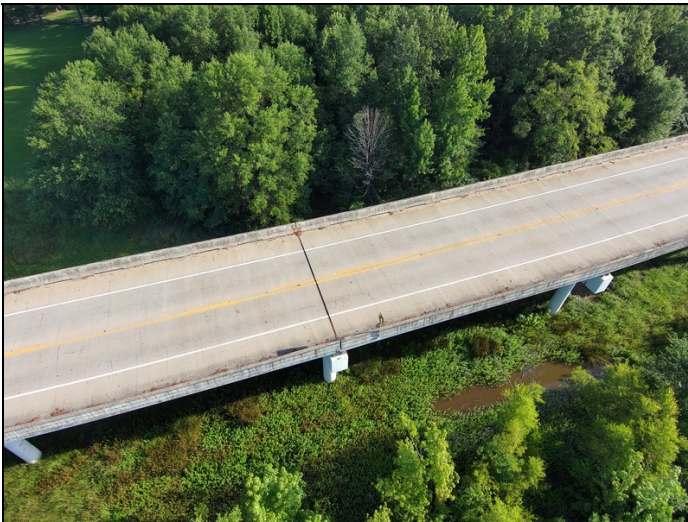
A-61 - Polymer Overlay Advised (Yes)

The topside of the deck has cracking in various locations.

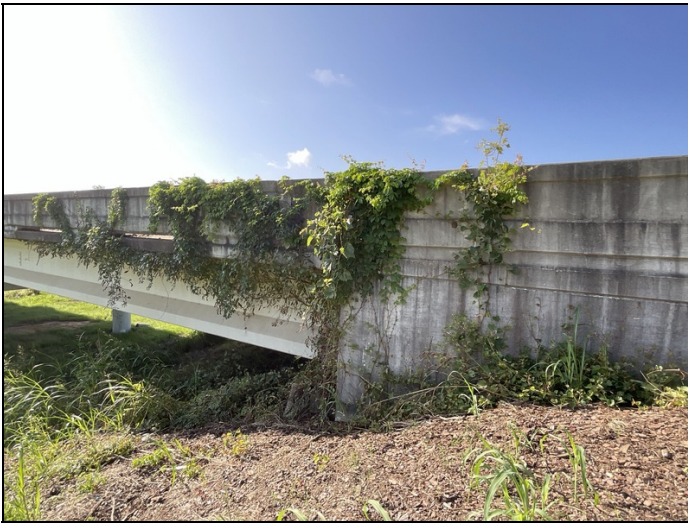
A-64 - Vegetation Removal Requested (Yes)

There is an excessive amount of vine growth on the left and right sides of the bridge.
