Asset #05823(Routine)

US 67-SEC.01-18.51 over RED RIVER

Location: .2 W JCT SH 355

Team Lead: Jared Kegley, Inspection Date: 08/10/2023

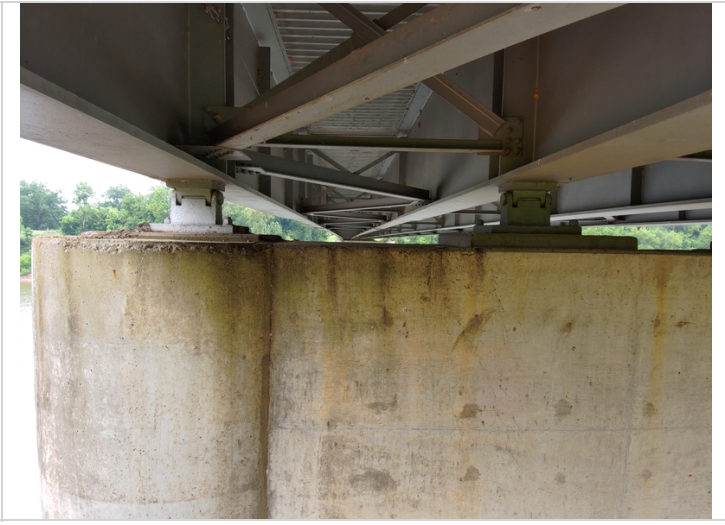
Pier 5 bearing 4

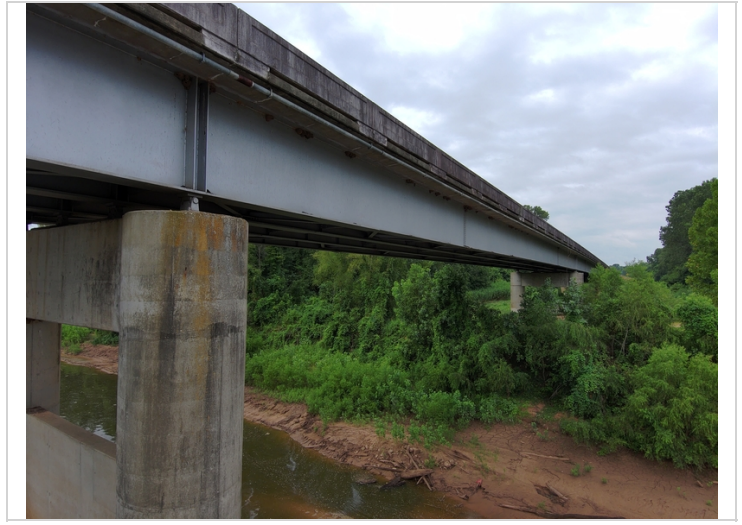
Outside of beams

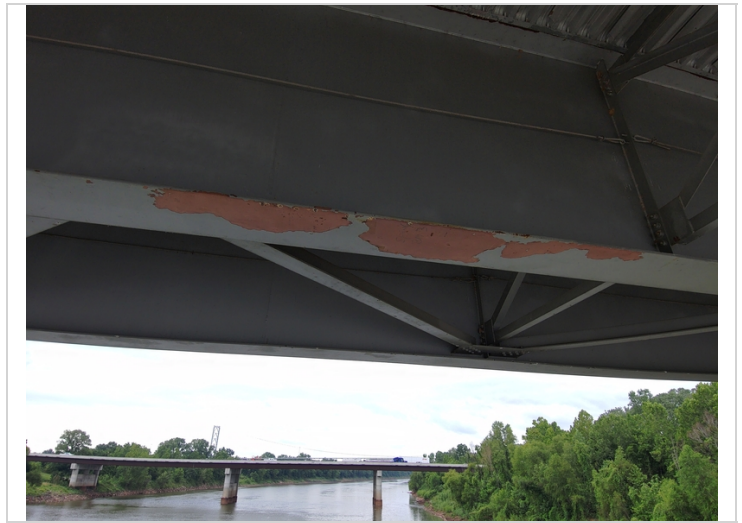
Paint loss on beams

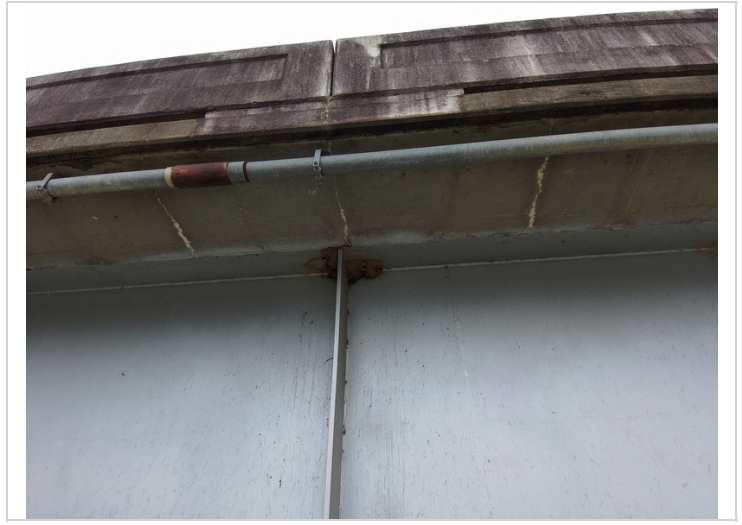
Deck is rated a 6 this inspection due to sealable deck cracks in all spans, deck spalling around assembly joints, cracking with efflorescence in both overhangs.

Cracking with efflorescence in overhangs

Polymer overlay is scheduled on this bridge in 2023.

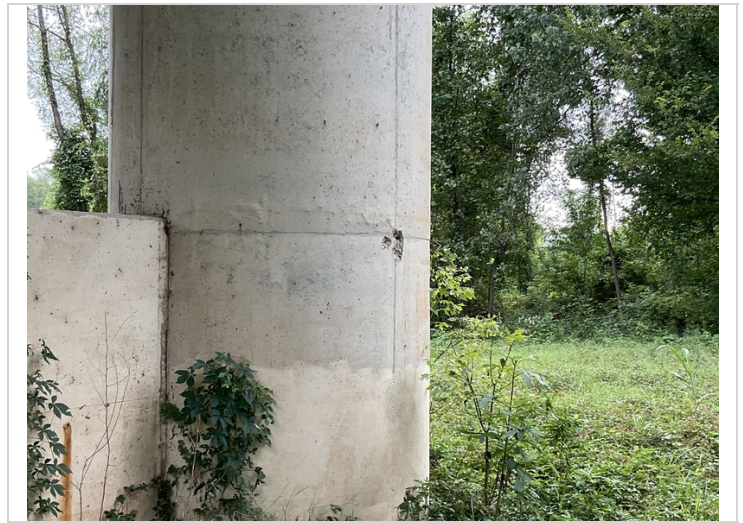
pier 4 column 2 Delam

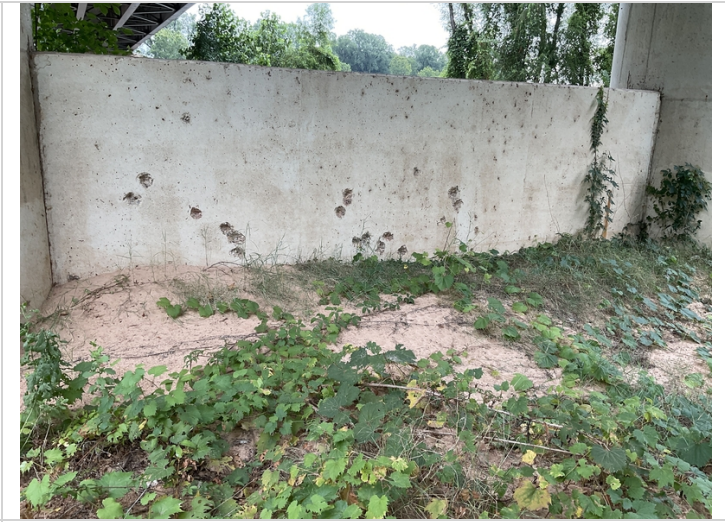
(210) Pier 4 wall has delams							
(1080-210) 2022 Underwater - Piers 5-7: Voids up to 2"D, located intermittently along the bottom of the pier walls. (29LF, CS2)							
(1090-210) 2022 Underwater - Pier 5: Void with exposed rebar that has up to 10% section, located at the bottom of the pier wall near the columns. (2LF, CS3)							
(1190-210) 2022 Underwater - Piers 5 & 7: Scaling up to 1/8"D, located from 5" below the waterline to 10' above the waterline. (19LF, CS2)							
2022 Underwater - Pier 6: Scaling up to 3/16"D, located from 5" below the waterline to 10' above the waterline. (10LF, CS2)							
215	Reinforced Concrete Abutment	LF	170	165	5	0	0
1130	Cracking (RC and Other)	LF	5	0	5	0	0

Pier 4 wall delams

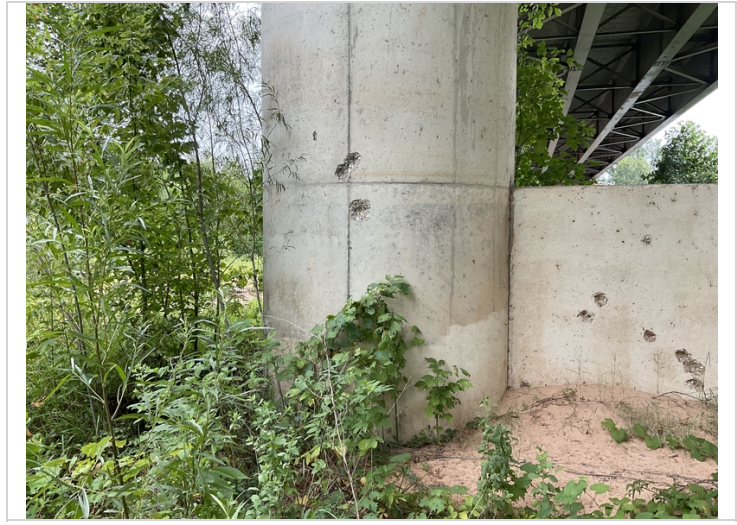
Pier 4 column 1 Delam

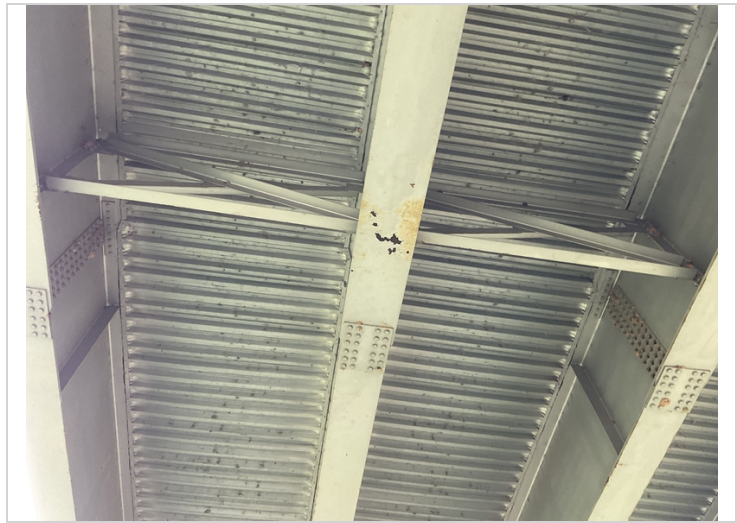
Paint chipping in various locations

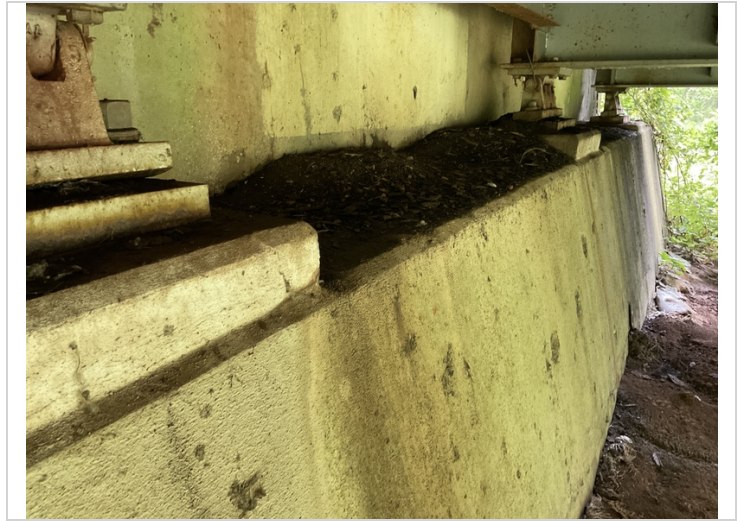
Caps need cleaned off

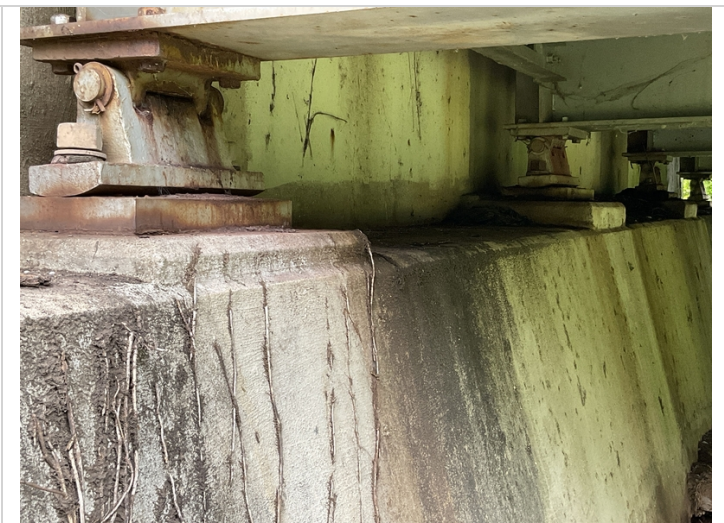
Corrosion on rocker bearings abutment 1

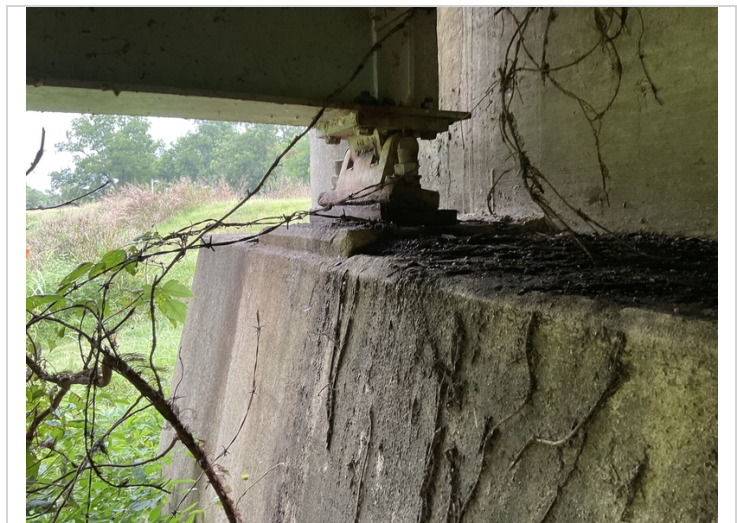
(311) All movable bearings are showing signs of corrosion, abutment 2 has excessive pack rust and that with the combination of section loss to bearing #1 on abutment 2 the whole of bearing #1 is now freefloating.							
313	Fixed Bearing	EA	24	20	0	4	0
1000	Corrosion	EA	4	0	0	4	0

Bearing is free floating from section loss abutment 2

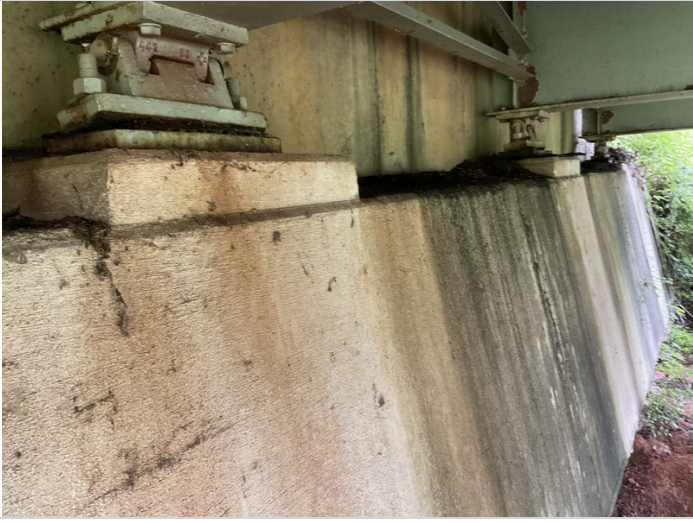
Corrosion pack rust abutment 2 bearing

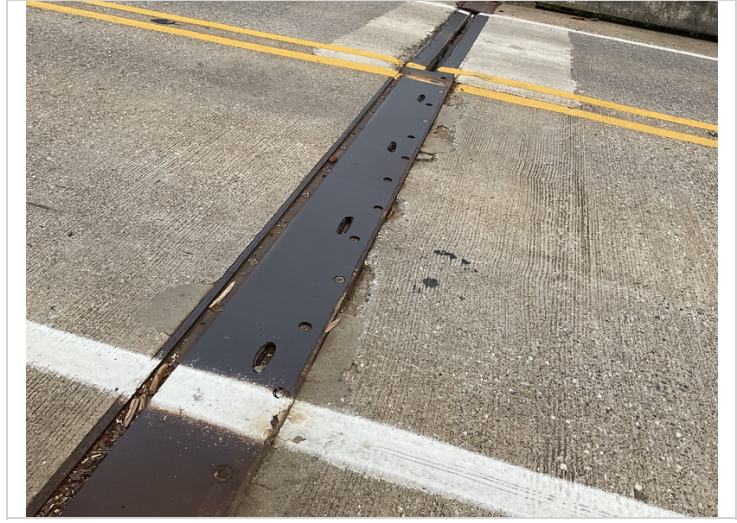
Delams around assembly joint #2

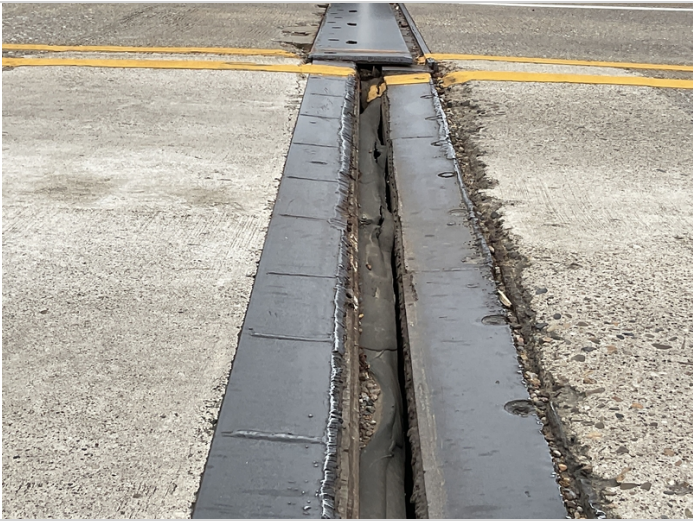
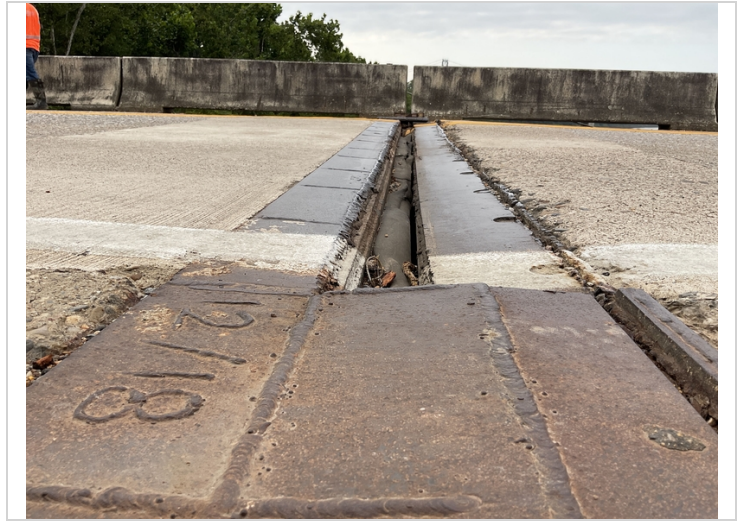
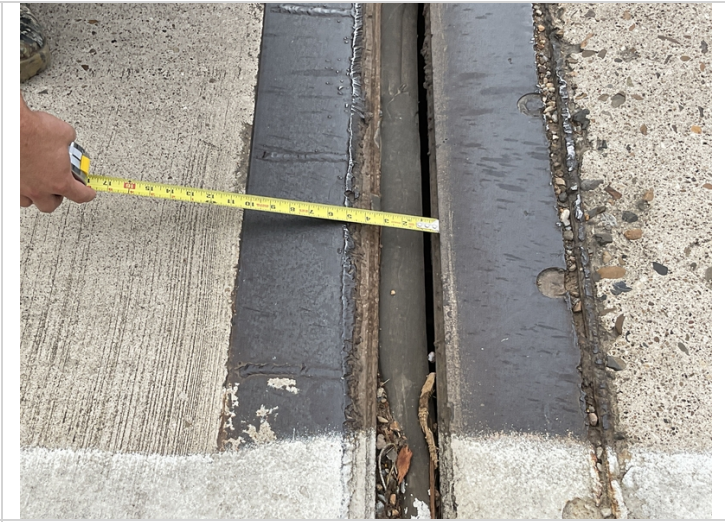
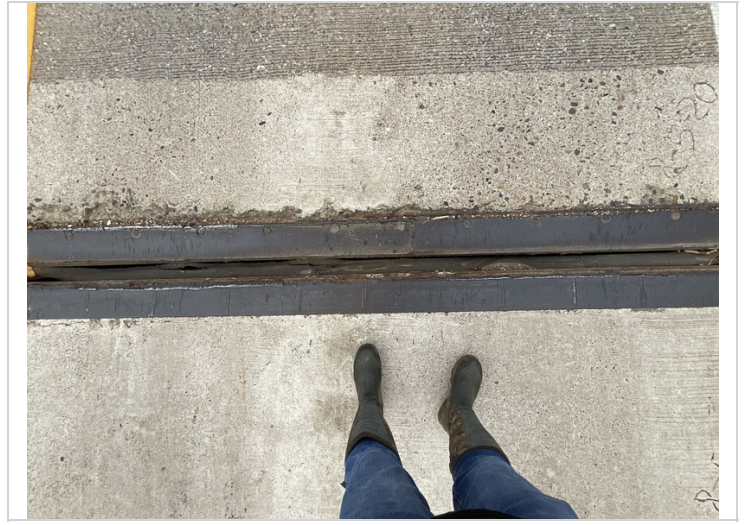
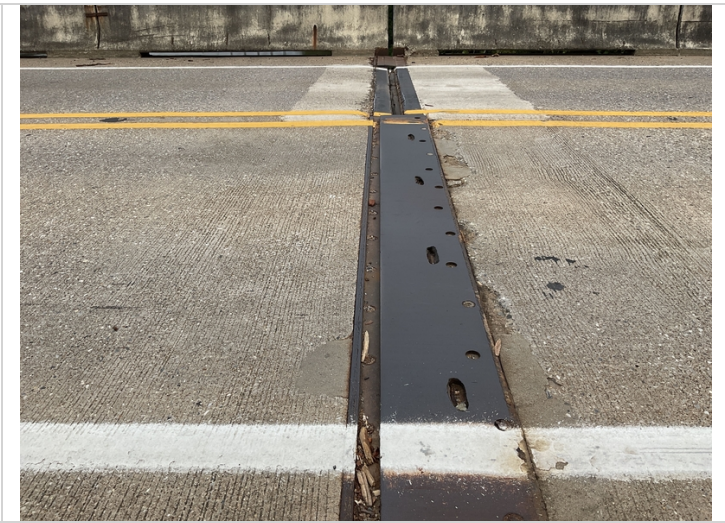
Assembly joint #2 repairs

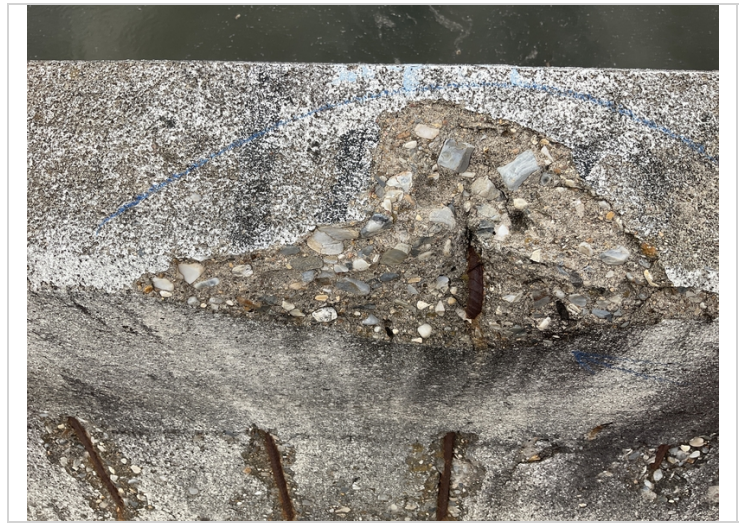
Large spall on top of parapet wall right side with rebar exposed

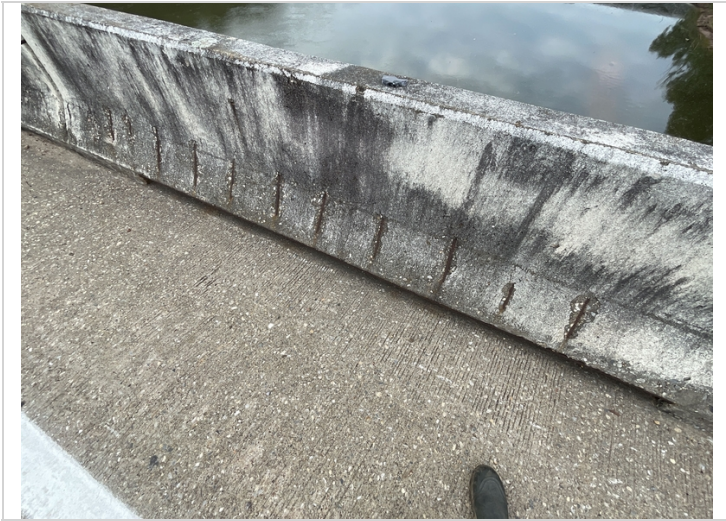
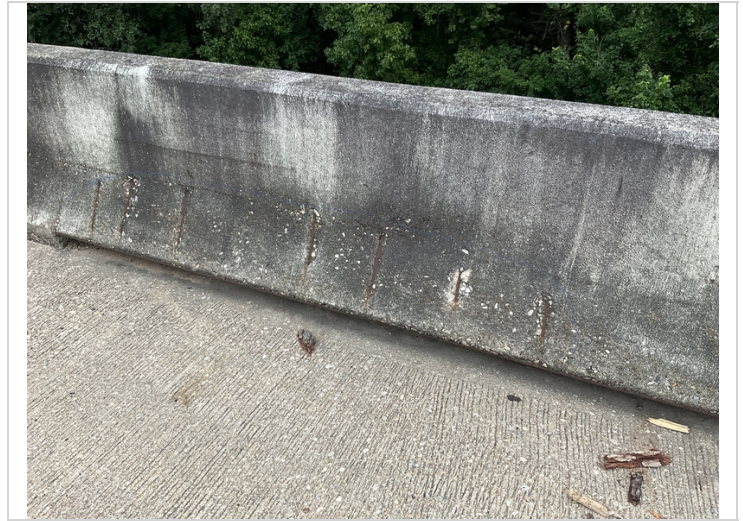
Rebar exposed in various locations on parapet wall

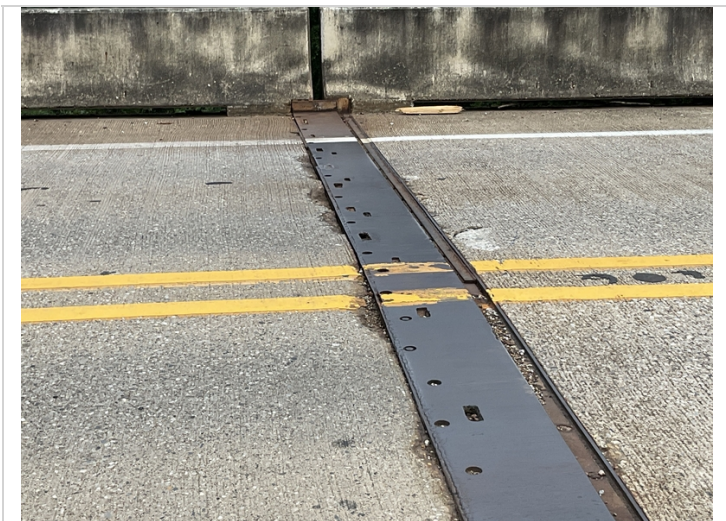
Assembly joint #1 left side has broken loose and can be heard well when any vehicle passes over it

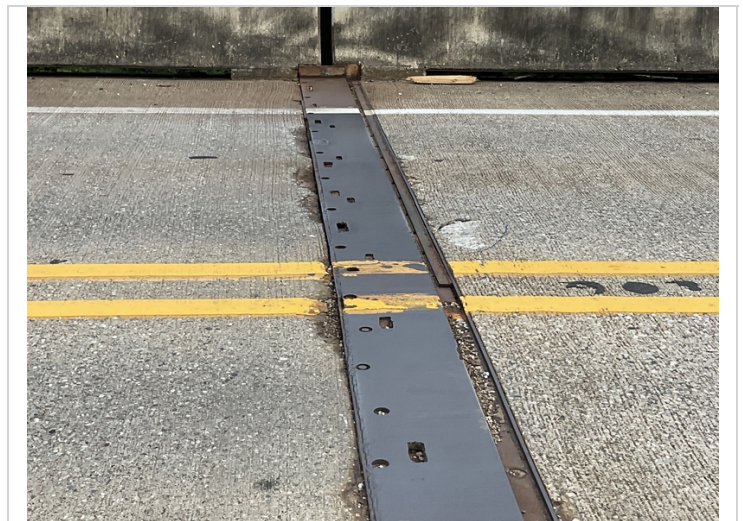
Delams around first slider plate

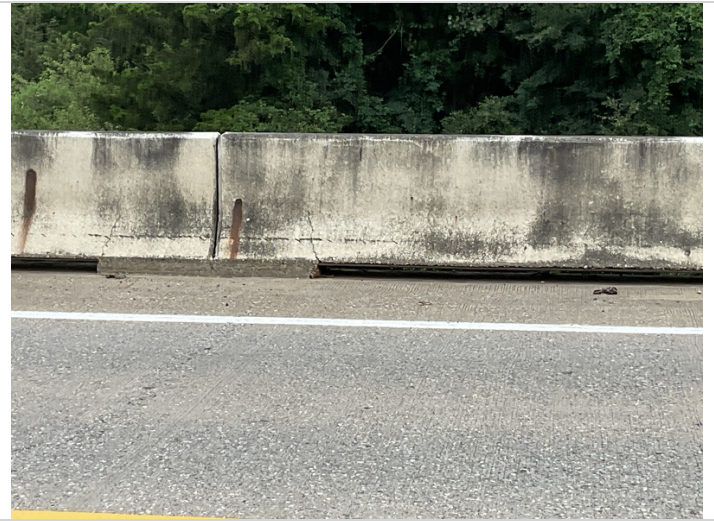
Rust staining and cracking in various locations of parapet wall

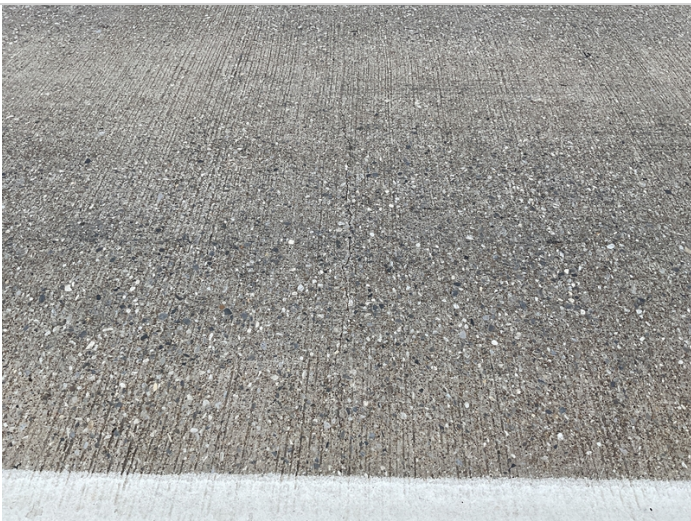
Deck cracking in various locations

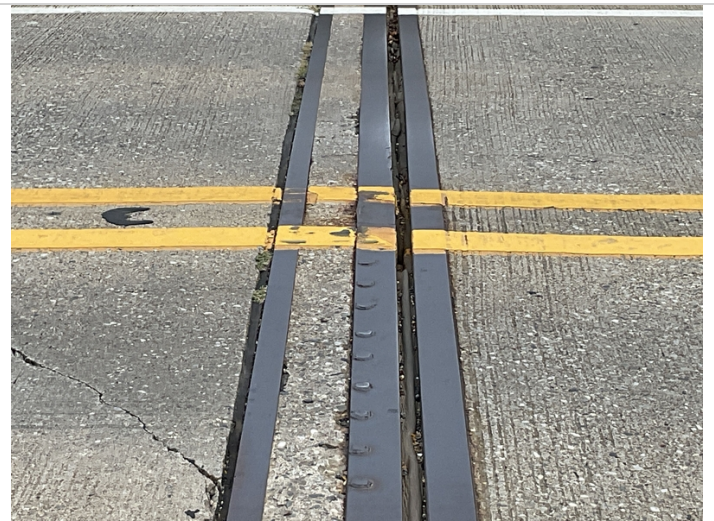
(302) first compression seal has damage to it and is leaking							
305	Assembly Joint without Seal	LF	64	32	0	15	17
2370	Metal Deterioration or Damage	LF	32	0	0	15	17

Damage to seal #1

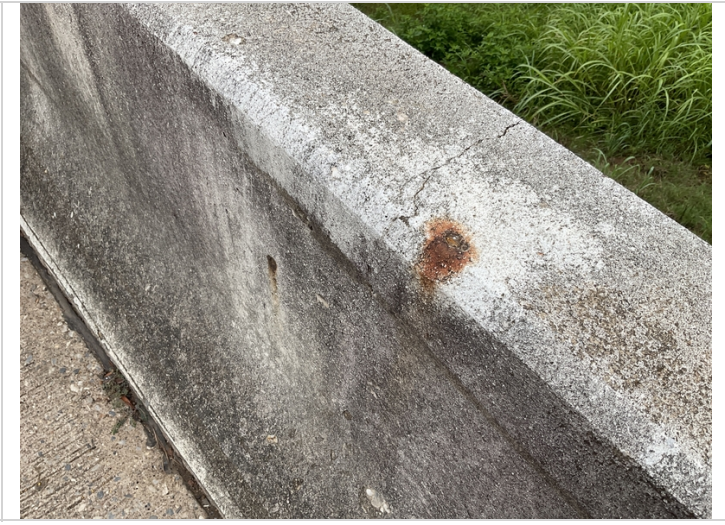
Cracking in parapet wall various locations

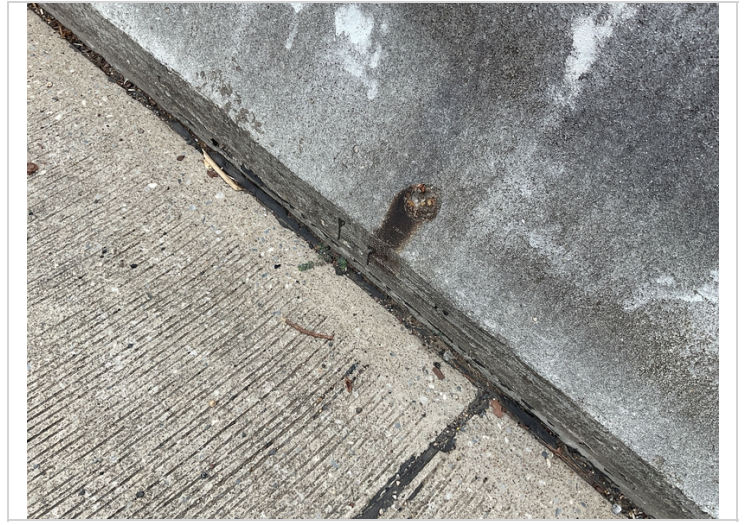
Delam in parapet wall various locations

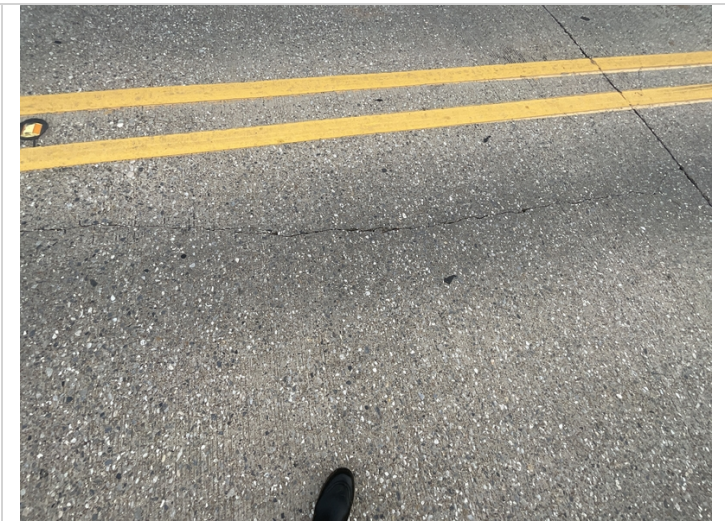
(321) Large cracking in approach slab in various locations							
331	Reinforced Concrete Bridge Railing	LF	2644	2044	300	300	0
1080	Delamination/Spall/Patched Area	LF	200	0	0	200	0
1090	Exposed Rebar	LF	400	0	300	100	0

Large cracking in approach slab

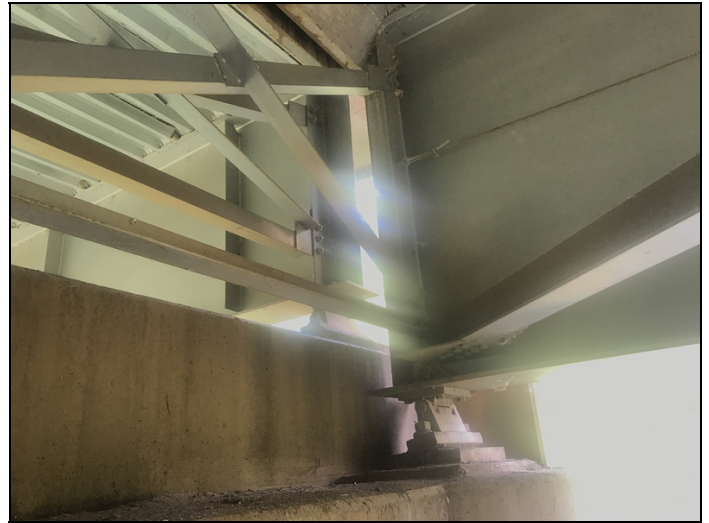
Bent 4 joint leaking causing rust on bearings and some debris on top of cap

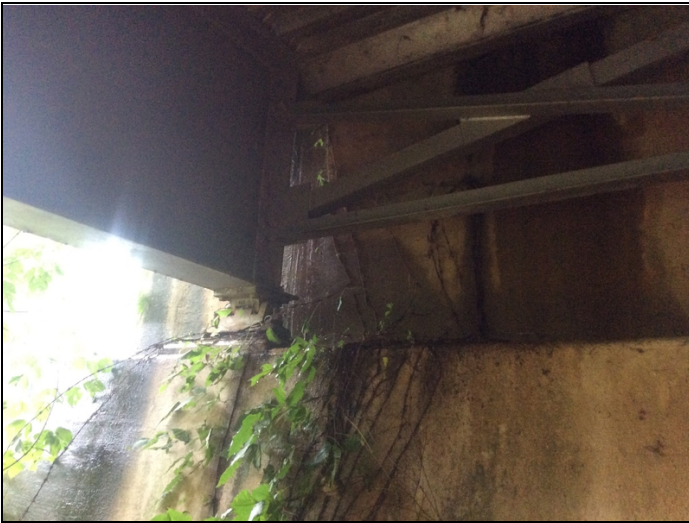
Joints leaking beginning and end of bridge causing rust on bearings.

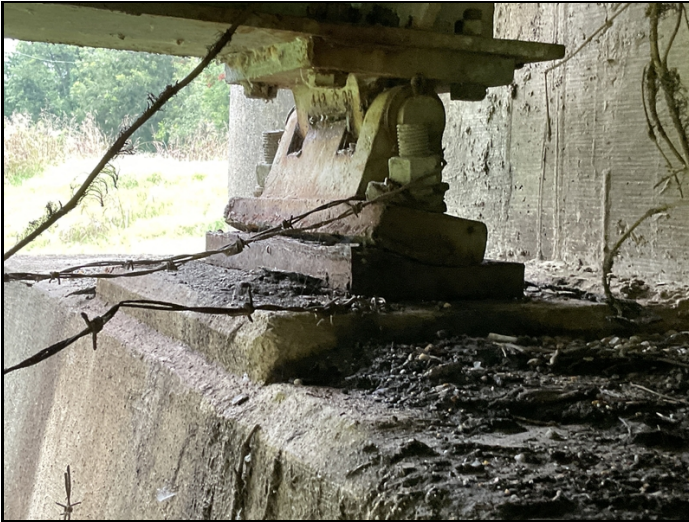
Section loss has caused bearing #1 on bent 10 to free float and all other bearing has large amounts of pack rust.

Floating bearing

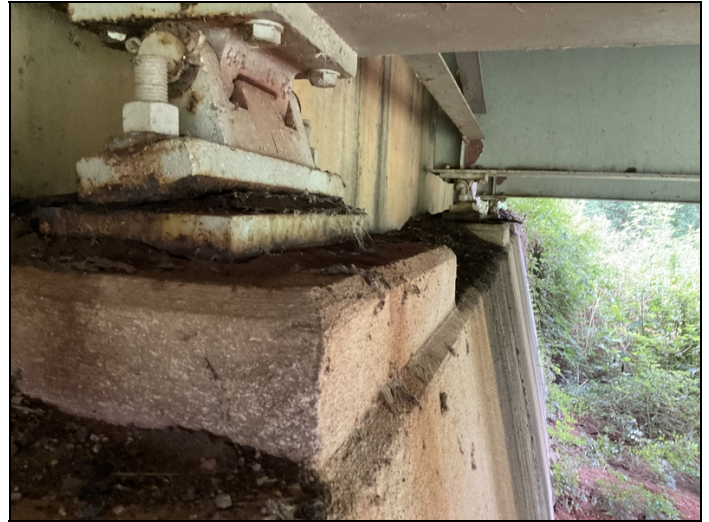
Pack rust
