Asset #06751(Routine)

U.S67 SEC.01-16.61 over SWAN CR.,UPRR,CR 111

Location: 1.9 MI.W. OF JCT. SH. 355

Team Lead: Jared Kegley, Inspection Date: 03/23/2023

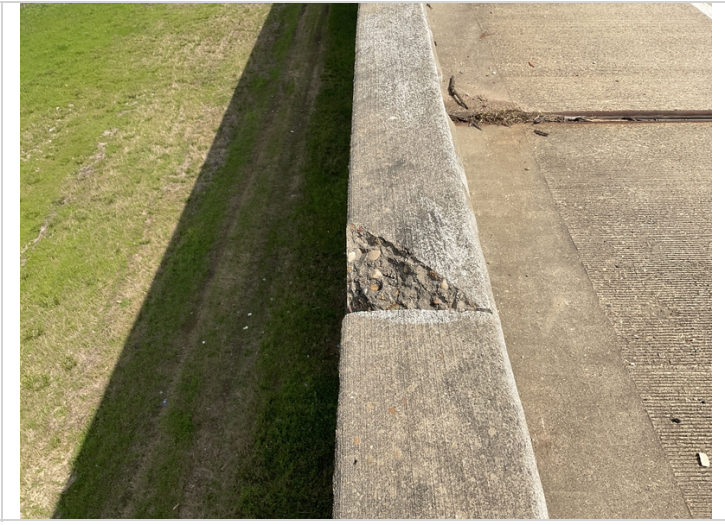
(331) 250' CS2 cracking throughout both RT and LT side of bridge railing in all spans. 1' CS2 rebar exposed. 3' CS2 spalling in concrete bridge railing in various locations. 1' CS3 spall in concrete bridge railing.

Spall in bridge railing

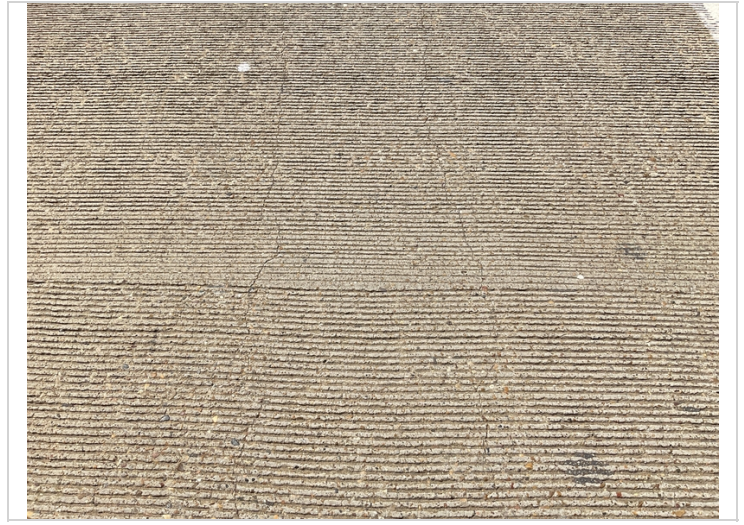
Deck is rated a 7 this inspection due to various locations of deck cracking and cracking with efflorescence throughout all spans of bridge.

Deck cracking

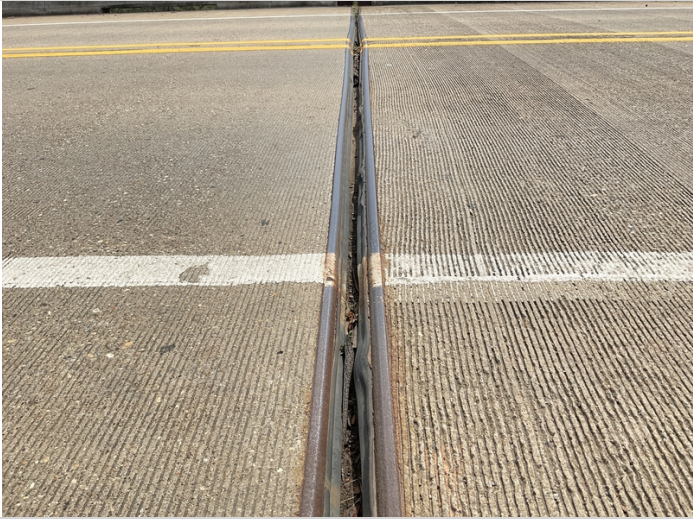
(300) Bent 13- 4' seal adhesion							
310	Elastomeric Bearing	EA	180	180	0	0	0
331	Reinforced Concrete Bridge Railing	LF	3405	3150	254	1	0
1080	Delamination/Spall/Patched Area	LF	4	0	3	1	0
1090	Exposed Rebar	LF	1	0	1	0	0
1130	Cracking (RC and Other)	LF	250	0	250	0	0

Joint adhesion

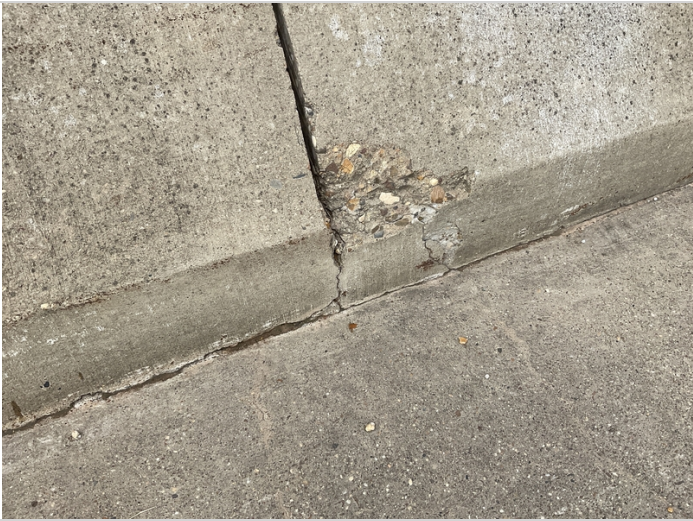
Spalls in bridge railing

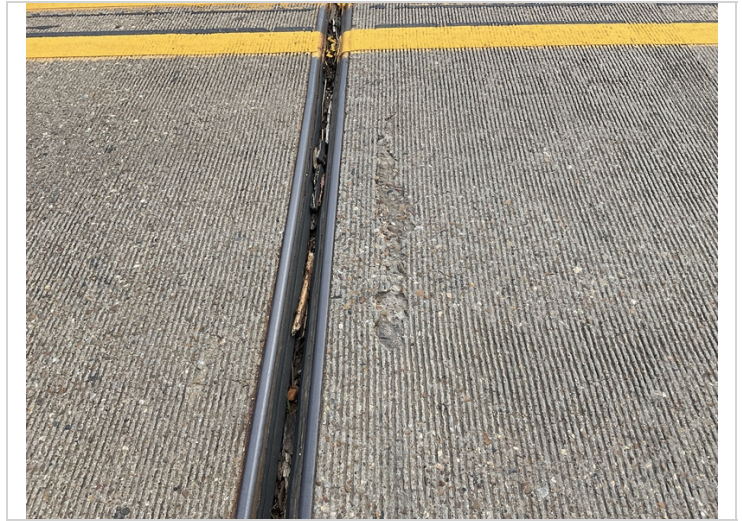
Deck spalls

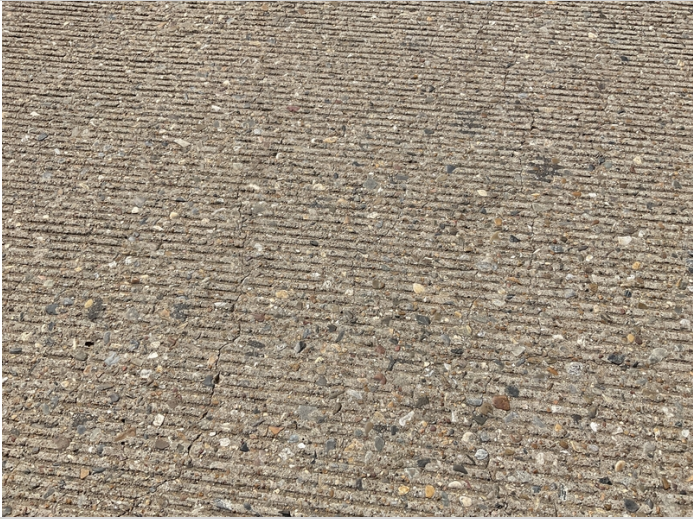
Deck cracking

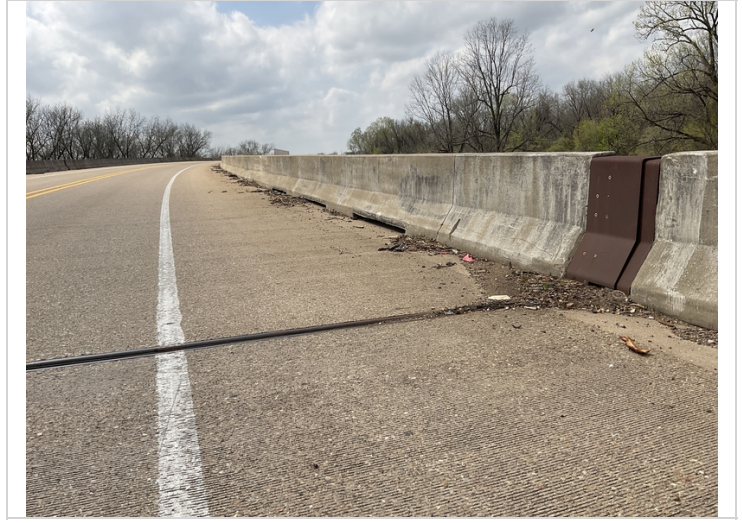
Deck washing needed

Deck washing needed

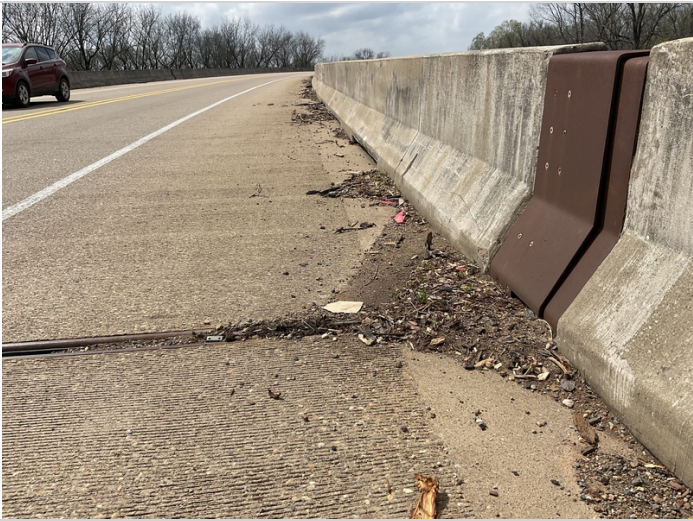
Deck washing needed

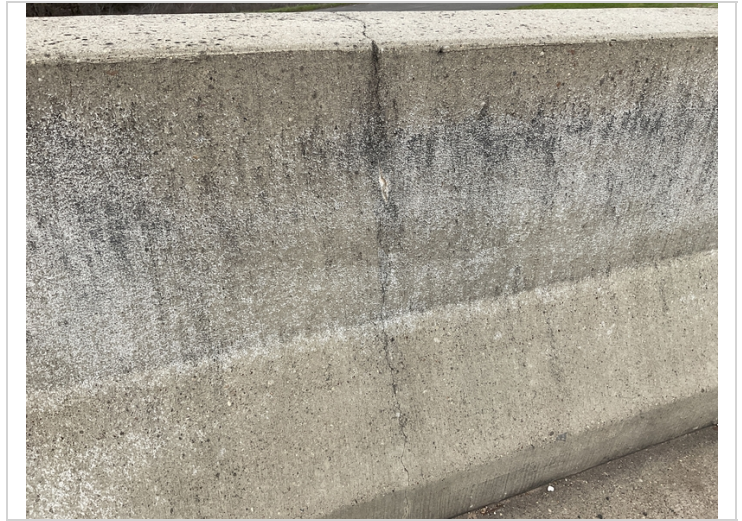
Cracking in bridge railing

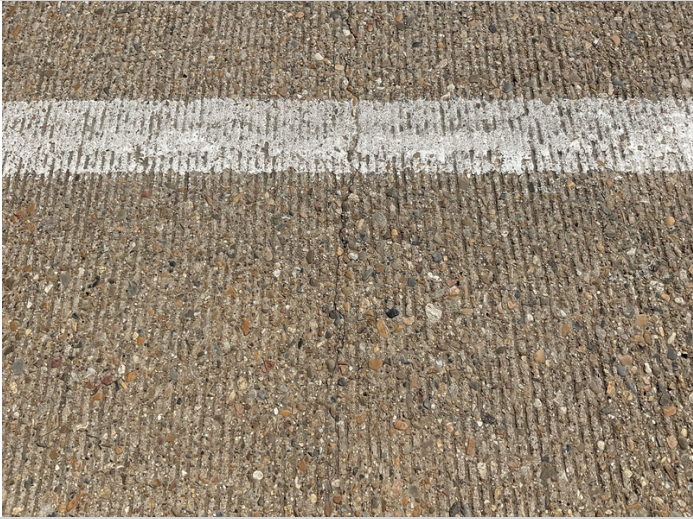
Deck cracking

Longitudinal and transverse cracking in all spans.

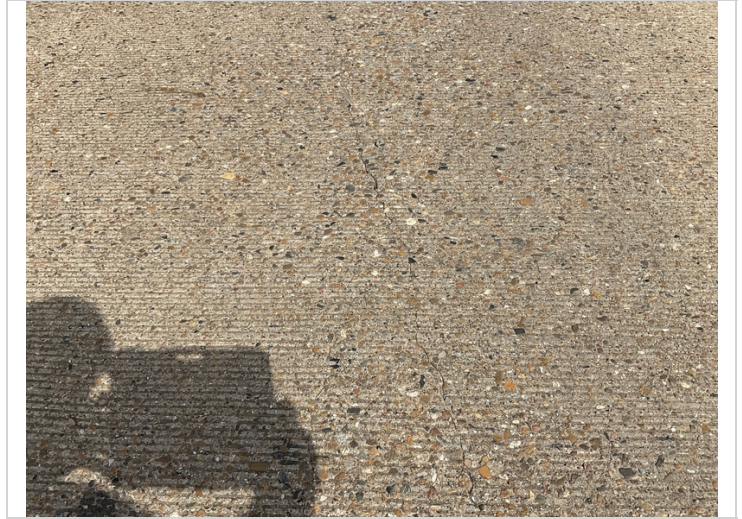
Deck cracking

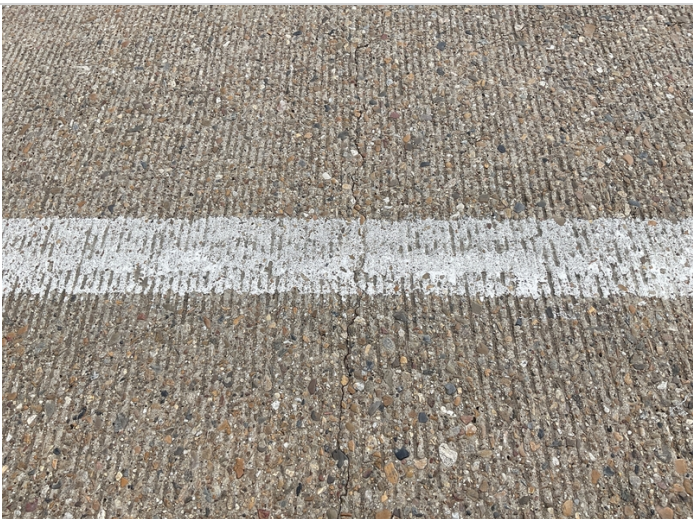
Sealable deck cracking throughout all spans

Sealable deck cracking

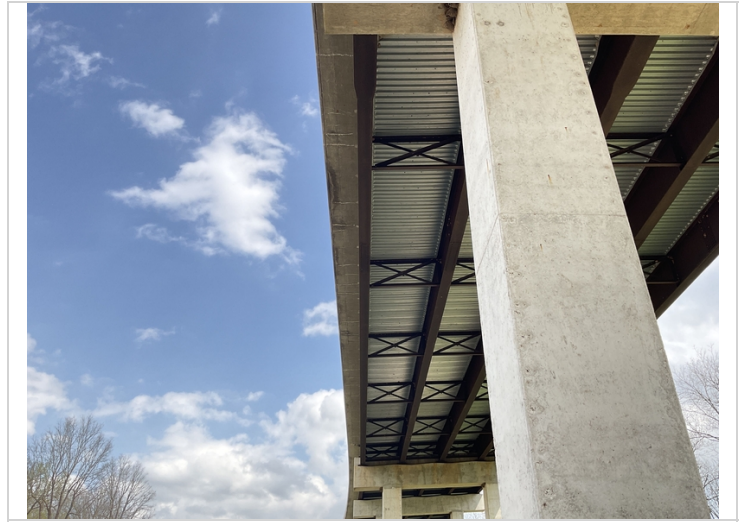
Efflorescence in overhangs

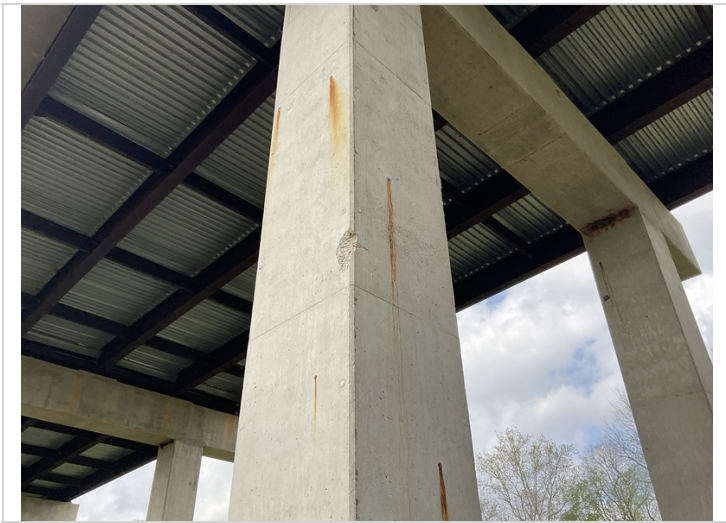
(205) Bent 2 column 2 spall Bent 4 column 2 spall Bent 8 column 2 spall Bent 11 column 1 spall Bent 14 column 1 spall Bent 15 column 1 spall Bent 17 column 1 spall Bent 24 column 1 spall							
215	Reinforced Concrete Abutment	LF	125	112	13	0	0
1120	Efflorescence/Rust Staining	LF	13	0	13	0	0

Bent 8 column 2 spall

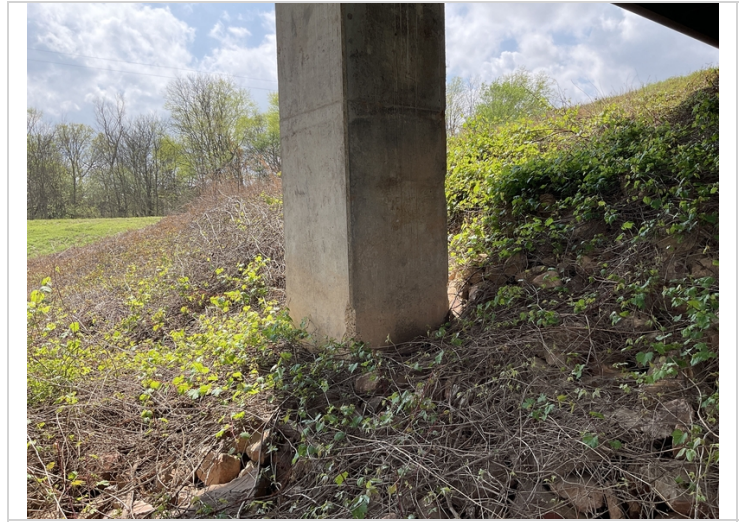
Bent 2 column 2 spall

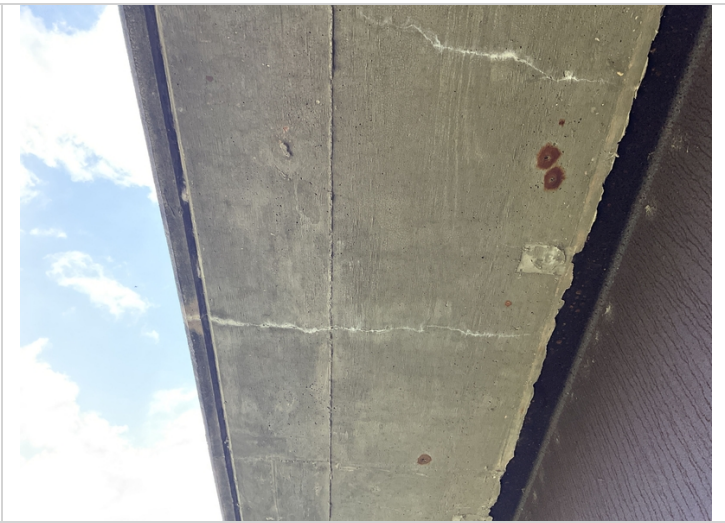
Efflorescence in overhangs

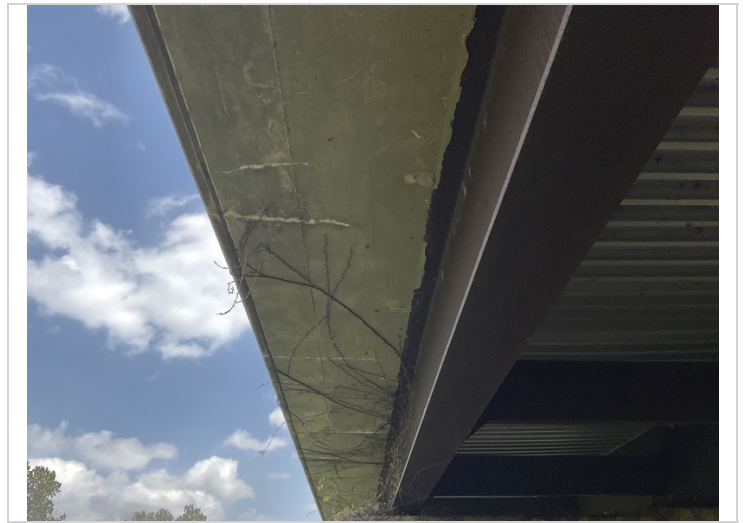
Efflorescence in overhangs

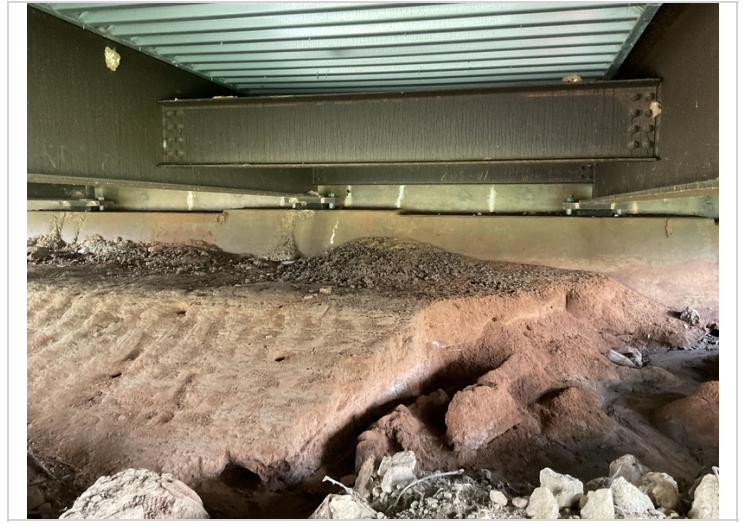
(215) 7' CS2 efflorescence in Bent 1 backwall 6' CS2 efflorescence to Bent 27 backwall							
234	Reinforced Concrete Pier Cap	LF	1023	1023	0	0	0
300	Strip Seal Expansion Joint	LF	424	420	4	0	0
2320	Seal Adhesion	LF	4	0	4	0	0

Efflorescence in backwall

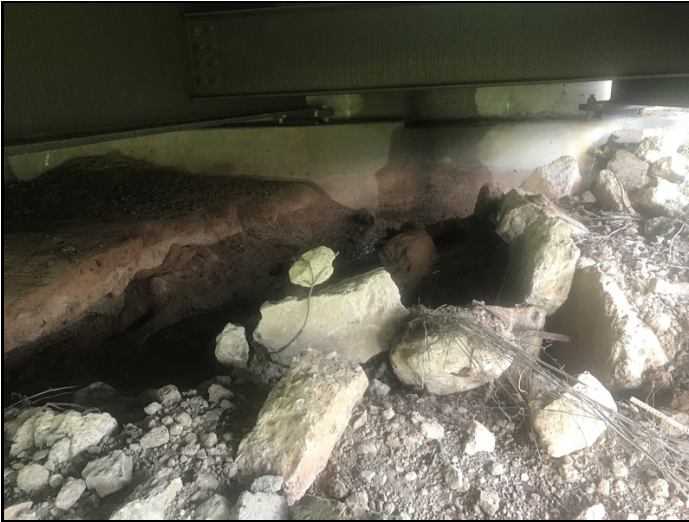
EROSION AT BENT 1 ABUTMENT
AND UNDER SPAN 1

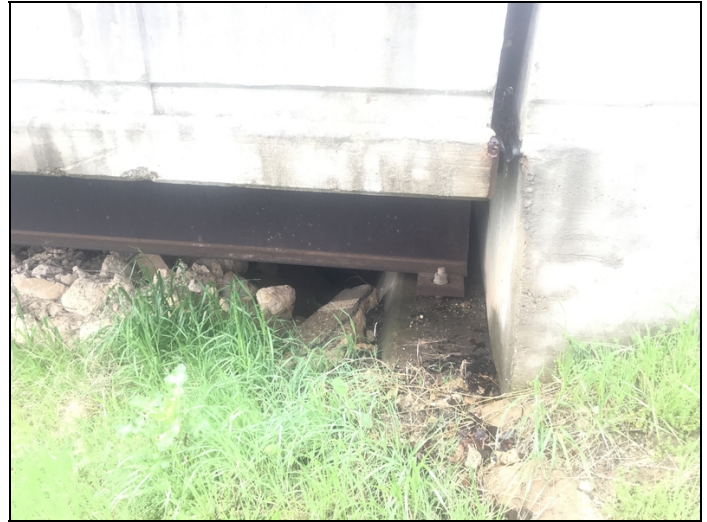
Water drain out joint under bridge

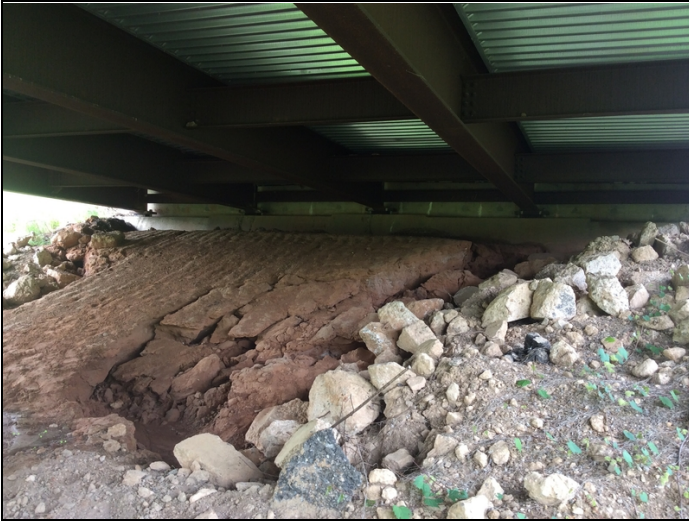
Erosion under span 1 at abutment

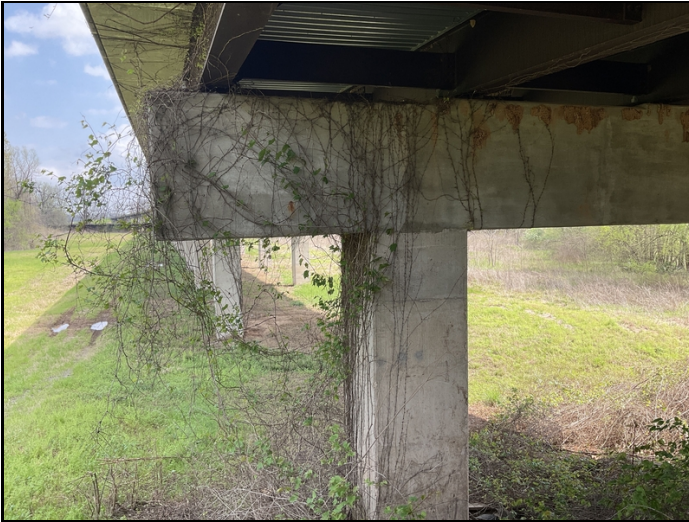
Bent 2 vines

AMS will handle.

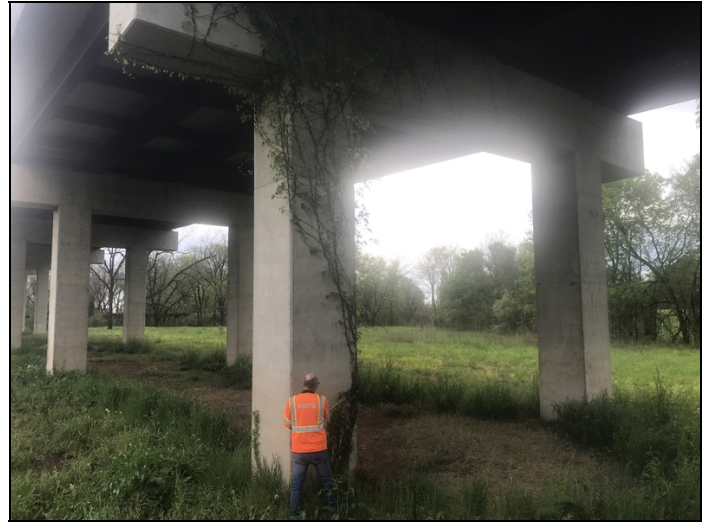
Bent #3 vines

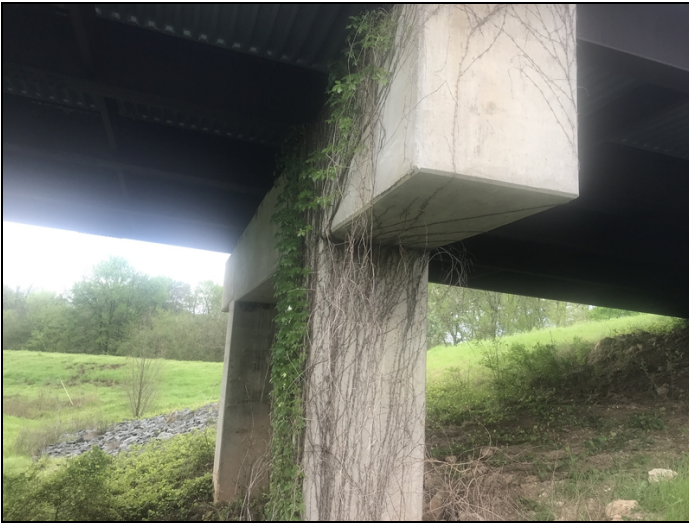
Bent #2 vines

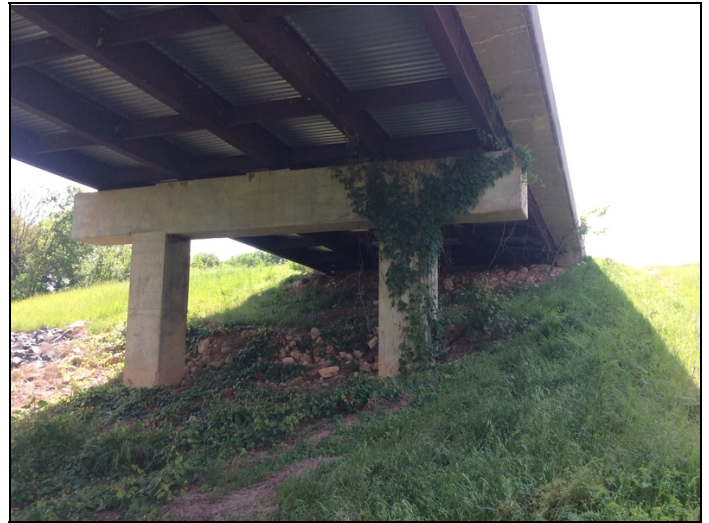
Vines growing on bent 2 and 3
