Asset #X1047(Routine)

U.S.67-01-18.19 over Drainage

Location: 0.4 MI. W.OF HEMP.CO.LINE

Team Lead: Jared Kegley, Inspection Date: 08/10/2023

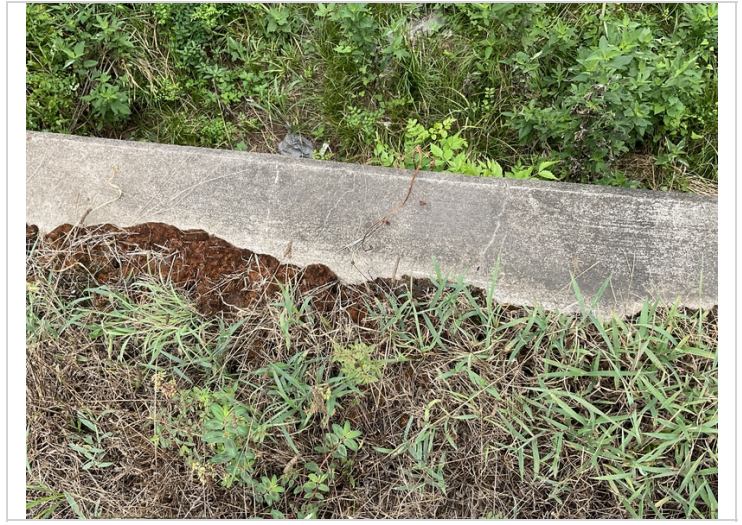
Cracking on headwall in various locations

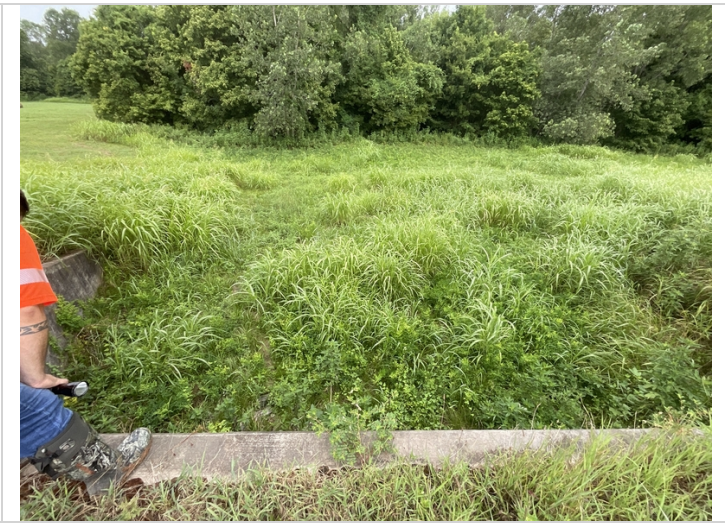
Comment: Channel rated an 8 due to being well vegetated.

Channel

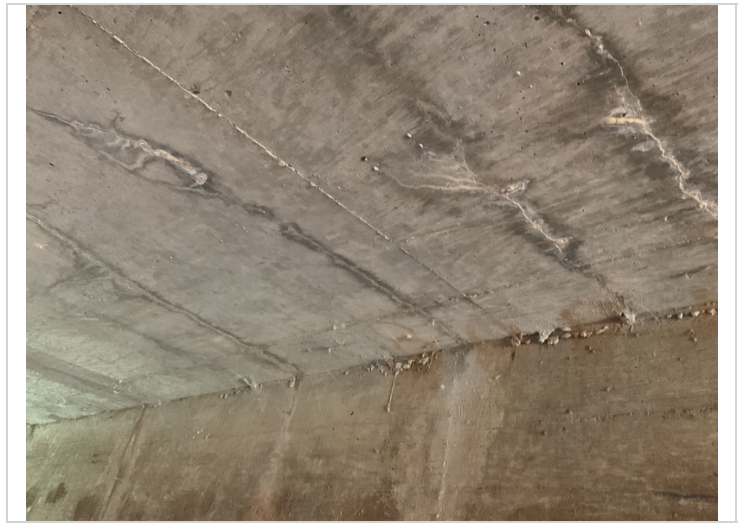
Comment: Box culvert rated a 7 due to cracking and efflorescence in all barrels of culvert.

Efflorescence barrel 1

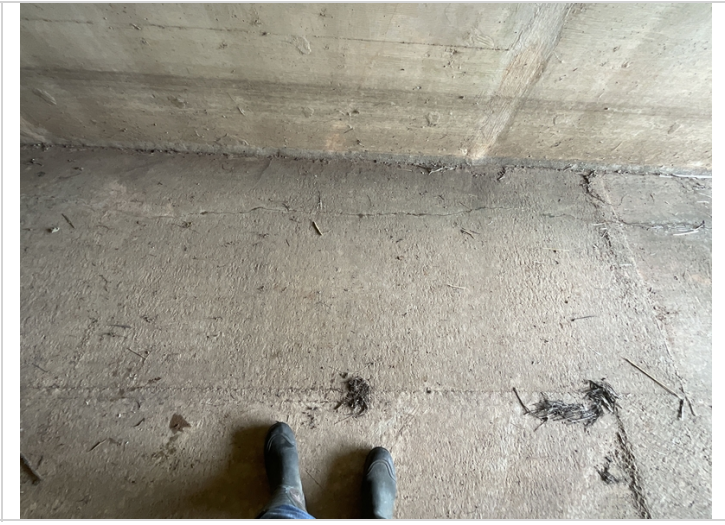
ELEMENTS	DESCRIPTION	UNITS	TOTAL				
				CS1	CS2	CS3	CS4
241	Reinforced Concrete Culvert	LF	279	224	55	0	0
1120	Efflorescence/Rust Staining	LF	15	0	15	0	0
1130	Cracking (RC and Other)	LF	40	0	40	0	0
(241) All barrels contain cracking, some with efflorescence, Barrels 1 & 2 have some longitudinal cracking.

Longitudinal cracking in barrel 1

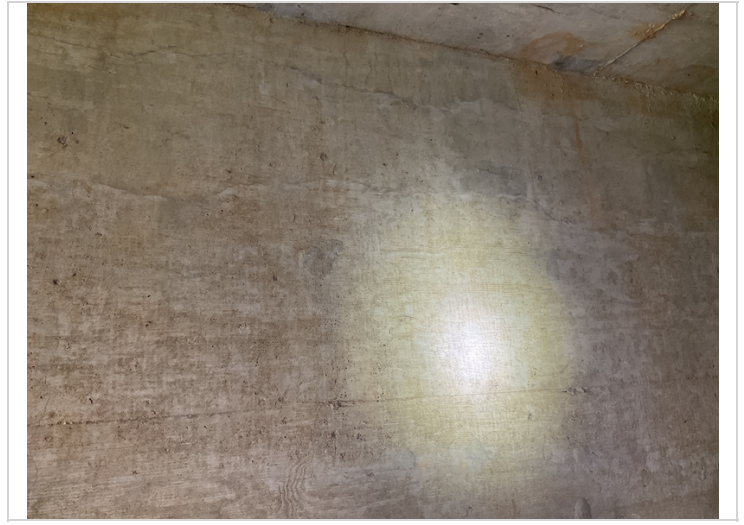
Longitudinal cracking barrel 1

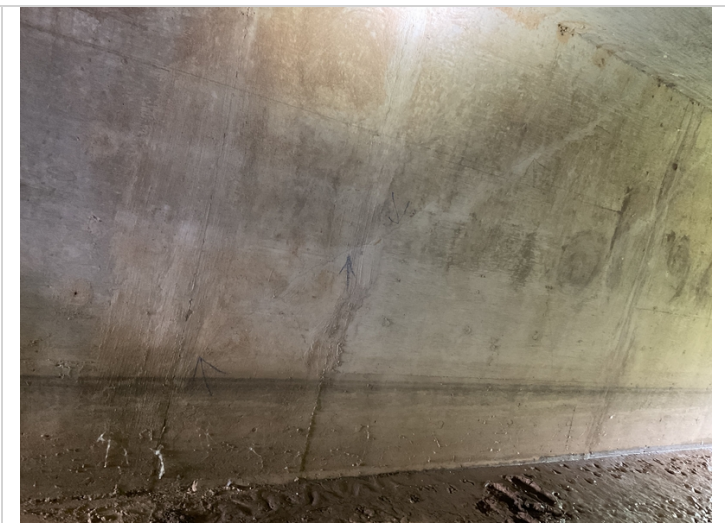
Longitudinal Cracking in barrel 2

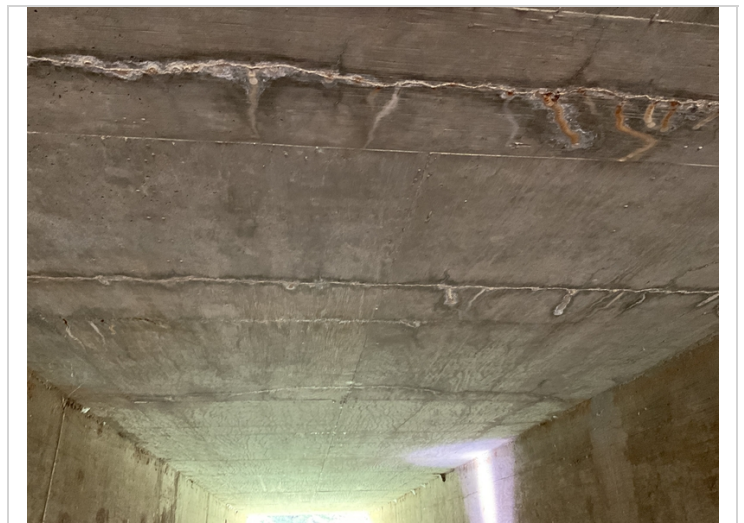
Cracking with efflorescence barrel 2

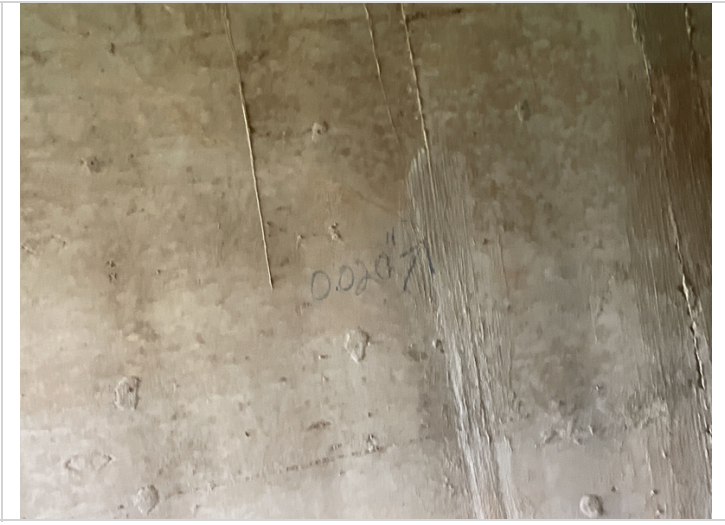
Cracking in barrel 2

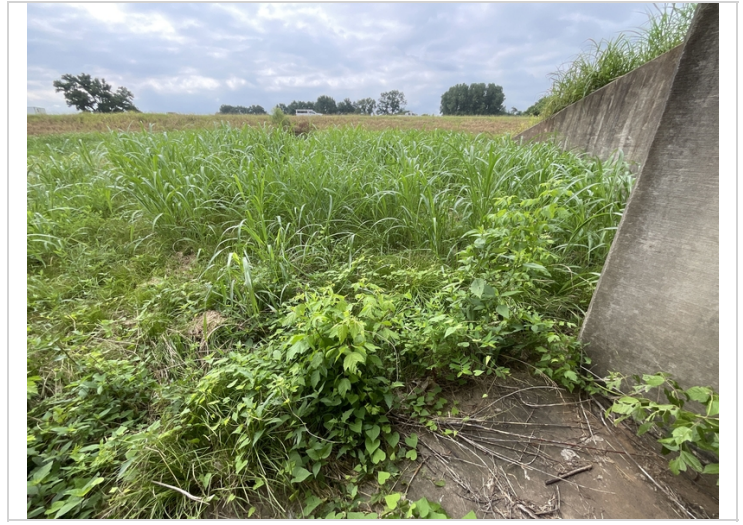
Right side of box needs cut

Vegetation needs mowed

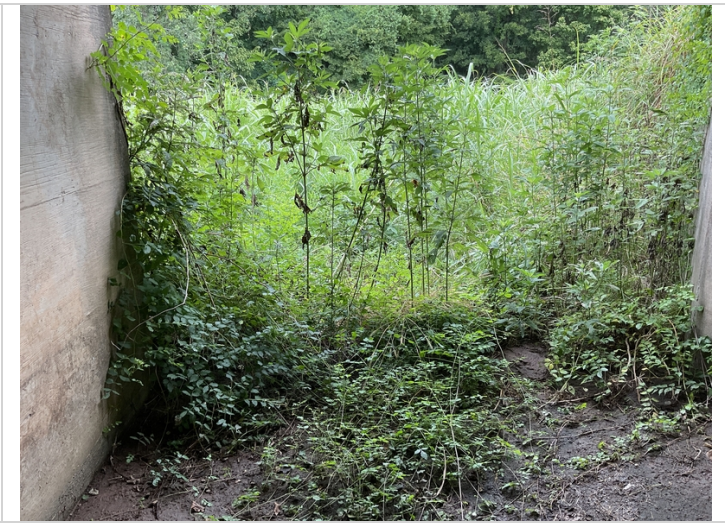
Left side of box needs cut

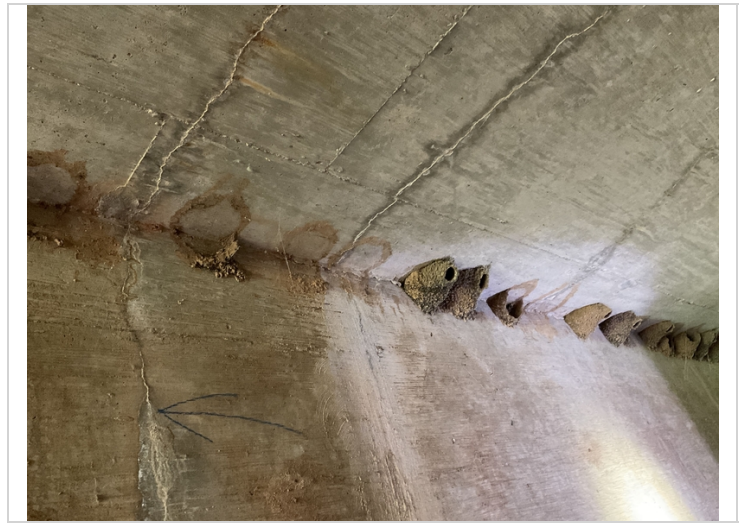
Efflorescence barrel 3

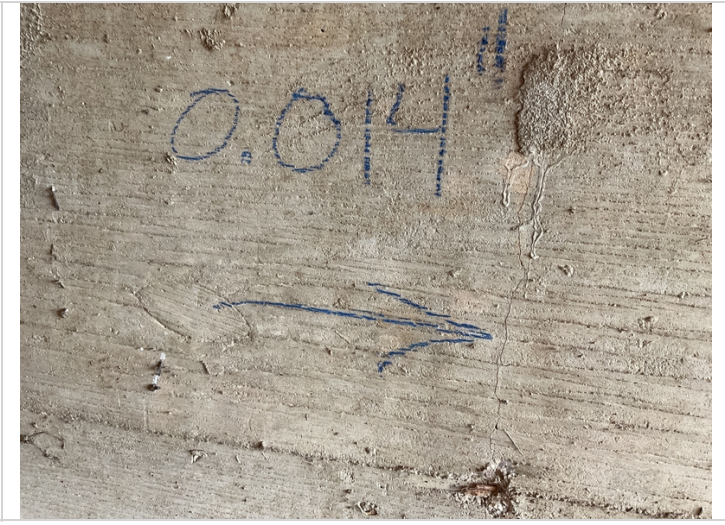
Crack in barrel 3

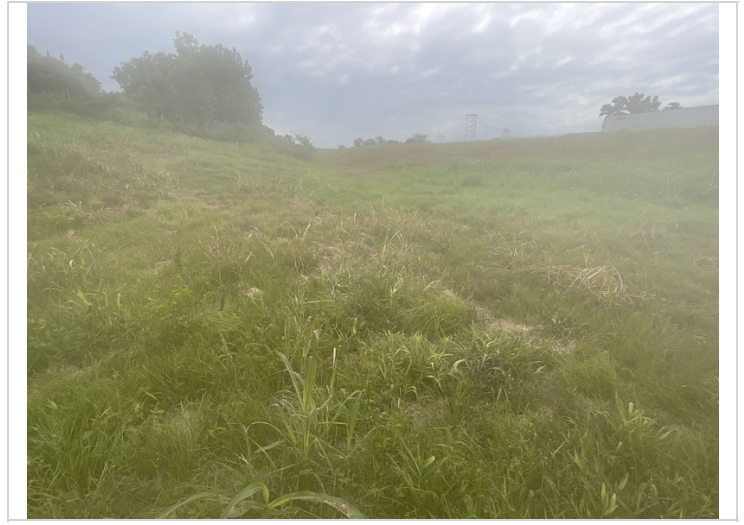
Channel

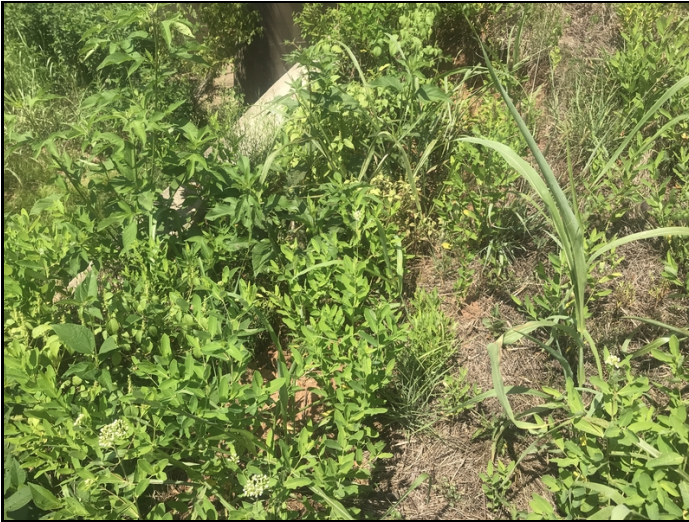
Erosion behind southeast wing, 6 ft x 4 ft x 2 ft deep.

8/10/2023...Re-opened MN for review to assign or monitor.
