Asset #05877(Routine)

SH 19-SEC 5 - 8.39 over BRUSHEY CREEK

Location: 8.83 MI NO JCT US 67

Team Lead: John King Inspection Date: 06/06/2023

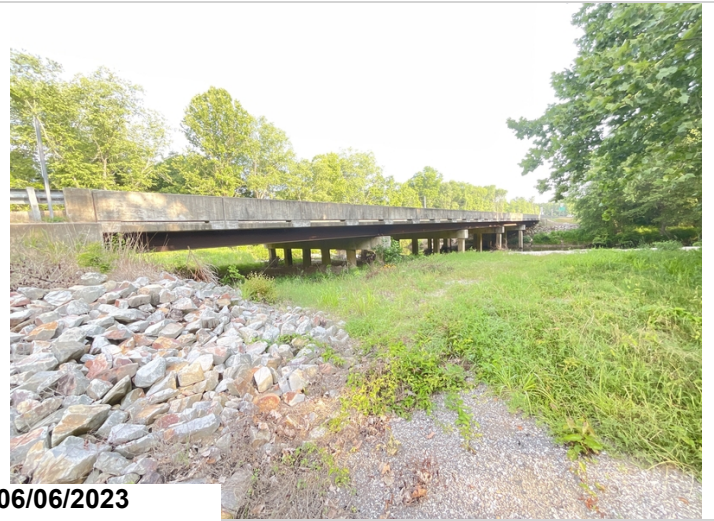
6/23 elevation photo take of right side bridge directions oh logmile.

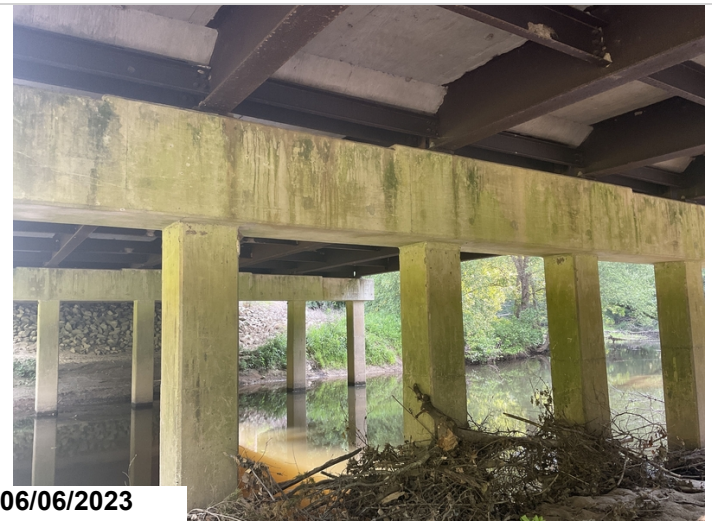
| ELEMENTS | DESCRIPTION | UNITS | TOTAL | CS1 | CS2 | CS3 | CS4 |
|---|---|---|---|---|---|---|---|
| (234) 6/23 typical photo of cap photos taken of bent 4&5 | | | | | | | |

6/23 typical photo of cap photos taken of bent 4&5

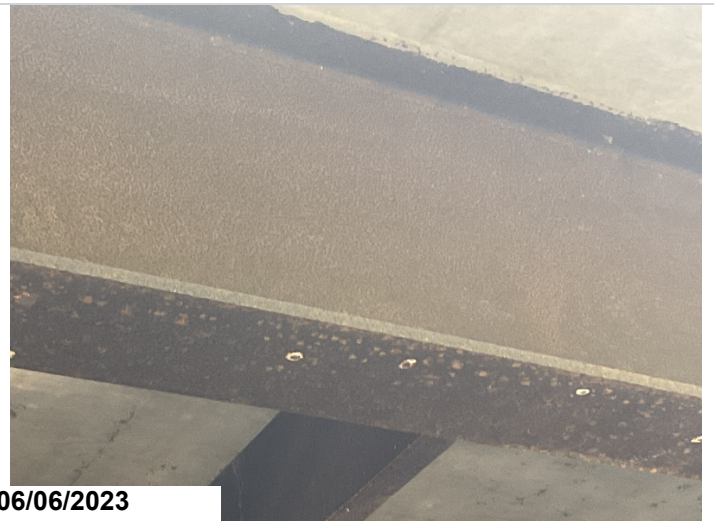
| ELEMENTS | DESCRIPTION | UNITS | TOTAL | CS1 | CS2 | CS3 | CS4 |
|---|---|---|---|---|---|---|---|
| (107)<br>6/2023 typical photo of weathering steel beams. Photo taken in span 1<br>(515-107) 6/2023 Light brown rusting on out side beam in span span 3 left side photo taken<br>(3430-515-107) 6/2023 Light brown rusting on out side beam in span span 3 left side photo taken | | | | | | | |

6/2023 Light brown rusting on out side beam in span span 3 left side photo taken

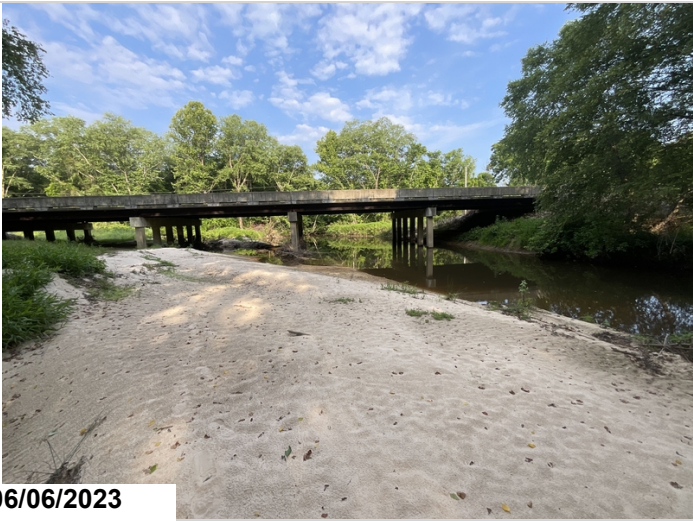
6/23 channel in good condition may need minor repair

6/2023 channel photo

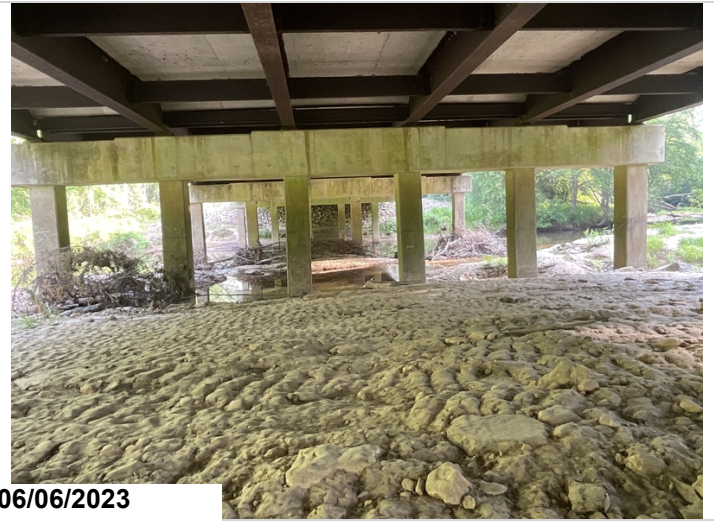
6/23 bents are in very good condition. see plan layout sheet steel piles with concrete encasement

6/2023 typical bent photos steel piles with concrete encasement

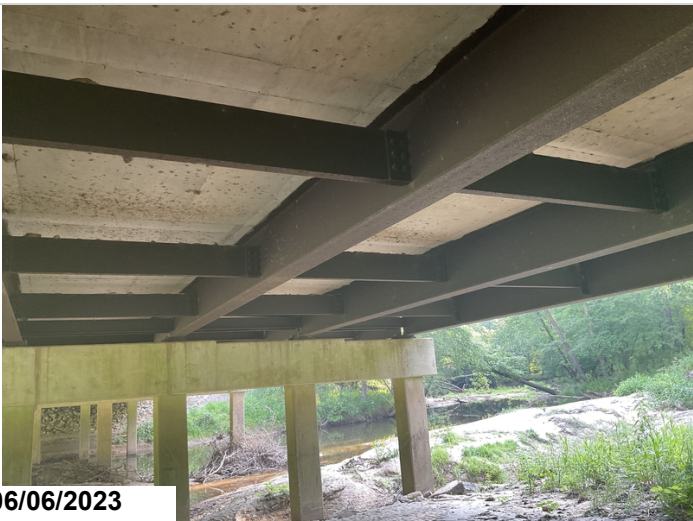
6/2023 Typical photo of wearing steel beams all spans  
Beams are in very good condition with some area of light brown rusting. over water. Typical on weathering steel beams.

6/2023 Typical photo of wearing steel beams all spans

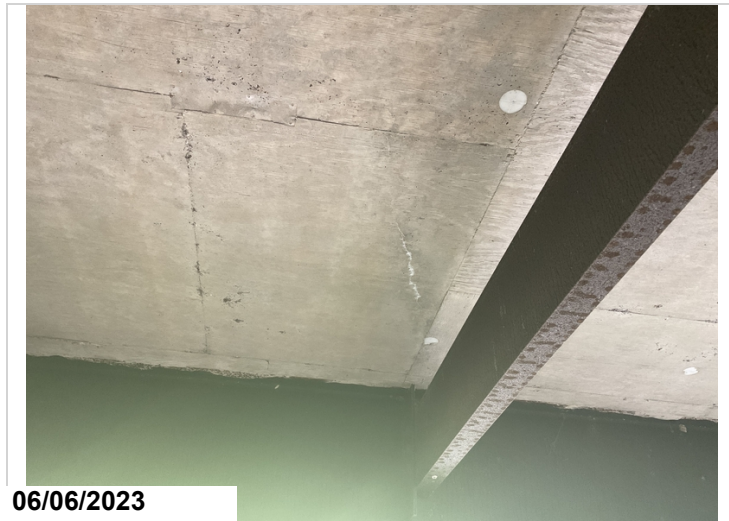
| ELEMENTS | DESCRIPTION | UNITS | TOTAL | CS1 | CS2 | CS3 | CS4 |
|---|---|---|---|---|---|---|---|
| (1120-12) 6/2023 cracking with white efflorescence .photo taken in span 2 bay 1 at bent 2 area | | | | | | | |

cracking with white efflorescence .photo taken in span 2 bay 1 at bent 2 area

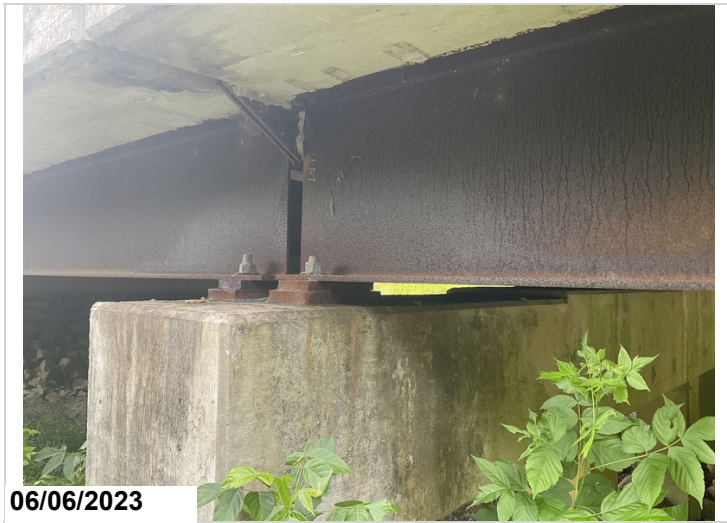
| ELEMENTS | DESCRIPTION | UNITS | TOTAL | CS1 | CS2 | CS3 | CS4 |
|---|---|---|---|---|---|---|---|
| (311) 6/2023 typical photo of bearings in good condition. some light rusting to weathering steel. | | | | | | | |

6/2023 typical photo of bearings

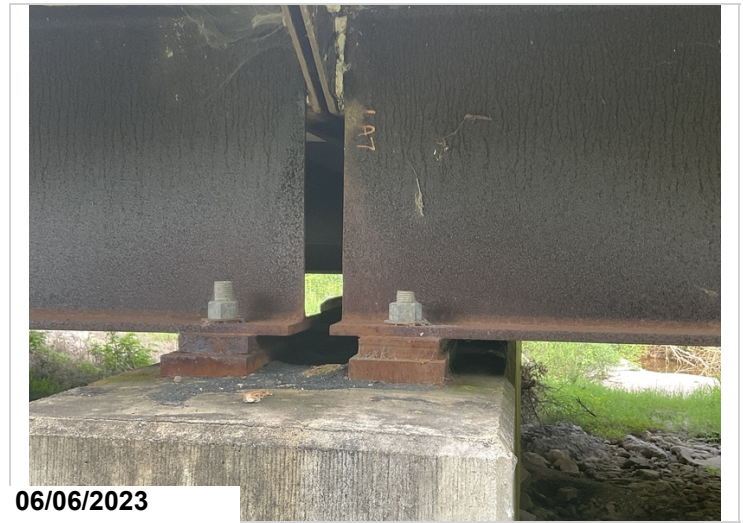
| ELEMENTS | DESCRIPTION | UNITS | TOTAL | CS1 | CS2 | CS3 | CS4 |
|---|---|---|---|---|---|---|---|
| (313) 6/2023 typical photo of bearings in good condition.. some light rusting to weathering steel. | | | | | | | |

6/2023 typical photo of bearings

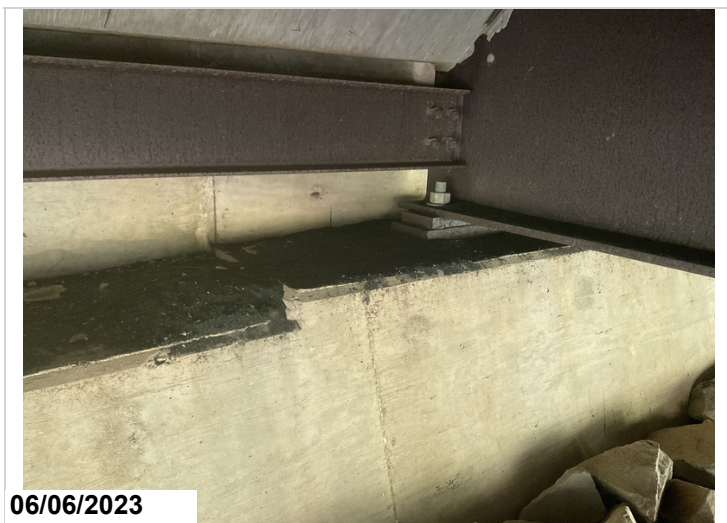
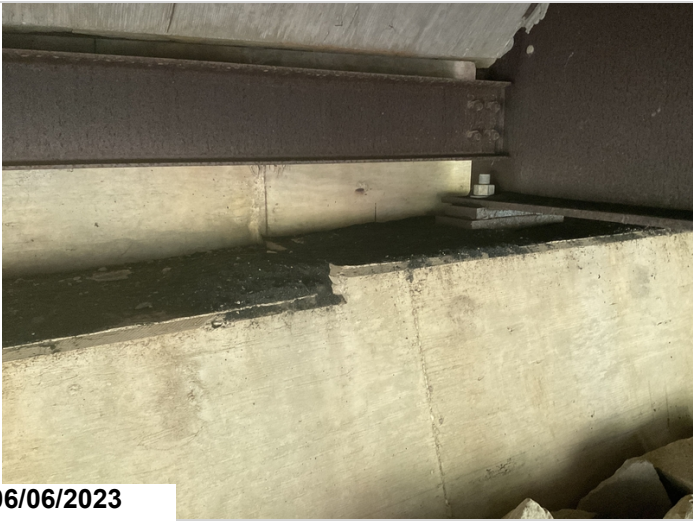
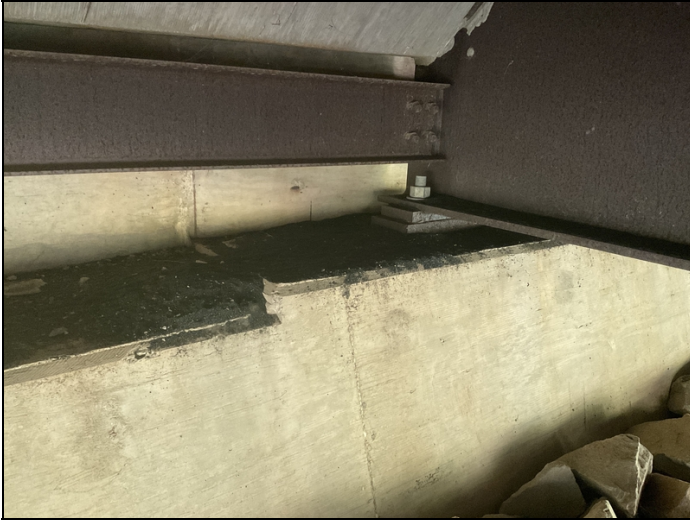
Photo of abutment 1 with sandblasting material on cap. other bent have some also..  
From joint repairs in 2021.

| ELEMENTS | DESCRIPTION | UNITS | TOTAL | CS1 | CS2 | CS3 | CS4 |
|---|---|---|---|---|---|---|---|
| (215) Photo of abutment 1 with sandblasting material on cap.<br>From joint repairs in 2021.. | | | | | | | |

Photo of abutment 1 with sandblasting material on cap.From joint repairs in 2021.

Photo of abutment 1 with sandblasting material on cap. From joint repairs in 2021.

Photo of abutment 1 with sandblasting material on cap. other bent have some also..  
From joint repairs in 2021.

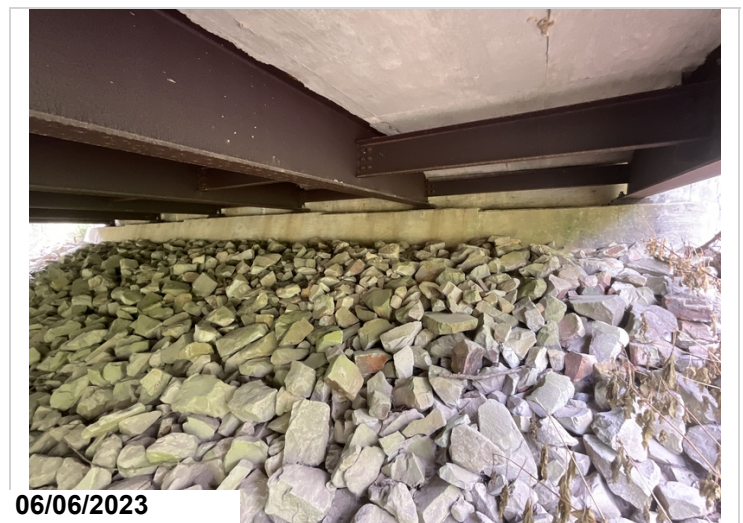
6/2023 photo of abutment 1

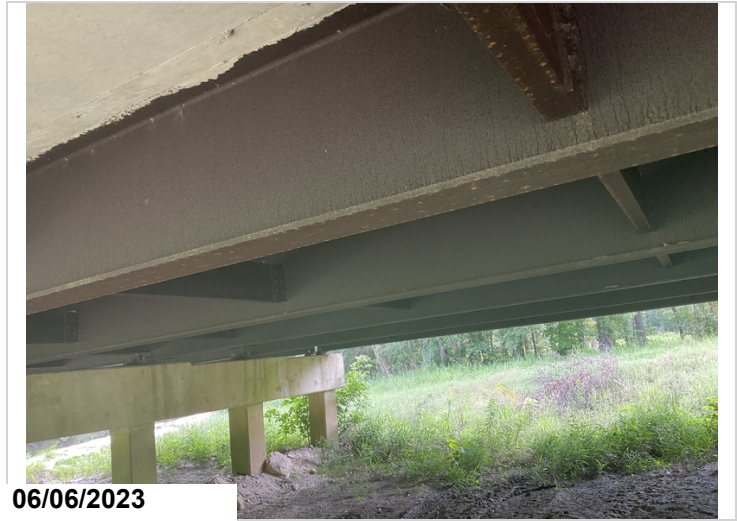
6/2023 typical photo of weathering steel beams. Photo taken in span 1

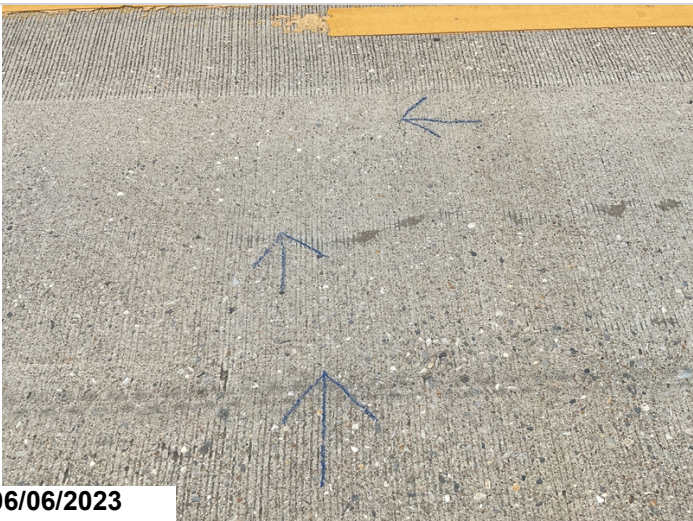
| ELEMENTS | DESCRIPTION | UNITS | TOTAL | CS1 | CS2 | CS3 | CS4 |
|---|---|---|---|---|---|---|---|
| 6/2023 unsealed cracks in deck photo of span 1 left side.<br>typical cracking in deck top side most all spans<br>cracking with white efflorescence .photo taken in span 2 bay 1 at bent 2 area | | | | | | | |

6/2023 typical cracking in deck top side most all spans photo taken in span 2 near bent 3

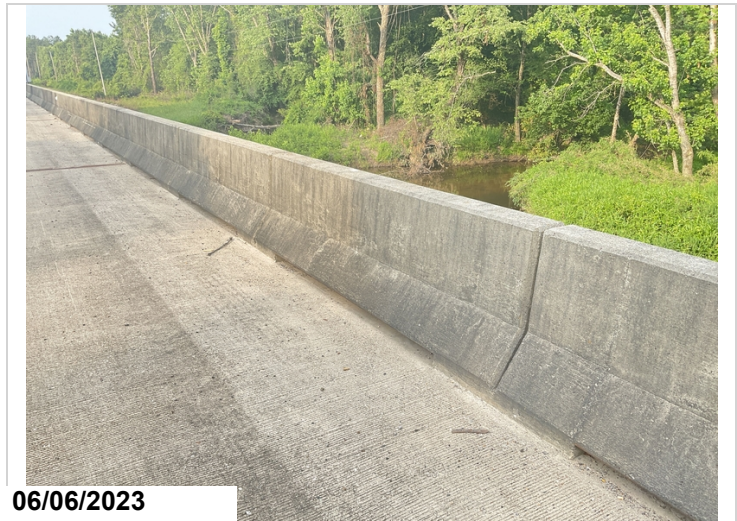
| ELEMENTS | DESCRIPTION | UNITS | TOTAL | CS1 | CS2 | CS3 | CS4 |
|---|---|---|---|---|---|---|---|
| (331) 6/2023 Typical photo of concrete bridge railing in good condition | | | | | | | |

6/2023 Typical photo of concrete bridge railing in good condition

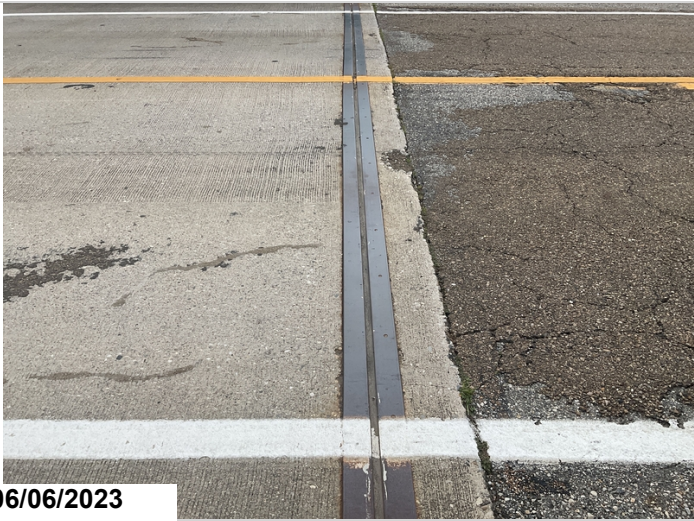
6/2023 photo of joint 1 beginning of bridge in good condition

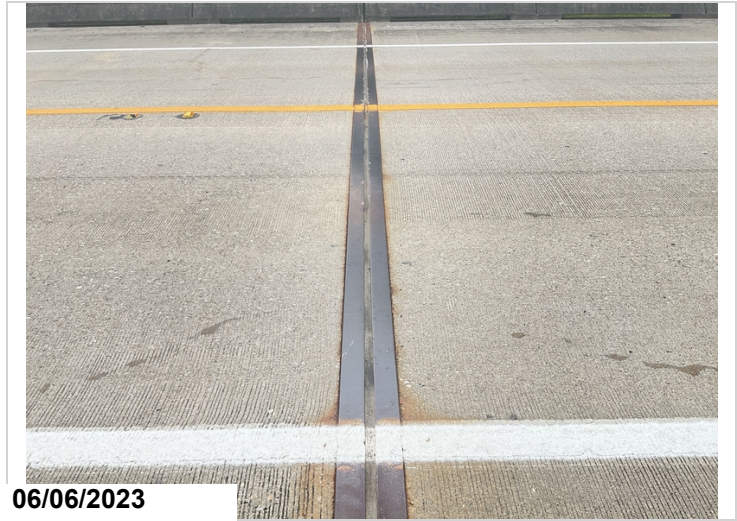
| ELEMENTS | DESCRIPTION | UNITS | TOTAL | CS1 | CS2 | CS3 | CS4 |
|---|---|---|---|---|---|---|---|
| (302) 6/2023 photo of joint at bent 2 good condition. Note typical good condition for all other joints.<br>joints were rework in 2021.. | | | | | | | |

6/2023 photo of joint at bent 2 good condition.

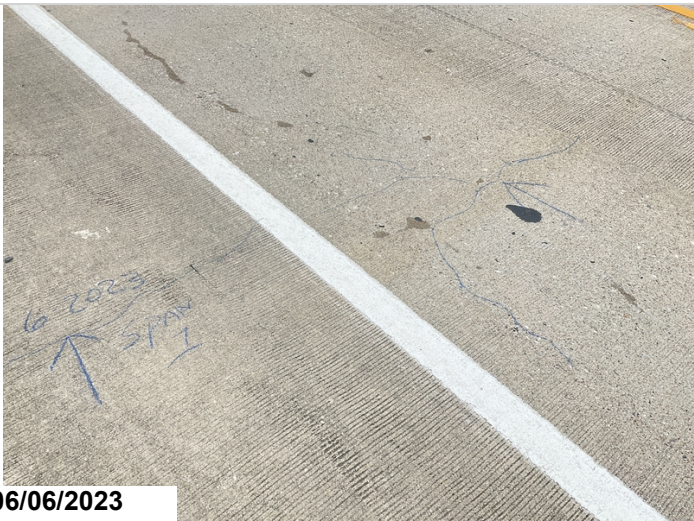
6/2023 unsealed cracks in deck photo of span 1 left side.

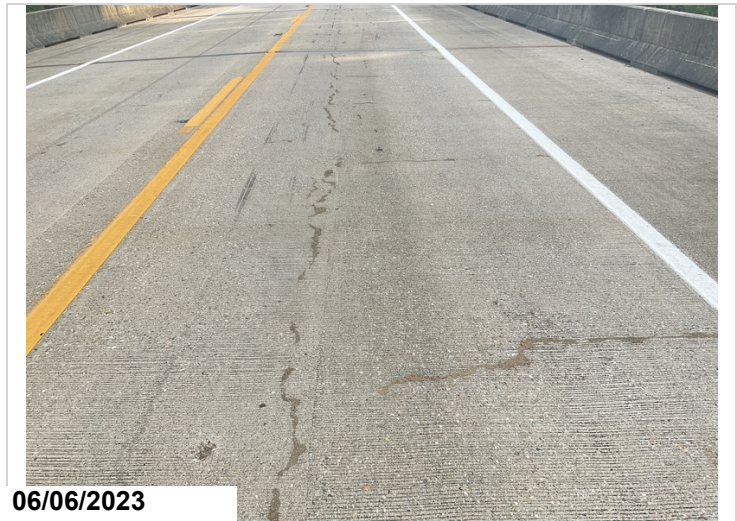
06/2023 very small cracks in deck , some have been sealed in past.

6/2023 small cracks in deck some sealed in past.

06/2023 very small cracks in deck , some have been sealed in past.
