Asset #05878(Routine)

SH 19 - 05 - 8.50 over BRUSHEY CREEK RELIEF

Location: 8.9 MI NO JCT US 67

Team Lead: John King Inspection Date: 10/02/2023

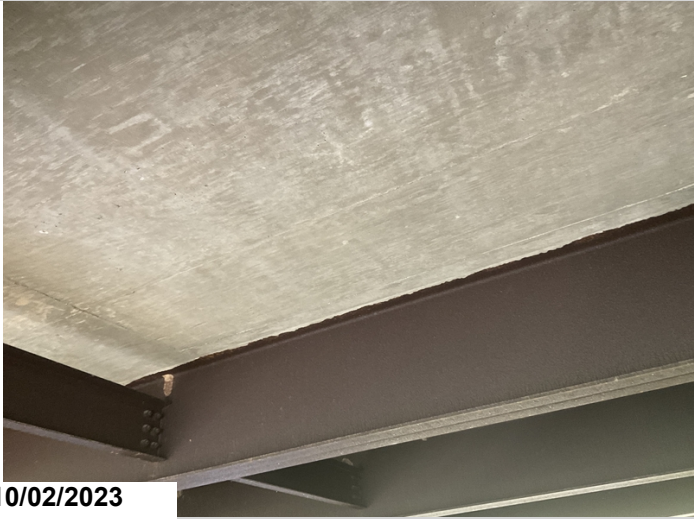
Typical underside of concrete deck

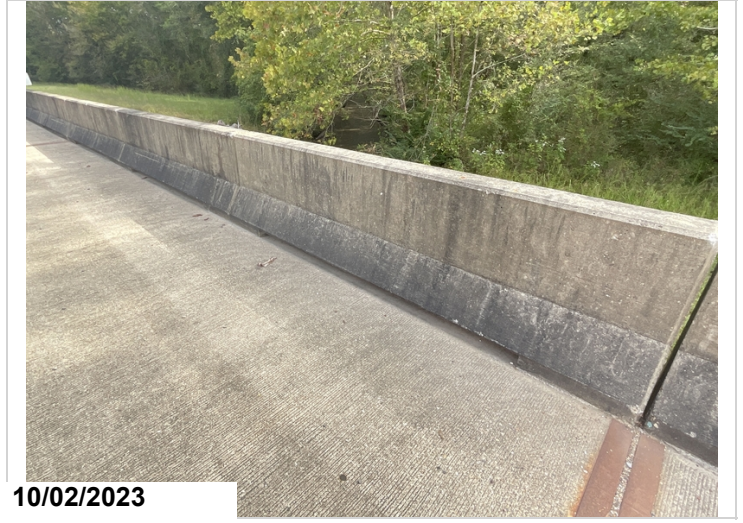
Typical photo of concrete parapet wall

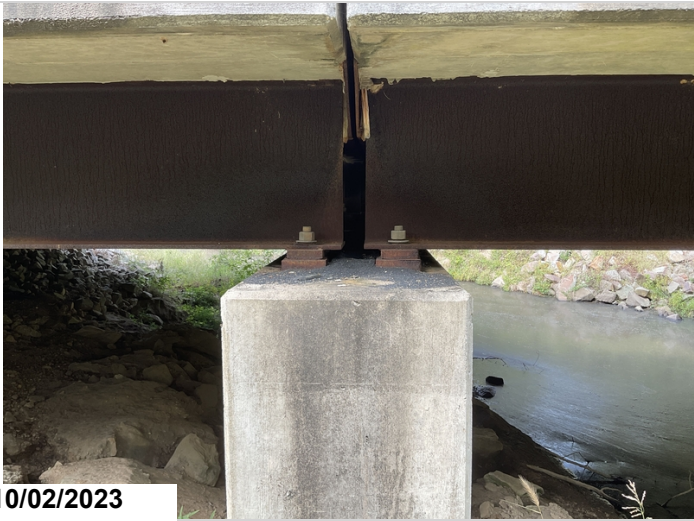
(300) Typical joints are in good condition, looks to have been replaced in the past. .							
311	Movable Bearing	EA	18	18	0	0	0
(311) bearings are in good condition. sand blasting material needs removed, and caps cleaned off. Bearing may have some very minor discoloring but no texture at this time							
313	Fixed Bearing	EA	18	18	0	0	0

Typical bearings photo

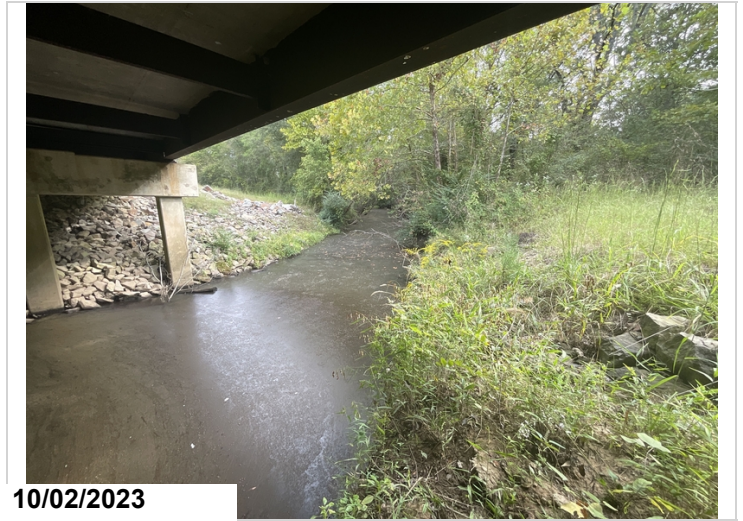
Channel to right side bridge

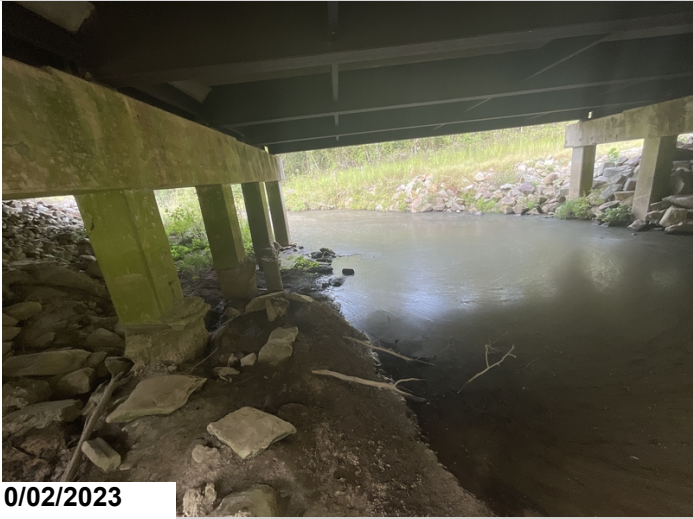
Channel on left side bridge.

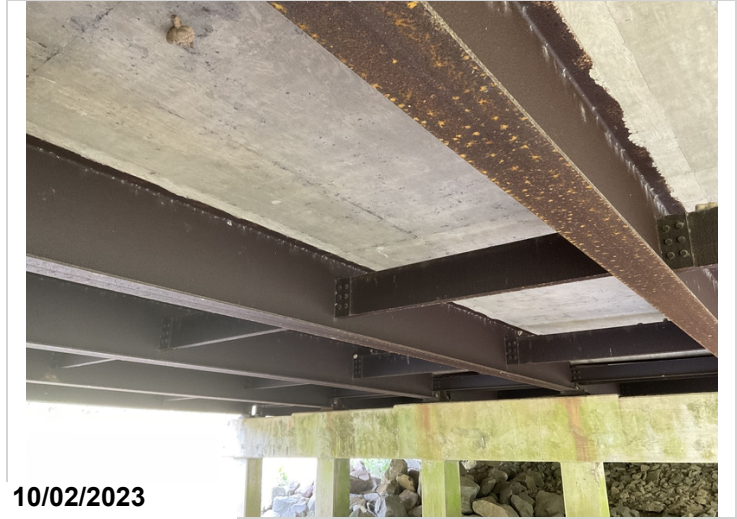
(107) weathering steel beams are in very good condition. (515-107) Weathering steel beams have fully development and tightly adhere. Bottom flange has minor yellow color from water and dust collecting..							
215	Reinforced Concrete Abutment	LF	121	121	0	0	0
227	Reinforced Concrete Pile	EA	12	10	2	0	0
1080	Delamination/Spall/Patched Area	EA	2	0	2	0	0

Typical superstructure photo with weathering steel beams

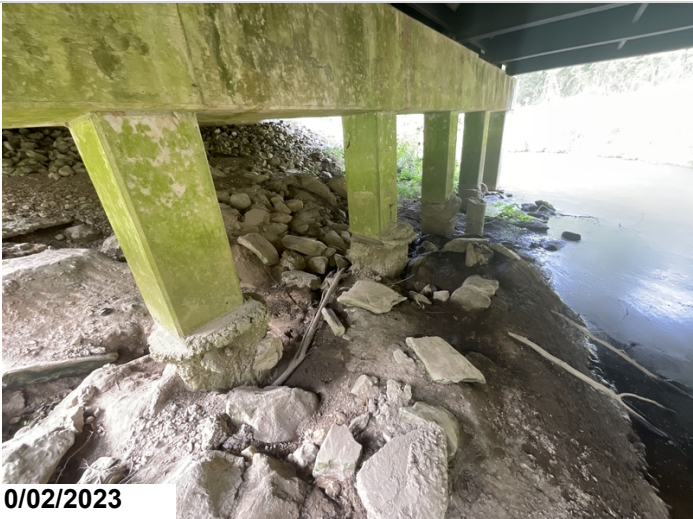
7 good due to erosion and scour with concrete repair around steel beams  
sand blasting material on all caps from joint repair also added light corrosion on all bearings.  
Bent 2 has some scouring and loss on rip to slope under span 1.

Bent 2 has some scouring and loss on rip to slope under span 1

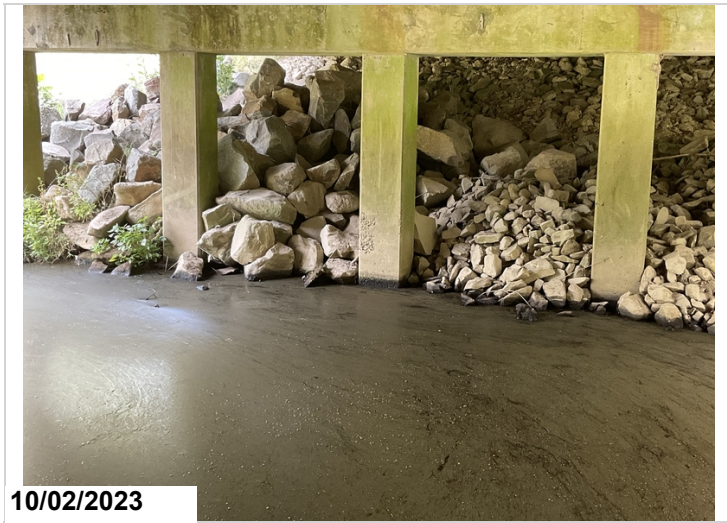
(227) 10-26-21 Bent #2 pile #4 bottom spall Bent #3 pile #3 honeycomb bottom of pile							
234	Reinforced Concrete Pier Cap	LF	166	166	0	0	0
300	Strip Seal Expansion Joint	LF	164	164	0	0	0

Bent 3 pile 3 honeycomb area at ground line

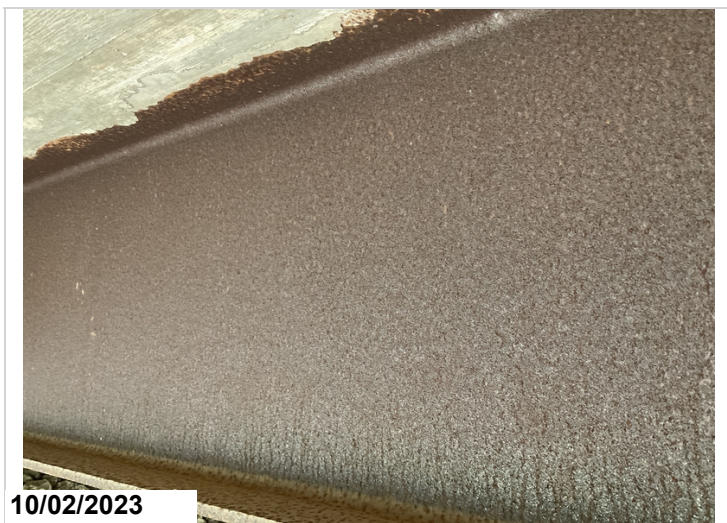
Weathering steel beams

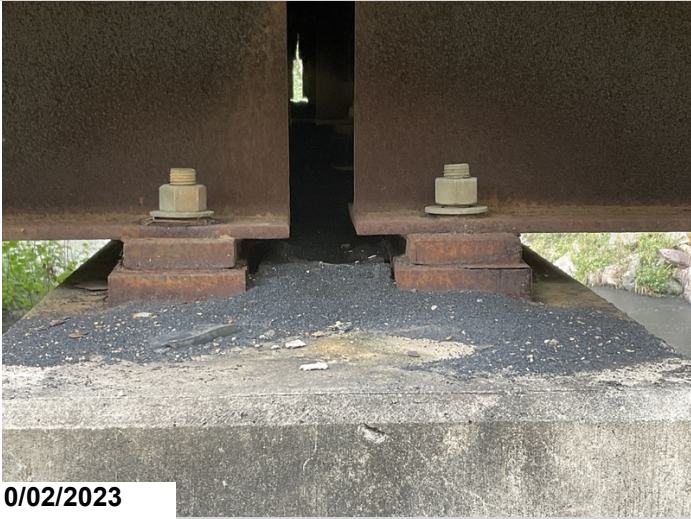
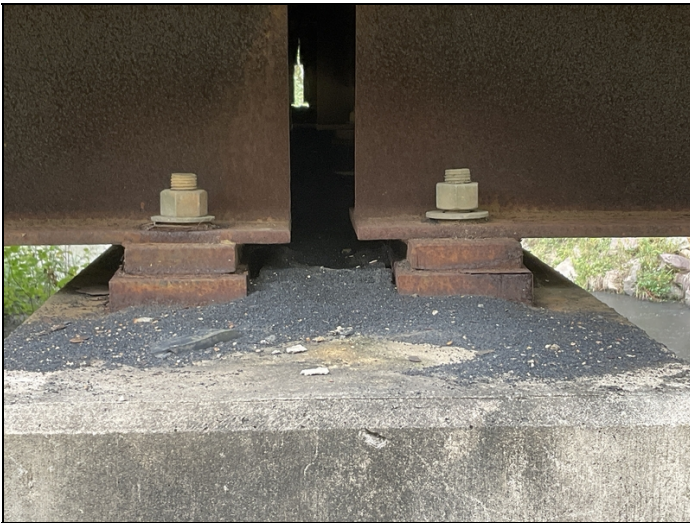
Bent 2 cap need cleaned

Bent 2 cap need cleaned.

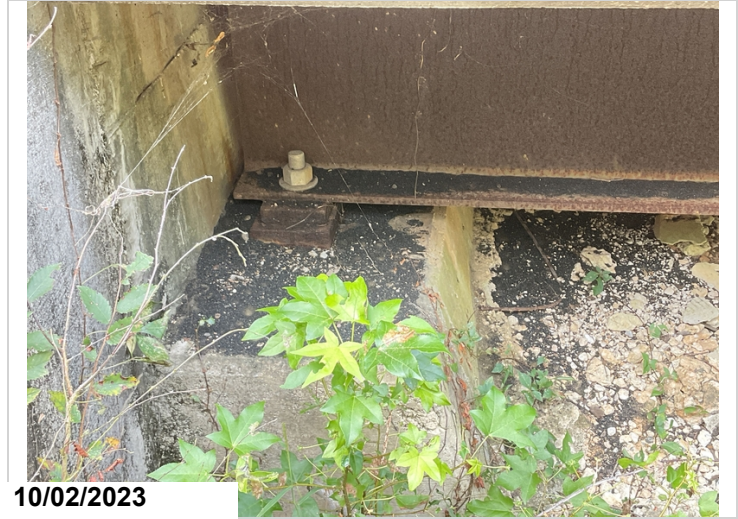
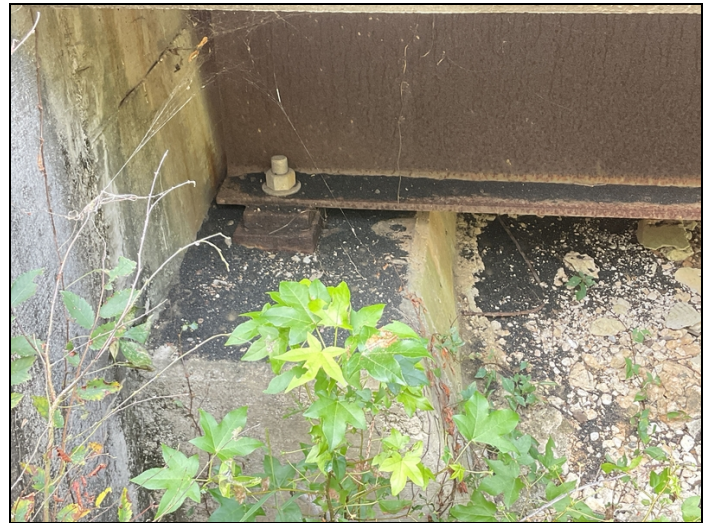
Bent 1 photo of sand blasting material left on cap from joint repair.

Bent 1 photo of sand blasting material left on cap from joint repair.

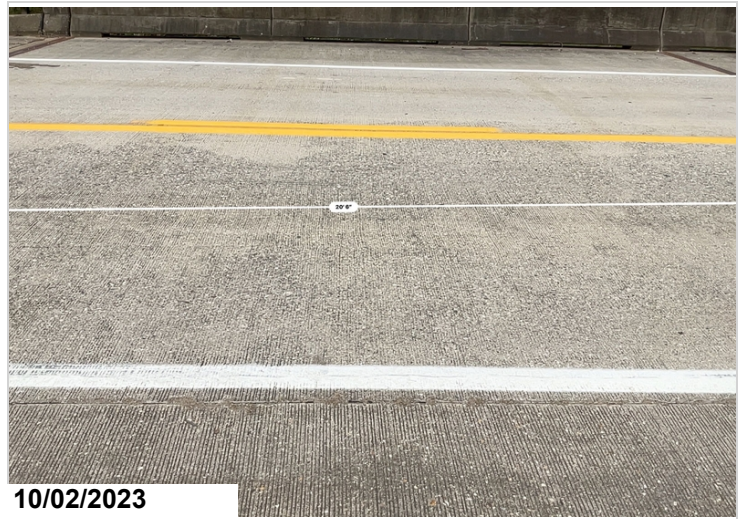
(12) Span 1 minor cracking in top of deck. all spans have some hair line cracking. Span 1 minor abrasion wearing to top of concrete deck. Span 2 has some abrasion wearing that has exposed coarse aggregate, aggregate remains secure in concrete.							
107	Steel Open Girder/Beam	LF	630	630	0	0	0
515	Steel Protective Coating	SF	12663	12663	0	0	0

Span 1 abrasion wearing to top of concrete deck

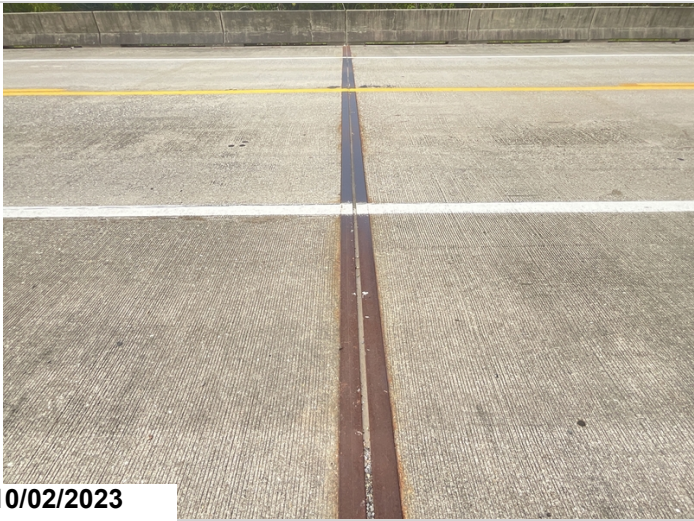
Typical joints are in good condition

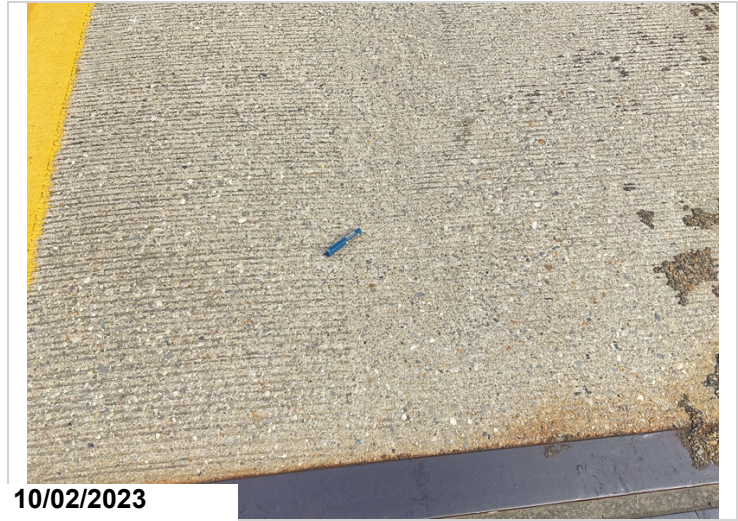
Span 1 minor cracking in top of deck

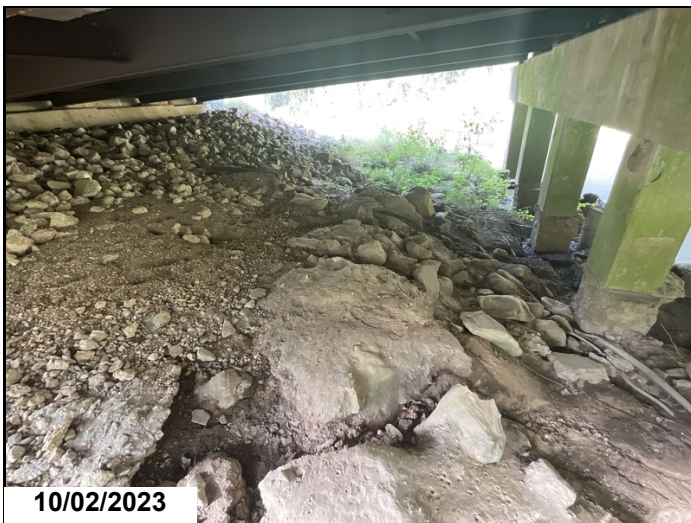
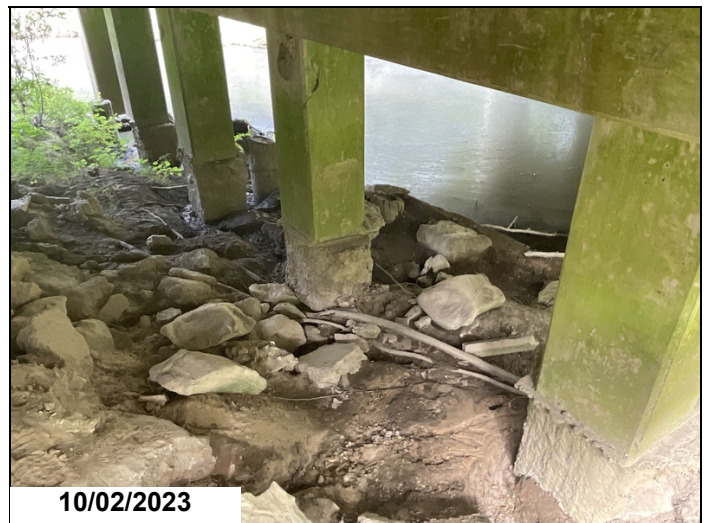
BENT 2 MATERIAL HAS WASHED AWAY FROM COLUMNS  
updated photo little to no change in condition.

10/23 update photo

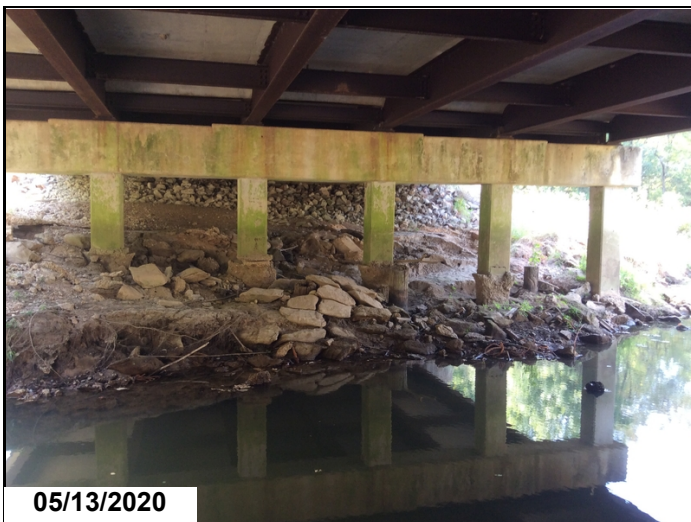
.Bent #3 has been repaired Bent #2 has erosion

Bent 2 erosion

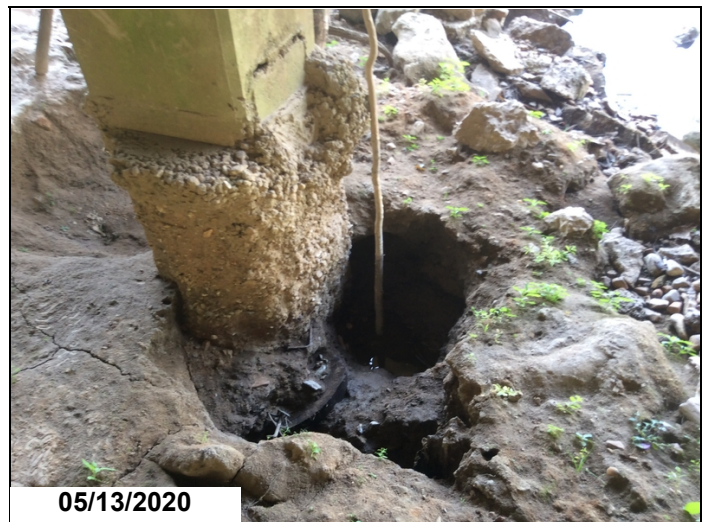
BENT 2 AT PILE 2 EROSION

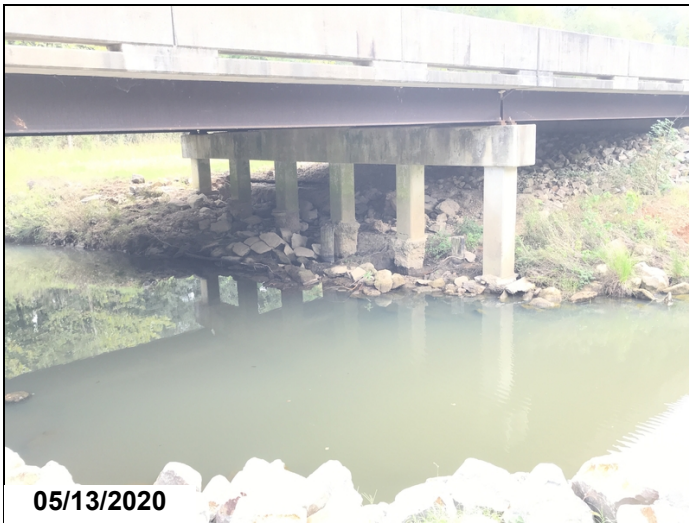
Erosion Bent #2

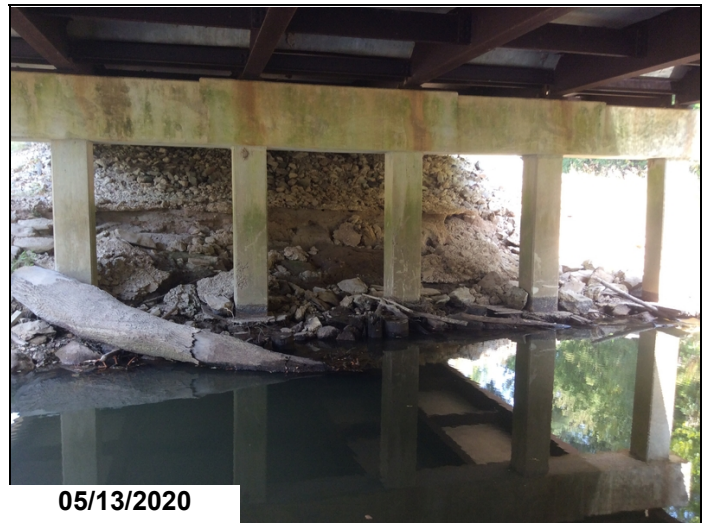
EROSION AT END BENT SLOPE

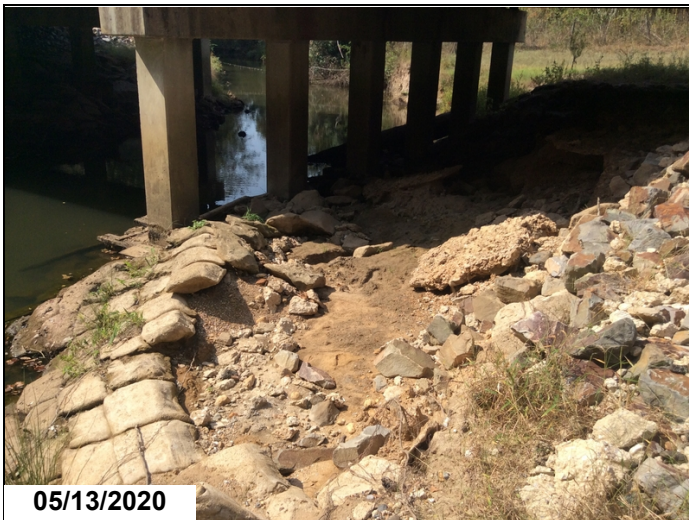
BENT 2 AND 3. MATERIAL HAS WASHED AWAY FROM COLUMNS. This photo of BT 3

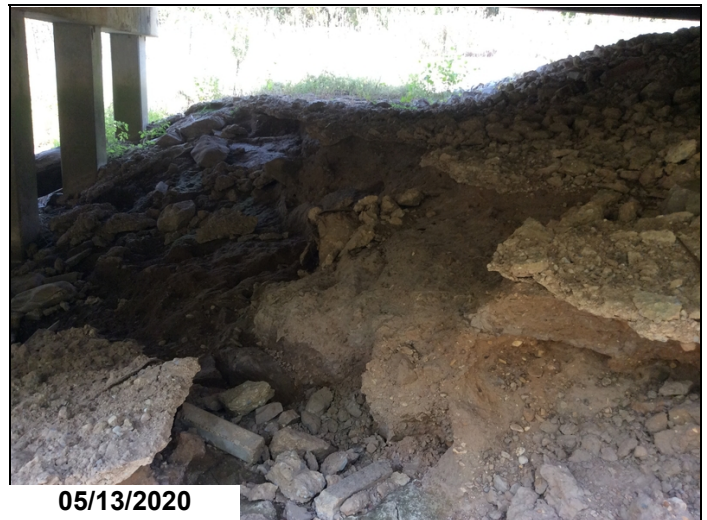
BENT 2 AND 3. MATERIAL HAS WASHED AWAY FROM COLUMNS.
