Asset #05061(Routine)

US 371 SEC 4 -3.00 over I 30- SEC-13- 43.95

Location: JCT HWY 371 & I-30

Team Lead: John King, Inspection Date: 06/19/2023

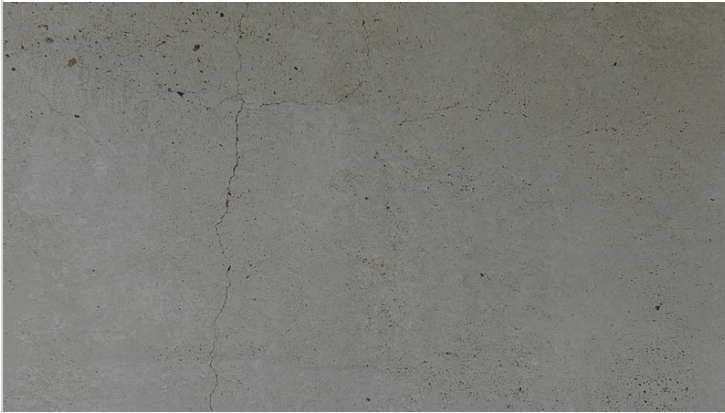
Bent 3 cap at top of column 3 has cracking in cap

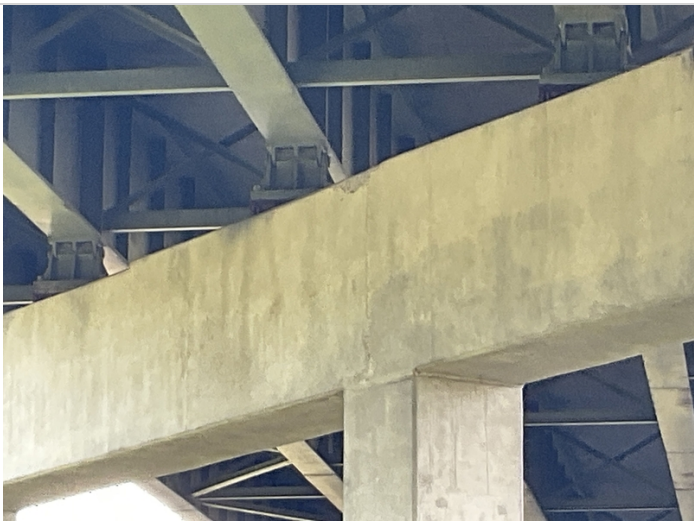
Delam bent 4 span 3 side on cap

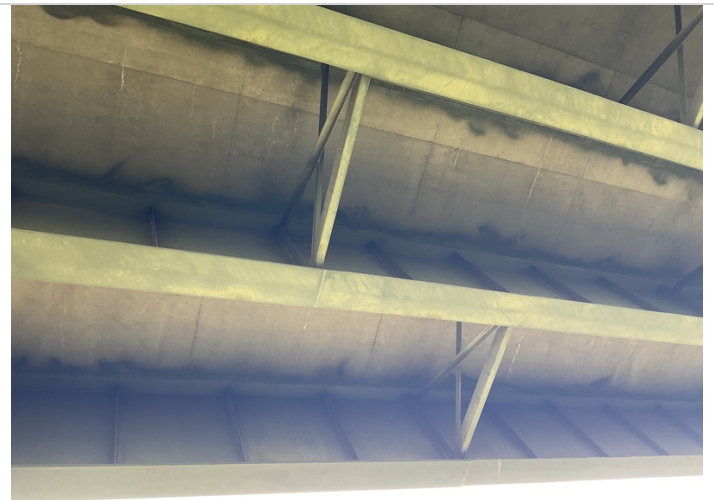
Span 3 efflorescence in various locations

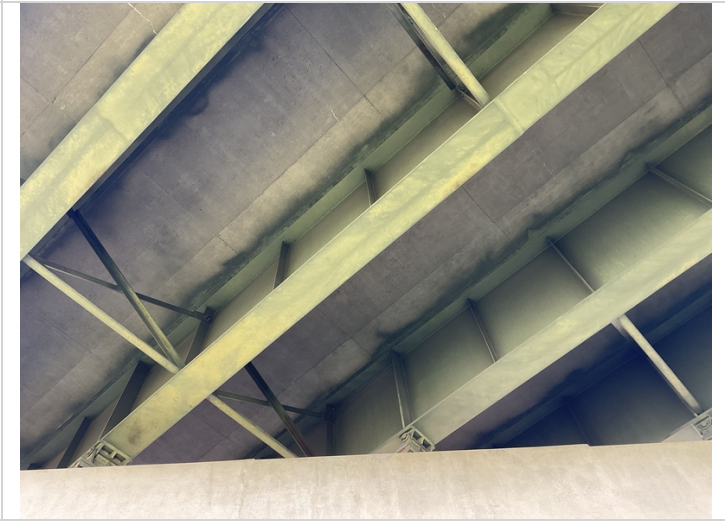
Beams chalking and oxide build up in various locations

Bearings are rusting with some section loss. all beams will need to be painted soon.

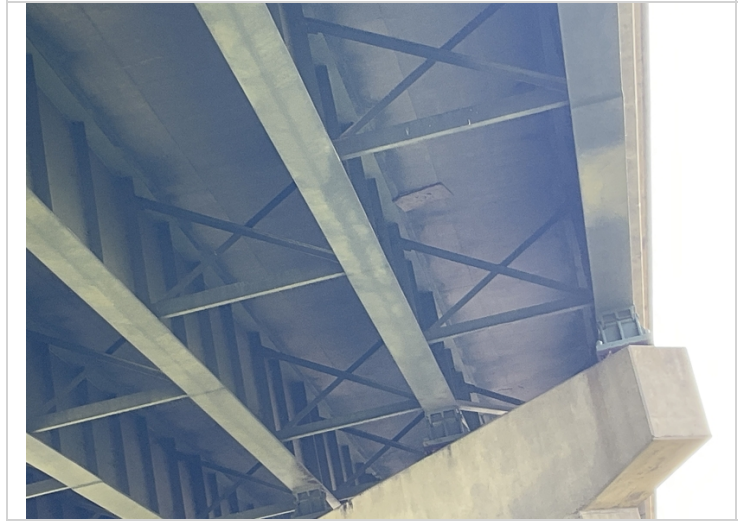
Span 3 bay 5 old patch

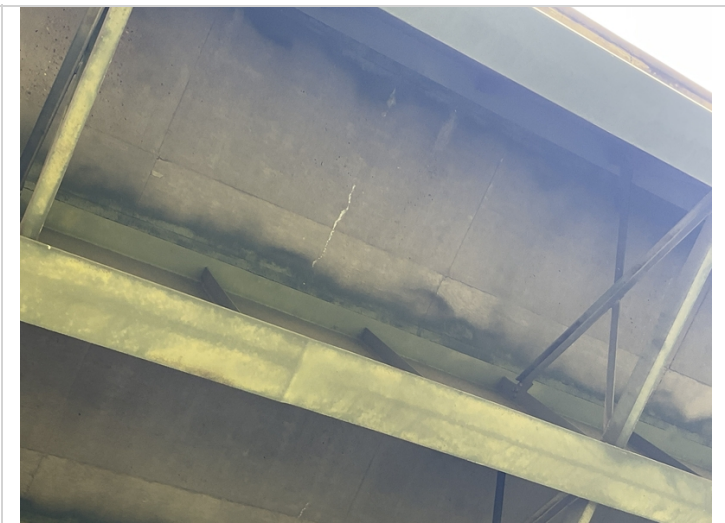
Span 3 efflorescence bay 5

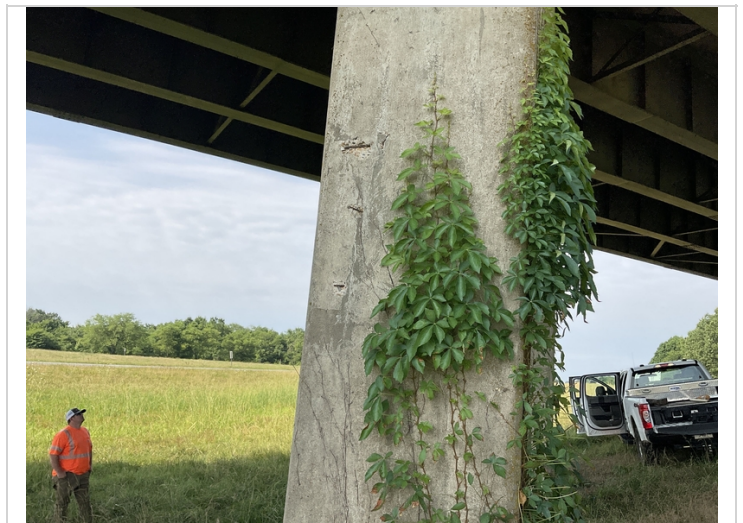
Bent 3 column 1 rebar exposed

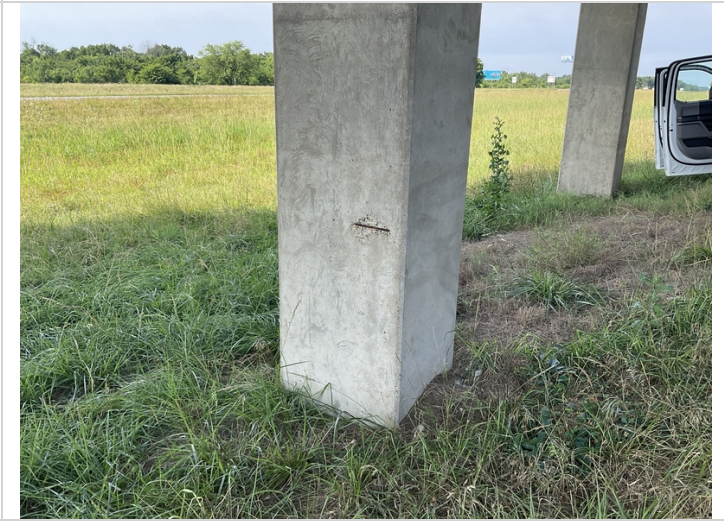
Bent 3 column 2 rebar exposed

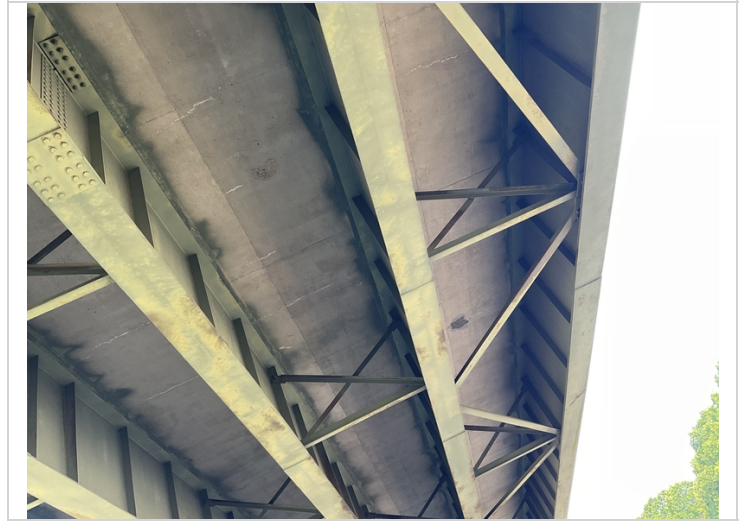
Span 2 bays 1 & 2 have spalls

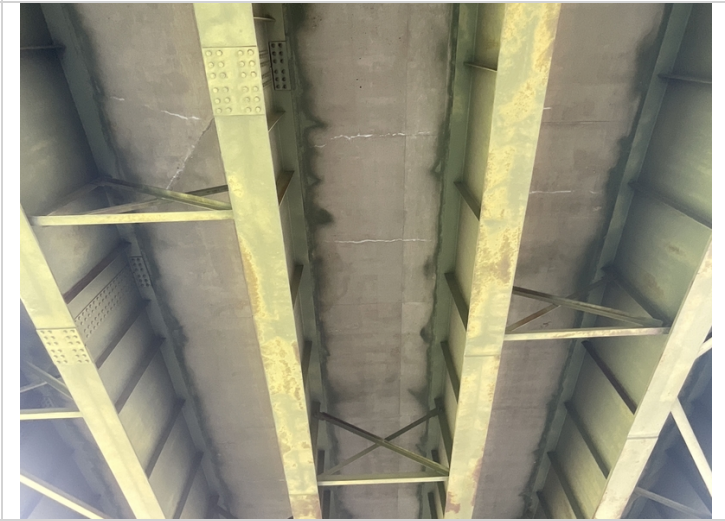
Span 2 efflorescence in various locations

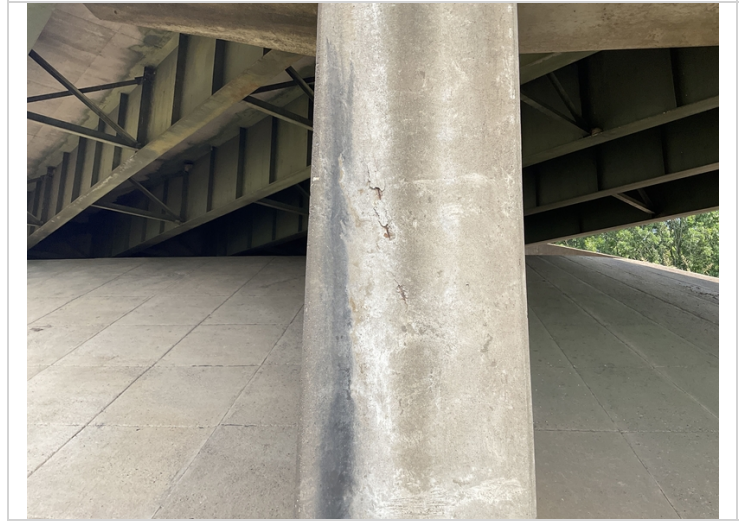
Delams with wire showing bent 2 column 3

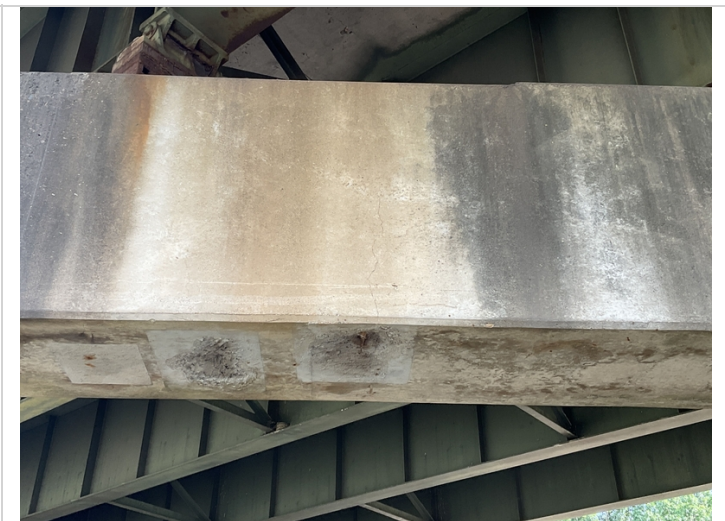
Cracking in bent 2 cap

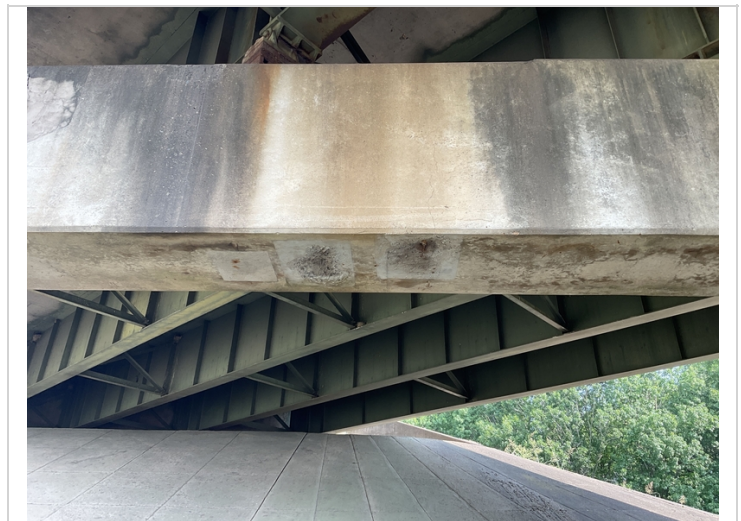
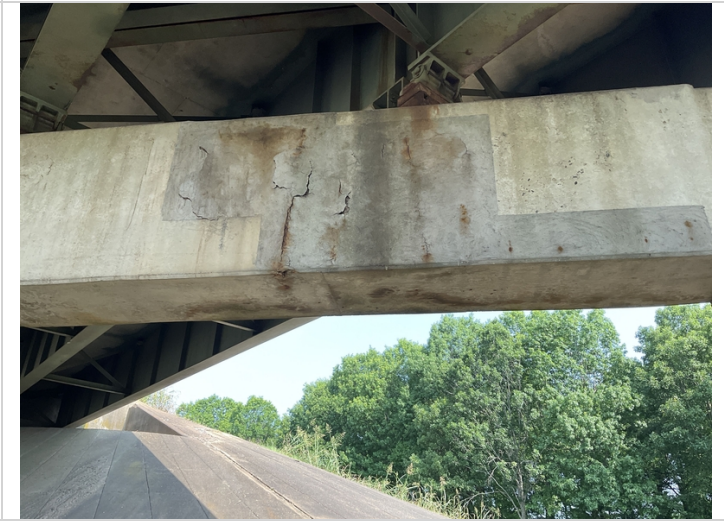
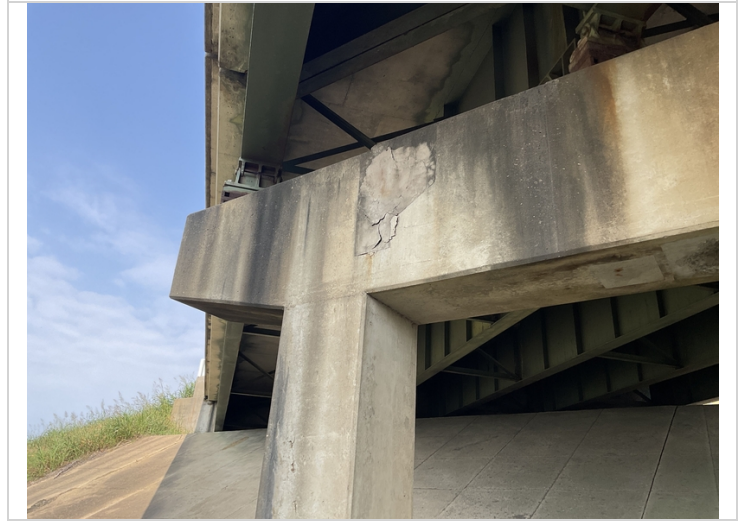
Bent 2 cap old patchwork is failing and popping out

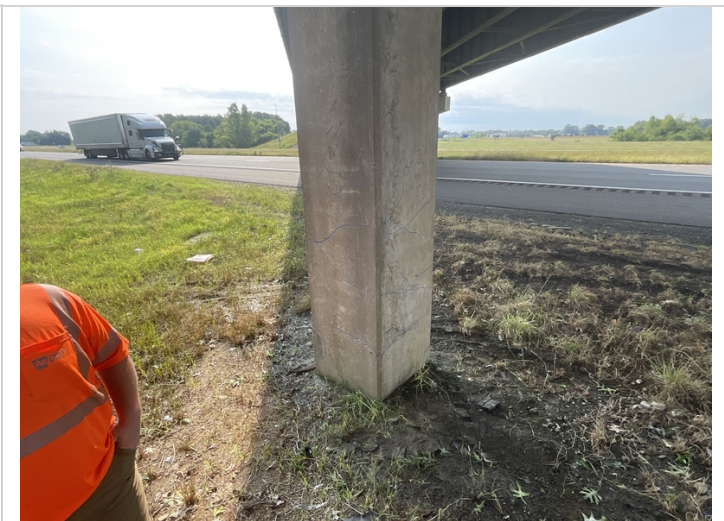
Column 1 bent 2 has cracking and delam

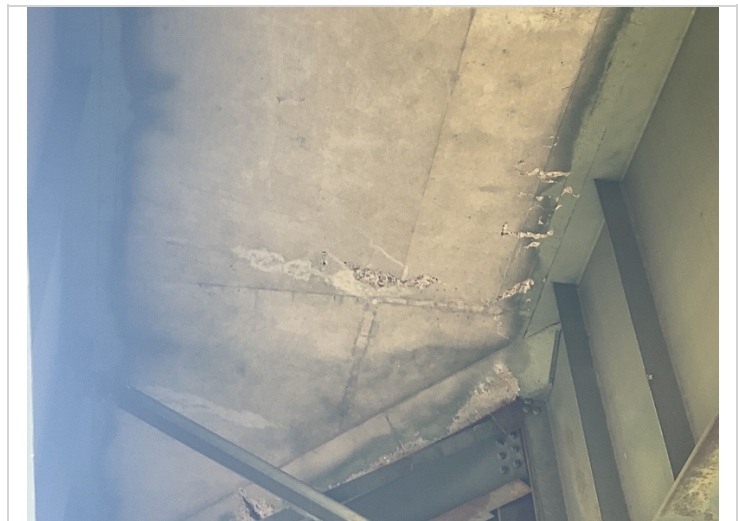
Span 1 bay 1 has spalls

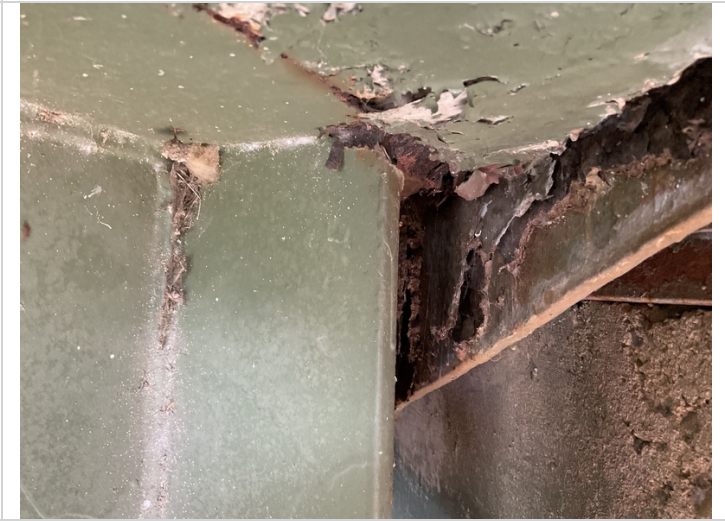
Beginning of bridge beam 1 has corrosion with section loss

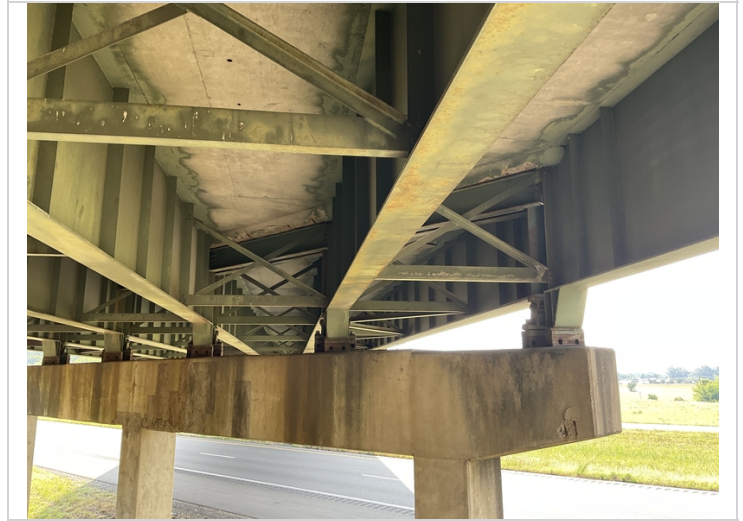
Most honches have spalls some with rebar exposed

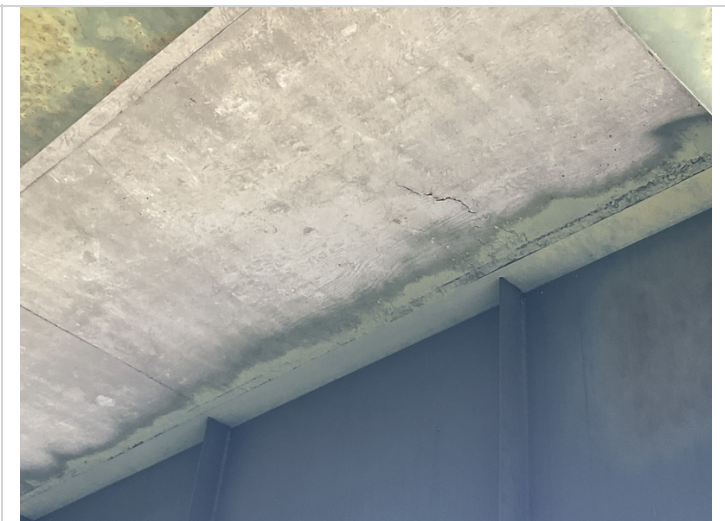
Span 1 bay 5 has spall

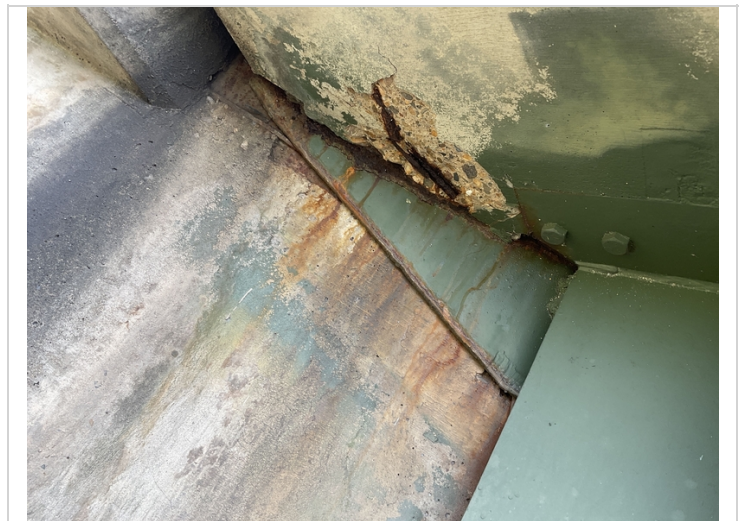
Beginning of bridge right side deck over hang has rebar exposed

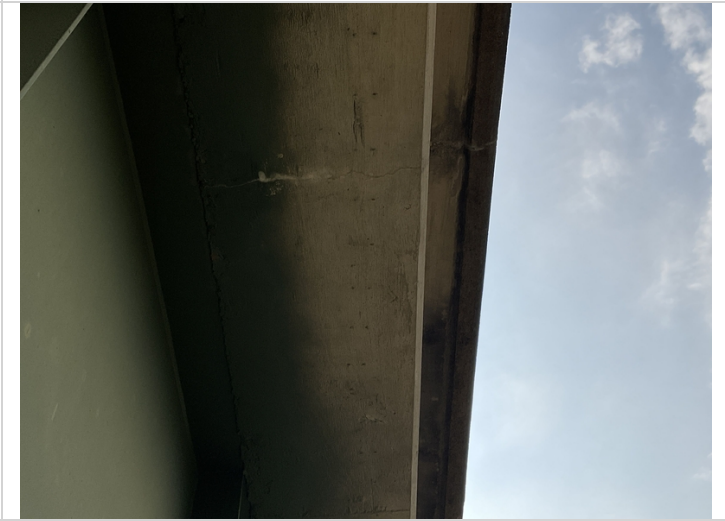
Deck over hangs have cracking and efflorescence in various locations

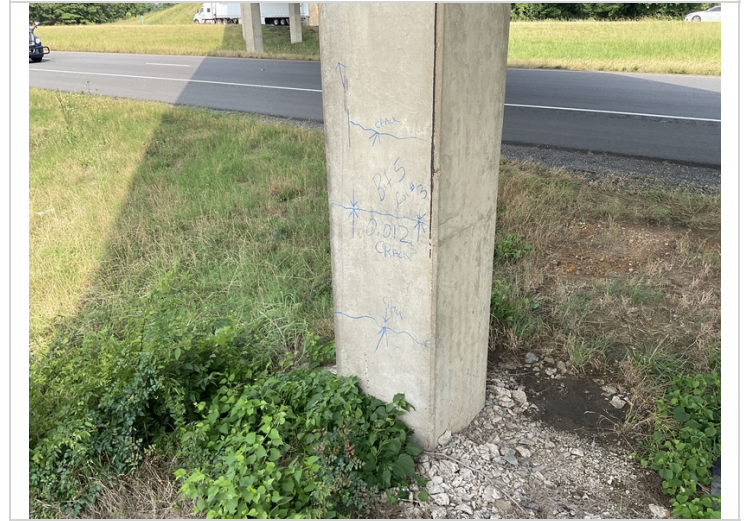
Cracking in bent 5 column 3

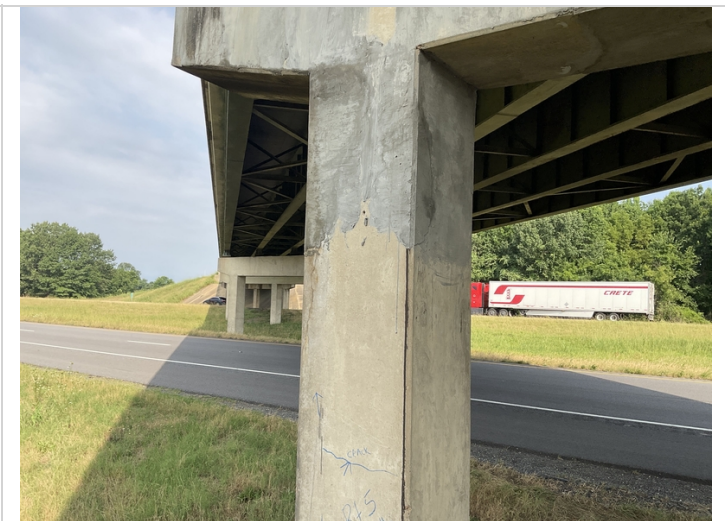
Old patch work bent 5 column 3

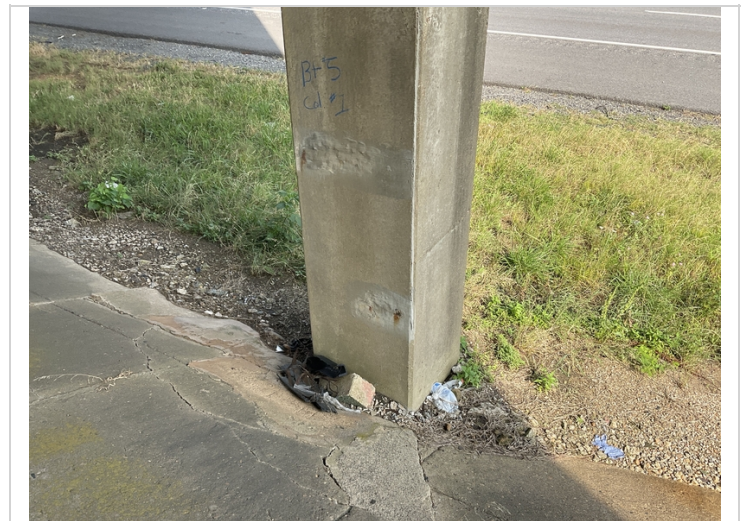
Old patch work bent 5 column 1

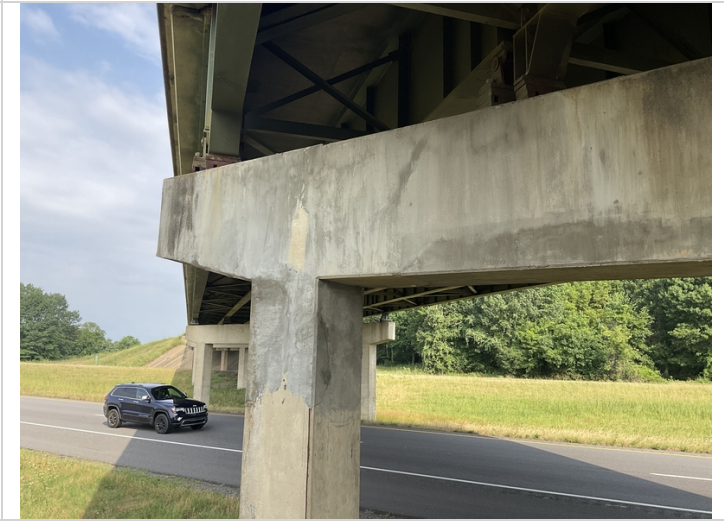
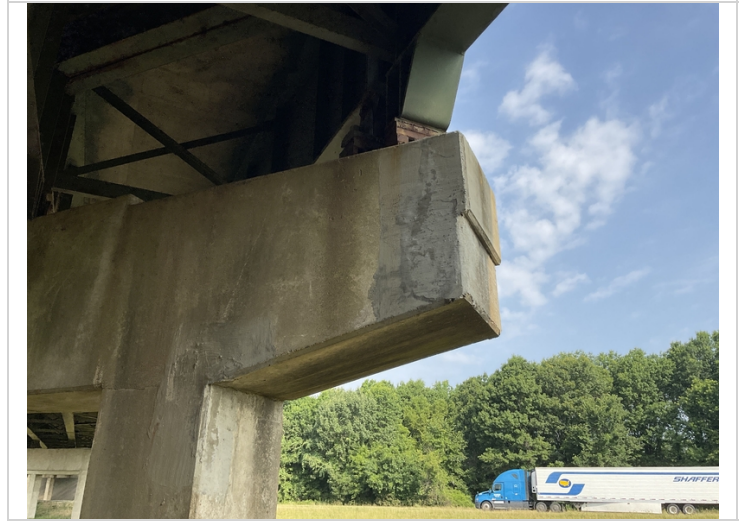
Old patch work bent 5

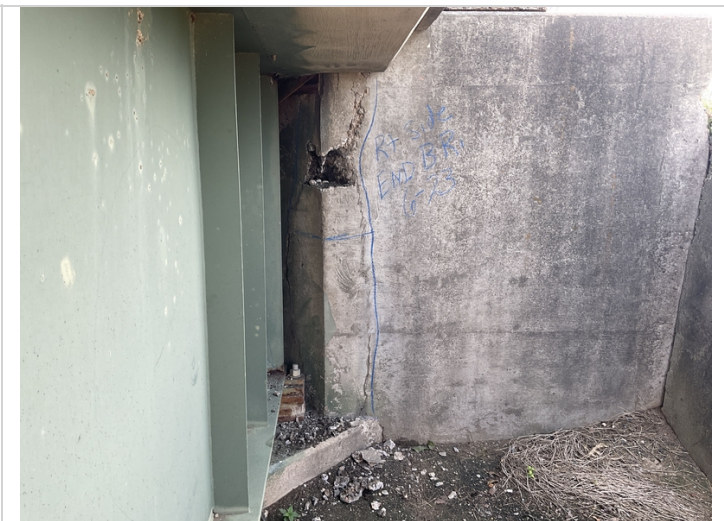
Bent 6 right side large spall with rebar exposed

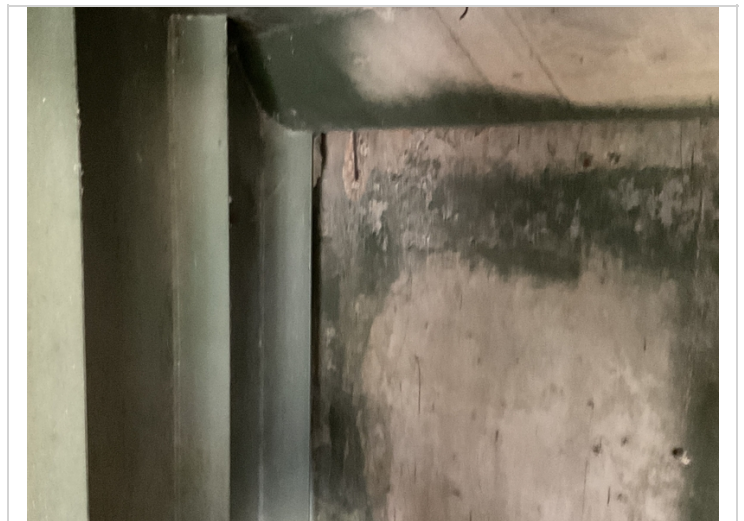
Bent 6 rebar exposed

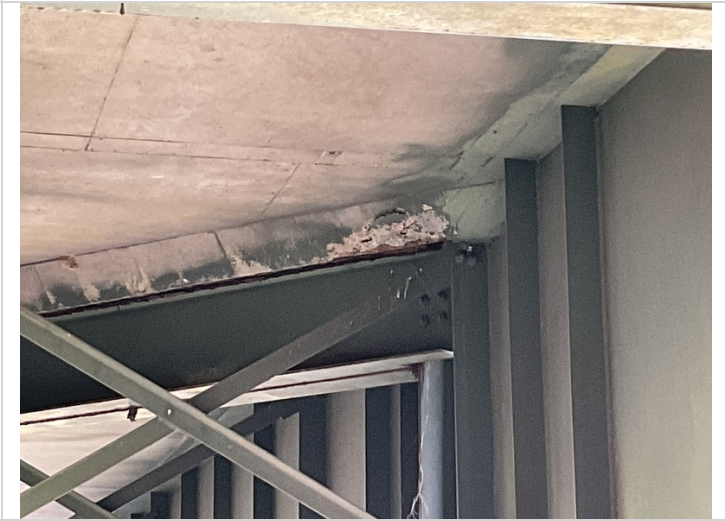
Spall in honches various locations

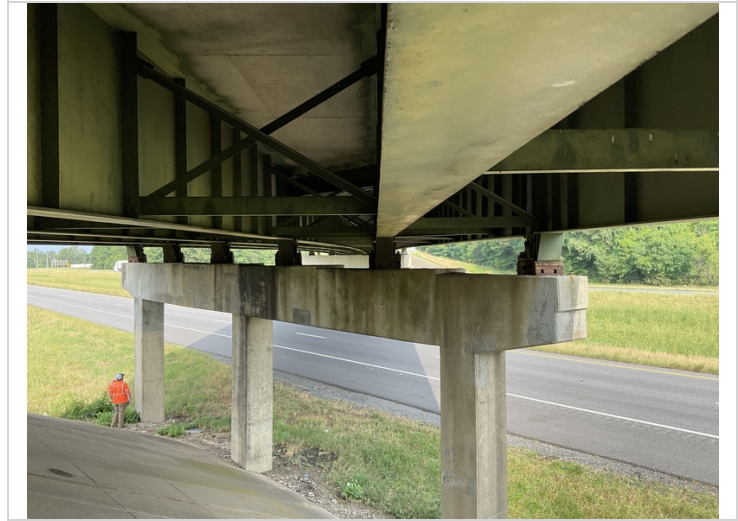
All movable bearings are showing corrosion

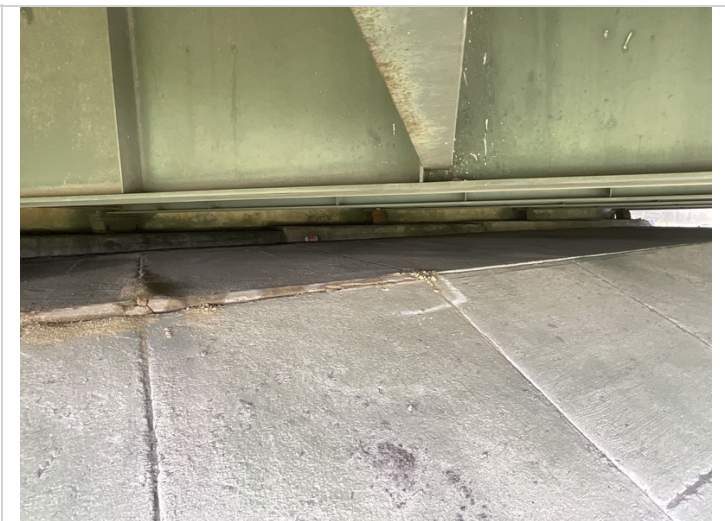
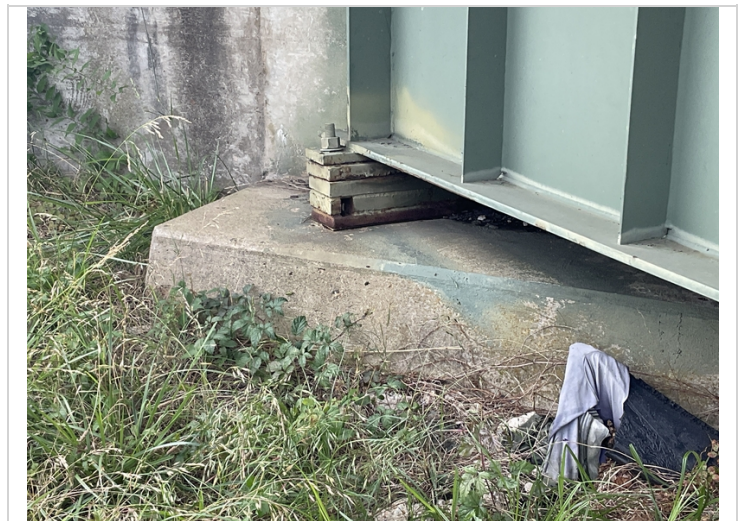
All fixed bearings are beginning to rust

All Fixed bearings are showing signs of rusting

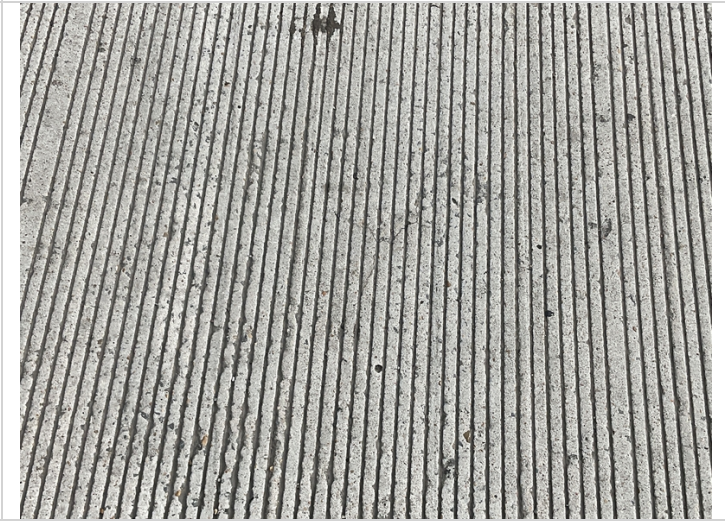
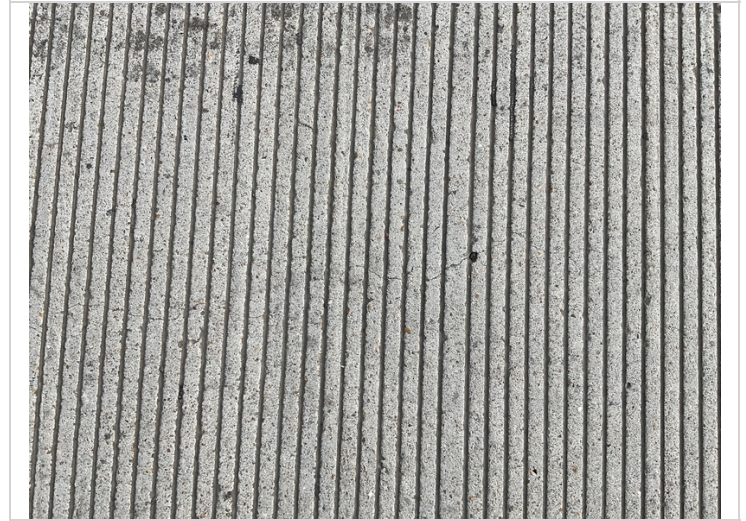
Cracking in deck various locations

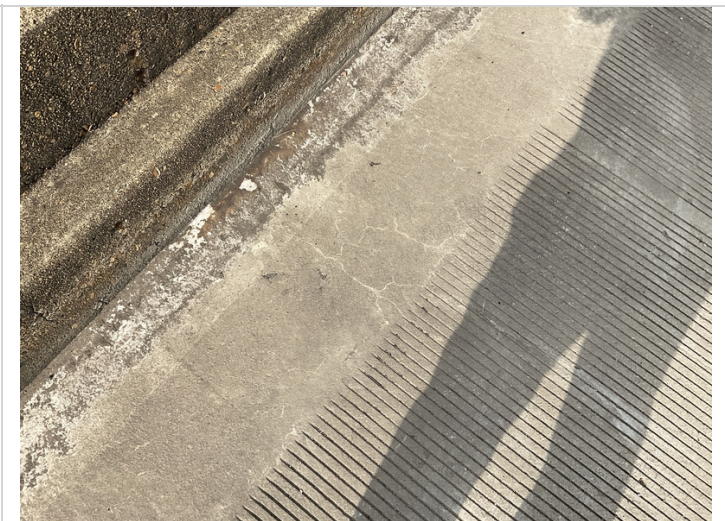
Map like cracking in various locations on deck

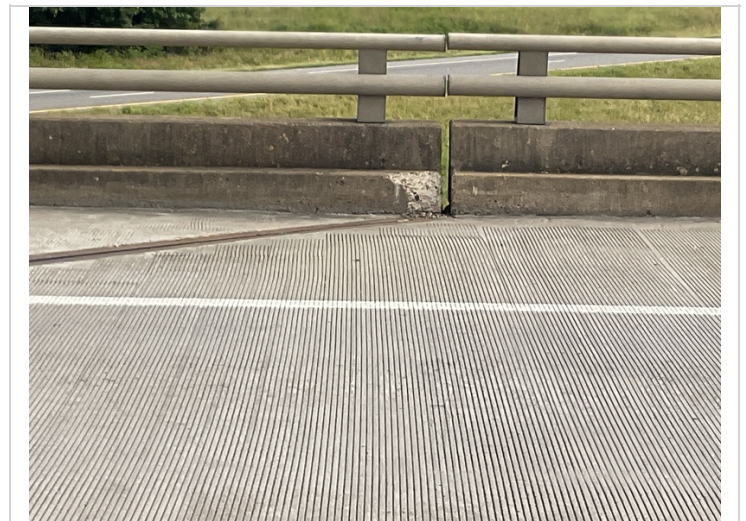
Span 4 left side of concrete railing above bent 5 spall

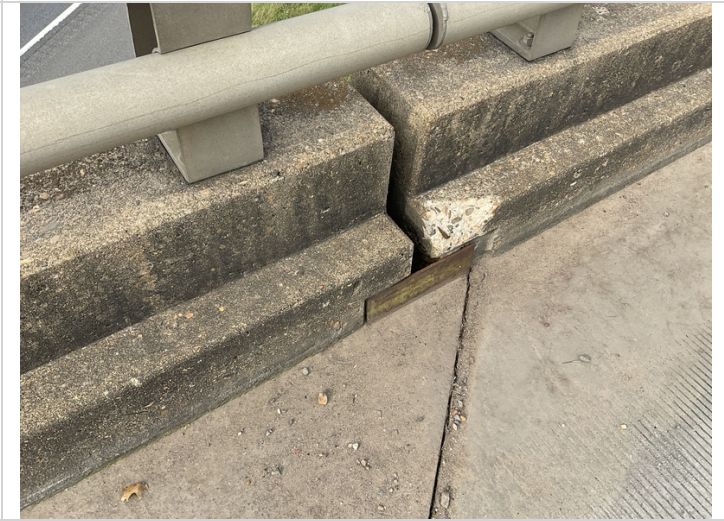
Delam Rt side end of span 1

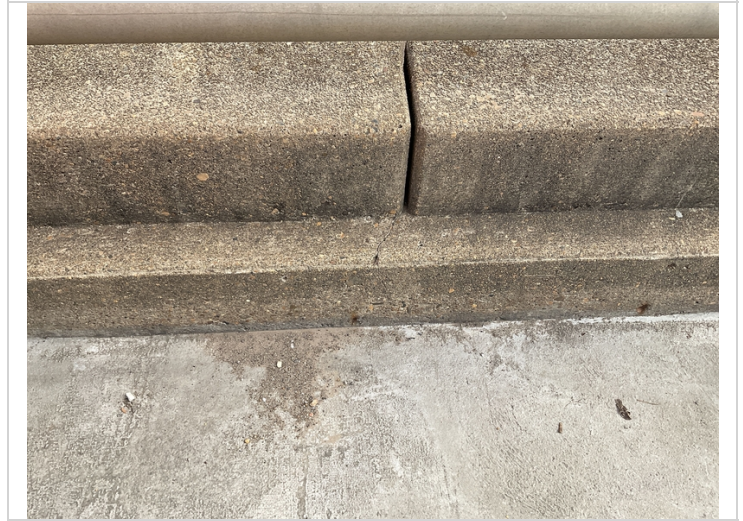
Cracking in concrete bridge railing

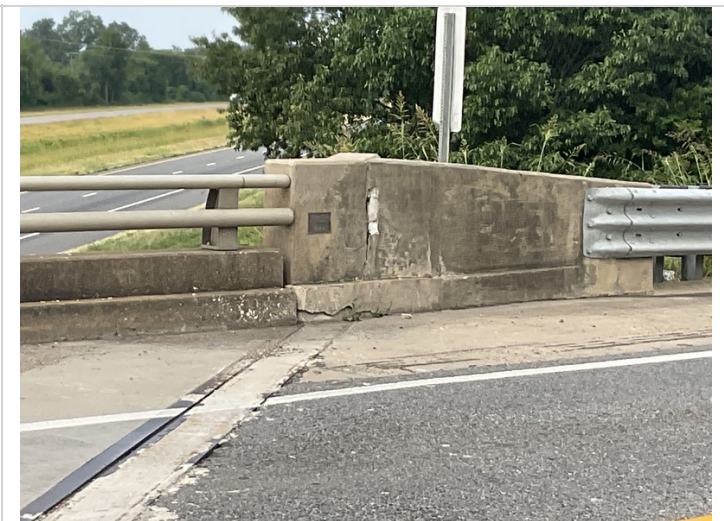
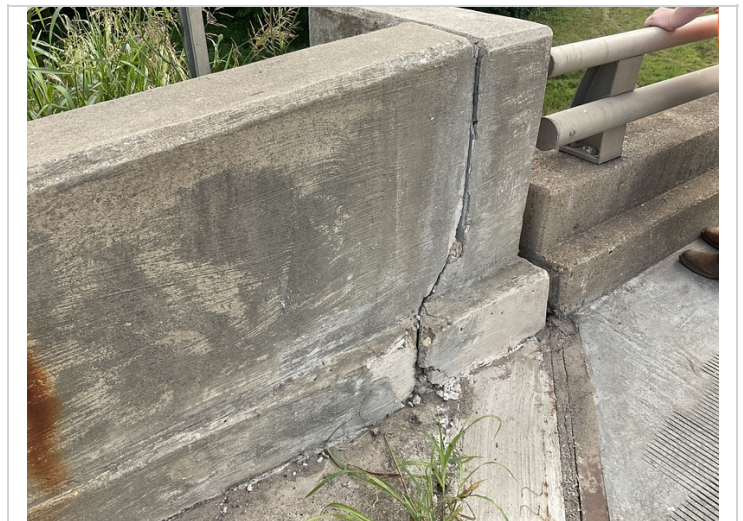
Walls beginning of bridge left and right side have delams
before first joint on bridge
