Asset #07172(Routine)

SH 24 SEC. 05-8.67 over TERRE ROUGE CREEK

Location: 8.71 MI E JCT 67 PRESCOTT

Team Lead: John King, Inspection Date: 06/13/2023

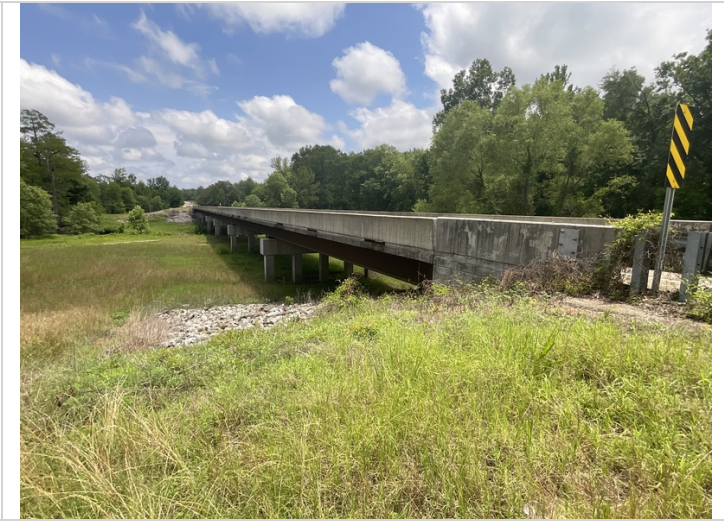
6/23 elevation of left side bridge

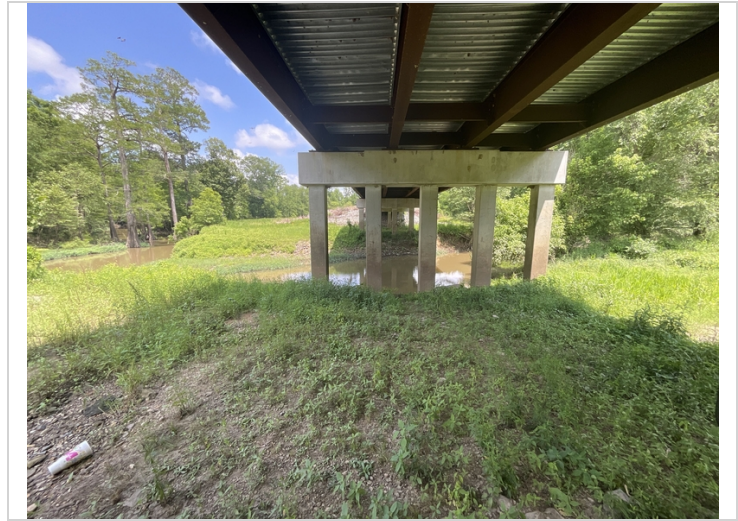
6/23 channel in very good condition vegetation along both sides of bank

6/23 channel vegetation

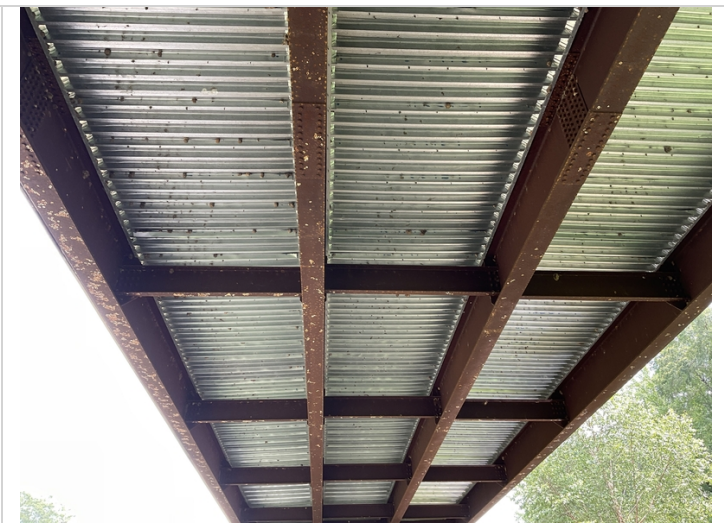
6/23 weathering steel beams are in very good condition. Some minor color changes in span 1  
And span 5 has some growth spores above creek channel.

Photo of weathering steel beams over water span 5

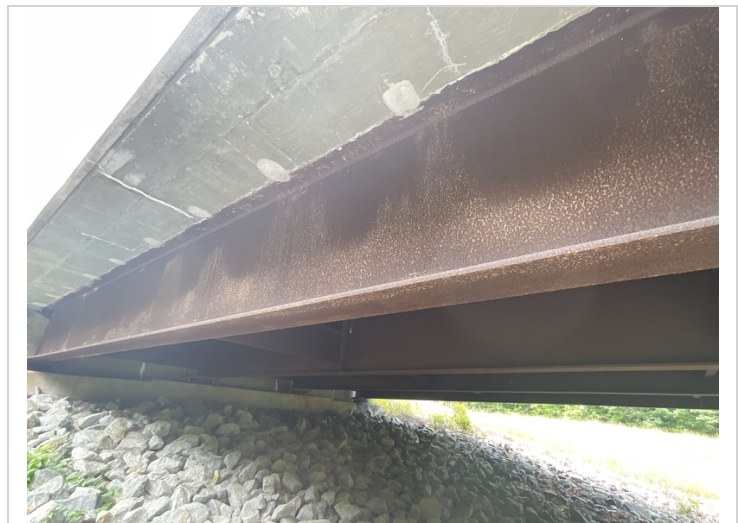
Span 1 beams 2,3&4 has a light color to weathering beams

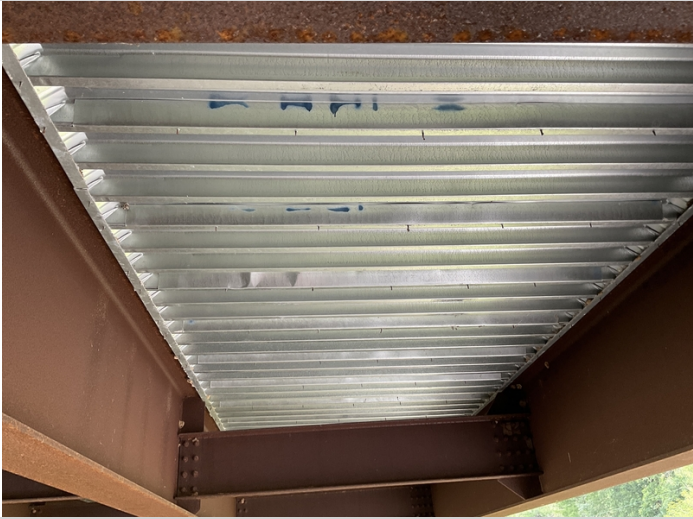
6/23 typical deck pans bottom side deck

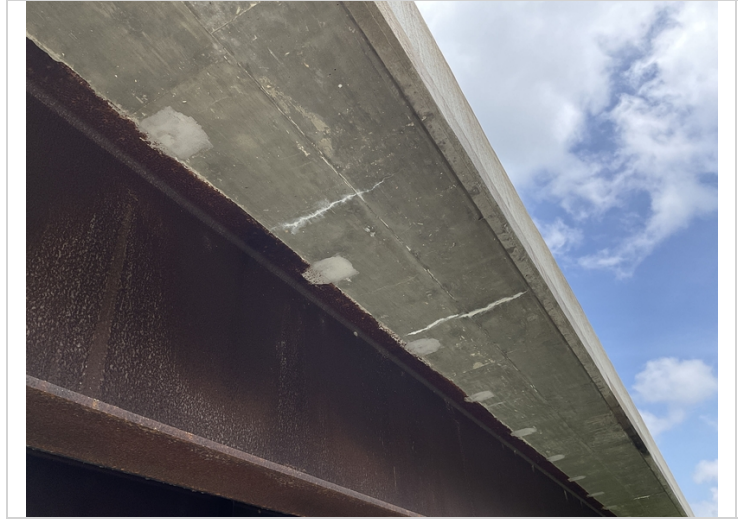
Typical efflorescence on over hangs

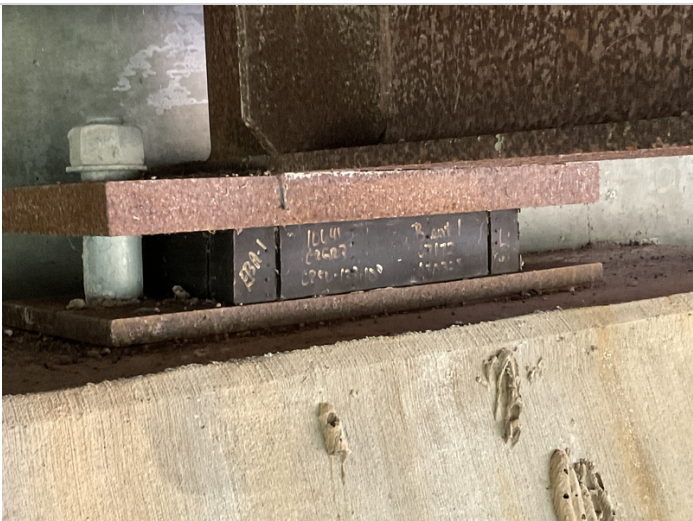
Photo of elastomeric bearing at beam 2 bent 1

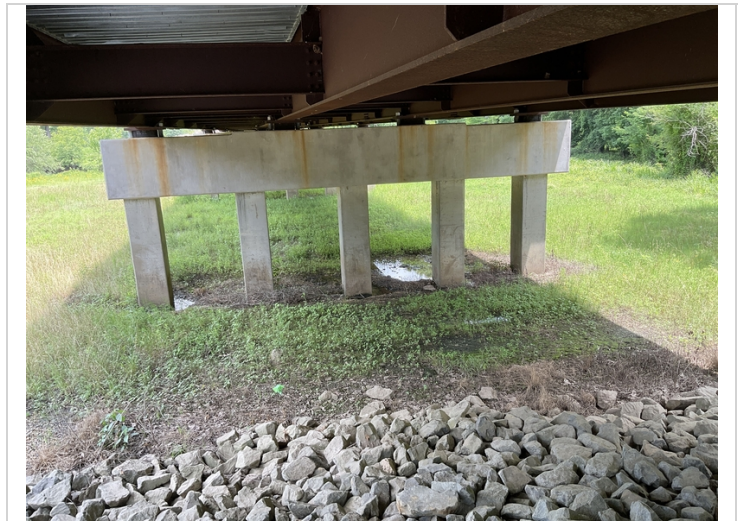
6/23 Substructure photo of bent 2

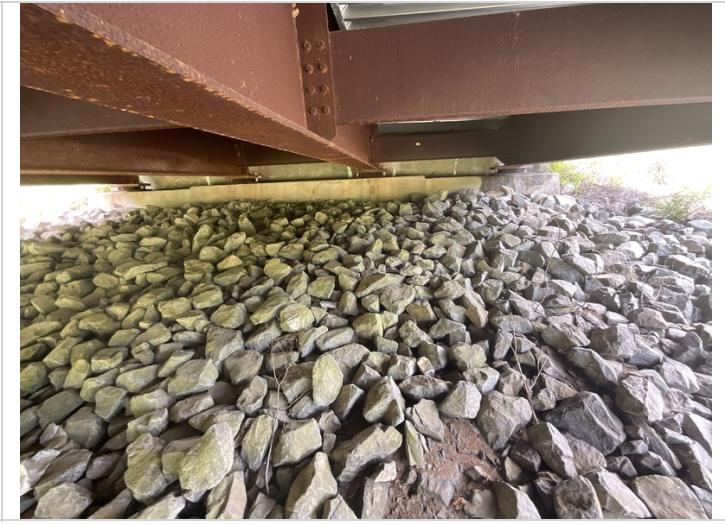
6/23 abutment photo of abutment 1 with riprap

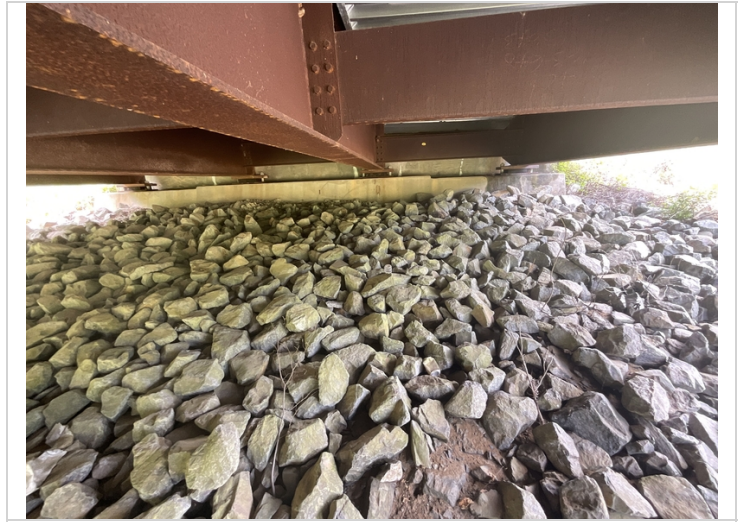
6/23 abutment photo of abutment 1 with riprap

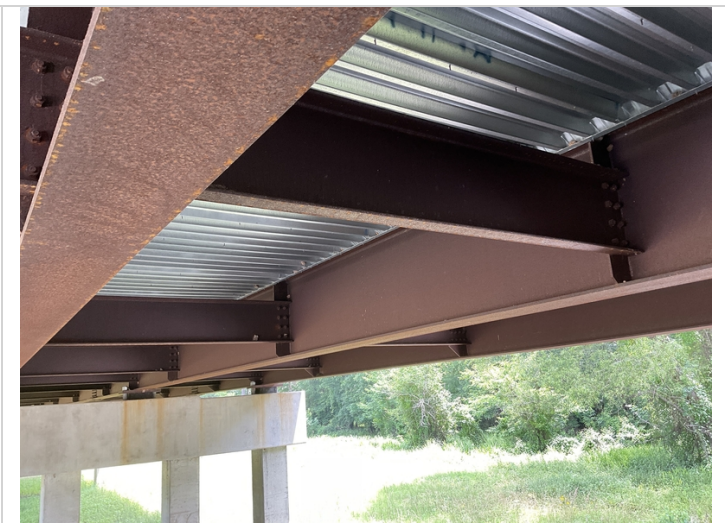
6/23 photo of weathering steel beams

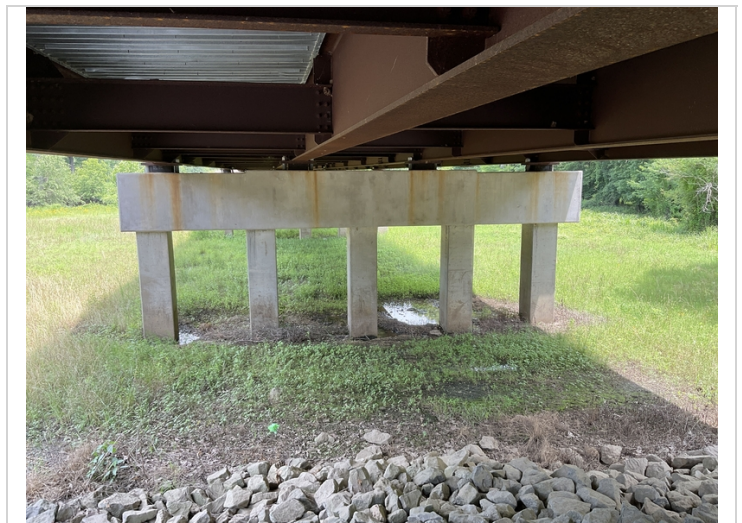
6/23 typical photo of bents photo taken of bent 2

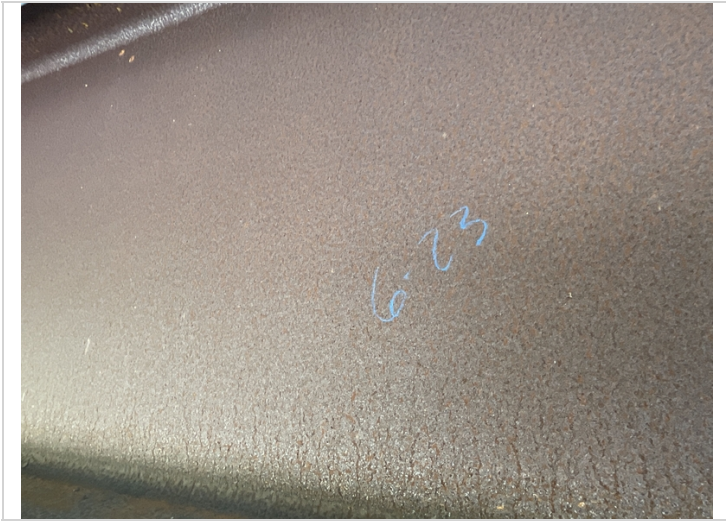
6/23 protective coating for weathering steel beams

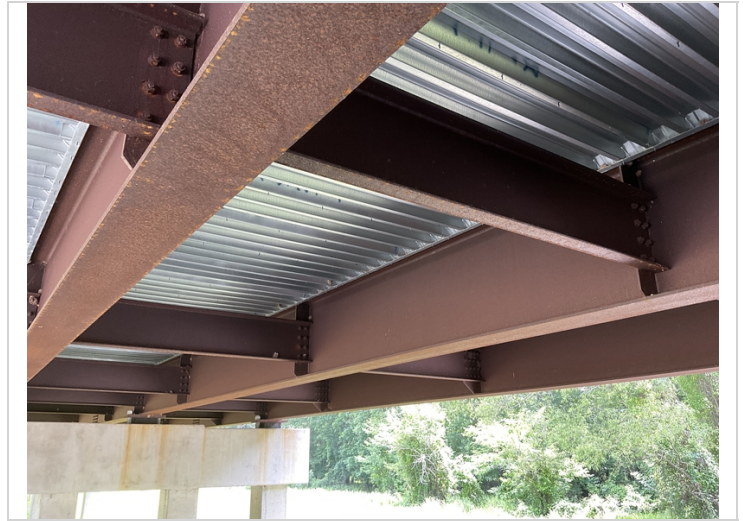
6/23 weathering steel beams.

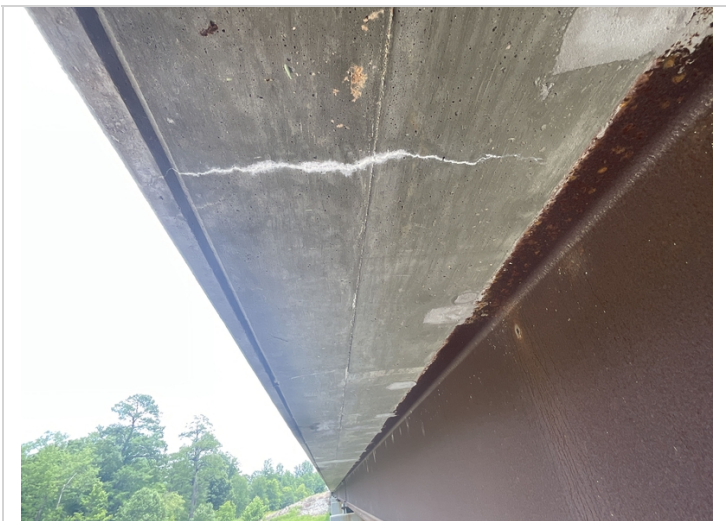
6/23 typical efflorescence on overhangs right and left side of bridge deck

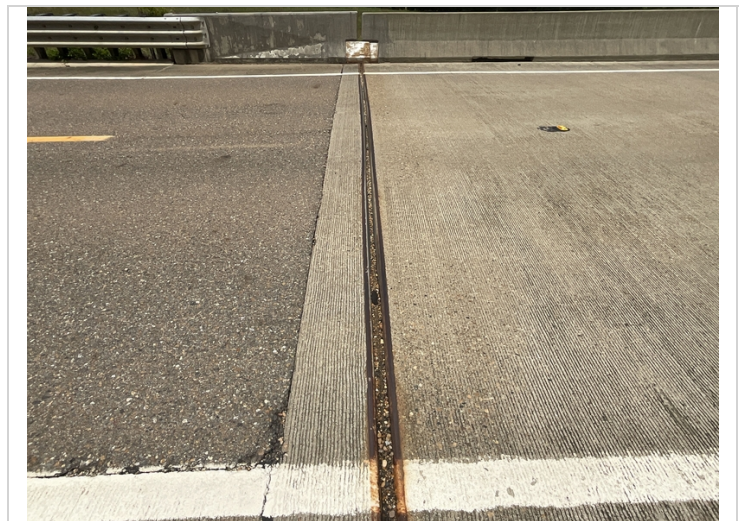
6/23 typical joint photo

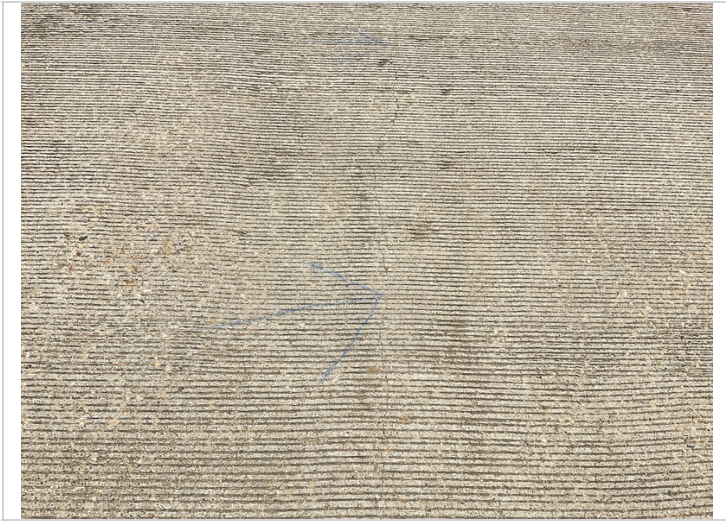
6/23 cracking in concrete deck

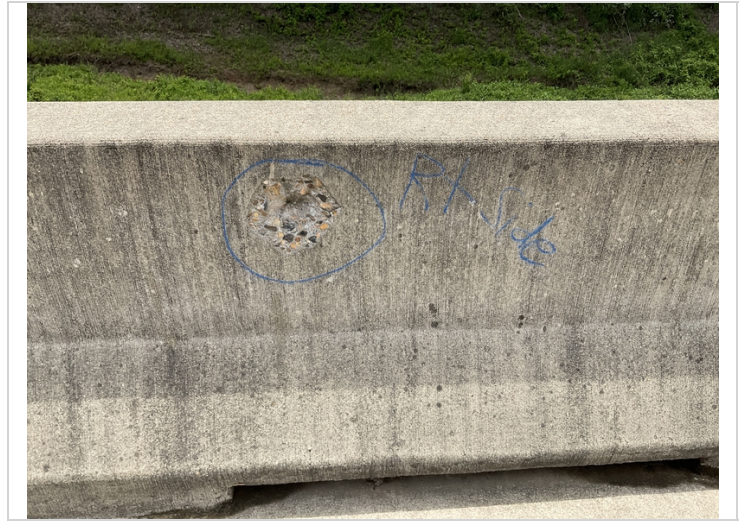
6/23 spall in concrete parapet wall Right side near end of bridge.

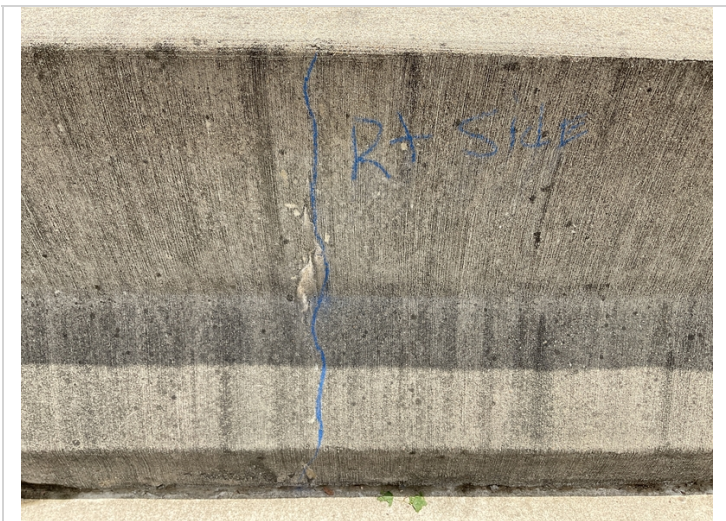
6/23Cracking with efflorescence in concrete parapet wall right and left sides.

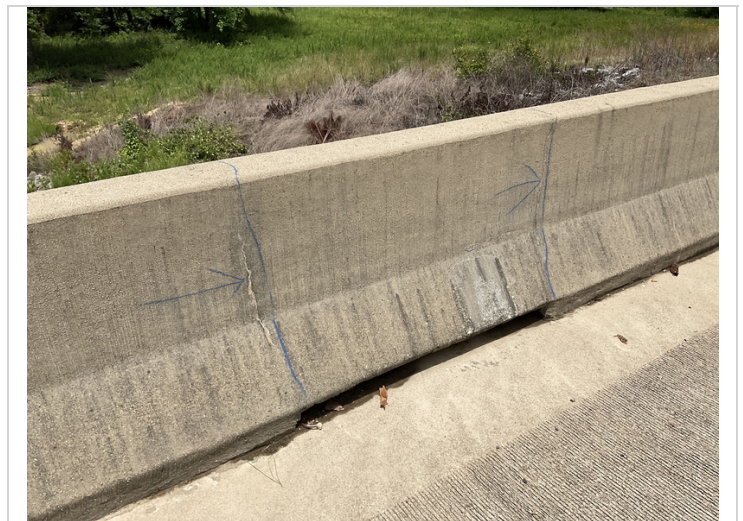
6/23 cracking in parapet wall right and left side.

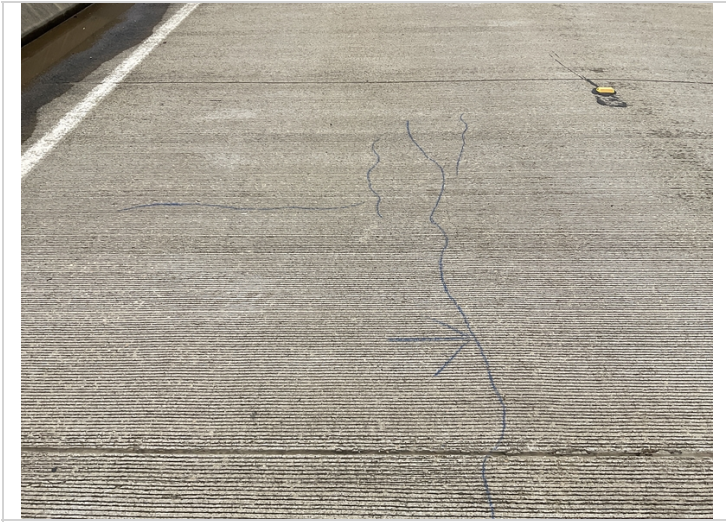
6/23 cracking in deck photo taken near end of bridge.

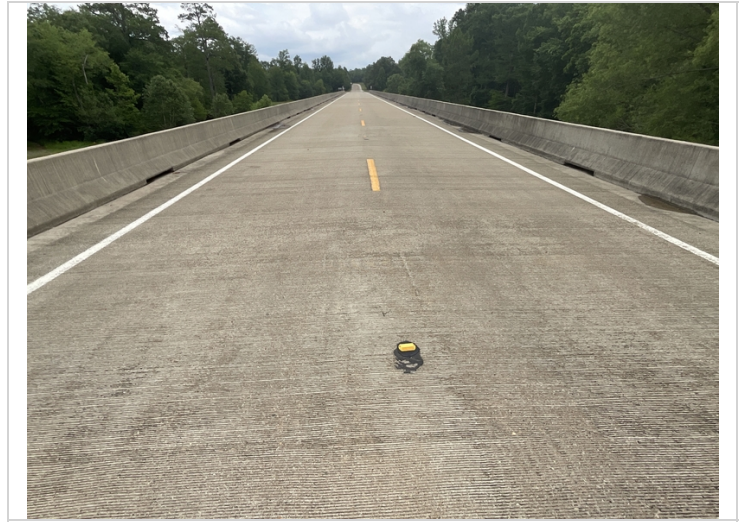
6/23 deck photo

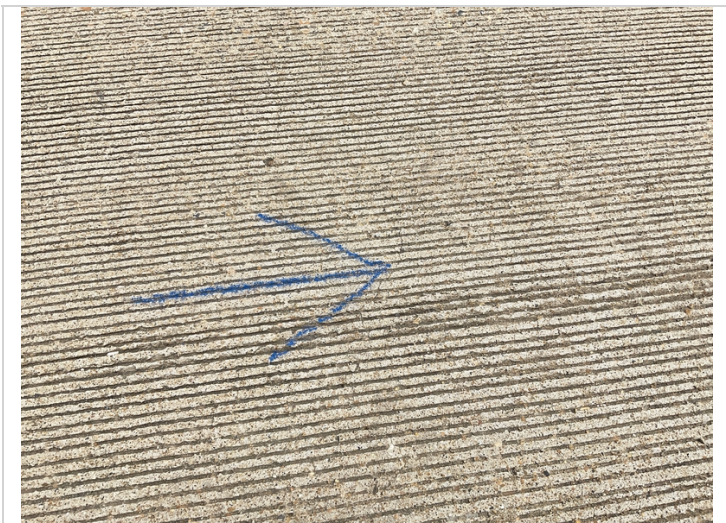
6/23 cracking in deck top side

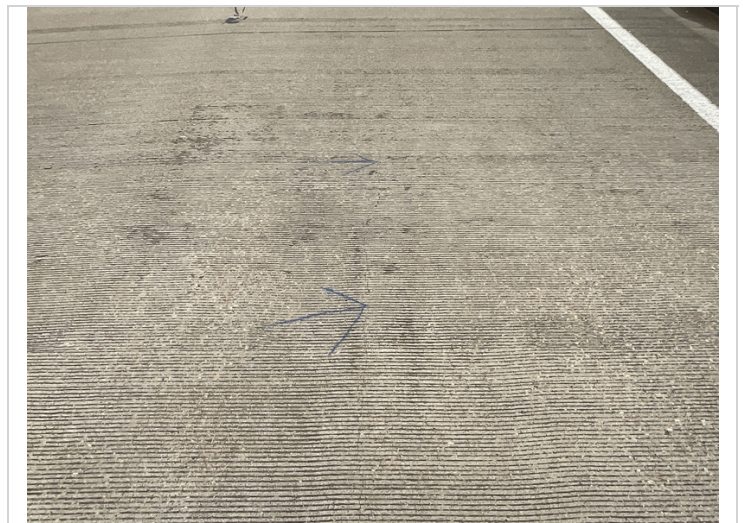
6/23 cracking in the deck mid span

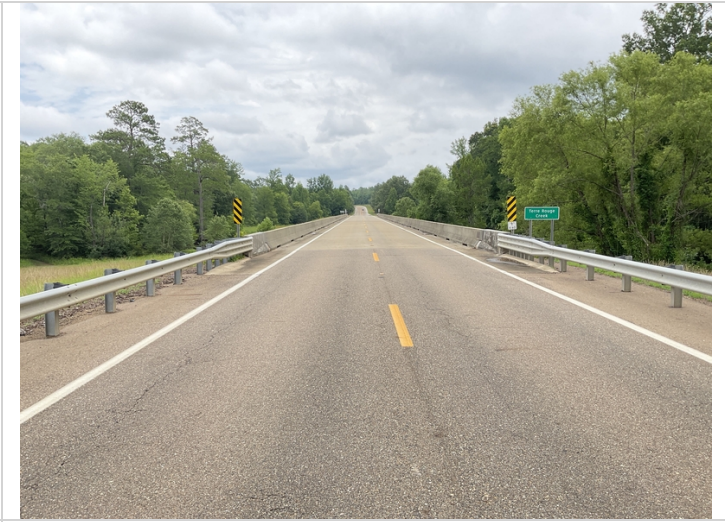
6/23 alignment
