**Asset #06671 (Routine, Underwater type 2)**  
**U.S. 278 -07-17.28 over LITTLE CANEY SLOUGH**  
**Location: 2.2M EAST ROSSTON**

**Team Lead: Jared Kegley, Inspection Date: 06/13/2022**

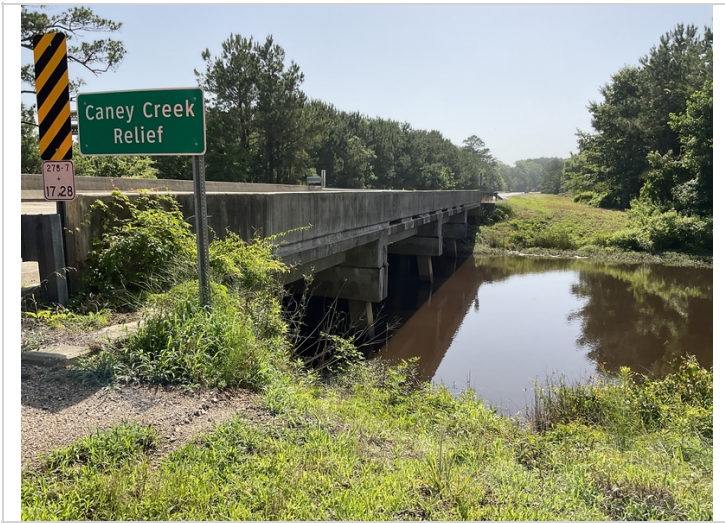
6/2022... Elevation

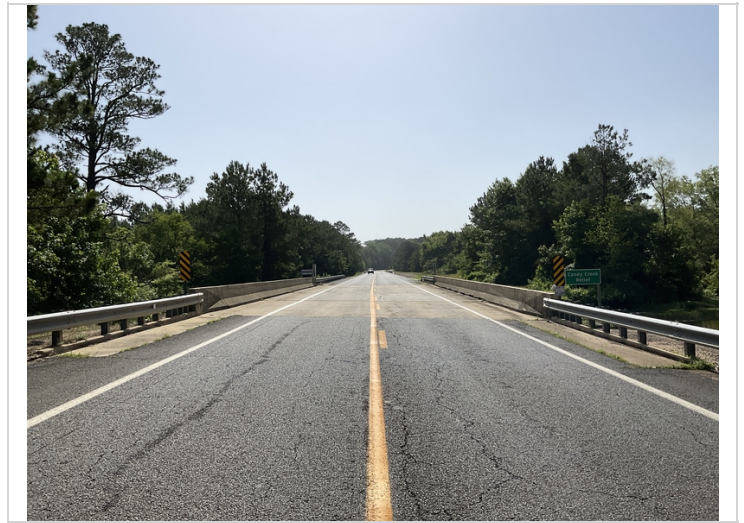
6/2022... Alignment

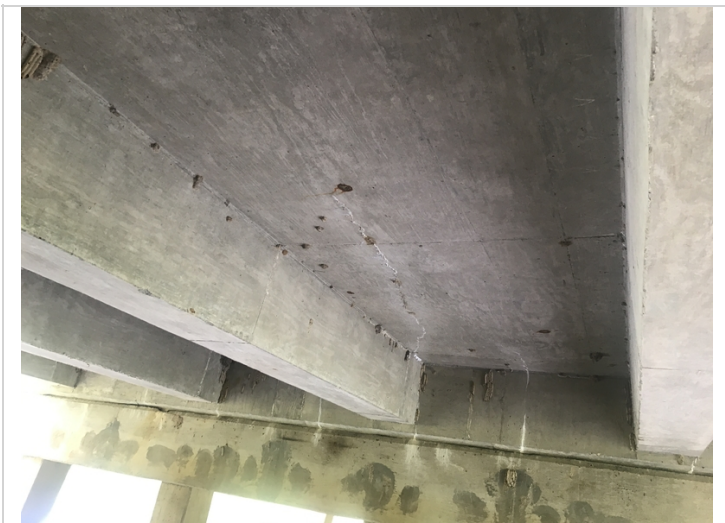
Efflorescence on bottom side of deck and overhangs...

Typical bottom of deck

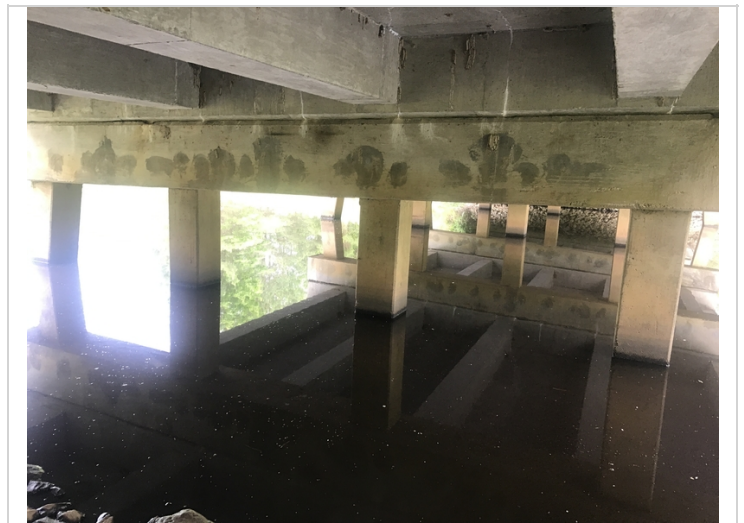
Comment: 6/2022...Minor cracking on caps in various locations...

Typical substructure

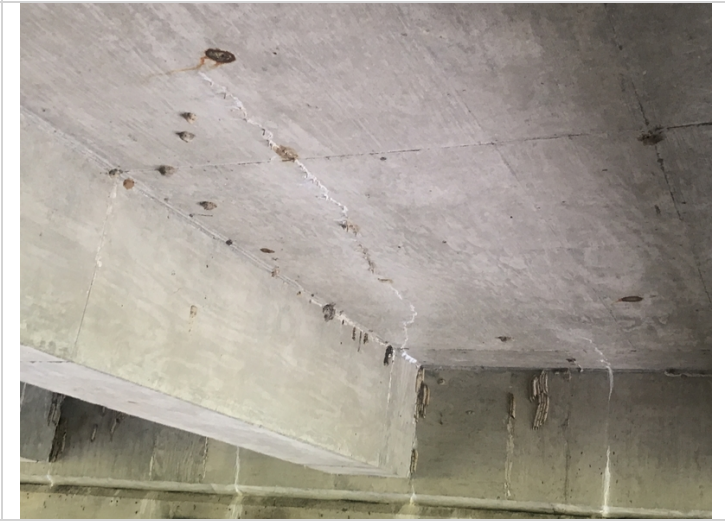
Span 4 photo of efflorescence

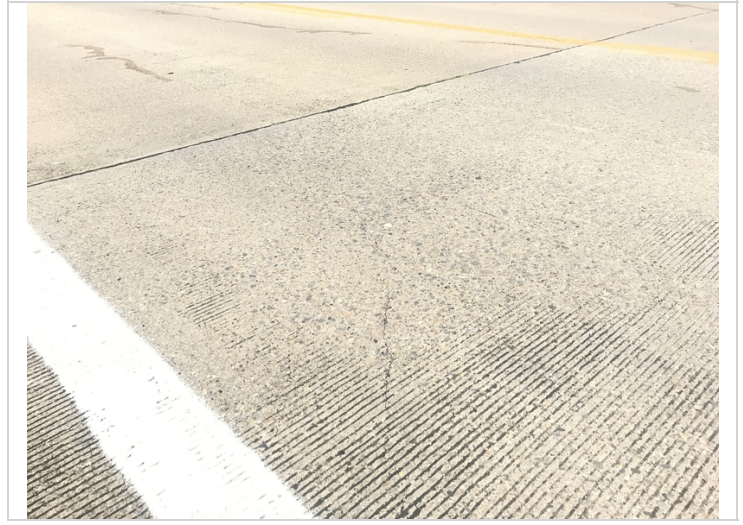
Comment: ...DIAGONAL DECKS CRACKS W/EFFLORESCENCE, CRACKS EXTENDS FROM BENTS INTO MID SPAN ON MOST SPANS (CRACKS HAVE BEEN SEALED)

Cracking some sealed some not sealed

**A-54 - Sealable Deck Cracks**

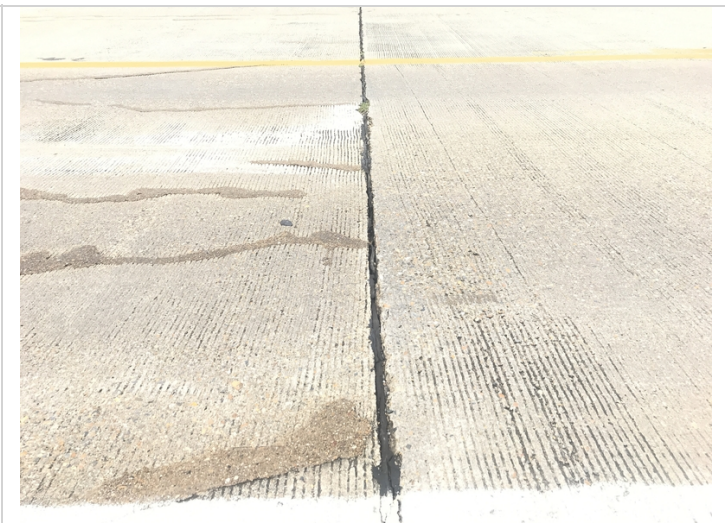
(301) Loss of adhesion all joints							
331	Reinforced Concrete Bridge Railing	LF	236	236	0	0	0

Photo of joint at Bent 3 typical all joints..

JOINTS NEED TO BE CLEANED AND RESEALED

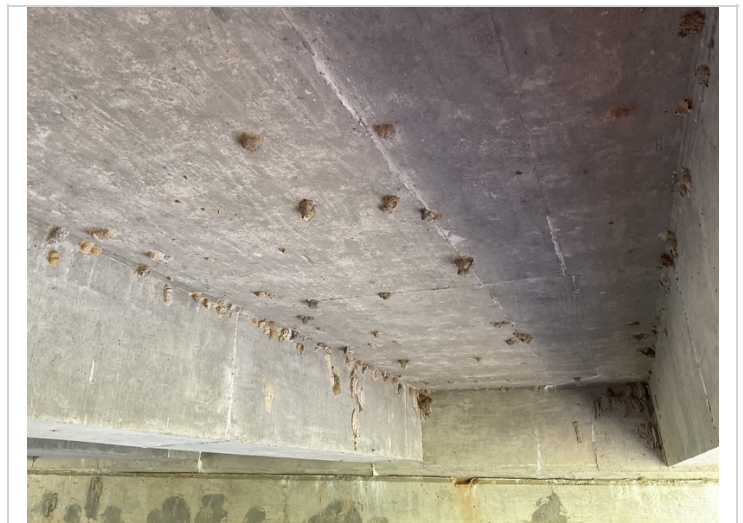
6/2022... underside of deck typical of all spans

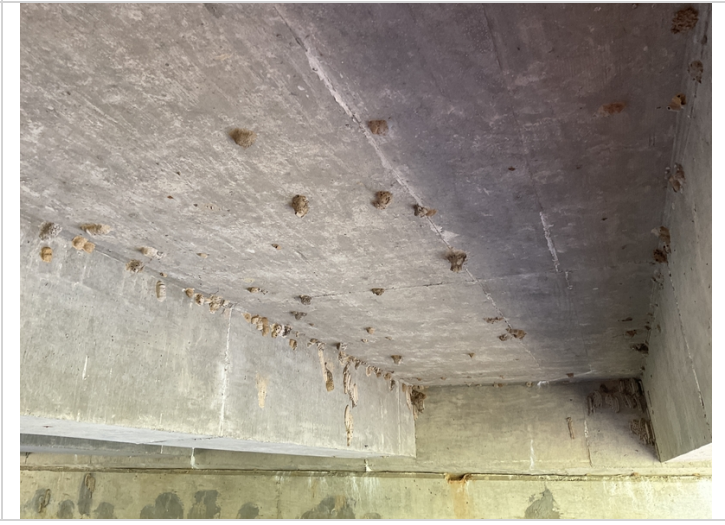
6/2022... underside of deck typical of all spans

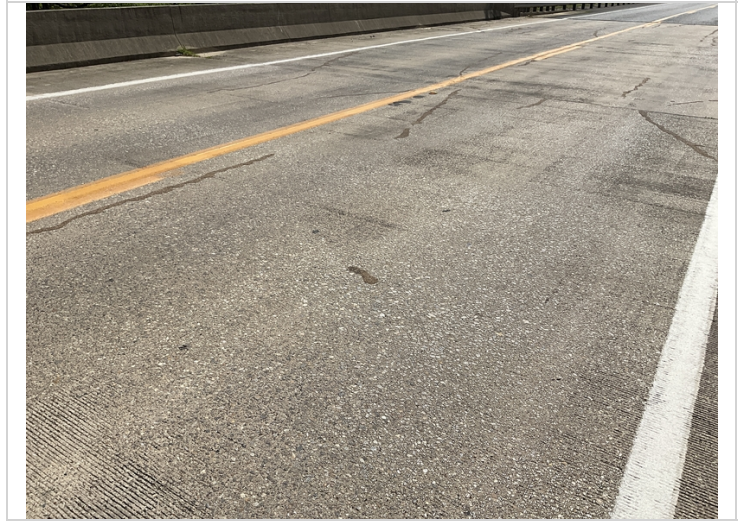
6/2022... deck photo typical of all spans

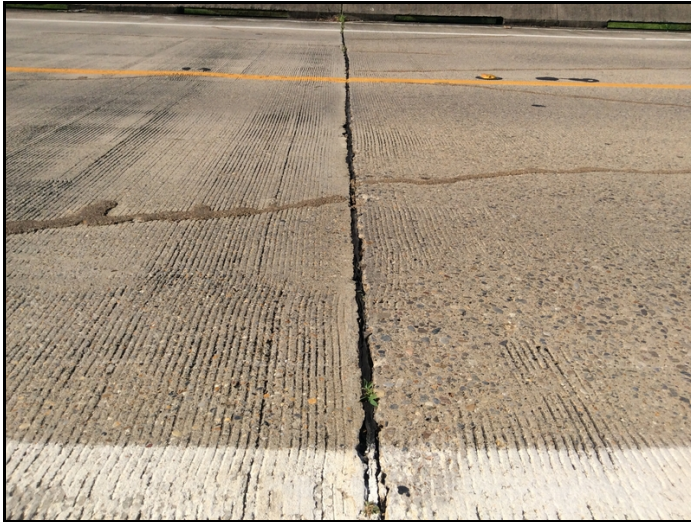
JOINTS NEED TO BE CLEANED AND RESEALED
