Asset #06672(Routine, Underwater type 2)
U.S. 278 -07-17.44 over LITTLE CANEY CREEK

Location: 2.4 MI EAST ROSSTON

Team Lead: Jared Kegley, Inspection Date: 06/13/2022

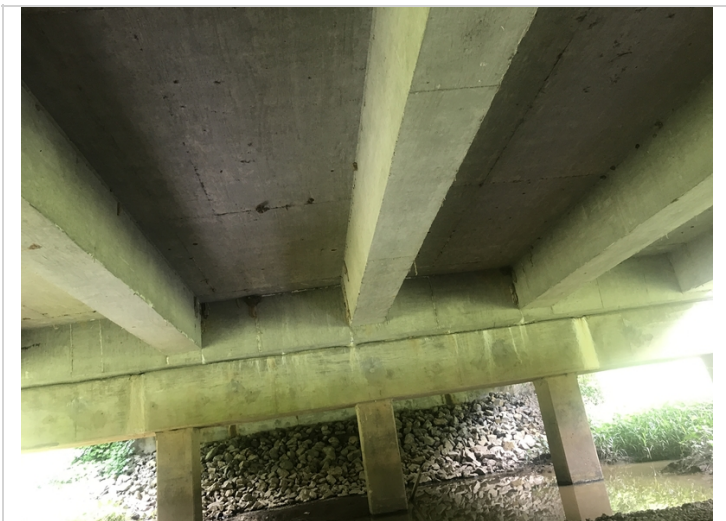
...diagonal deck cracks originate from bents and run back or ahead 6' to 8' in length note:cracks were sealed in past
- Efflorescence/Rust Staining on bottom side of deck... 6/2022... Efflorescence on underside of deck various locations..
minor cracking various locations

Typical bottom of deck photo

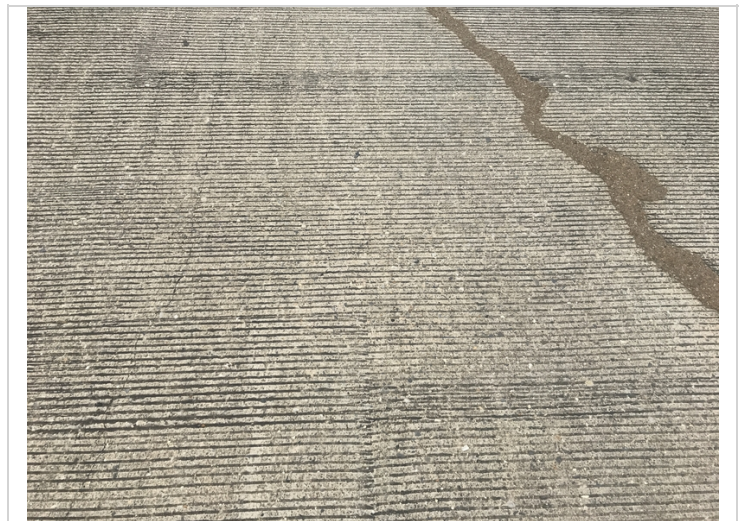
Some cracks sealed and other not sealed

A-54 - Sealable Deck Cracks

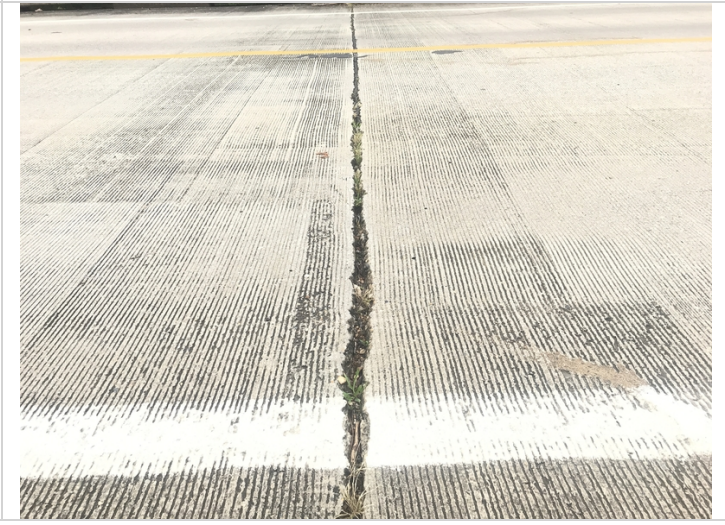
Photo taken of joint @ Bent 2

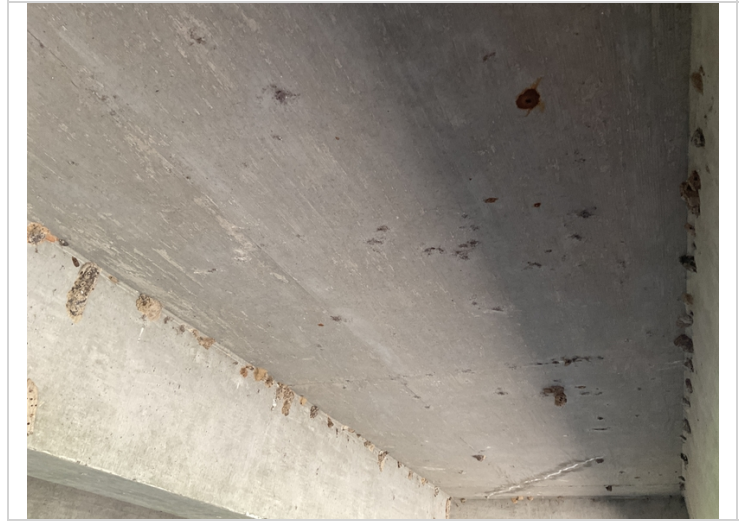
6/2022. Underside of deck typical of all spans

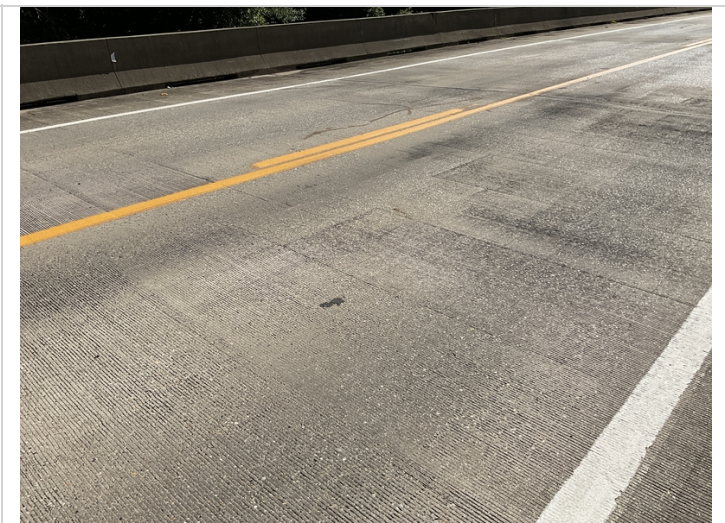
6/2022... deck photo typical of all spans

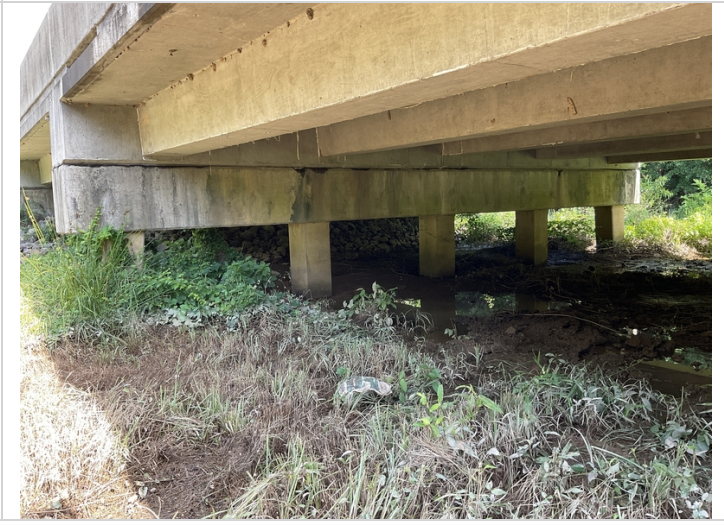
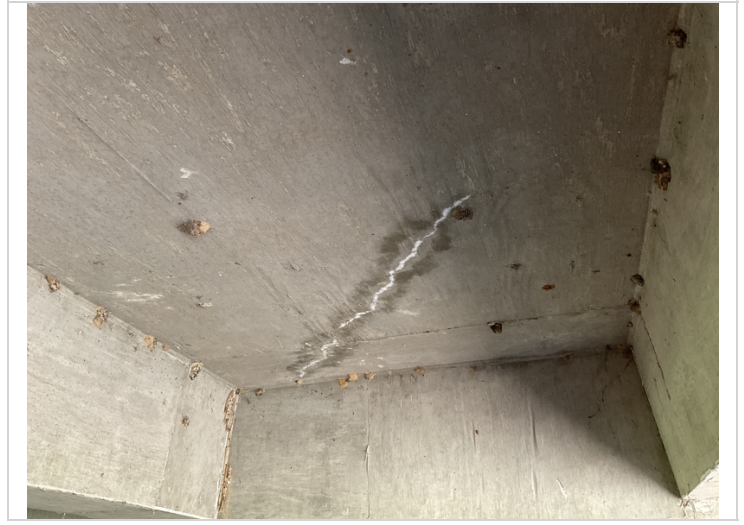
Efflorescence on underside of deck various locations

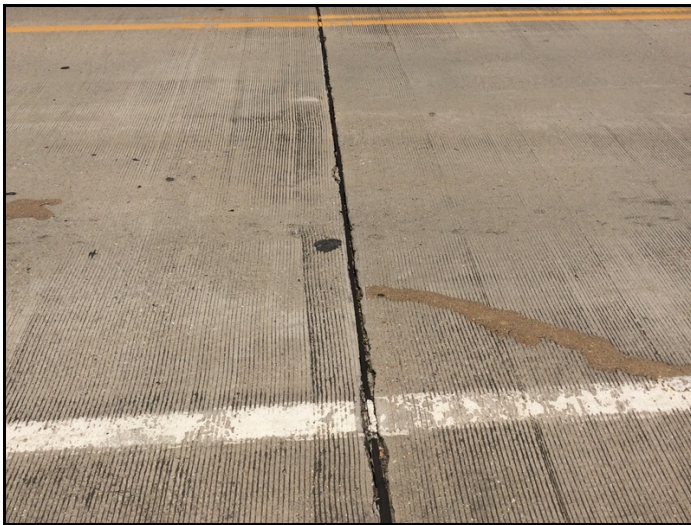
Joint 8

ALL JOINTS HAVE SOME AREAS OF MISSING MATERIAL

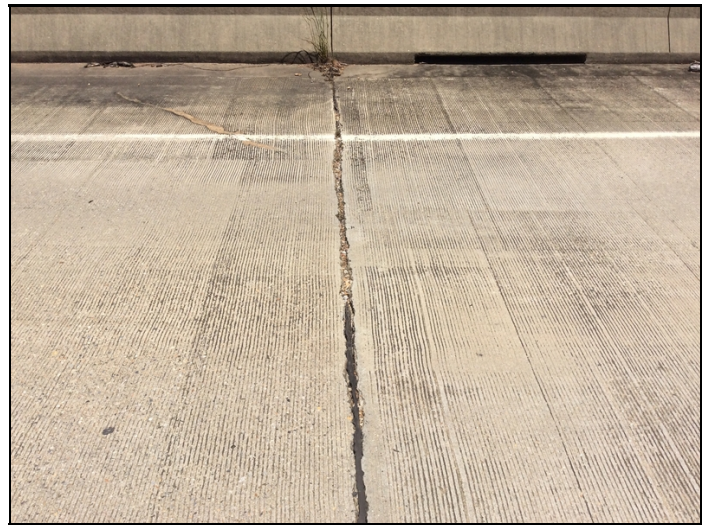
ALL JOINTS HAVE SOME AREA 'S OF MISSING MATERIAL,

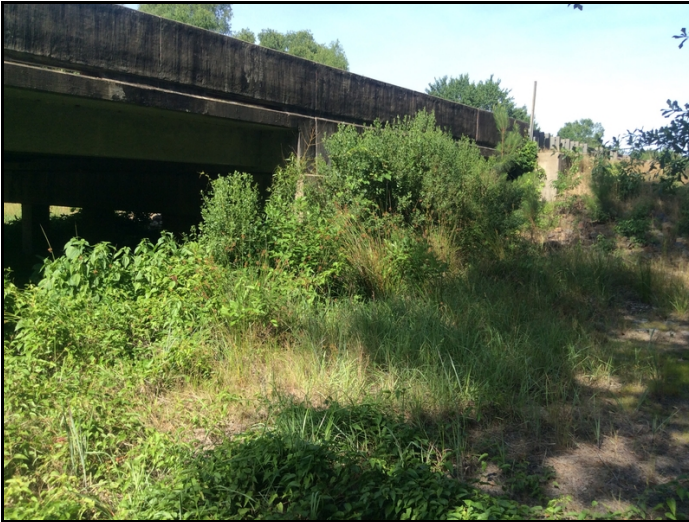
TREES AND BRUSH GROWING UNDER AND ALONG
SIDES OF BRIDGE

A-64 - Vegetation Removal Requested

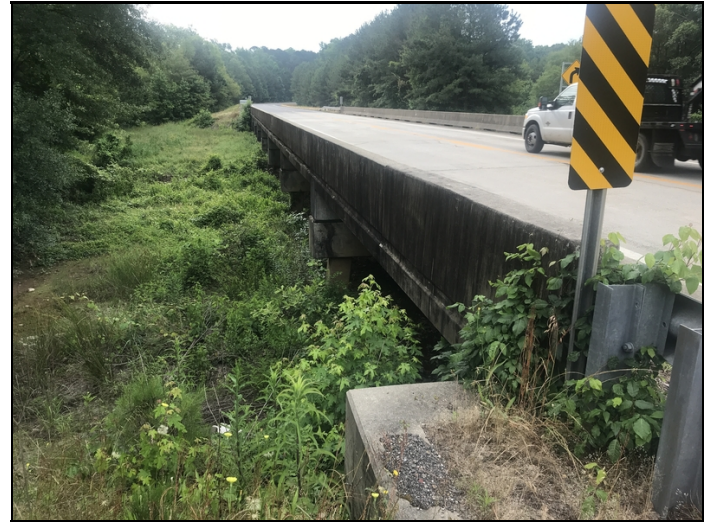
TREES AND BRUSH GROWING UNDER AND ALONG SIDES OF BRIDGE

New photo taken 06/022020

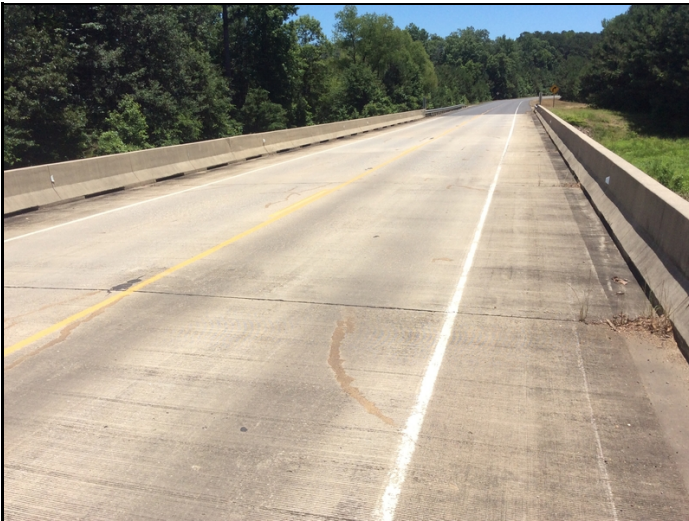
ALL SPANS HAVE MINOR DECK CRACKS THAT HAVE NOT BEEN SEALED ,MOST CRACKS WERE SEALED IN PAST.
(DATE UNKNOWN EST. 2004)

Deck cracks

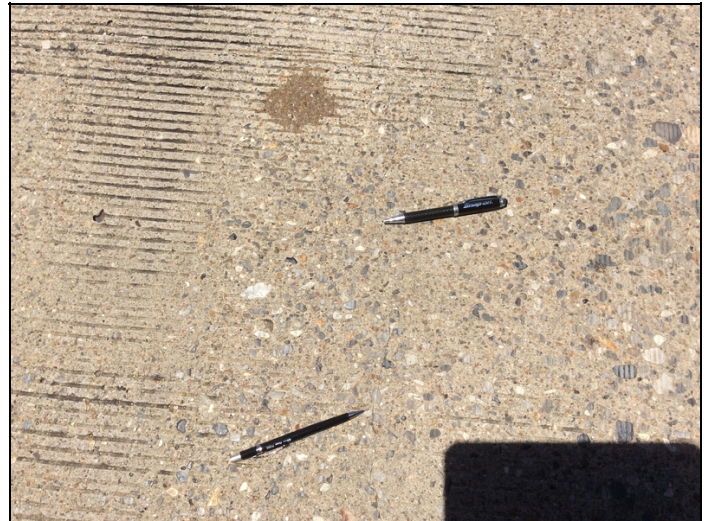
Deck cracks

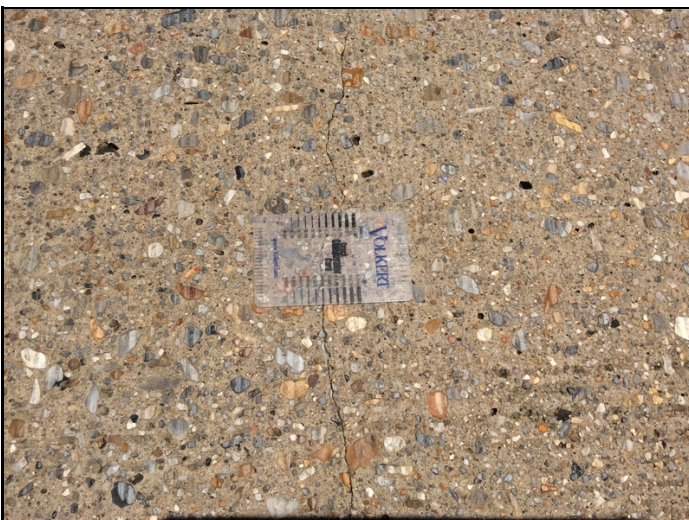
crack size 0.030 inch

Deck cracks 0.030 size
