Asset #06673(Routine, Underwater type 2)

US 278 - 07 -22.59 over CYPRESS CREEK

Team Lead: John King, Inspection Date: 02/14/2022

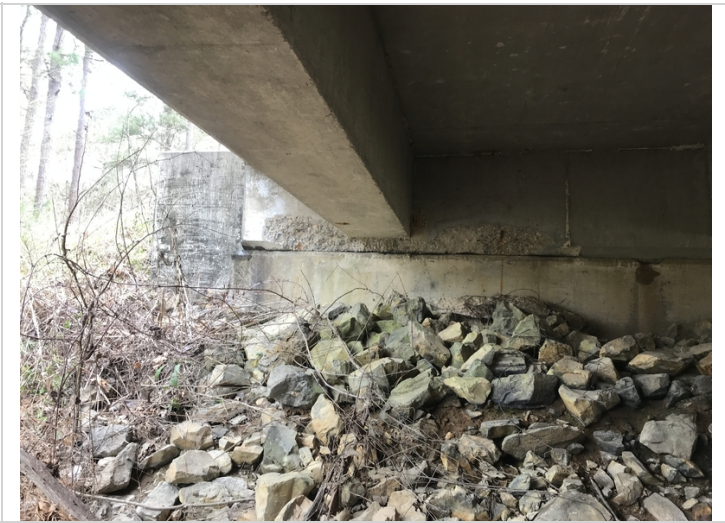
ELEMENTS	DESCRIPTION	UNITS	TOTAL	CS1	CS2	CS3	CS4
12	Reinforced Concrete Deck	SF	4511.4	4366.4	115	30	0
1080	Delamination/Spall/Patched Area	SF	30	0	0	30	0
1120	Efflorescence/Rust Staining	SF	15	0	15	0	0
1130	Cracking (RC and Other)	SF	100	0	100	0	0
(1080-12) 2/19/2020... Approx. 10 ft spall on horizontal deck wall at bent 1 under beam 5, Approx. 20 ft of spalling on horizontal deck wall at bent 5...

Approx. 10 ft spall on horizontal deck wall at bent 1 under beam 5...

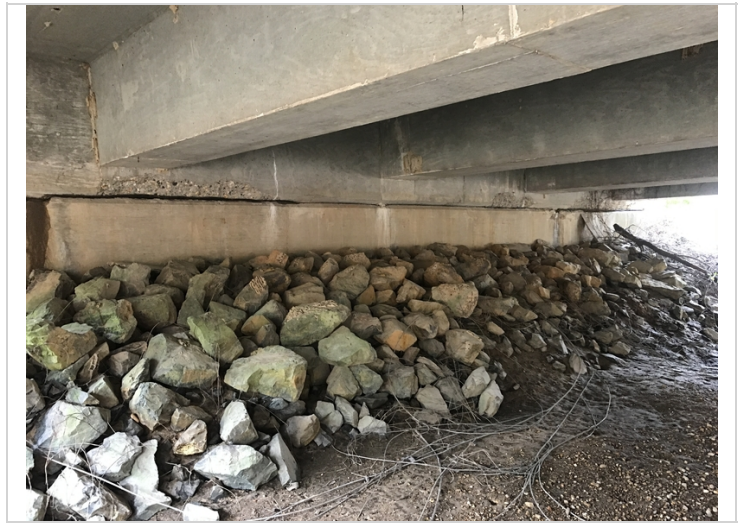
Approx. 20 ft of spalling on horizontal deck wall at bent 5.

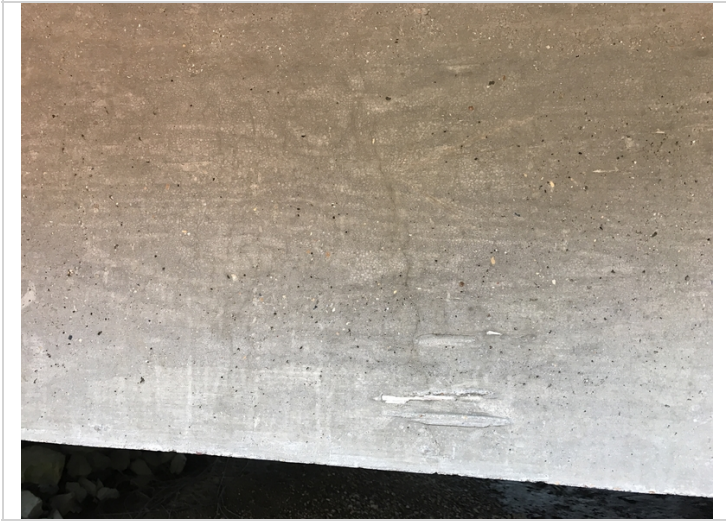
ELEMENTS	DESCRIPTION	UNITS	TOTAL				
				CS1	CS2	CS3	CS4
110	Reinforced Concrete Open Girder/Beam	LF	590.5	590.5	0	0	0
(110) 2/19/2020...Minor cracks on concrete tee beams in various locations...02/2022 abutments at both ends of bridge Diaphragm between tee beams are spalled no rebar exposed.... no maint. need at this time

Minor cracks on concrete tee beams in various locations

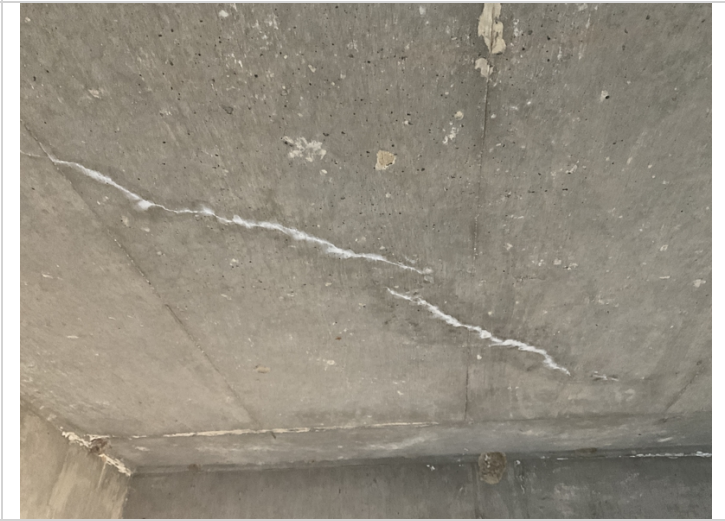
02/2022 efflorescence

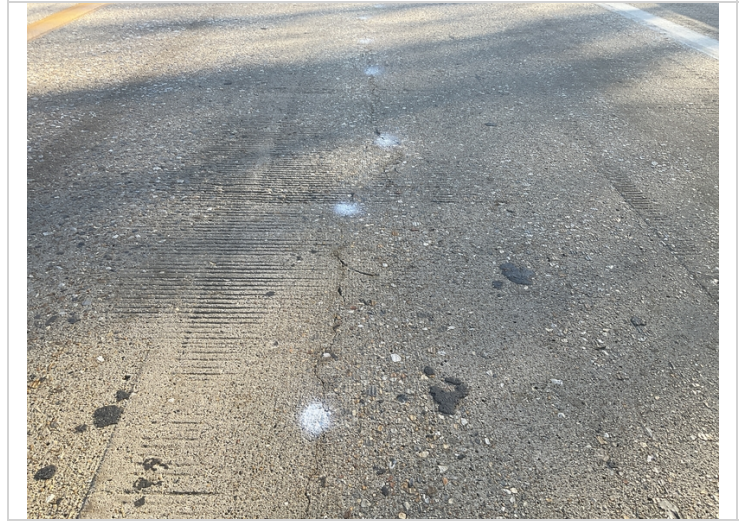
2022 cracking in deck

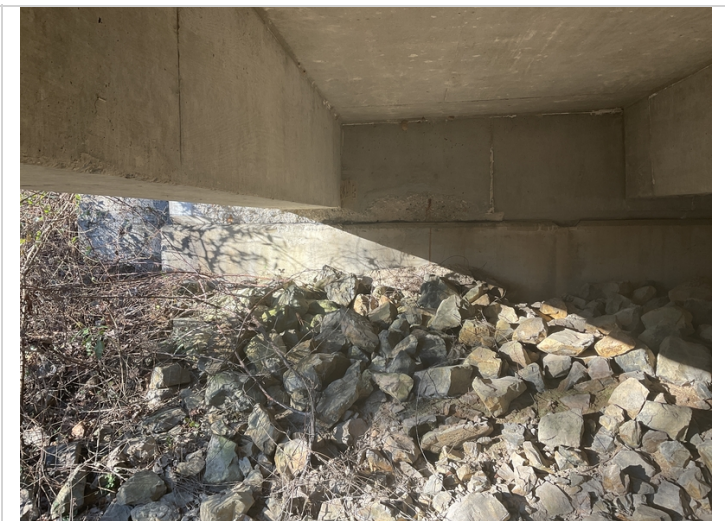
Comment: Backwall: Spalls abutment 1&5 on rt side  
02/2022 soundings taken per this inspection..

Abutment 1 right side spall

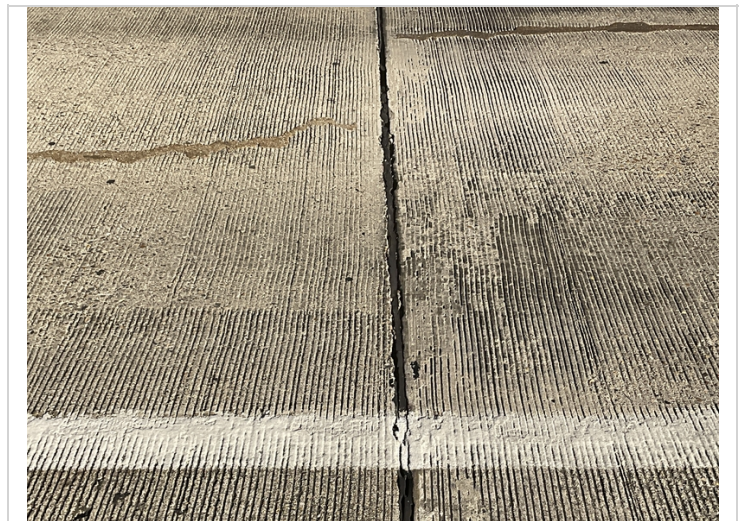
(301) 2/22 Joints need cleaned and repaired typical all joints							
(2320-301) 2/19/2020...10' of pourable joint seal missing, bents 2 and 3...							
331	Reinforced Concrete Bridge Railing	LF	236	236	0	0	0

Joints need cleaned and repaired typical all joints

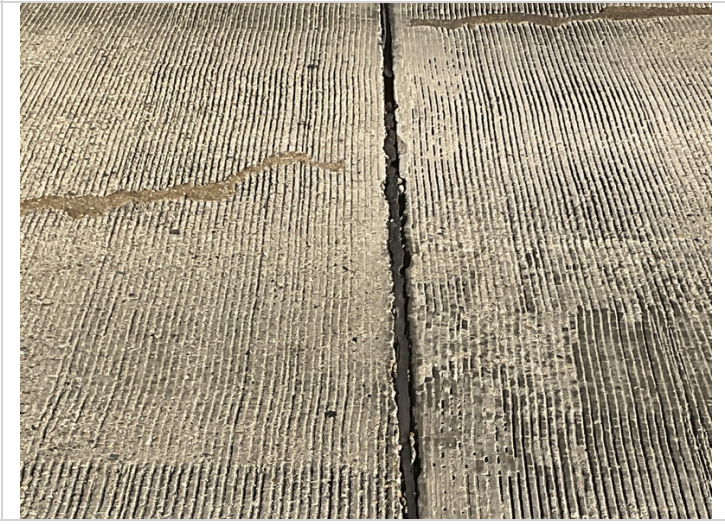
Joints need cleaned and repaired typical all joints

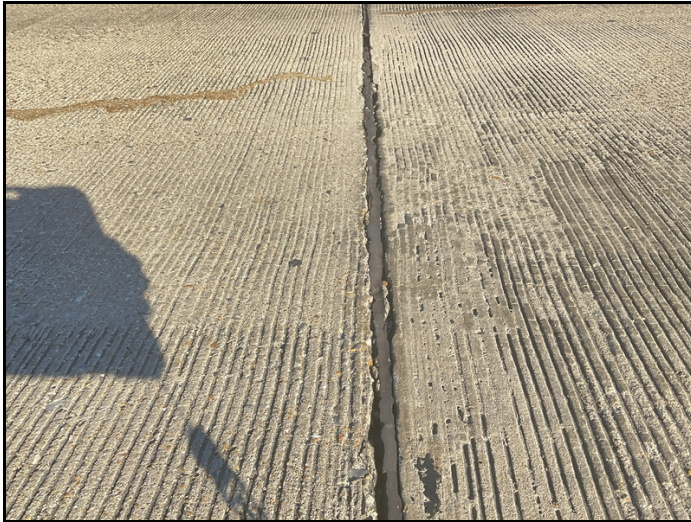
Joints need cleaned and repaired typical all joints

**Type of Work:** Replace (General)

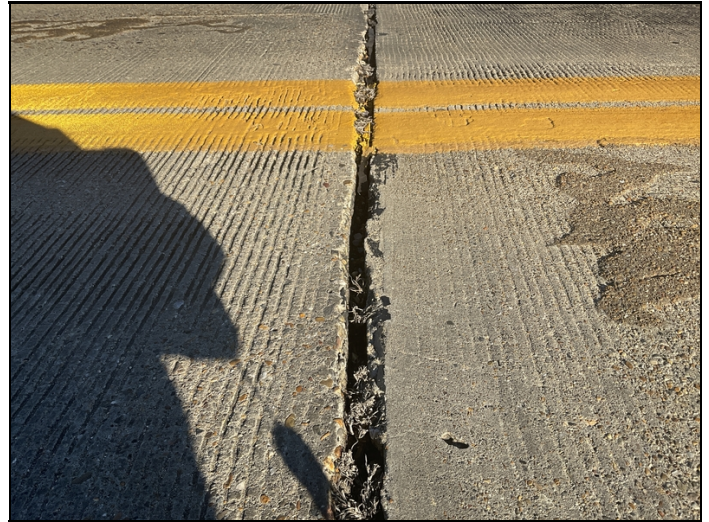
Joints need cleaned and repaired typical all joints
