Asset #M0083(Routine)

US 278 -07 - 22.14 over CREEK

Team Lead: Jared Kegley, Inspection Date: 06/13/2022

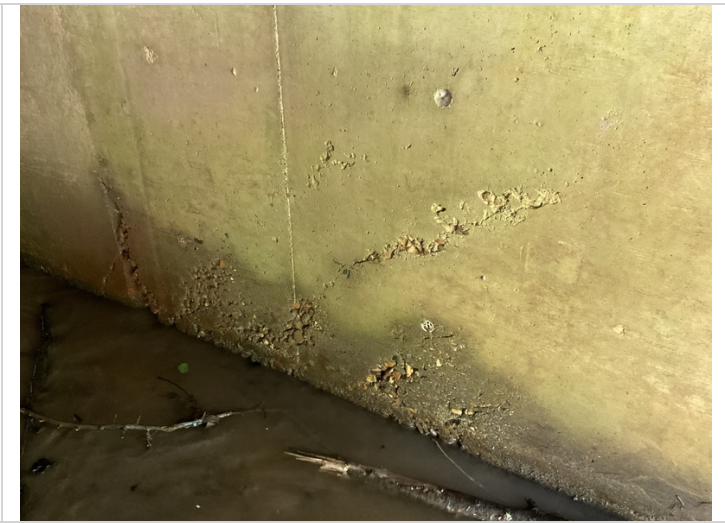
Beaver dam in barrel 1

Type of Work: (Inactive) (Inactive) 1 - Clean
