## Bridge 06345 Inspection Report

Asset #06345(Routine)

S.H. 19 -05 - 9.90 over NUMBER ONE BAYOU

Team Lead: John King Inspection Date: 10/02/2023

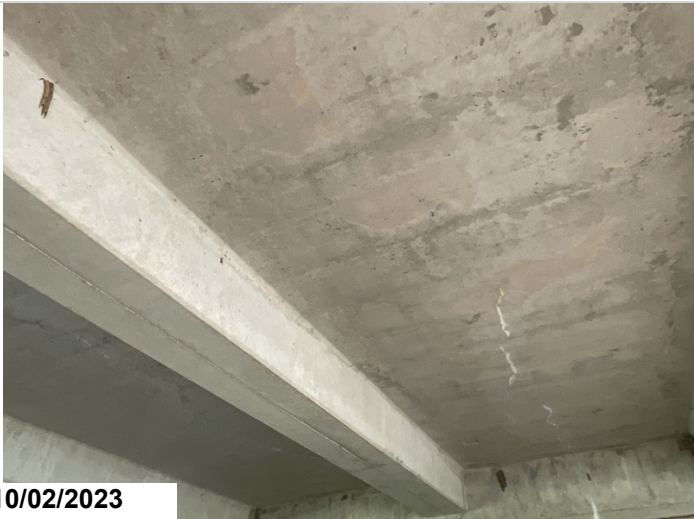
Deck 7 good due to minor cracking in deck. All spans, efflorescence in bottom of deck.

Last span bay 2 and 3 efflorescence bottom of deck

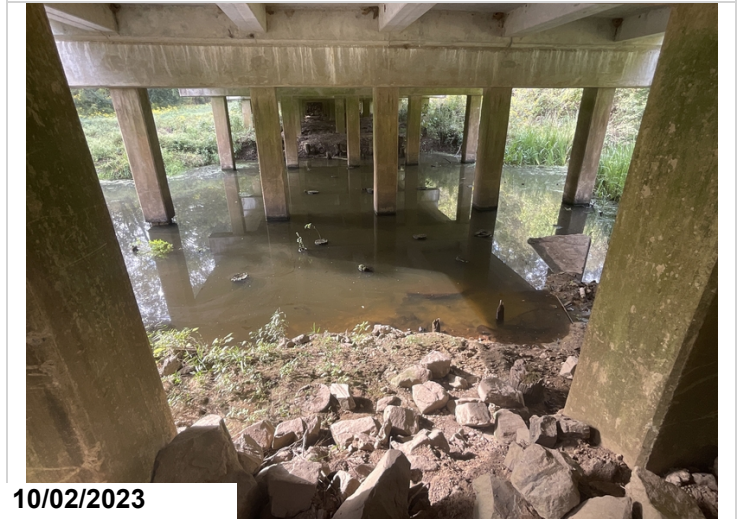
Some minor scour around bents and in channel.

Minor scour under bridge

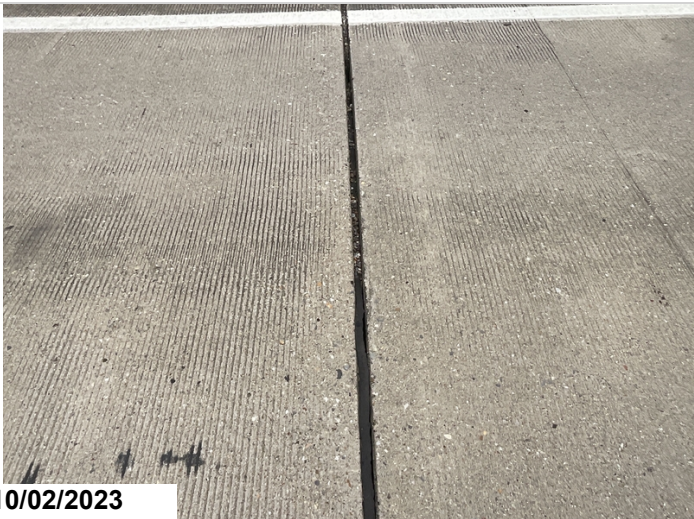
Typical photo of joints

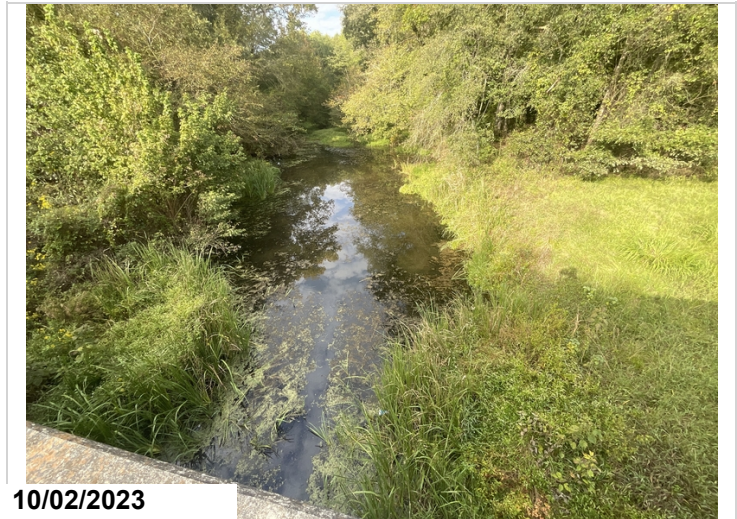
Channel on left side bridge

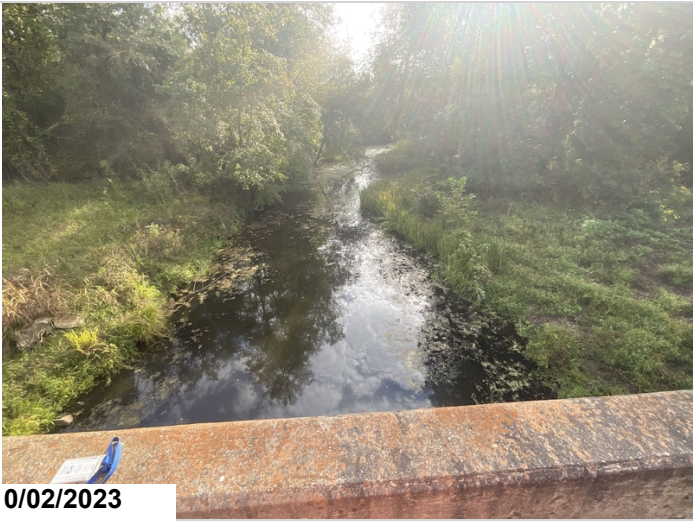
Channel on right side bridge

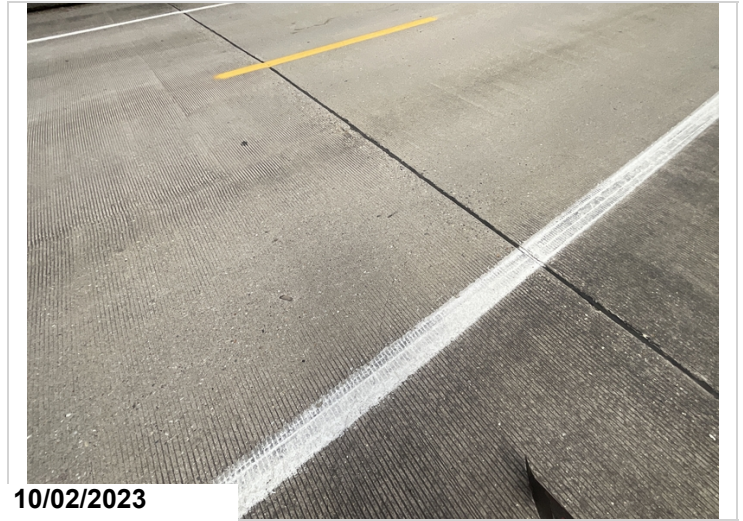
Span 7 cracking in top of deck 0.018

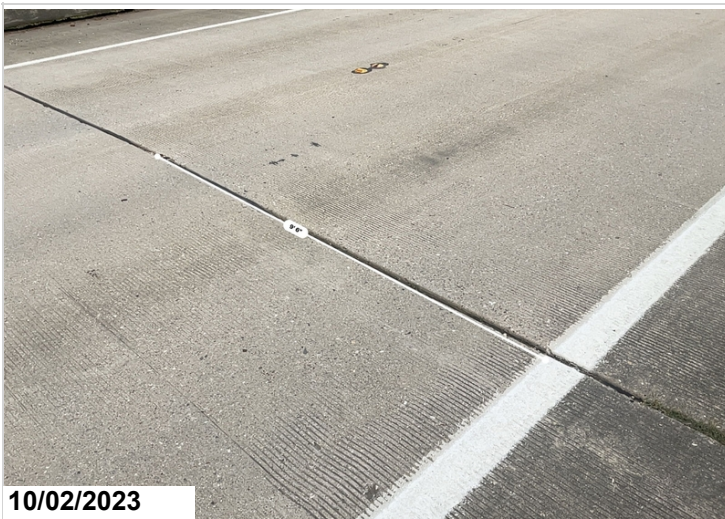
Joint 7 around 9 ft joint missing

**A-59 - Joint Repair Needed (Yes)**

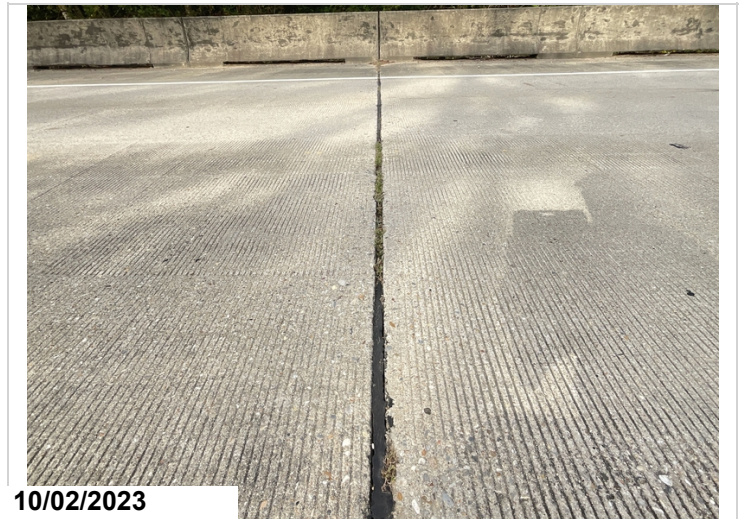
Joint 4 part of poured joint missing with grass growing in joint line

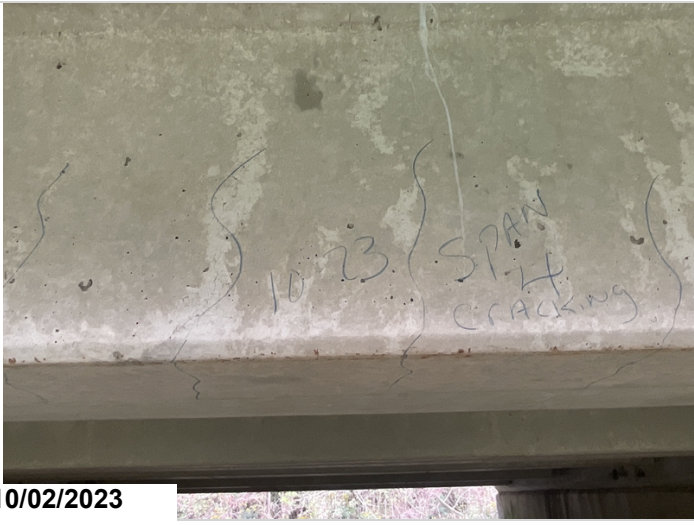
Sub Structure is in good condition Minor cracking in tee beams in all spans.

Span 4 photo taken of very light cracking in tee beams  
0.010 size.

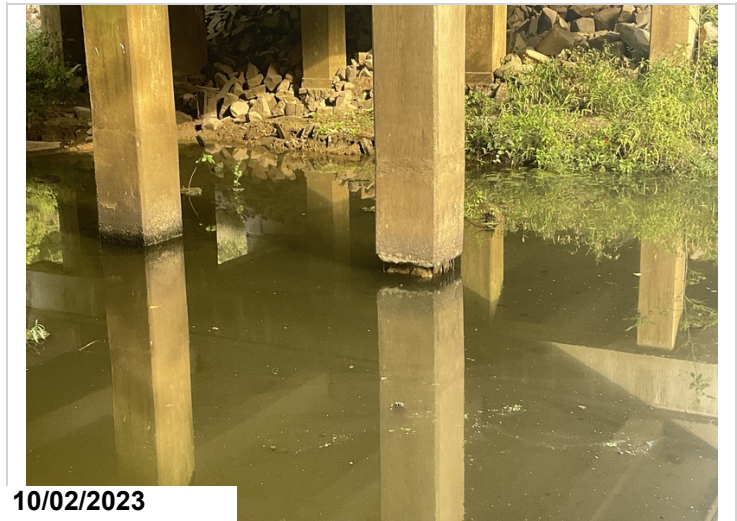
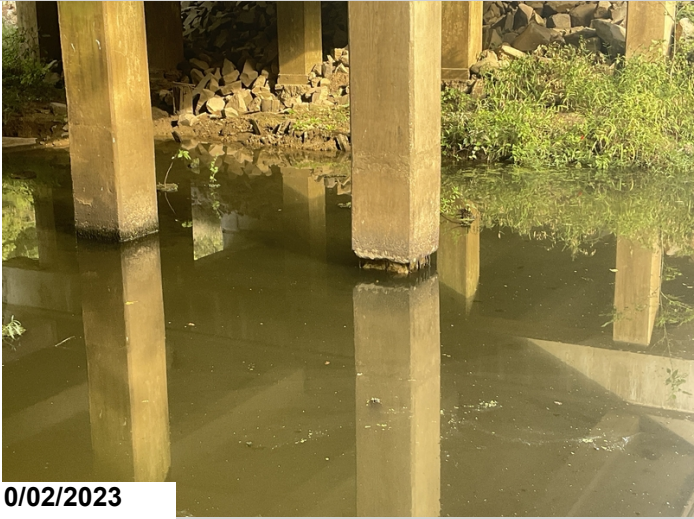
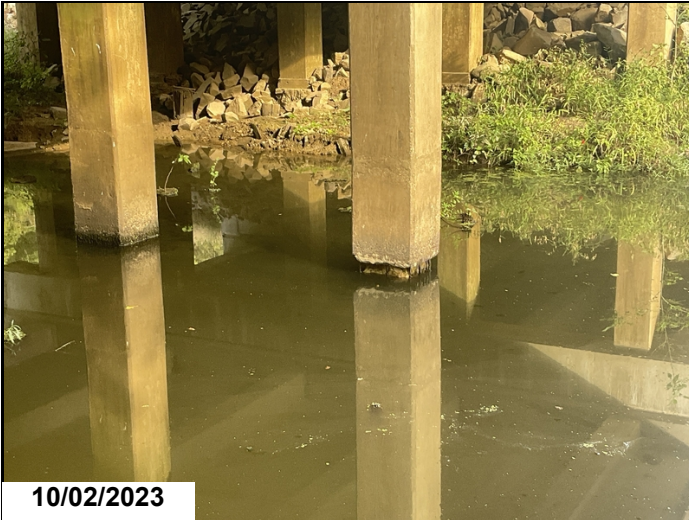
Piles: Bent 8 pile 5 bottom of concrete ENCASEMENT EXPOSED

Bent 8 pile 5 concrete encasements has come apart at  
ground line exposure of rebar with heavy section loss to  
rebar. Note concrete is only encasements for steel pile

Bent 8 pile 5 concrete encasements has come apart at ground line exposure of rebar with heavy section loss to rebar. Note concrete is only encasements for steel pile

bent 8 pile 5 concrete material missing between the "H" pile and the concrete encasement

**Type of Work:** Repair (General)

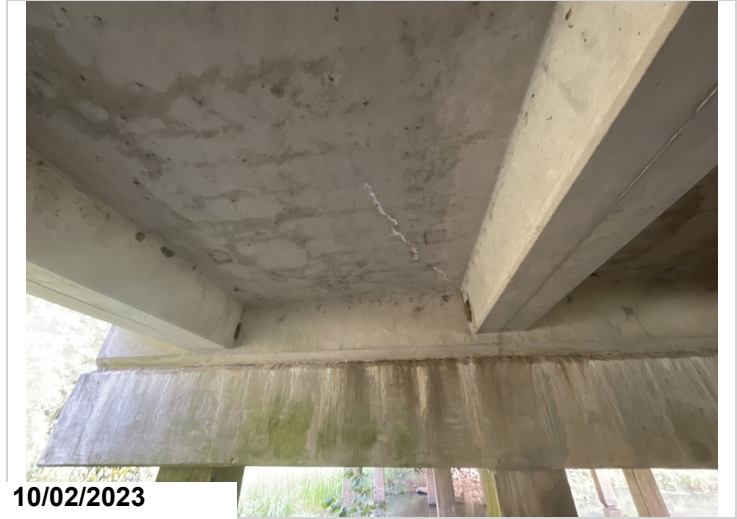
Span 5 efflorescence in bottom of deck bay 1 at bent 6 area.

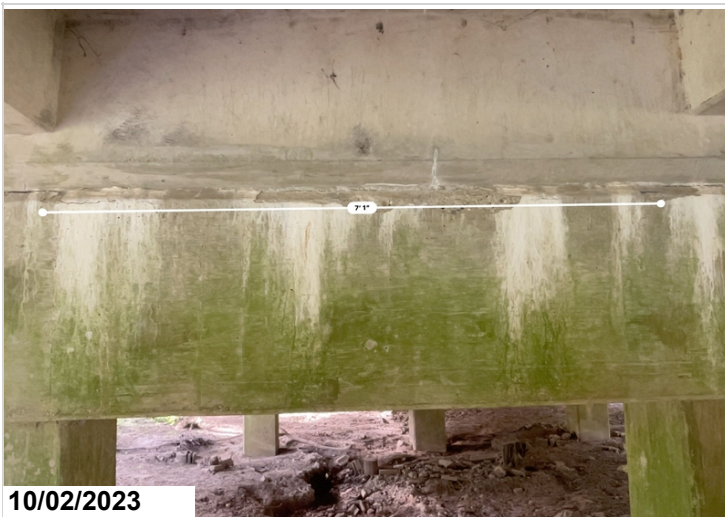
Bent 5 span 5 small spall on top of cap 7 ft long.

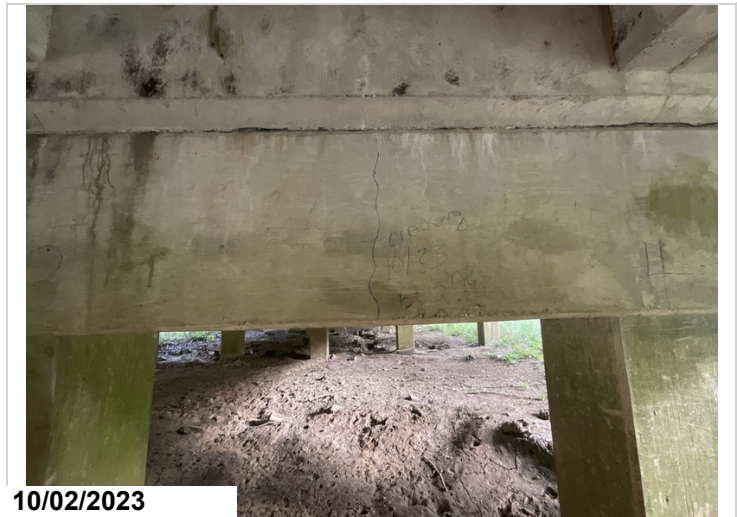
Bent 3 light cracking in cap between piles 3 and 4 span 2 side.

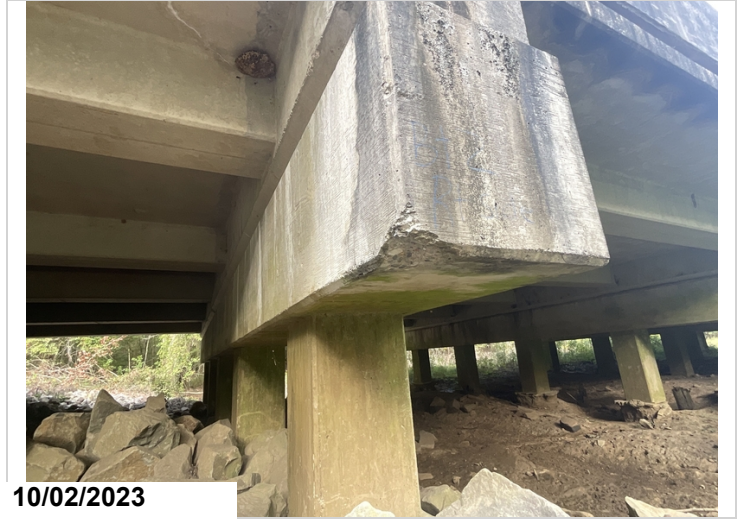
Bent 2 cap right side bottom of cap on end small spall.

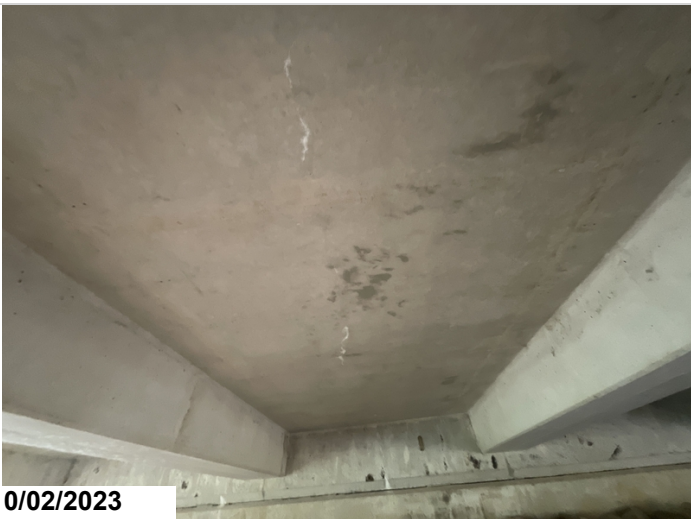
Span 1 bay 3 efflorescence in bottom of deck

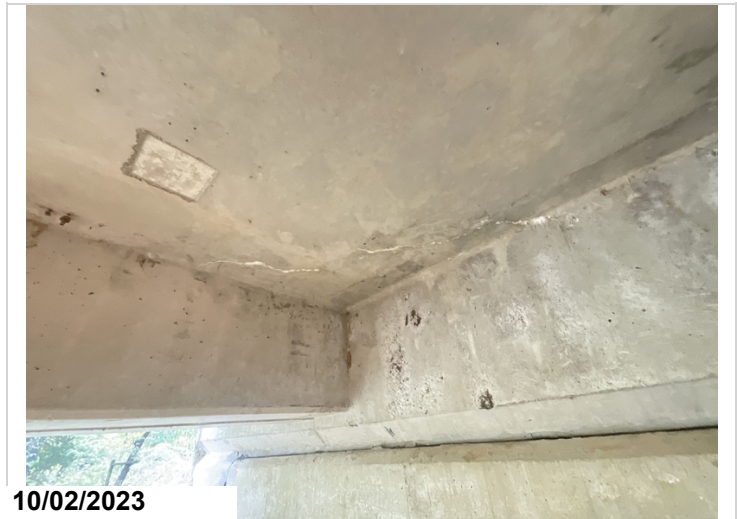
Span 1 at bent 1 bay 4 efflorescence in bottom of deck

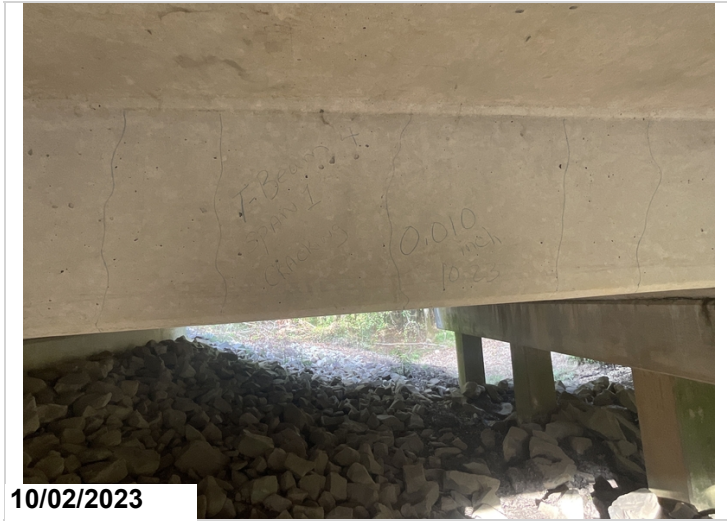
Span 1 light cracking in concrete tee beams size 0.010  
photo of beam 4

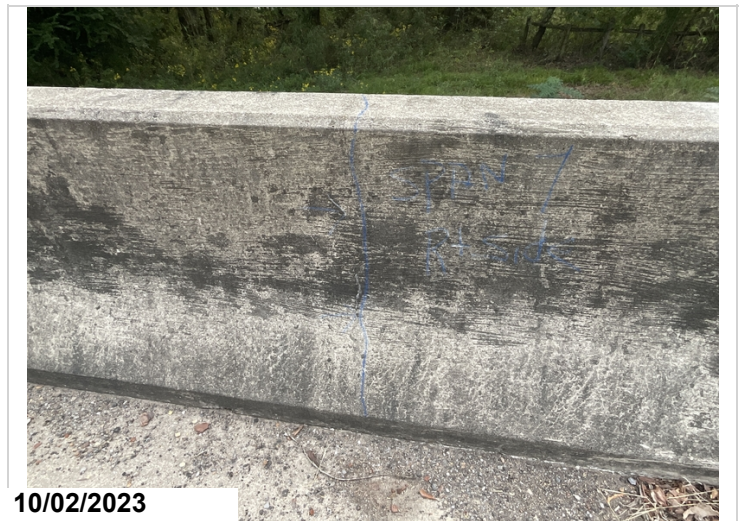
Span 1 right side cracking in parapet wall

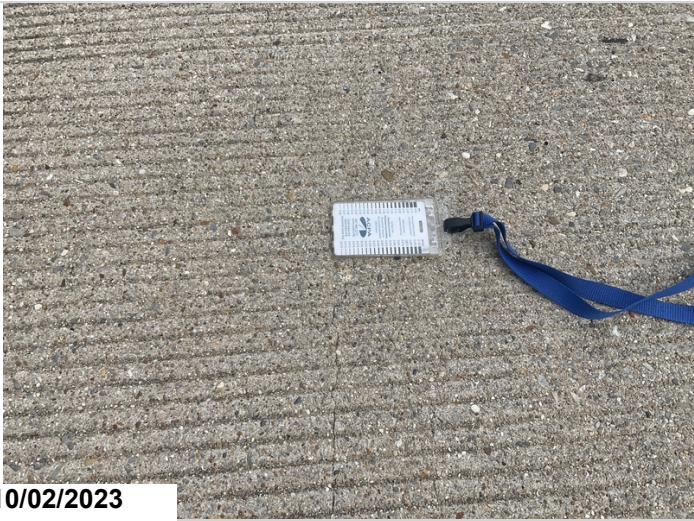
Span 1 cracking in deck

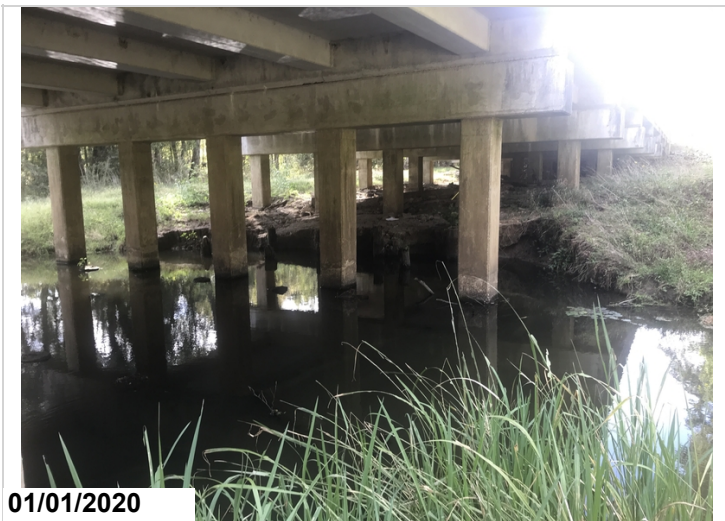
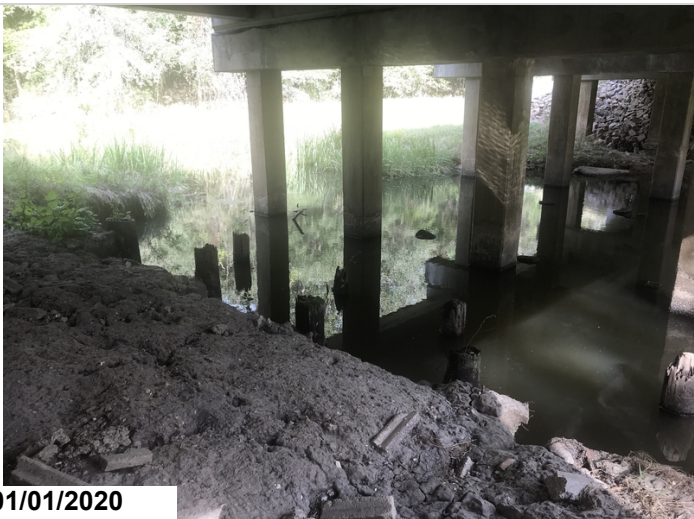
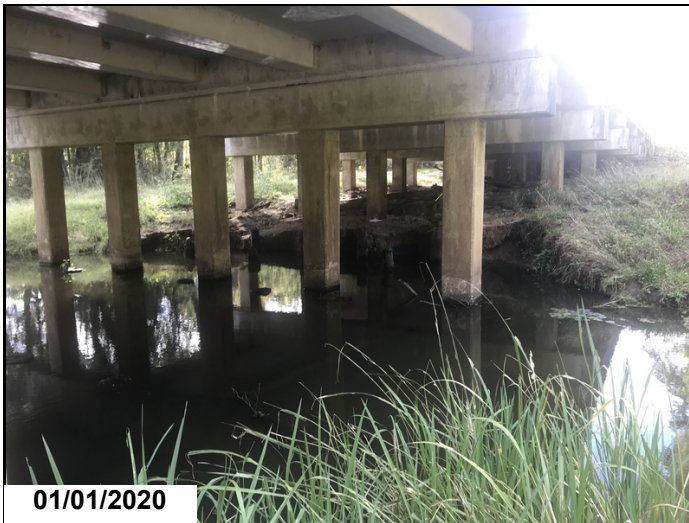
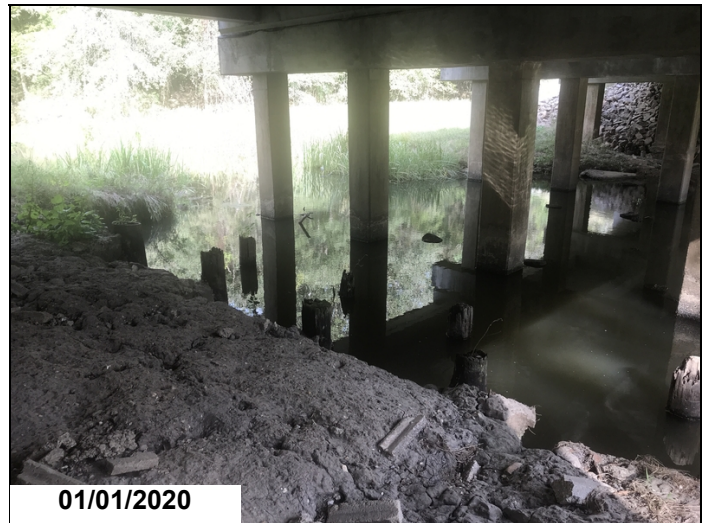
Erosion at under Span #6 7' deep hole width of bridge

Erosion under Span #6

7' deep hole Erosion under Span #6 next to bent #7....

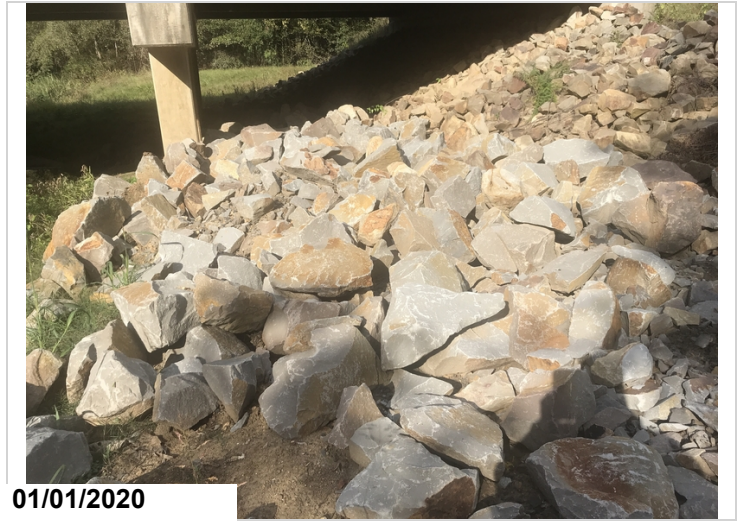
2019 flood slope protection

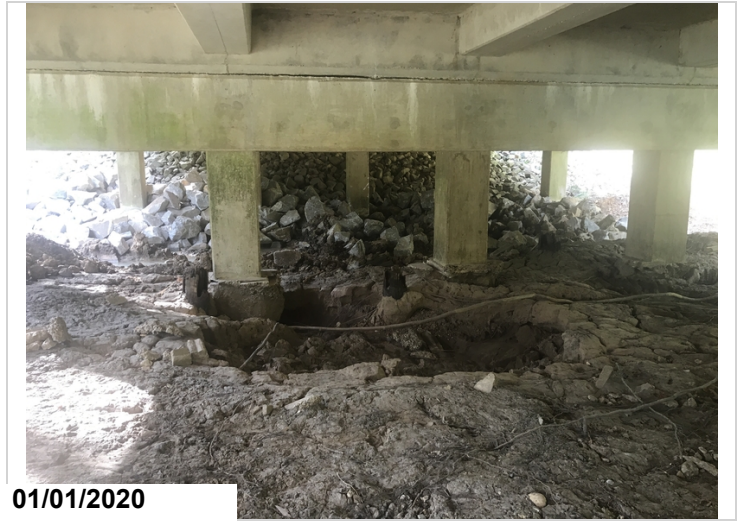
Erosion around bent #3

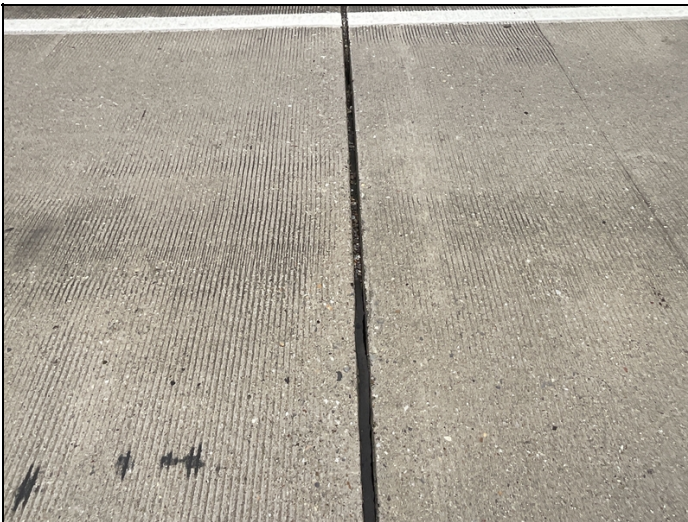
Typical photo of joints
