## Bridge 06346 Inspection Report

Route:19 Section:05 Log:10.09

District 03, 99 - Nevada County

**Team Lead:** John King, **Inspection Date:** 10/12/2023

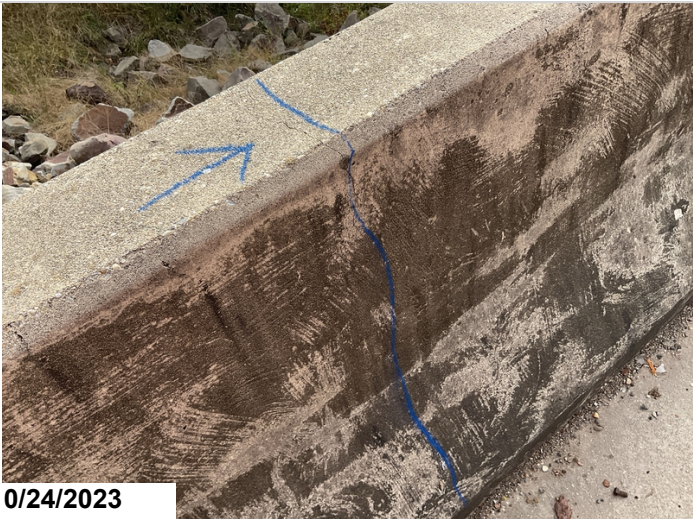
(331) Bridge railing is in good condition. Minor cracking in concrete railing.

Cracking in concrete railing

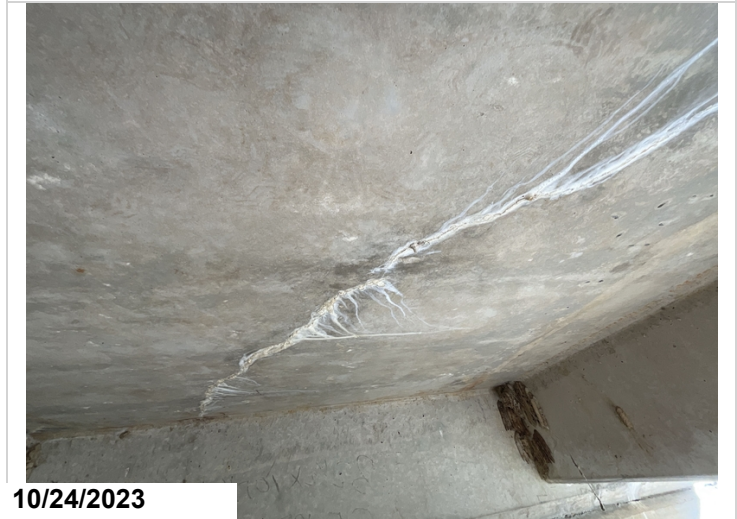
Span 3 at bay 4 efflorescence on bottom of deck.

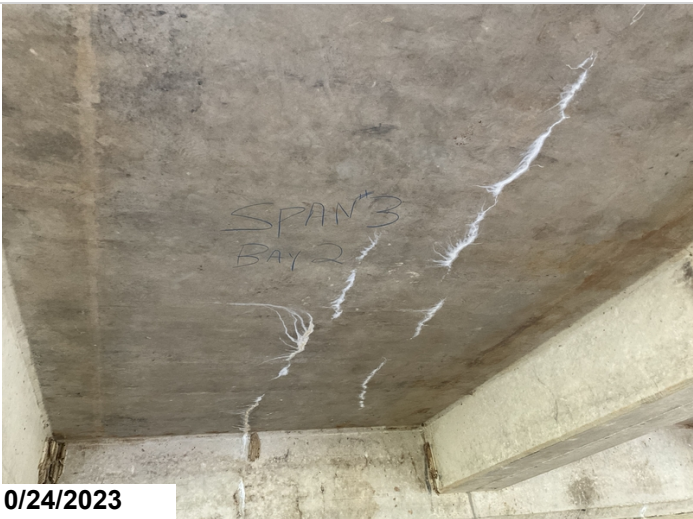
Span 3 bay 2 efflorescence with minor rusting.

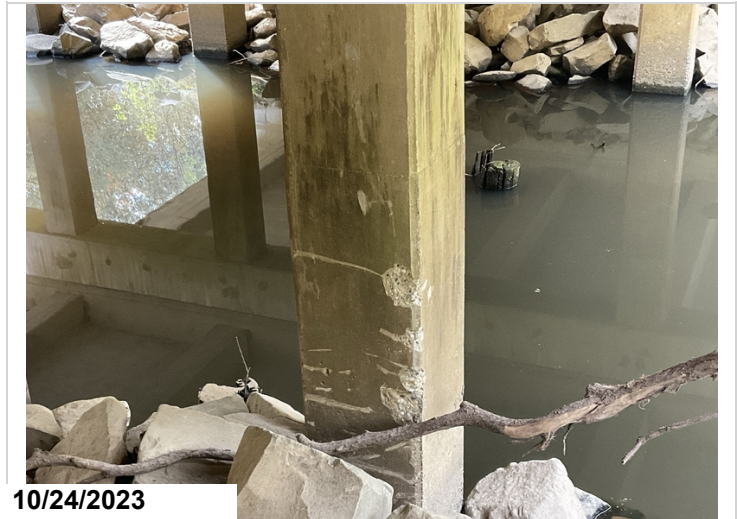
Bent 3 pile 2 minor spalling on concrete encasement.

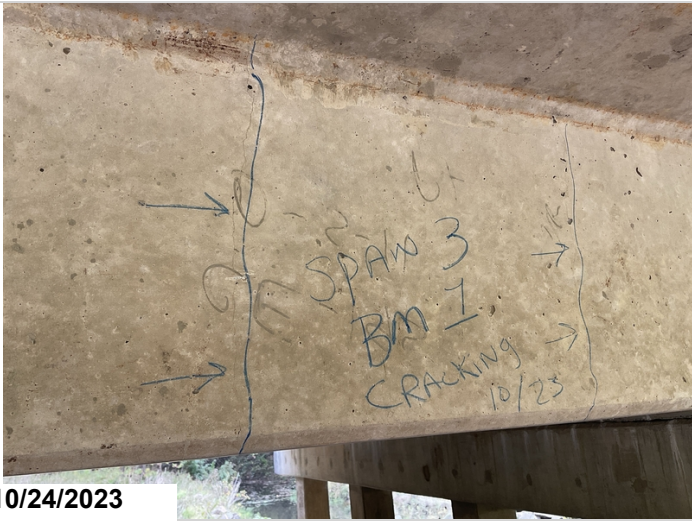
Beam 1 span 3. Minor cracking.

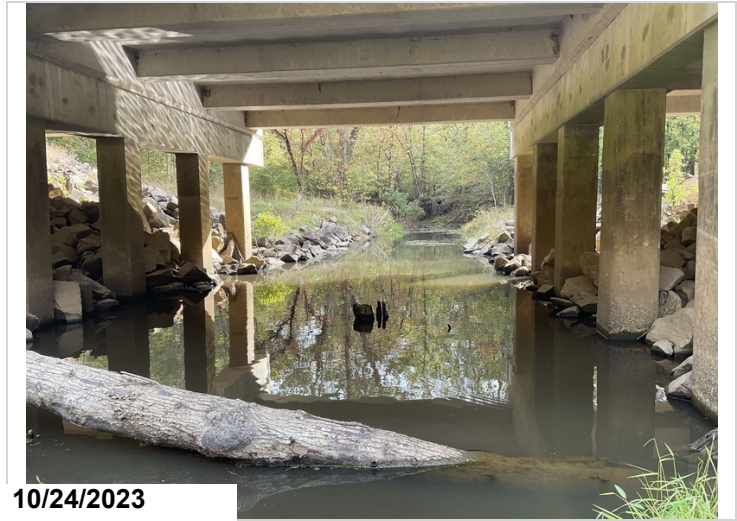
Downstream in very good condition. Very well vegetated.

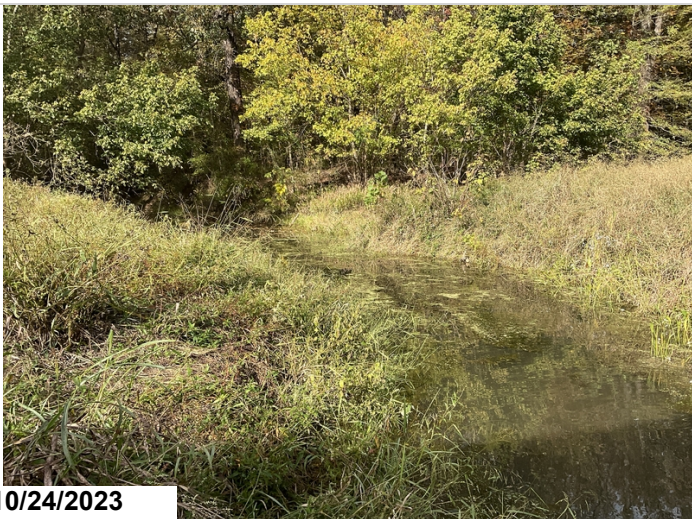
Upstream in very good condition. Very well vegetated.

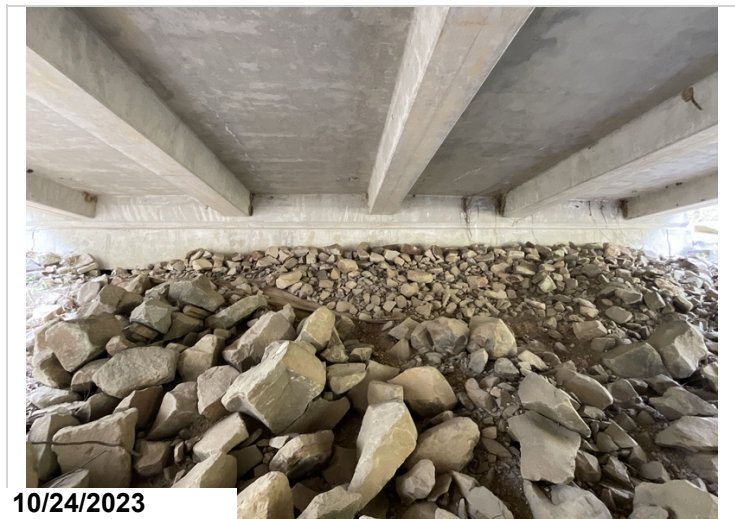
Abutment 1 in very good condition.

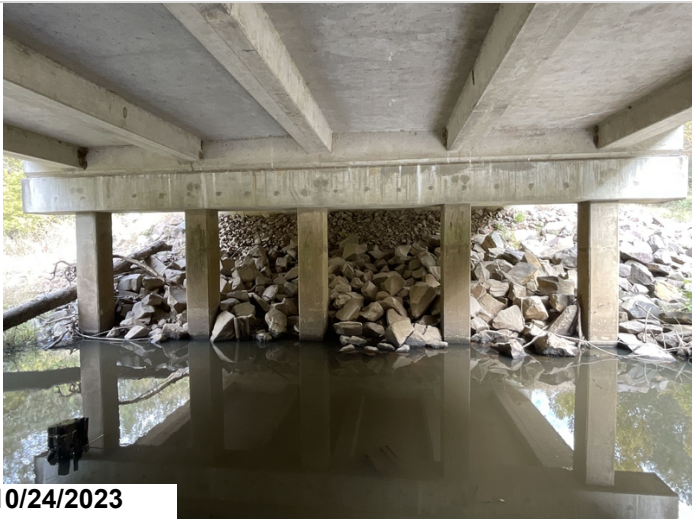
Bent 3 in very good conditions.

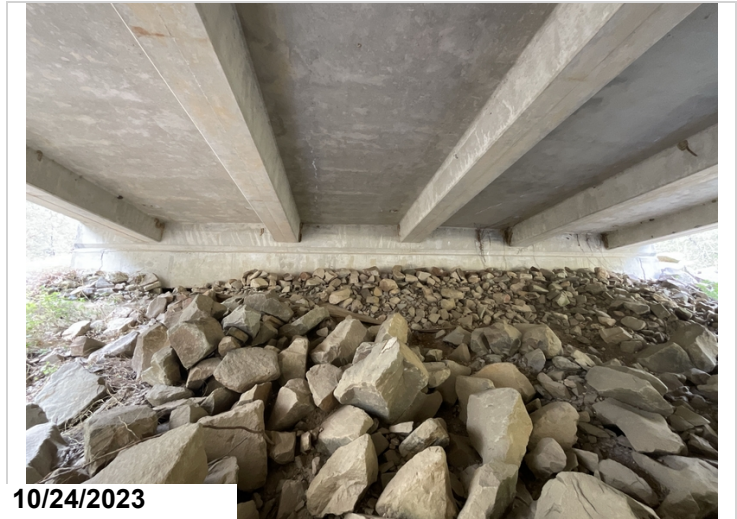
Abutment 1 in very good condition.

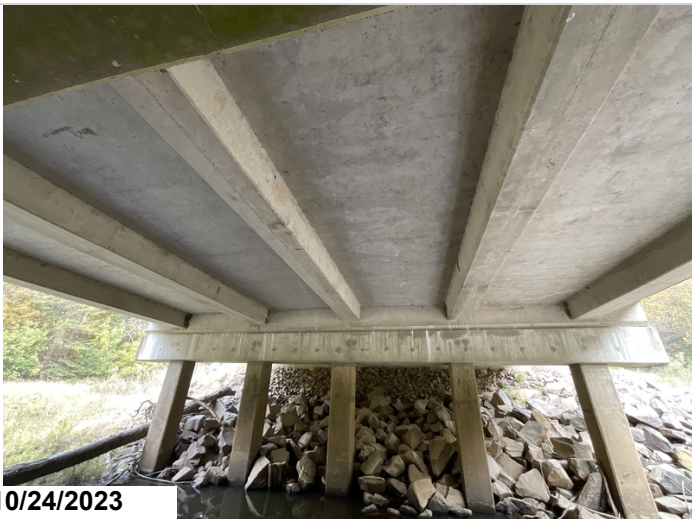
Photo taking in span 2 Superstructure in good condition.  
Minor cracking in concrete T Beam.

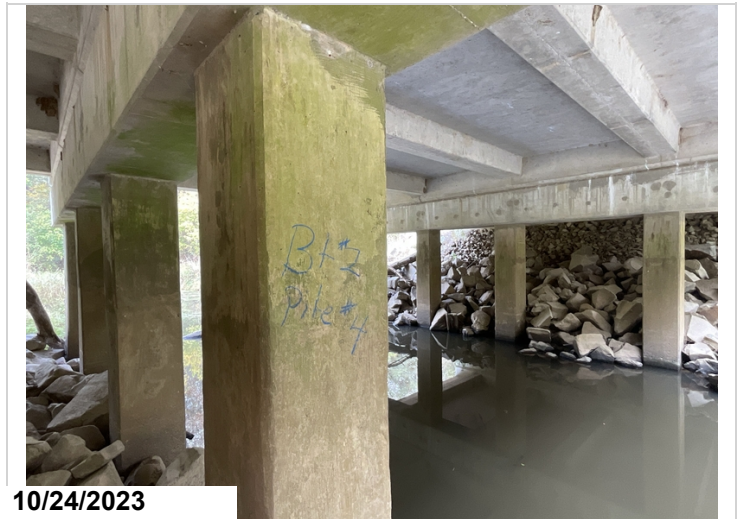
Bent 2 pile 4 concrete encasement in good condition.

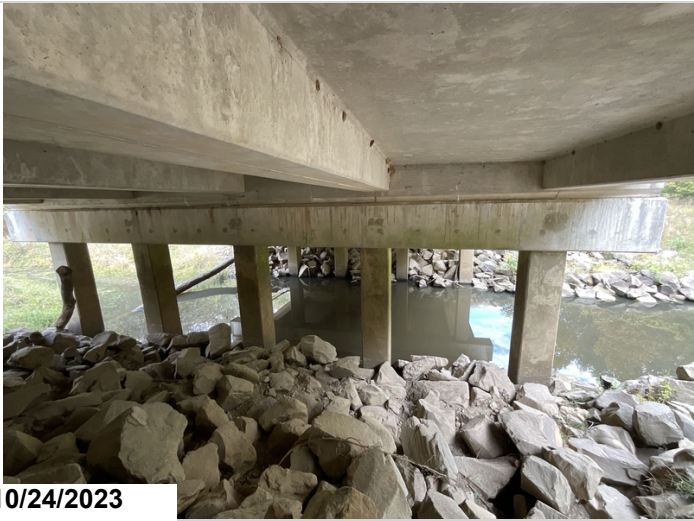
Bent 2 cap span 1 side typical photo of cap.

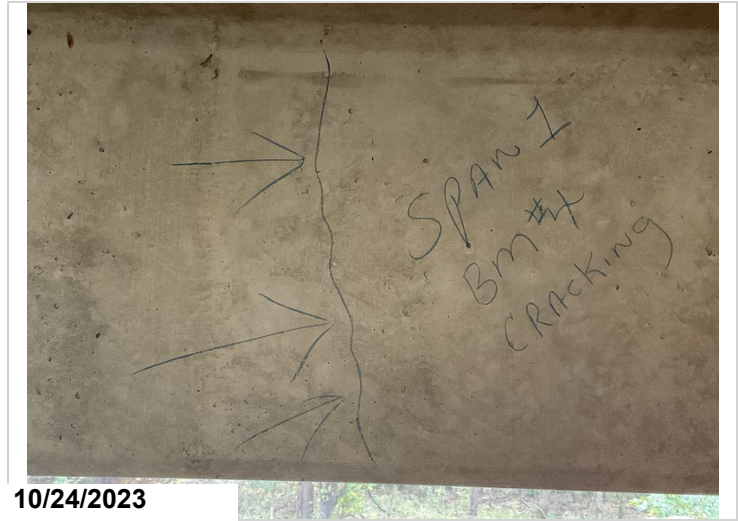
Span 1 beam 4 minor cracking in concrete.

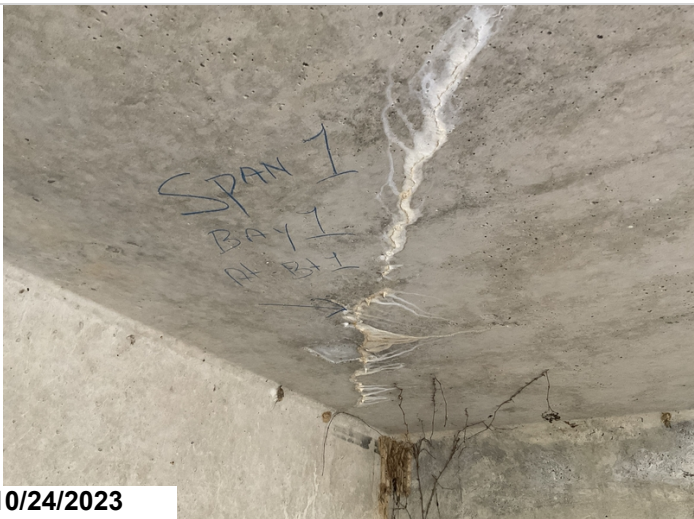
Span 1 bay 1,2,3,4 Efflorescence with rusting.

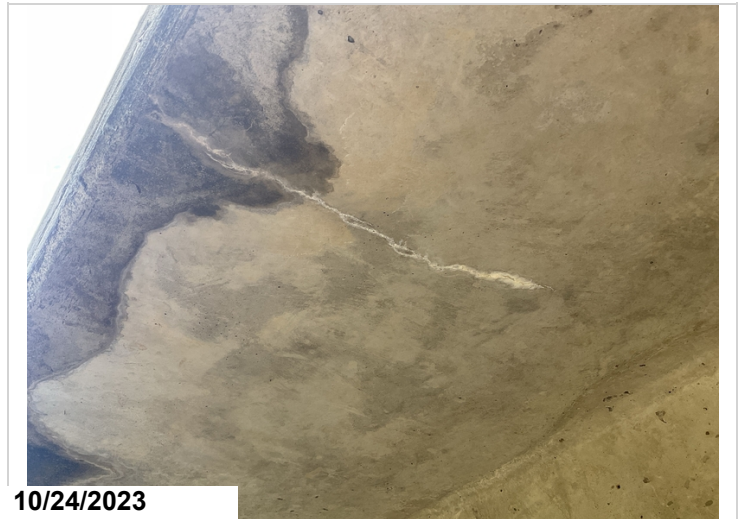
Efflorescence on bottom of deck.

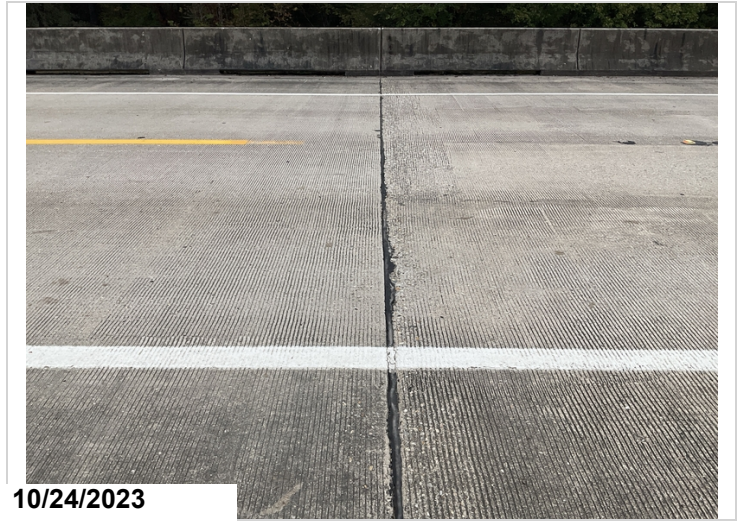
Joint condition in satisfactory condition at bent 2 and 3.

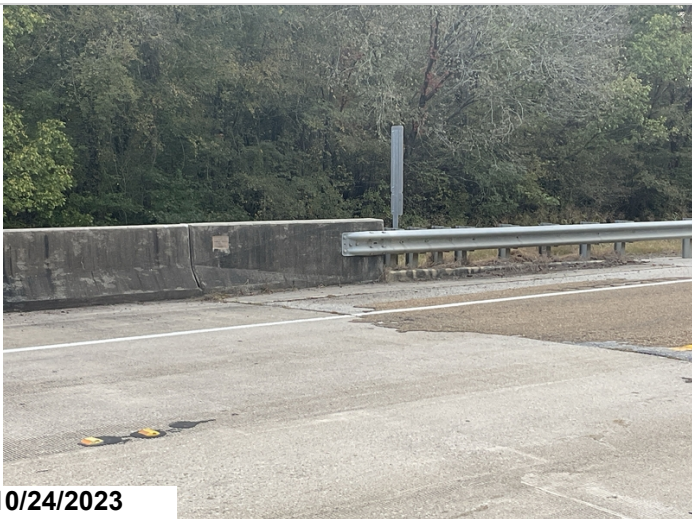
Bridge railing transition in good condition.

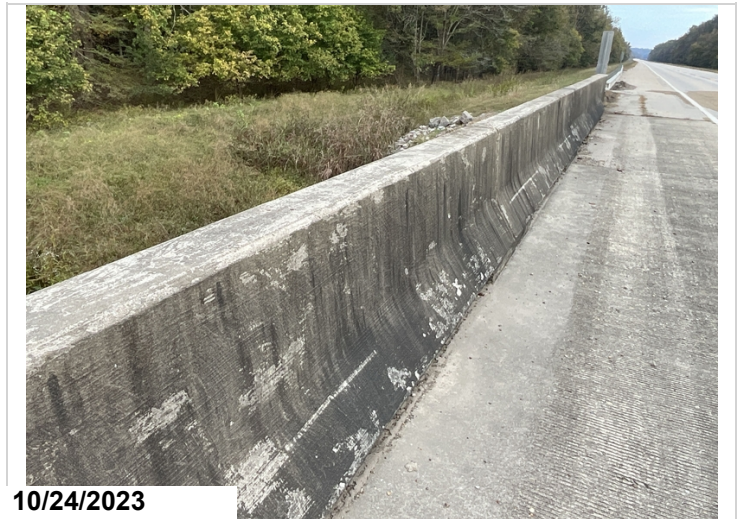
Bridge railing in good condition.

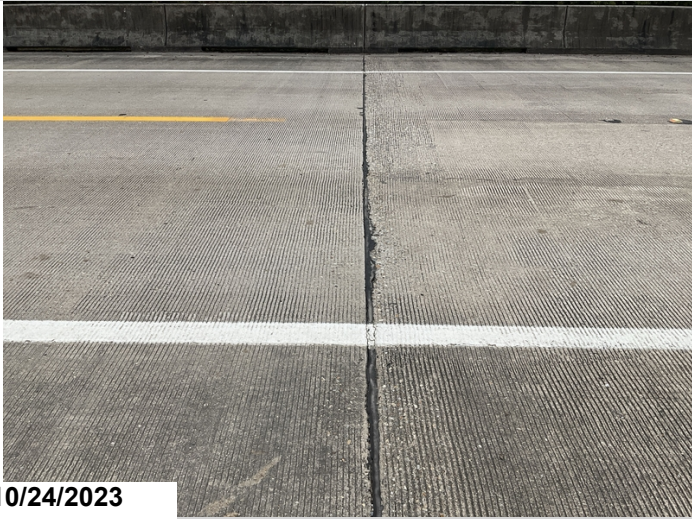
Joint seal in satisfactory condition.

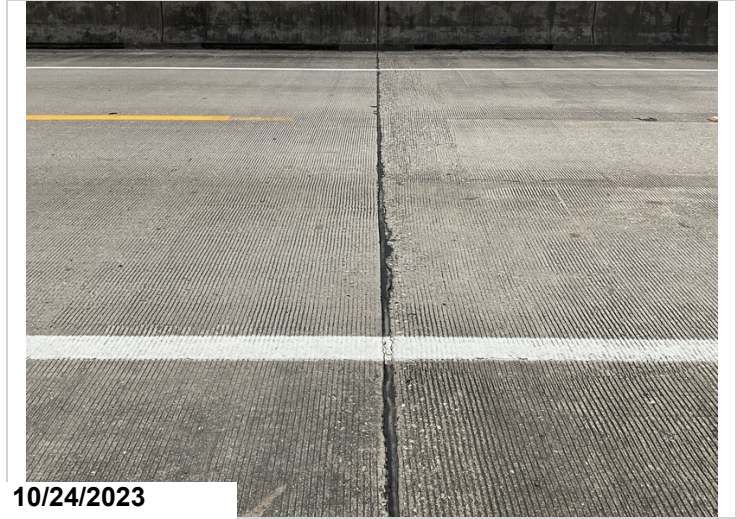
Joint seal at bent 2 & 3 are in satisfactory condition.

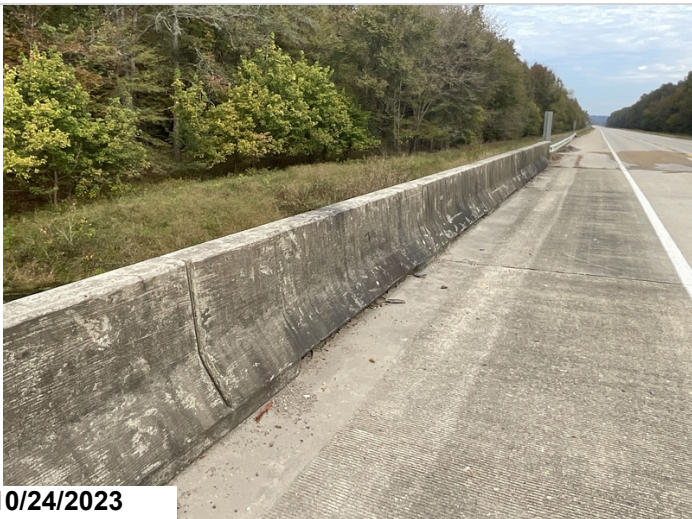
Bridge railing is in good condition. Photo on the left side.

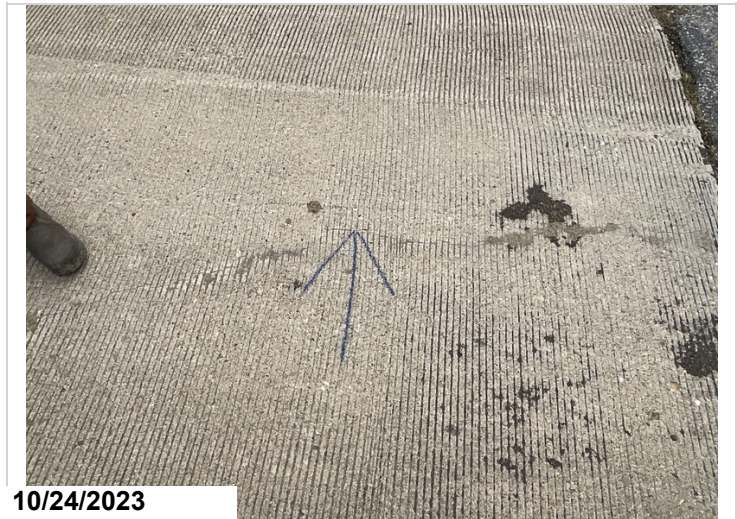
Cracks in the deck.

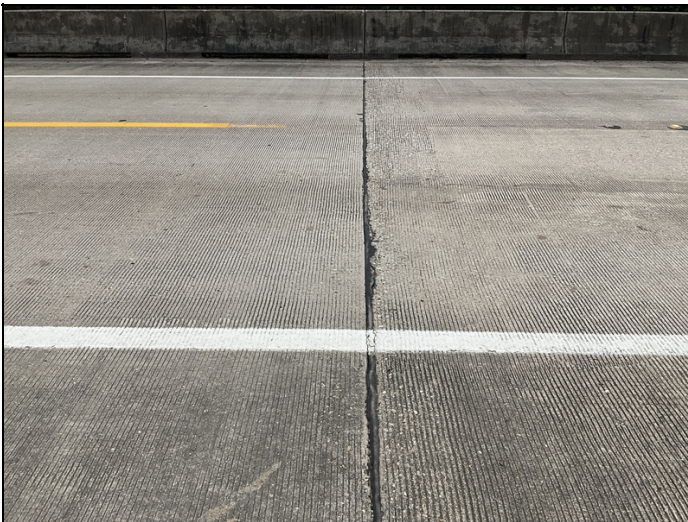
Joint seal in satisfactory condition.

**A-59 - Joint Repair Needed (Yes)**
