Bridge 06347 Inspection Report

Asset #06347(Routine)

SH 19 - 05 -10.86 over LITTLE MISSOURI RV RLF

Team Lead: John King Inspection Date: 10/12/2023

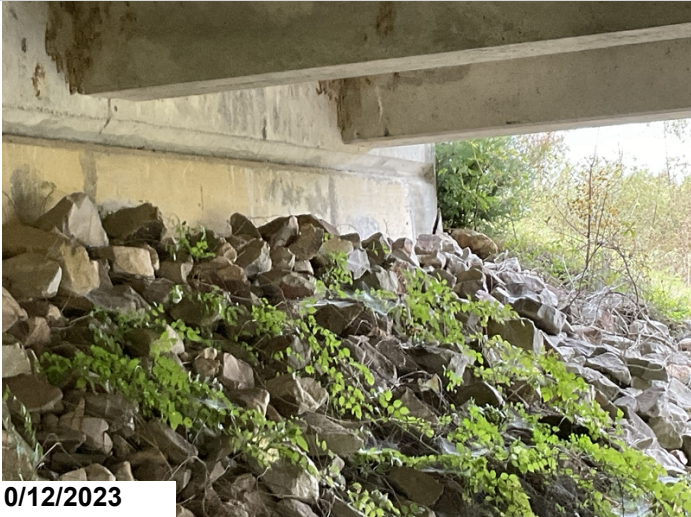
Abutments 1 left side small spall on edge

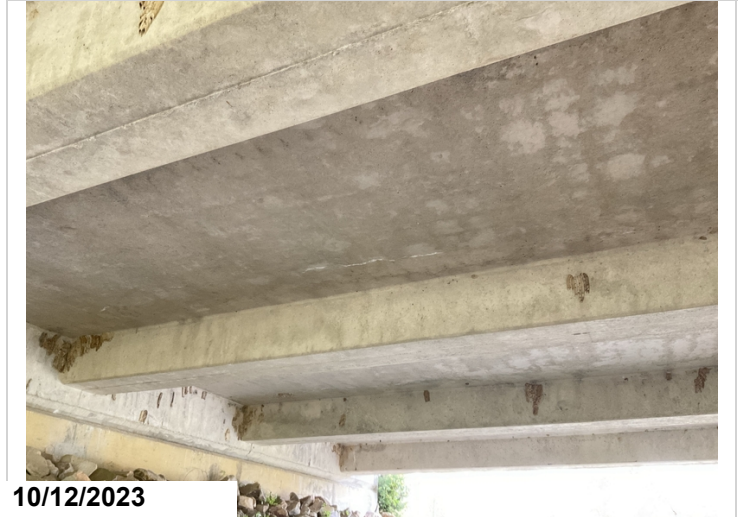
Bay 3 span 1 efflorescence

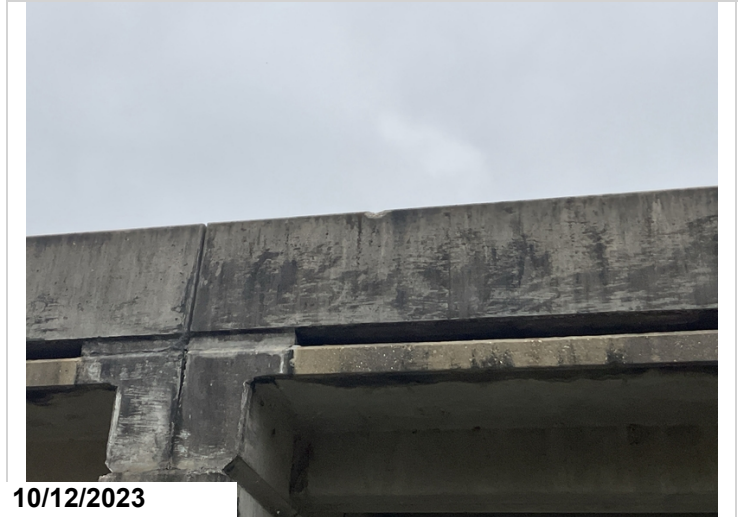
Span 3, right bridge rail, spall on the top of the rail.

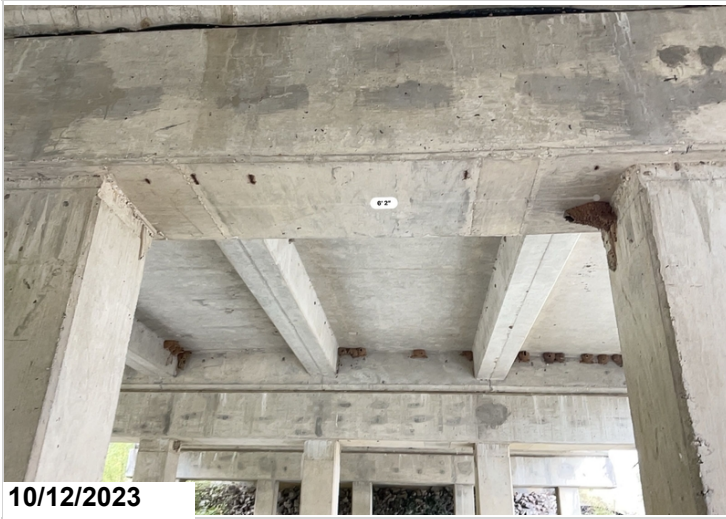
Bent 4, bottom of cap between pile 2 and 3, exposed rebar.

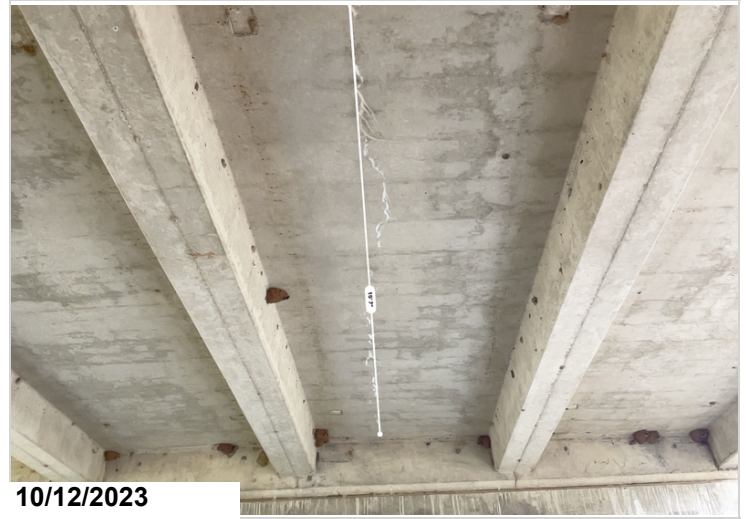
Span 5, bay 2, typical longitudinal crack with efflorescence.

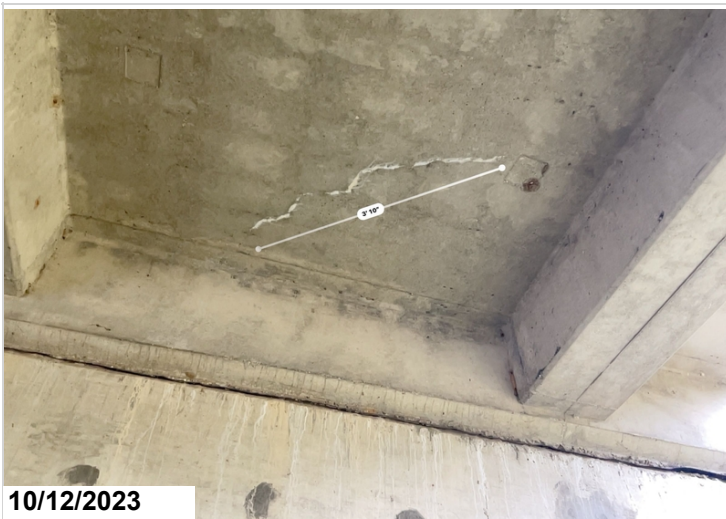
Span 7, bay 4, efflorescence in the under surface.

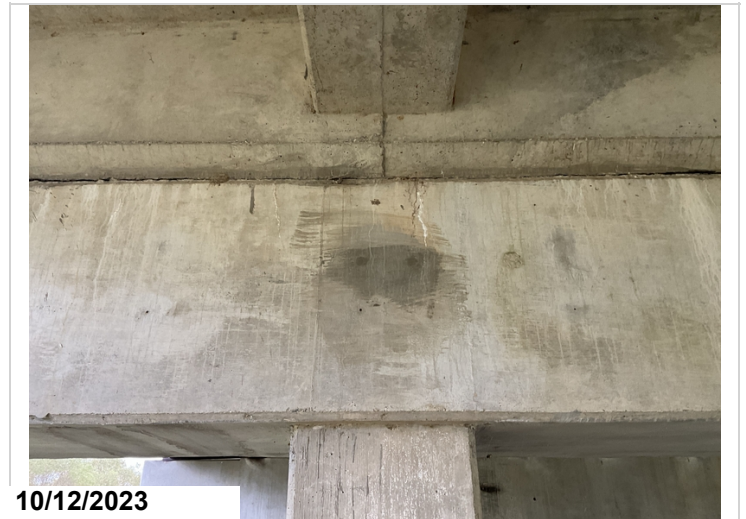
Bent 9 back, above pile 2, cracks with efflorescence in the cap.

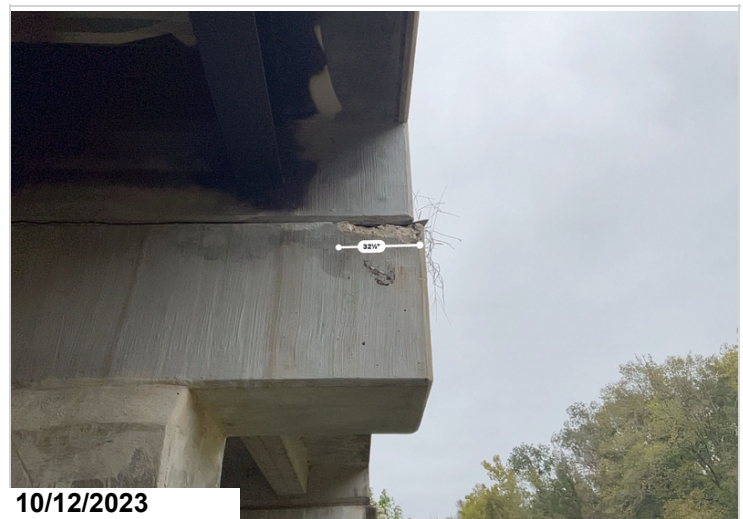
Bent 15 back, right edge, spall in the top of the cap.

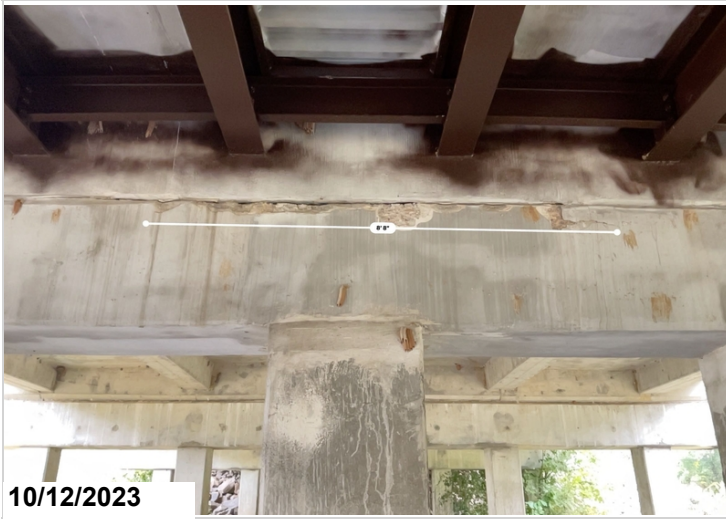
Bent 15 back, large spalls at the top of the cap above pile 3.

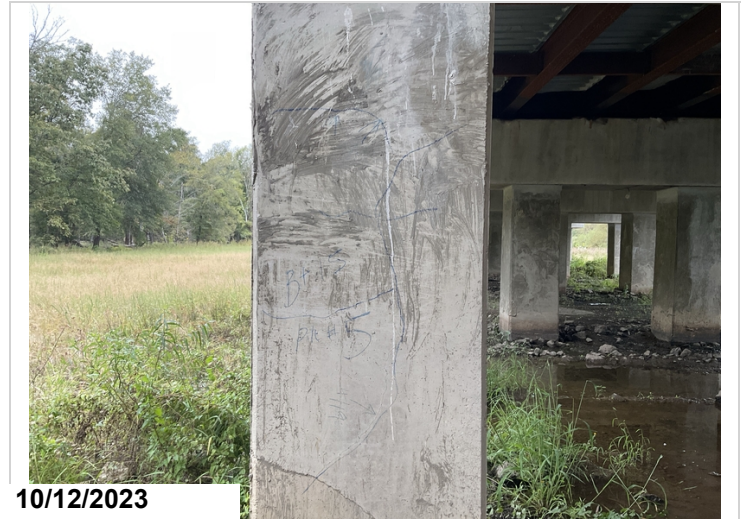
Bent 15, pile 5 ahead, cracks in the concrete encasement.
Typical.

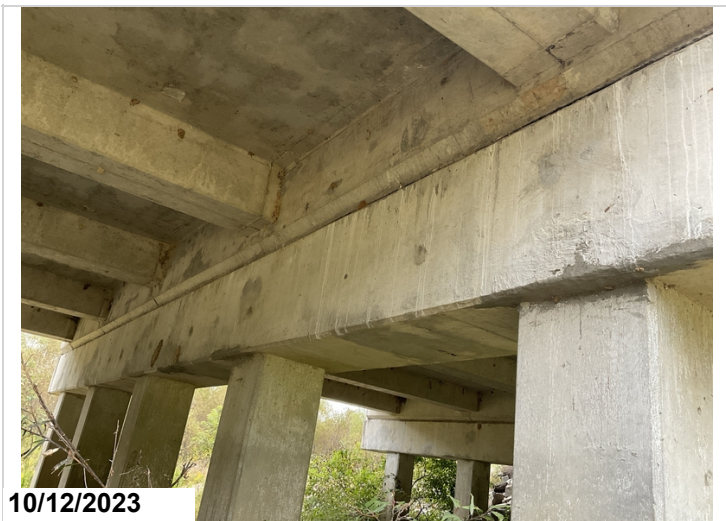
Bent 16, back side of cap, patches above pile.

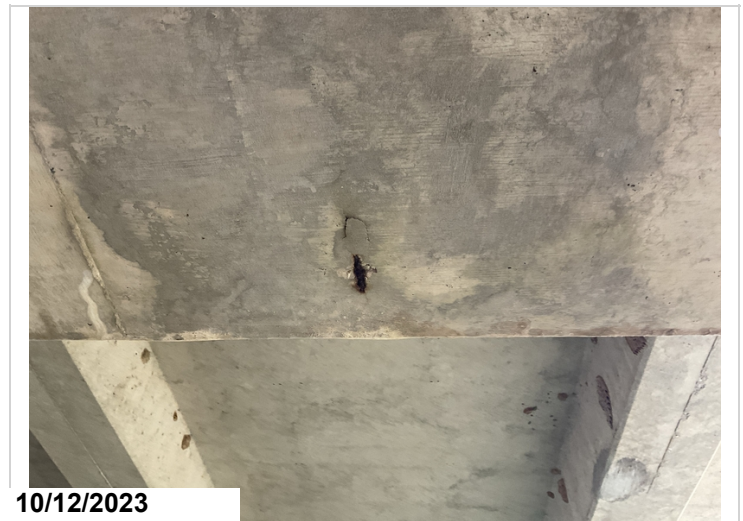
Bent 16, bottom between pile 3 and 4, exposed rebar.

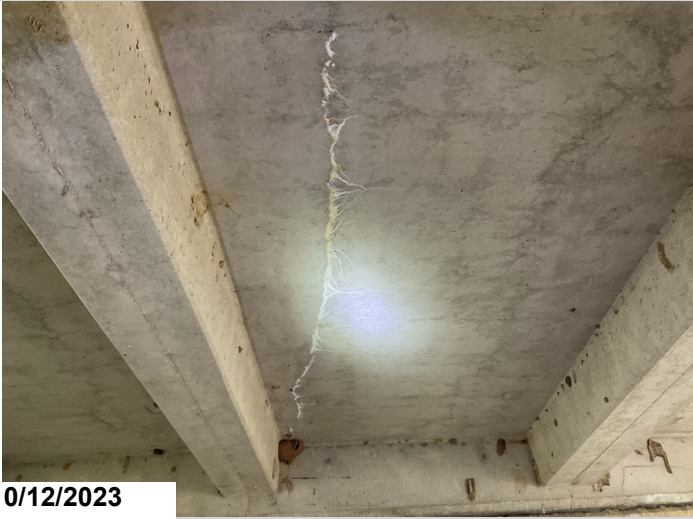
Span 16, bay 2, crack with efflorescence in the under surface.

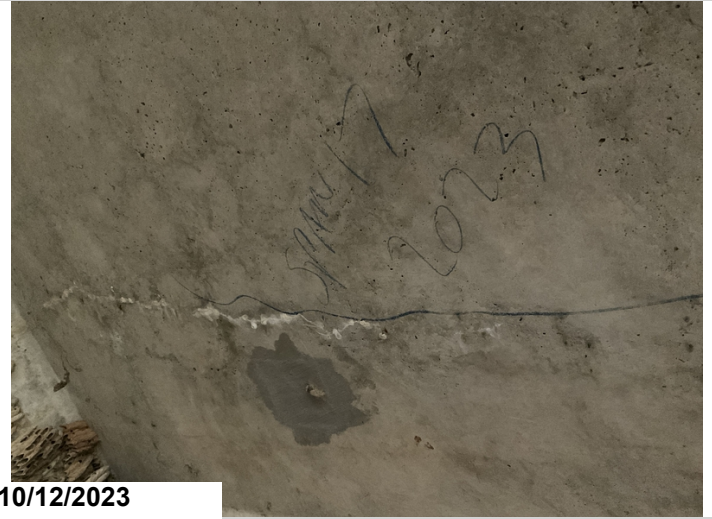
Span 17, bay 3 near bent 18, crack with efflorescence in the under surface.

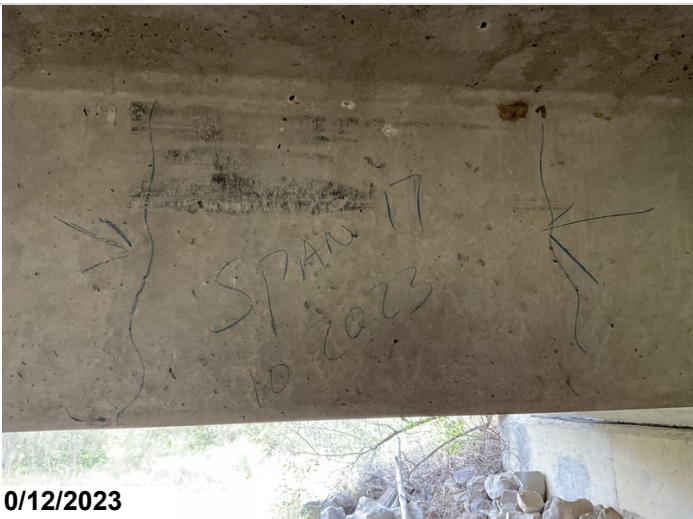
Span 17, girder 2 right side, minor cracks.

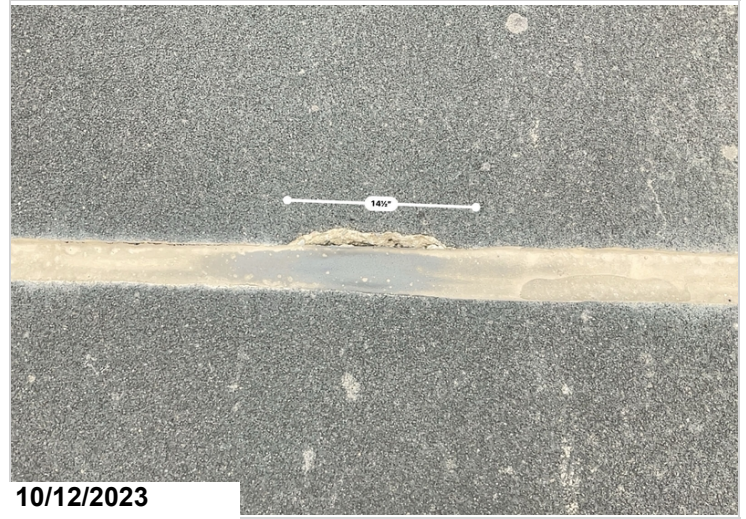
Joint main Spain minor spall near center road.

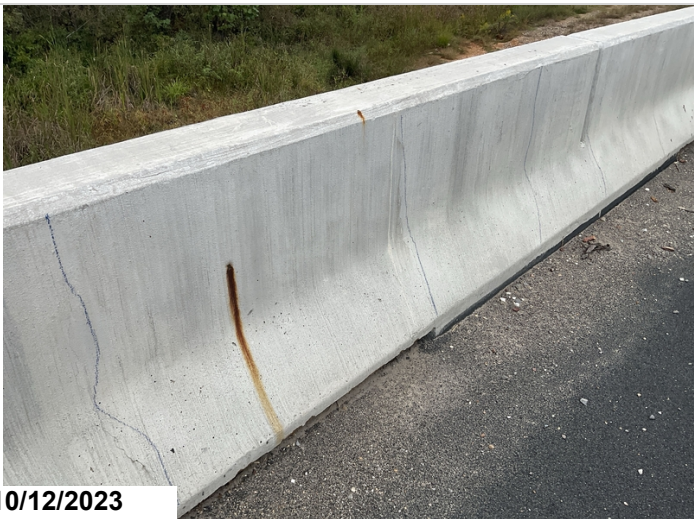
Minor cracks in parapet wall main-span

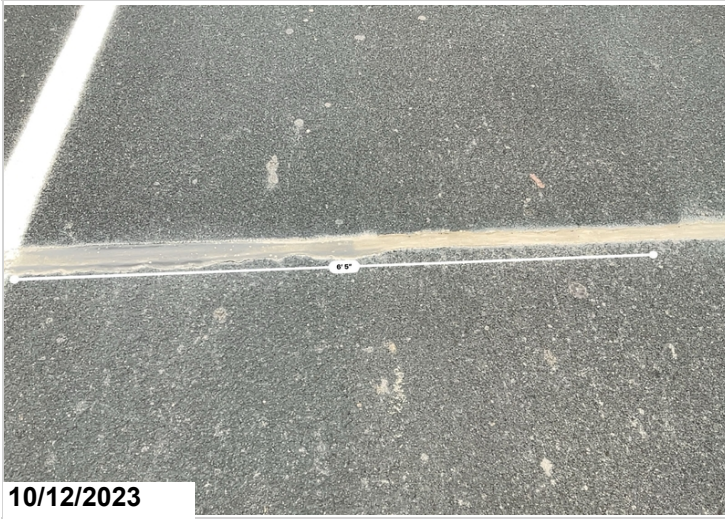
Joint coming loose from edges joint 8

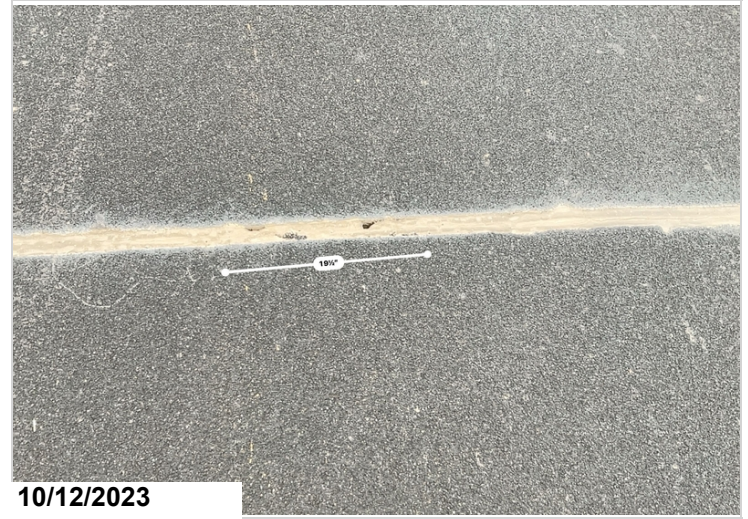
Main span joint with small hole. Joint 8

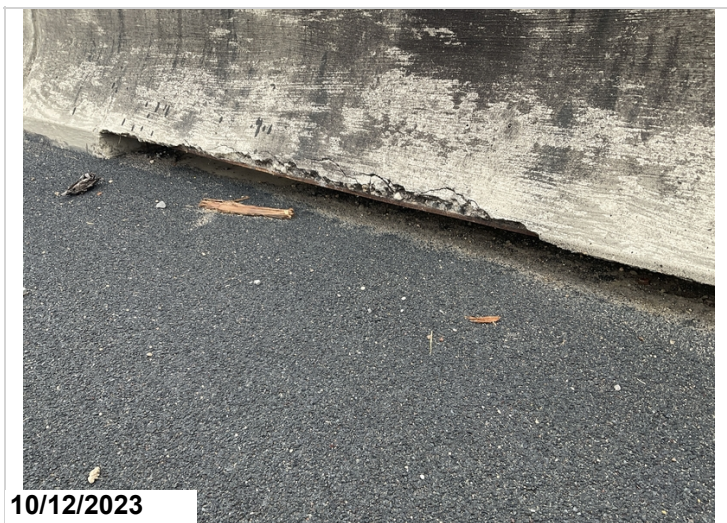
2023 small spalls in parapet wall photo taken right side span
4. Approach span

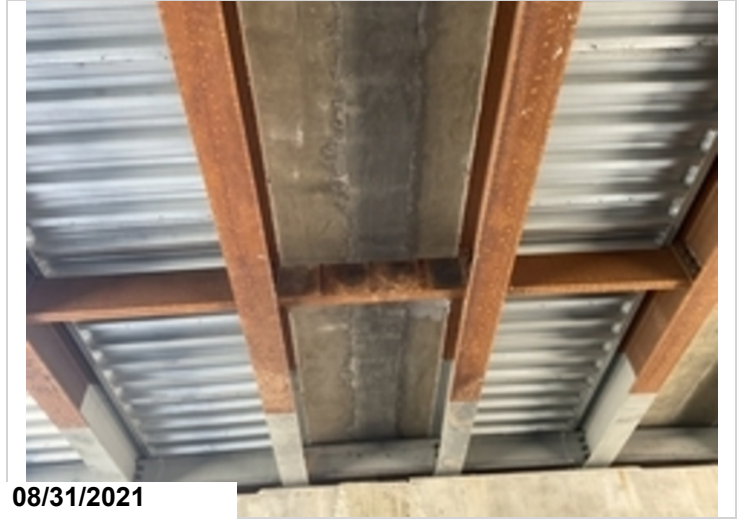
no deck pans at closure pour
