Bridge M3801 Inspection Report

Inspection Notes

US 278 - 06 - 3.54 over BODCAU CREEK

Team Lead: John King Inspection Date: 09/05/2024

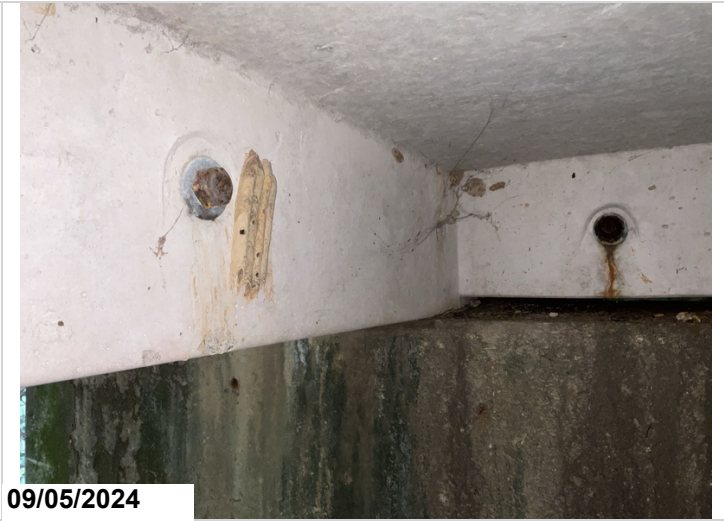
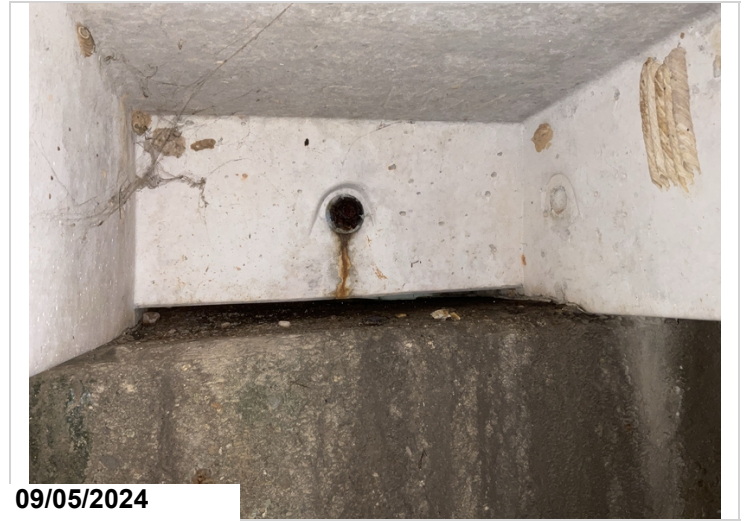
The precast units are bolted together per this inspection but have considerable amounts of section loss.

Precast units are bolted together

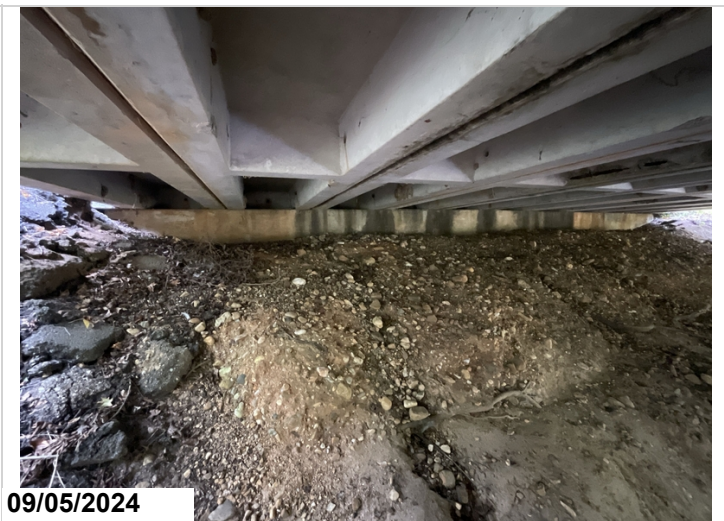
Bent 4

The bent 4 abutment has approximately 2' of linear cracking found directly under the precast unit 5.

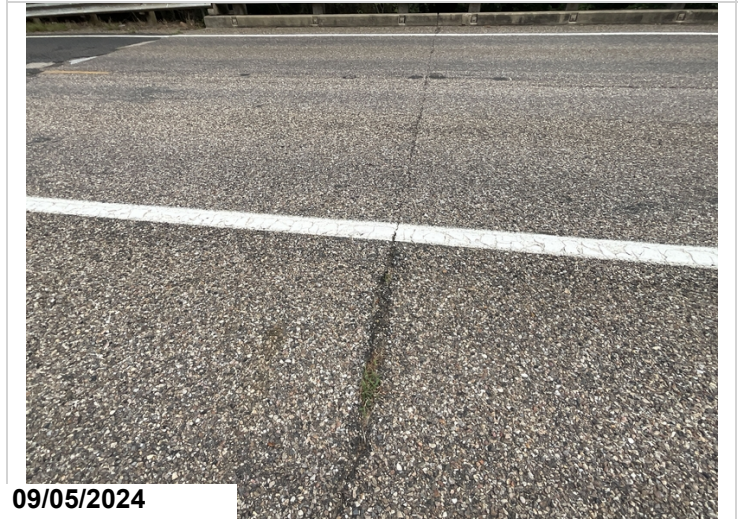
All joint lines are impacted by asphalt overlay that inhibits joint movement.

(301) Pourable joint seal, All joint lines, Debris impaction from wearing surface, CS4							
330	Metal Bridge Railing	LF	114	114	0	0	0
331	Reinforced Concrete Bridge Railing	LF	114	104	10	0	0
1080	Delamination/Spall/Patched Area	LF	10	0	10	0	0

Joint filled by asphalt overlay impacting joint movement

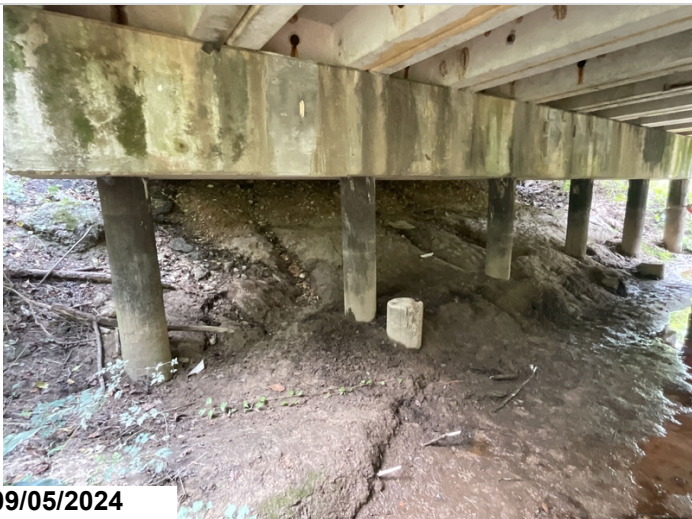
The scour rating is a 7 this inspection due to minor scour located around the timber piles at intermediate bents 2 & 3.

Bent 3, Minor scour

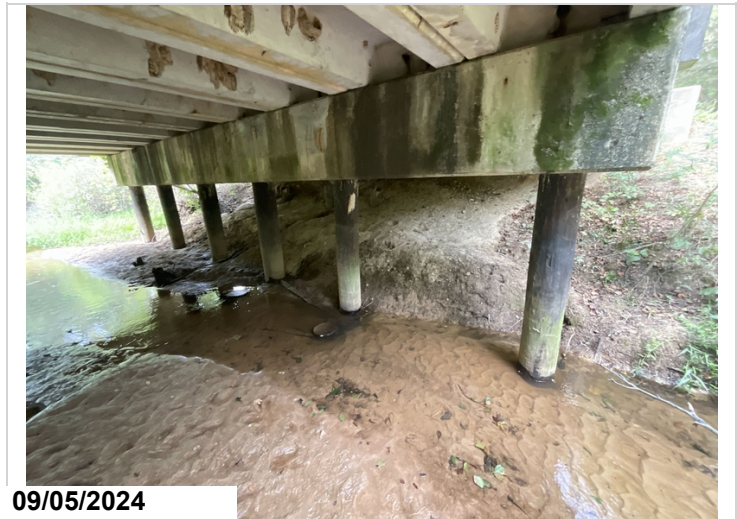
Bent 2, Minor scour

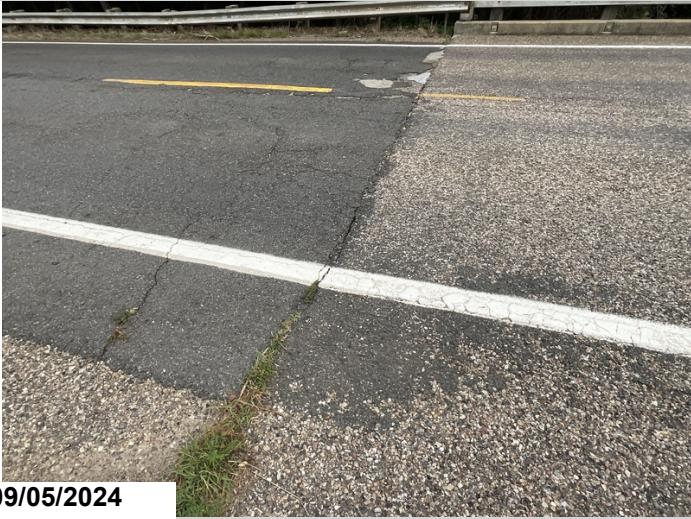
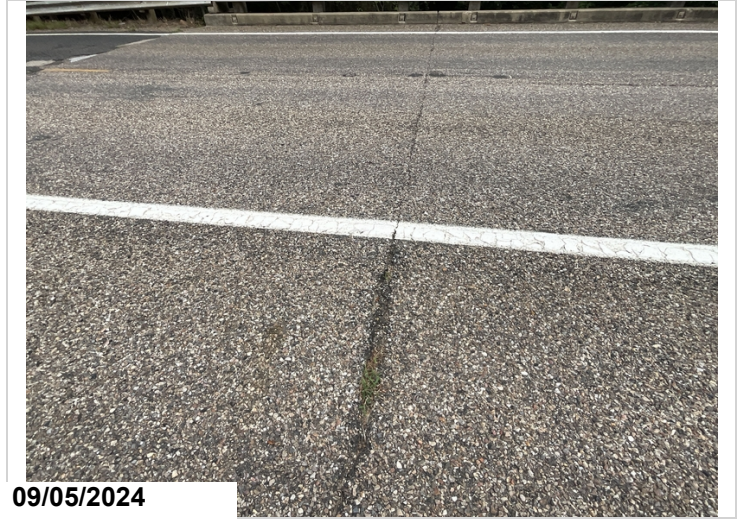
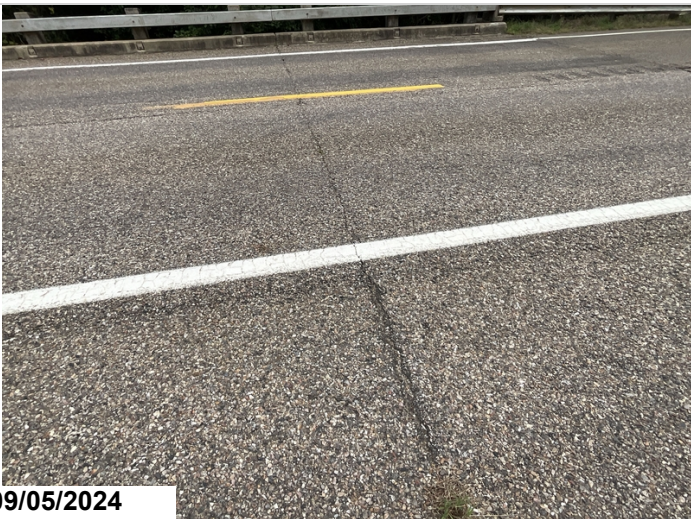
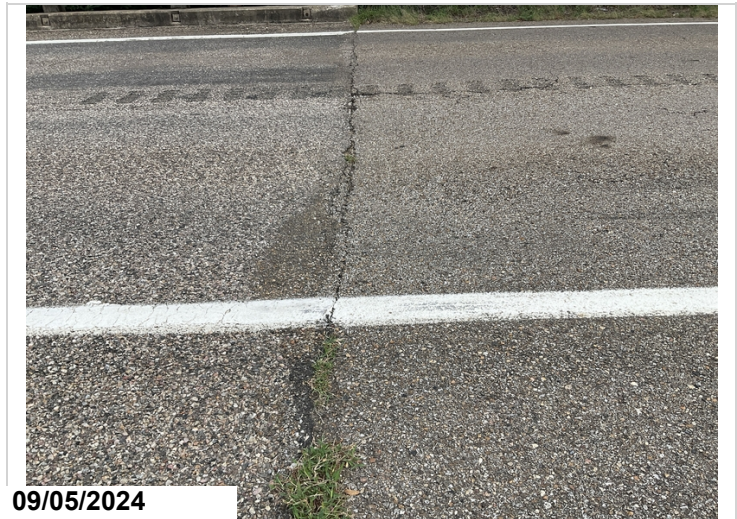
Asphalt overlay and chip seal has cracking throughout entire deck, all joints are impacted by asphalt.

(16) Asphalt overlay covering deck							
(510-16) Wearing surface, Along all joint lines as well as various locations in all spans, Cracking, CS1 & CS2							
110	Reinforced Concrete Open Girder/Beam	LF	627	606	13	8	0
1080	Delamination/Spall/Patched Area	LF	3	0	3	0	0
1090	Exposed Rebar	LF	18	0	10	8	0

Wearing surface, Bent 1, Cracking, CS2

Wearing surface, Bent 2, Cracking, CS2

Wearing surface, Bent 3, Cracking, CS2

Wearing surface, Bent 4, Cracking, CS2

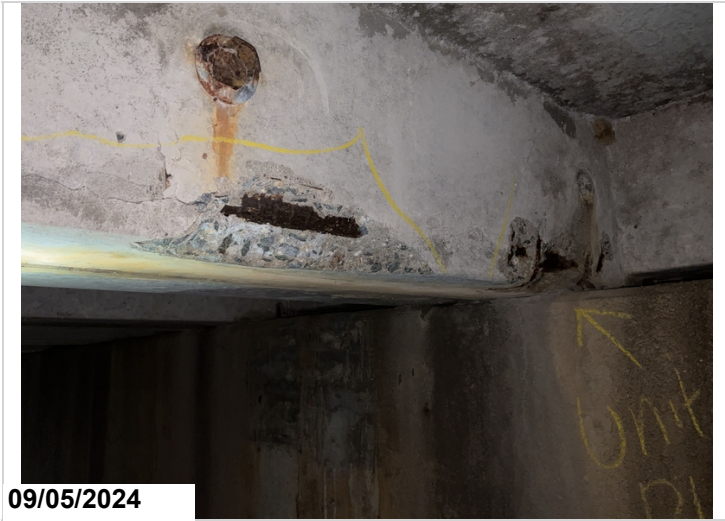
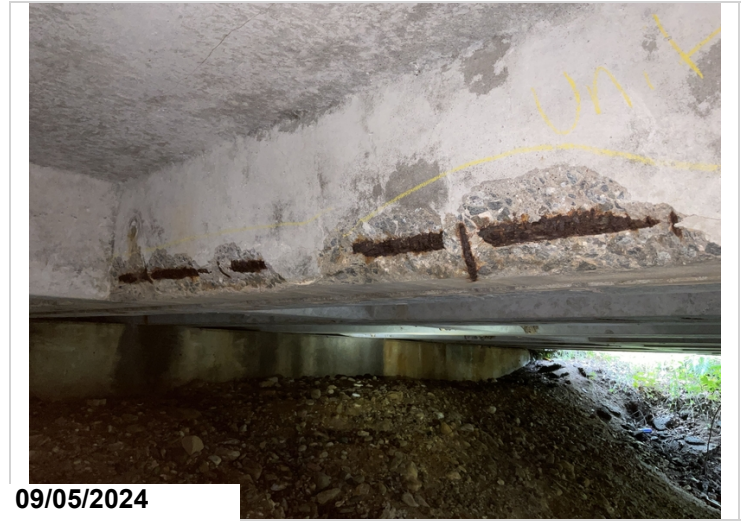
(110) All spans, Minor spalling is present along stems in various locations, CS2							
Span 2:							
Unit 3, Exposed rebar, CS2							
Unit 5, Exposed rebar, CS2							
Unit 5, Exposed rebar with 1/8" section loss, CS3							
Unit 10, Exposed rebar, CS2							
Span 3:							
Unit 4, Exposed rebar with 1/8" section loss, CS3							
215	Reinforced Concrete Abutment	LF	81	79	2	0	0
1130	Cracking (RC and Other)	LF	2	0	2	0	0

Span 3, Unit 4, Exposed rebar, CS3

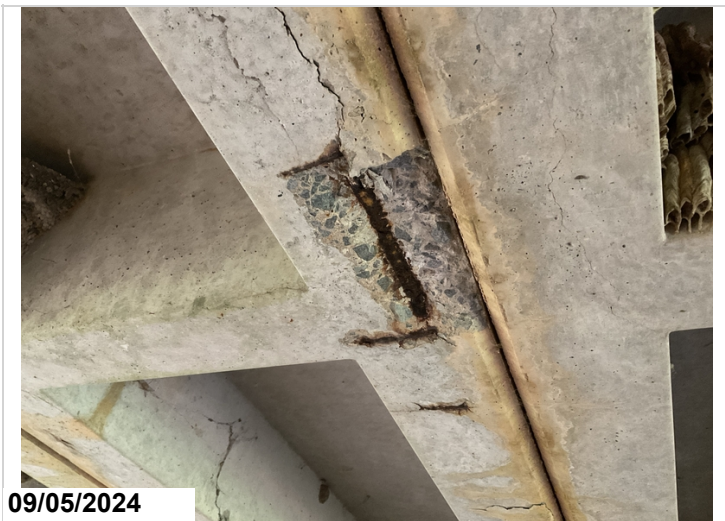
Span 2, Unit 3, Exposed rebar, CS2

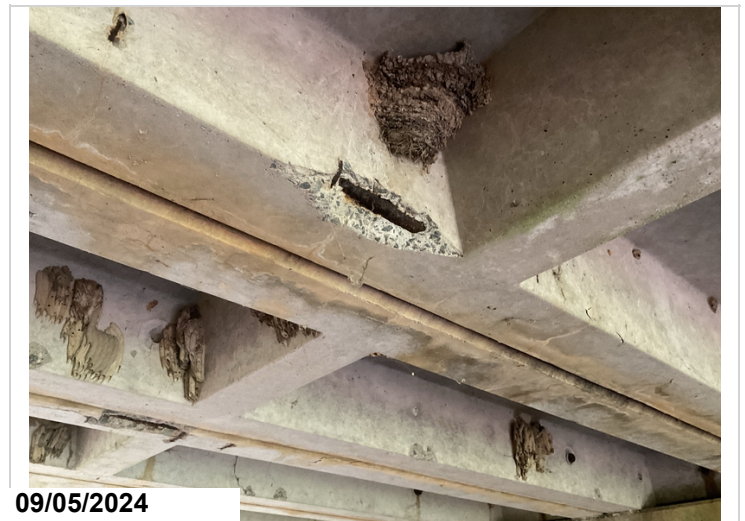
Span 2, Unit 5, Exposed rebar, CS2

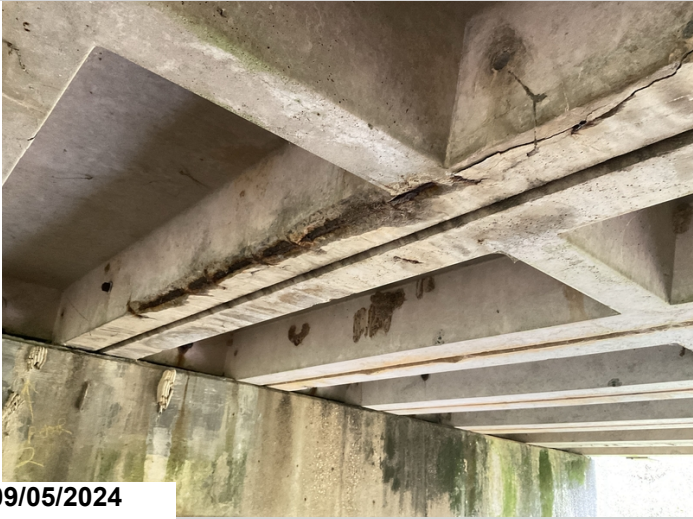
Exposed rebar on unit 5 is 3' away from bent 3 cap.

Span 2, Unit 5, Exposed rebar, CS3

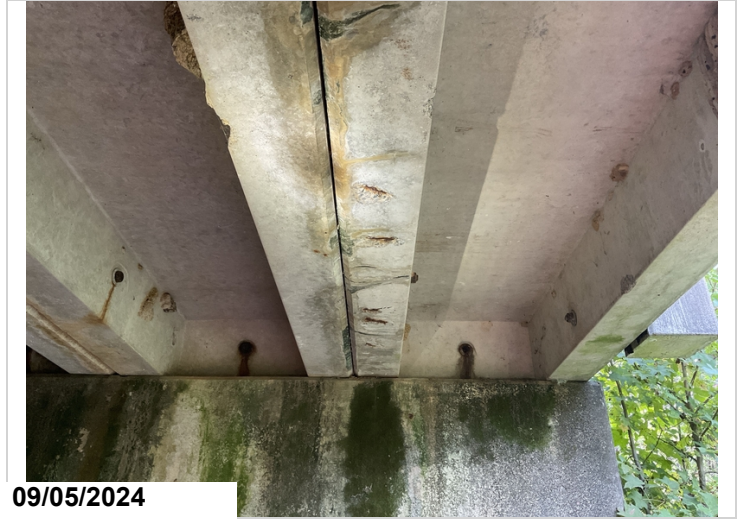
Span 2, Unit 10, Exposed rebar, CS2

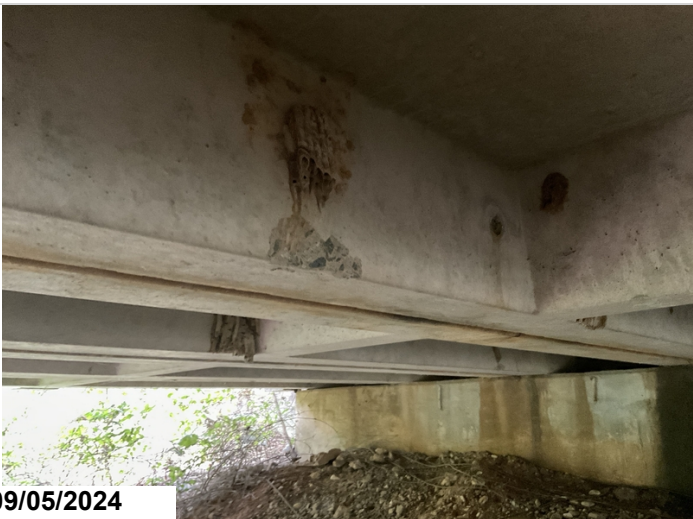
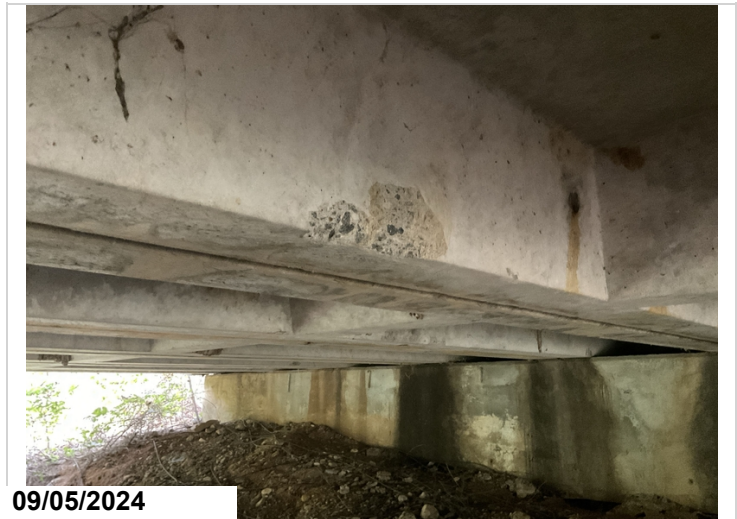
In both spans 1 & 2 there are minor areas of spalling found to the bottom stems in various locations.

Span 1, Minor spalling, CS2

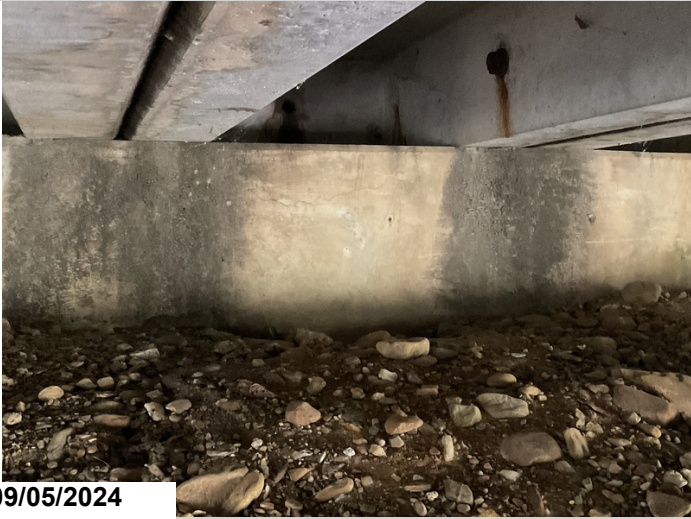
(215) Concrete abutment, Bent 4, Span 3 side, Cracking, CS2							
Linear cracking is located under the precast unit 5 at the bent 4 cap.							
228	Timber Pile	EA	12	11	1	0	0
1140	Decay/Section Loss	EA	1	0	1	0	0

Bent 4, Looking ahead, Linear cracking under unit 5, CS2

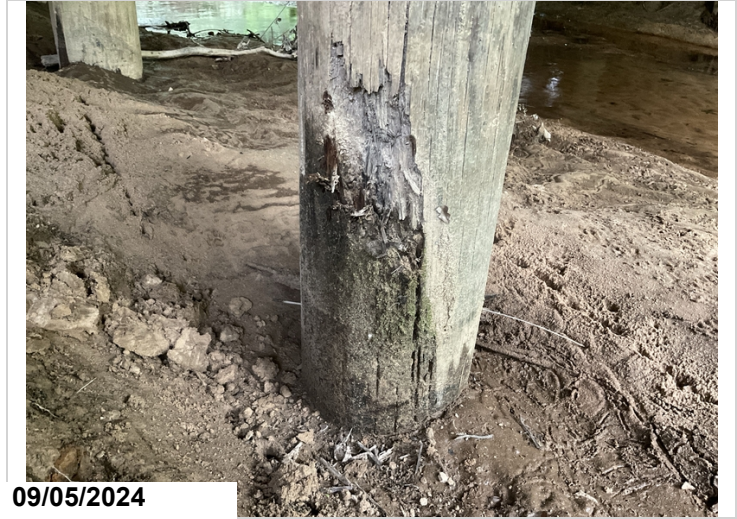
Pile 5 at bent 2 shows approximately 1" of outer shell decay and is located 1.5' above the ground level at the time of this inspection.

(228) Timber pile, Bent 2 Pile 5, Decay, CS2							
The timber pile shows signs of 1" outer shell decay and is located approximately 1.5' above the ground level during the time of this inspection.							
234	Reinforced Concrete Pier Cap	LF	71	66	5	0	0
1130	Cracking (RC and Other)	LF	5	0	5	0	0

Bent 2, Pile 5, Decay, CS2

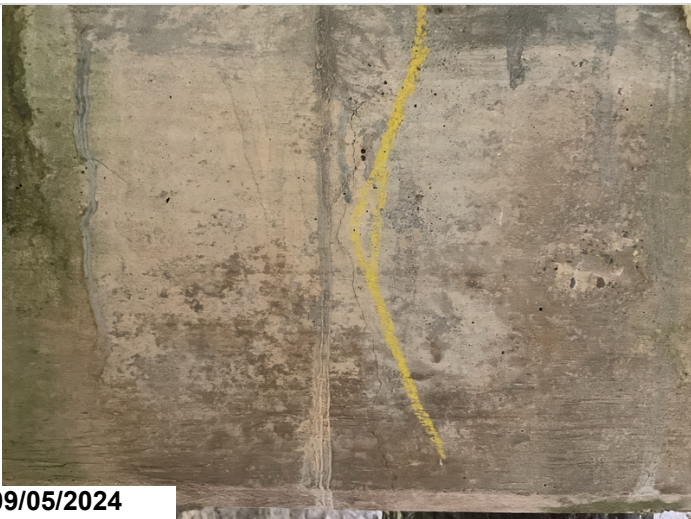
There is minor cracking to the intermediate bents 2 & 3 caps in various locations.

(234) Concrete pier cap, Both intermediate bents 2 & 3, Minor cracking found to various locations, CS2							
301	Pourable Joint Seal	LF	133	0	0	0	133
2350	Debris Impaction	LF	133	0	0	0	133

Bent 2, Looking back, Cracking, CS2

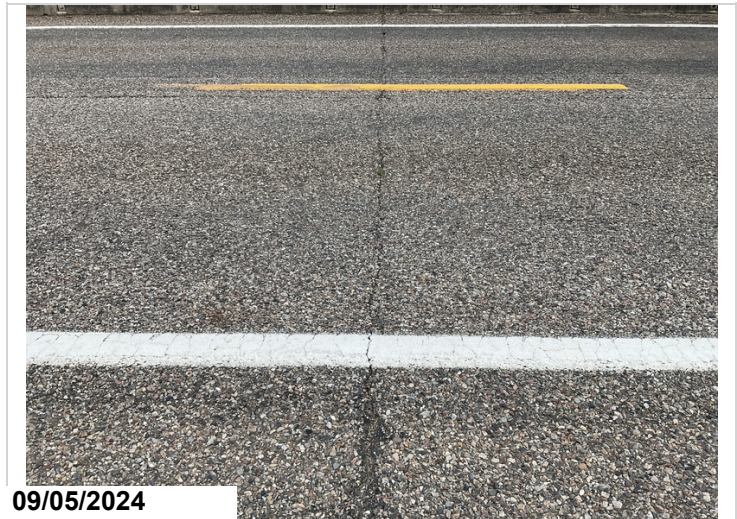
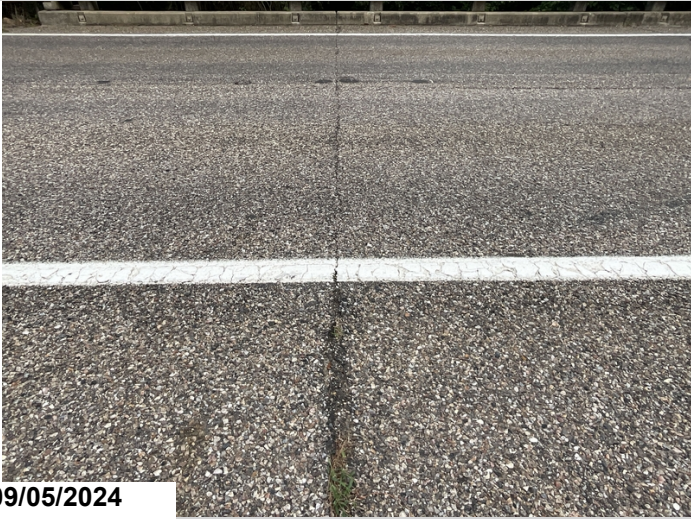
Pourable joint seal, Bent 3, Debris impaction, CS4

Pourable joint seal, Bent 2, Debris impaction, CS4

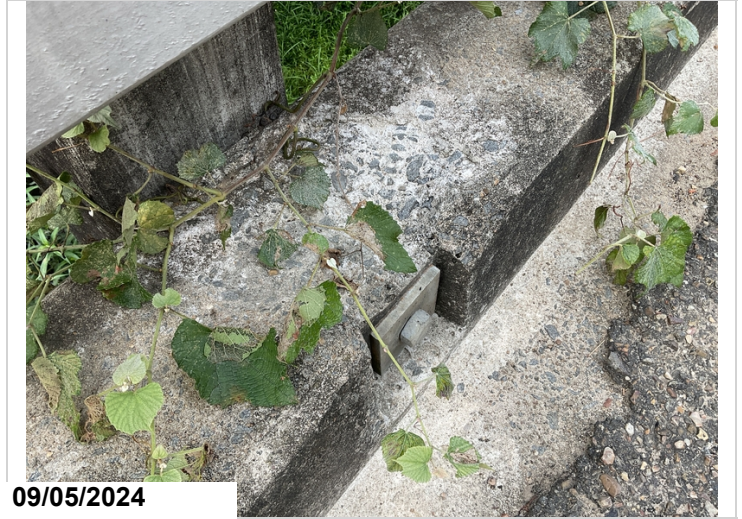
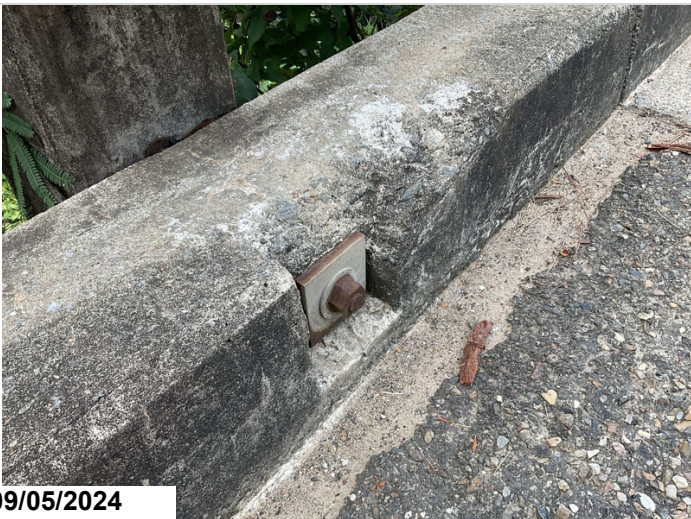
Both sides of concrete bridge railing have spalling in various locations.

ELEMENTS	DESCRIPTION	UNITS	TOTAL	CS1	CS2	CS3	CS4
	(331) Concrete bridge railing, Both right and left sides, Spalling, CS2

Concrete bridge railing, Both Rt and Lt sides, Spalling, CS2

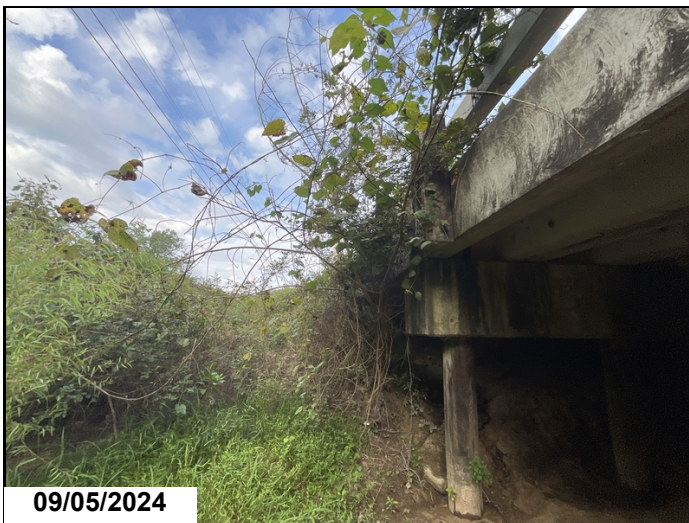
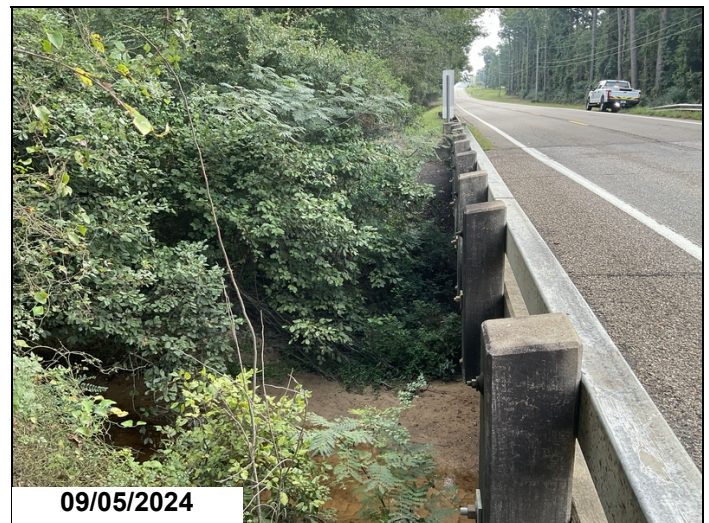
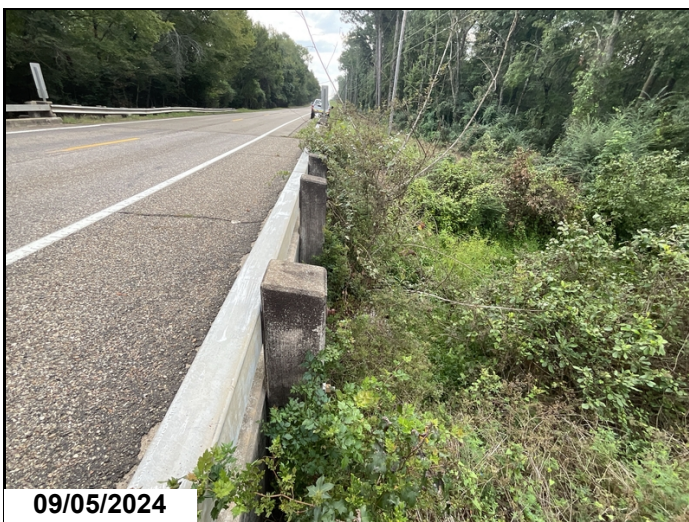
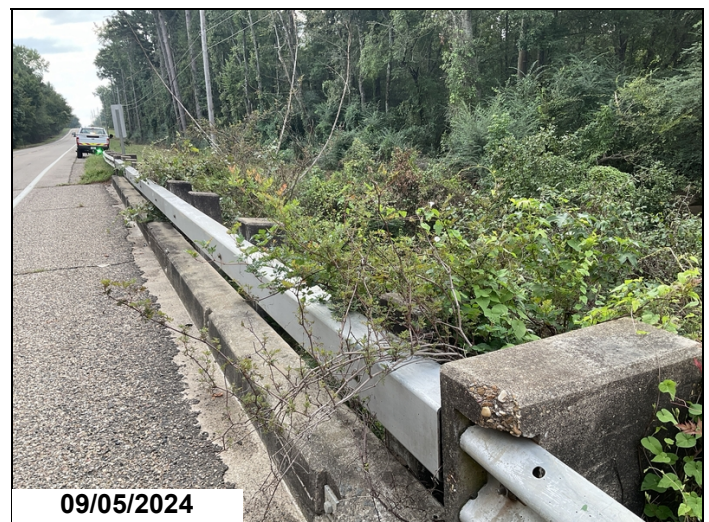
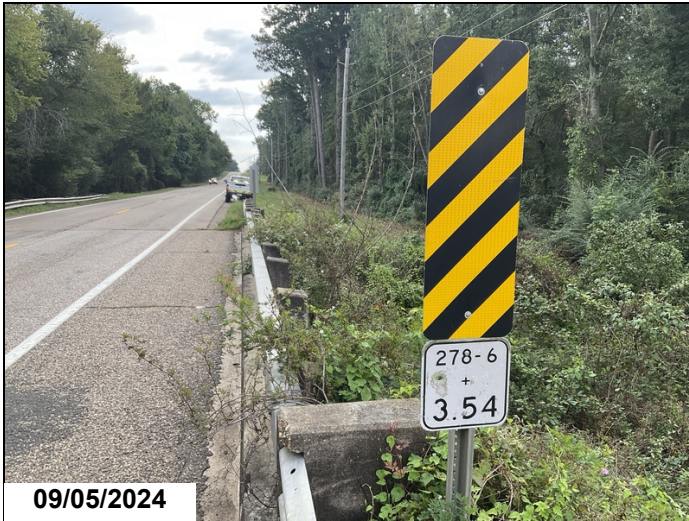
Vegetation and brush growing along both sides of bridge

9/5/2024 - Re opened maintenance need due to worsening condition.

9/5/2024 - Updated photo of vegetation

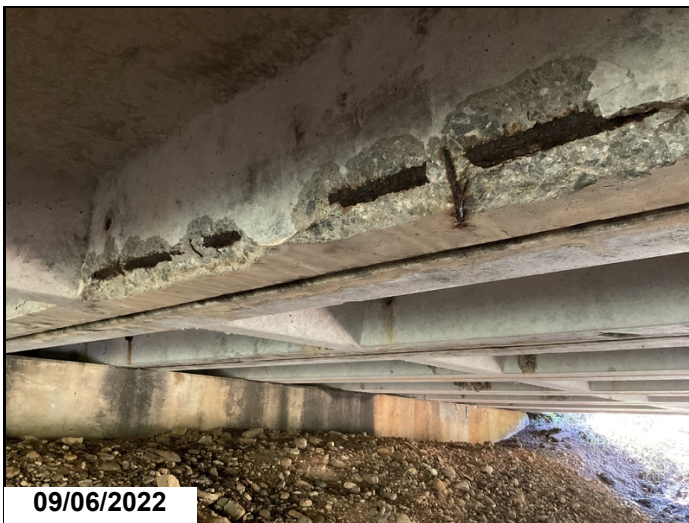
Span 3 precast channel beams has exposed rebar in multiple units but largest section is unit 5 RT stem.

Span 1 unit 5 LT stem has large section of exposed rebar with section loss. Span 2 unit 5 RT stem has large section of exposed rebar with section loss. Span 3 unit 5 RT stem has large section of exposed rebar with section loss.

Span 3 unit 5 RT stem

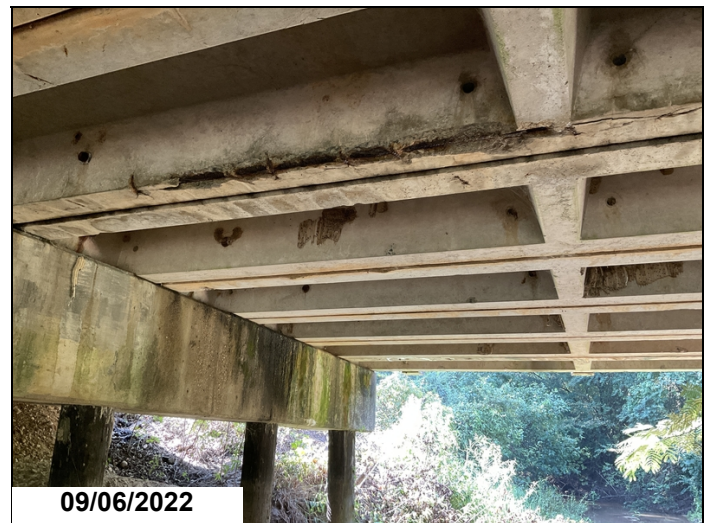
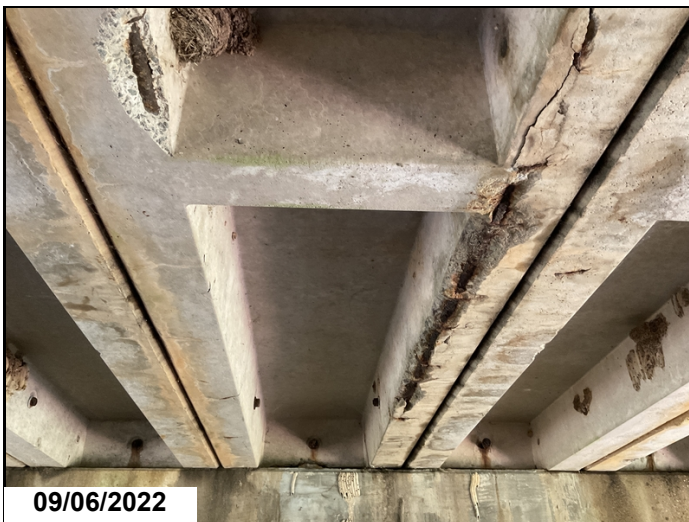
Span 2 unit 5 RT stem

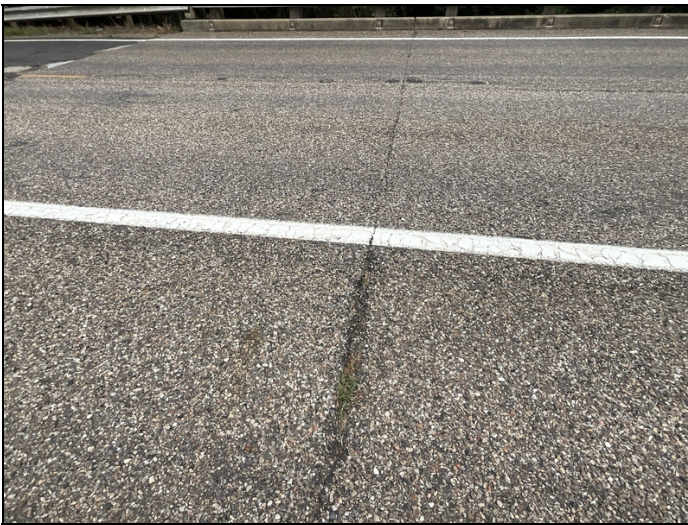
All joint lines are impacted by asphalt overlay that inhibits joint movement.

Joint filled by asphalt overlay impacting joint movement

A-59 - Joint Repair Needed (Yes)
