Bridge M0491 Inspection Report

Asset #M0491(Routine)

US 371 - 05 -27.68 over CREEK

Team Lead: Jared Kegley Inspection Date: 02/12/2024

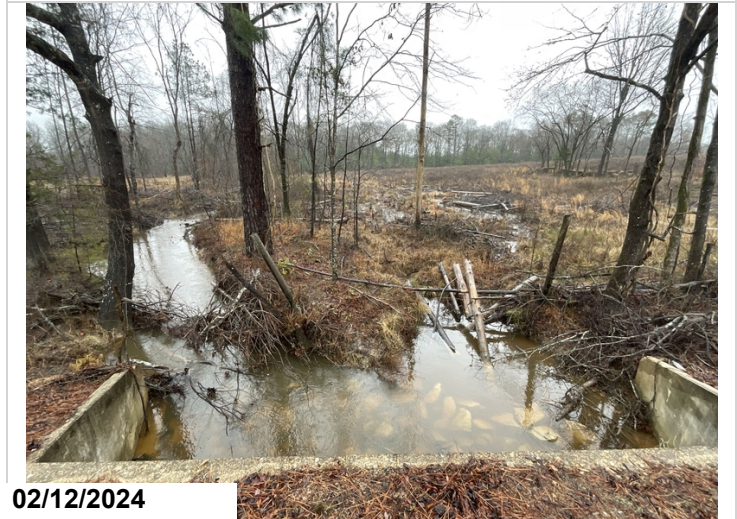
61 - Channel/Channel Protection (6 - Bank is beginning to slump. River control devices and embankment protection have widespread minor damage. There is minor stream bed movement evident. Debris is restricting the channel slightly.) Channel rating is a 6 this inspection due to minor streambank damage located in various locations both upstream and downstream of the box culvert. Debris is slightly restricting channel upstream of the box culvert. Channel is slightly misaligned on upstream side of channel.

Upstream channel

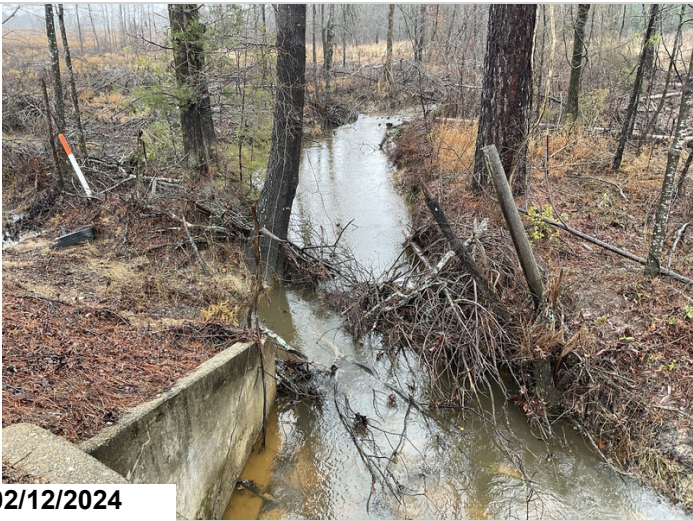
Upstream channel

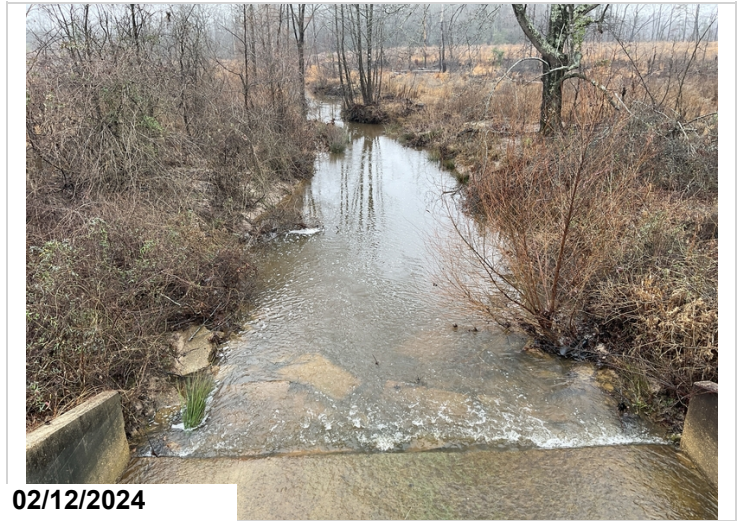
Downstream channel

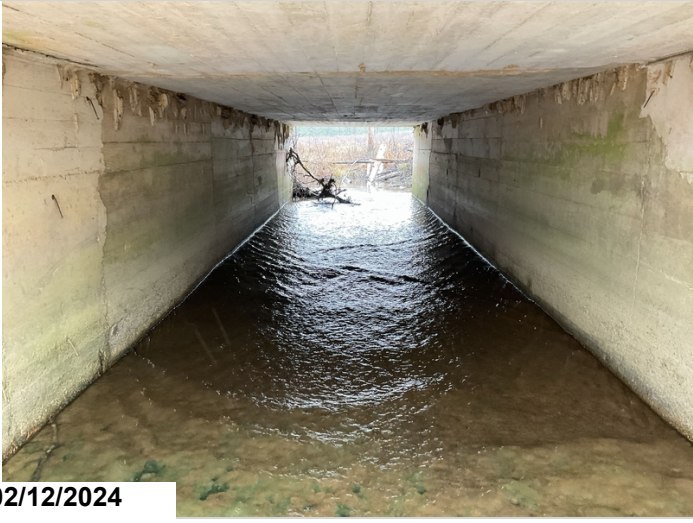
Typical through shot of box culvert

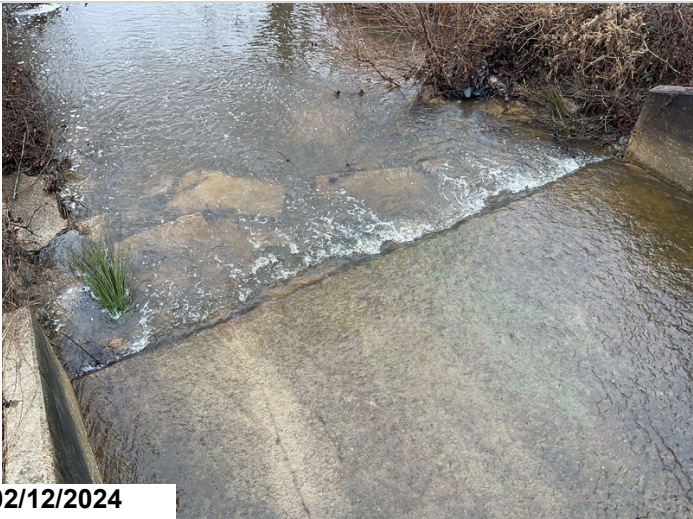
Scour rating is a 7 this inspection due to minor scour. Both the inlet and outlet ends of the box culvert have repairs that have been made prior to this inspection.

Outlet repairs for previous scour

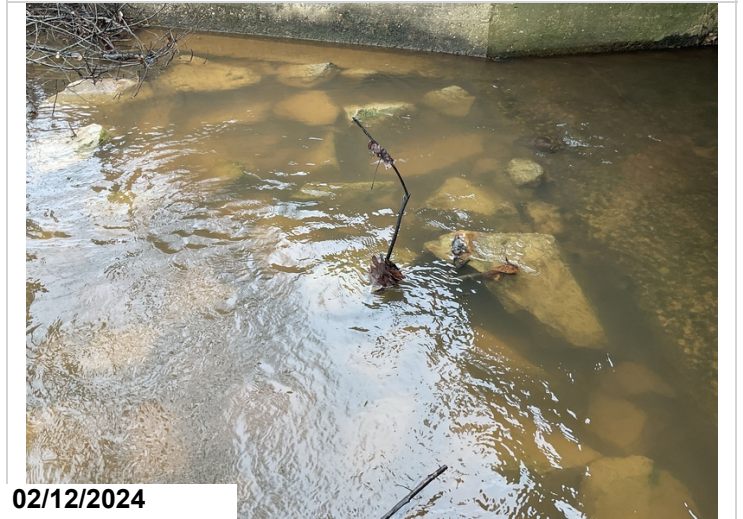
Rip rap used for scour protection at inlet ends

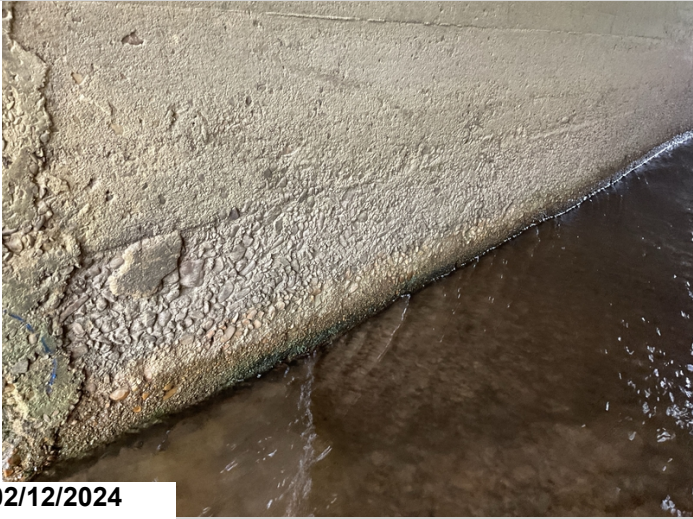
Barrel 2 abrasion. CS2

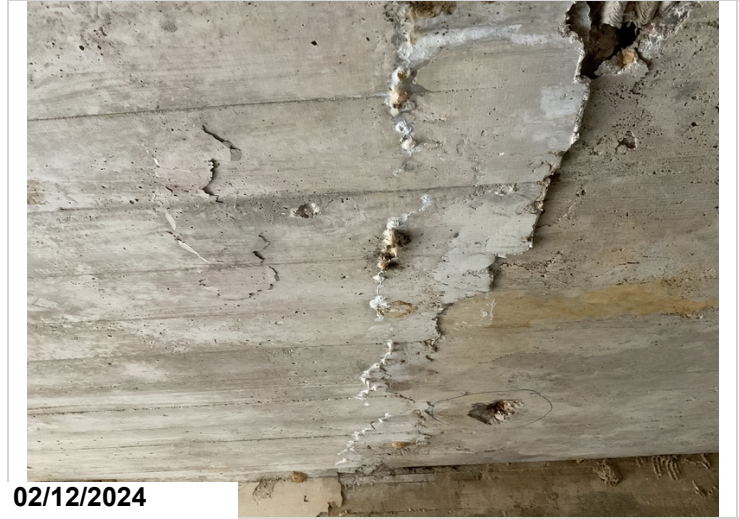
Barrel 2 efflorescence. CS2

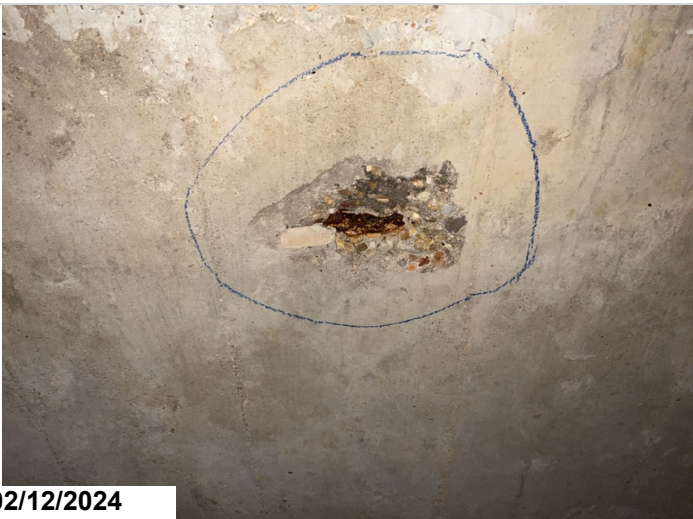
Barrel 2 exposed rebar. CS3

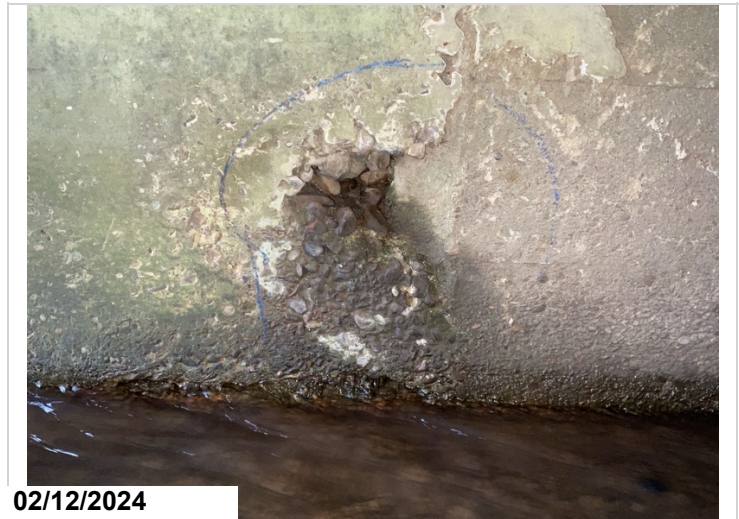
Barrel 2 spall. CS3

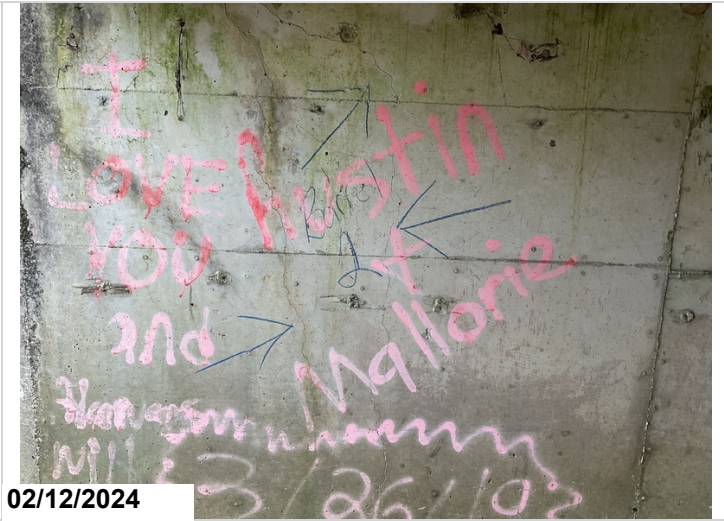
Barrel 2 cracking. CS2

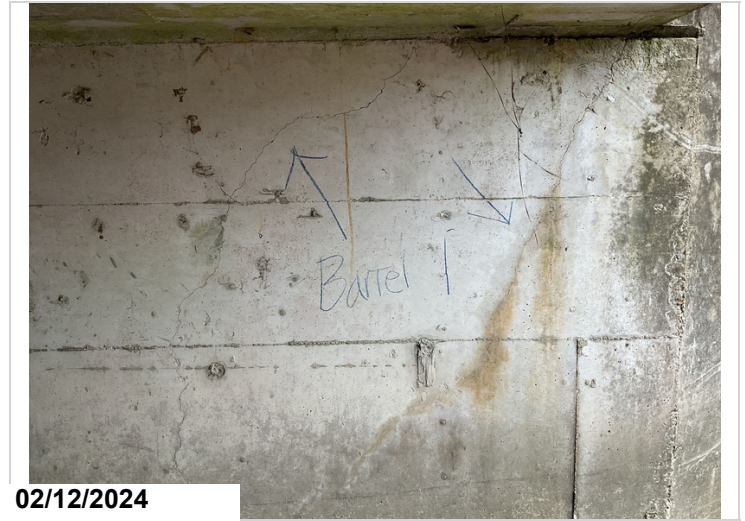
Barrel 1 cracking. CS2

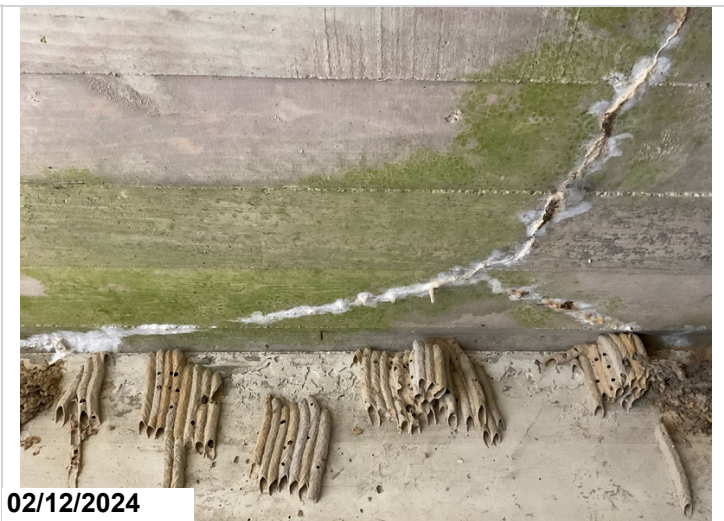
Barrel 1 efflorescence. CS2

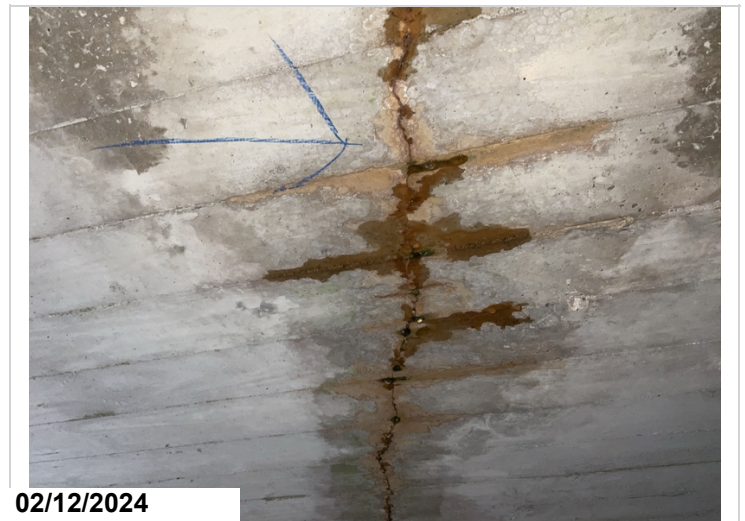
Barrel 1 efflorescence with rust staining. CS3

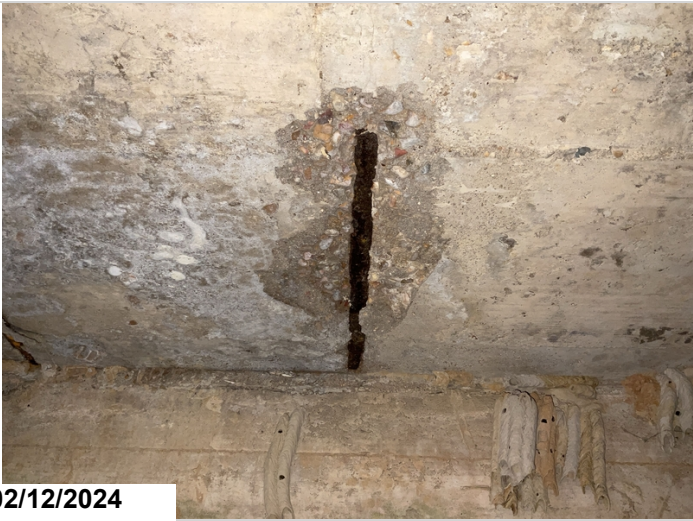
Barrel 1 exposed rebar. CS3

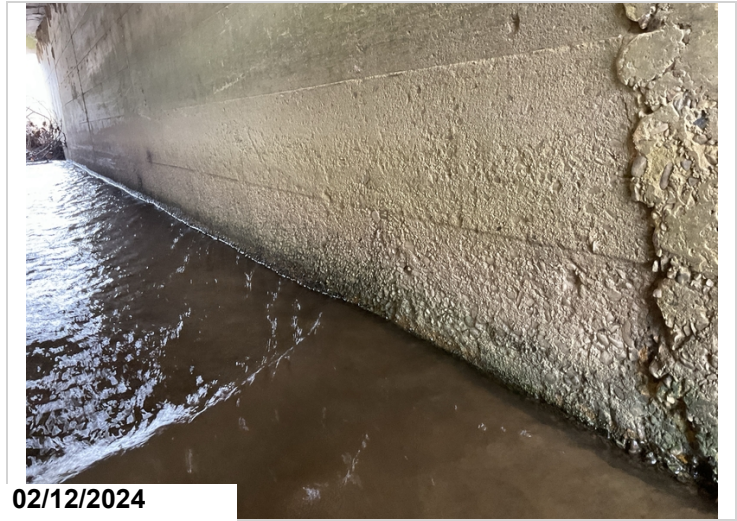
Barrel 1 abrasion. CS2

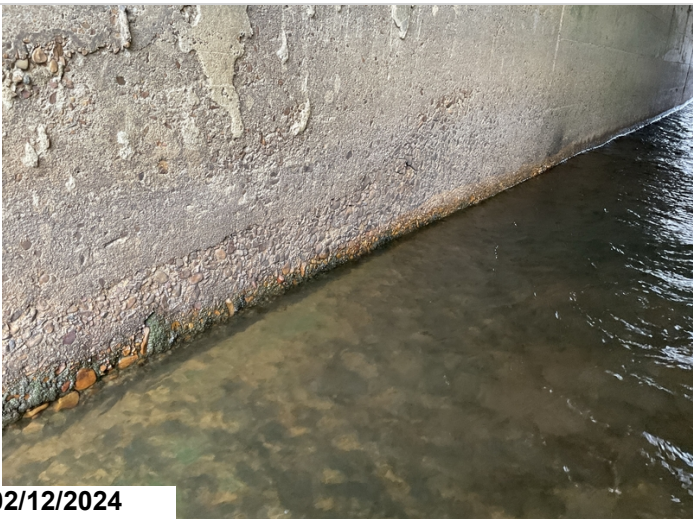
Barrel 1 abrasion. CS2

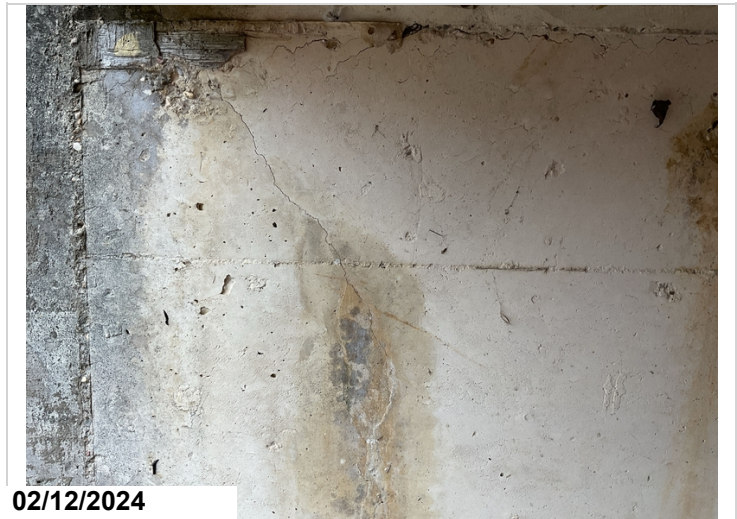
ELEMENTS	DESCRIPTION	UNITS	TOTAL	CS1	CS2	CS3	CS4
241	Reinforced Concrete Culvert	LF	96	31	56	9	0
1080	Delamination/Spall/Patched Area	LF	4	0	2	2	0
1090	Exposed Rebar	LF	6	0	0	6	0
1120	Efflorescence/Rust Staining	LF	3	0	2	1	0
1130	Cracking (RC and Other)	LF	12	0	12	0	0
1190	Abrasion/Wear (PSC/RC)	LF	40	0	40	0	0
(241) Spalling is located in various locations of both barrels 1 & 2. Exposed rebar is located in both barrels 1 & 2 throughout the ceiling of the box culvert. Efflorescence is located in various locations throughout the ceiling of both barrels 1 & 2. Minor cracking is located throughout both barrels 1 & 2. Minor abrasion is found near the bottom of box culvert in both barrels 1 & 2.

Typical cracking throughout both barrels 1 & 2. CS2
