Bridge M0492 Inspection Report

US 371 - 05 -26.67 over CREEK

Location: 1.69 MI NO OF COLUMBIA CO

Team Lead: Jared Kegley Inspection Date: 02/12/2024

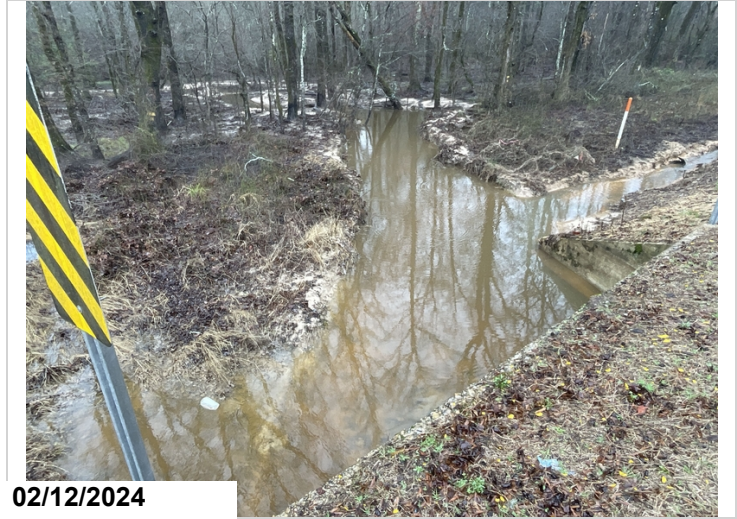
61 - Channel/Channel Protection (6 - Bank is beginning to slump. River control devices and embankment protection have widespread minor damage. There is minor stream bed movement evident. Debris is restricting the channel slightly.) Channel rating is a 6 this inspection due to some streambank damage in various locations of upstream and downstream sides of channel.

Upstream channel

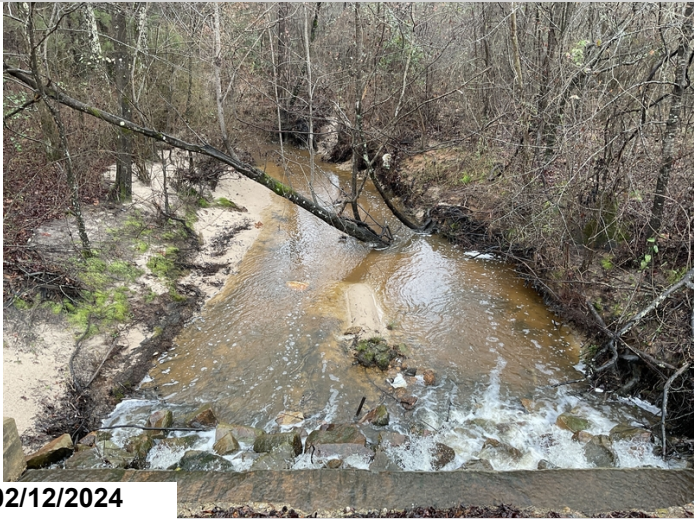
Downstream channel

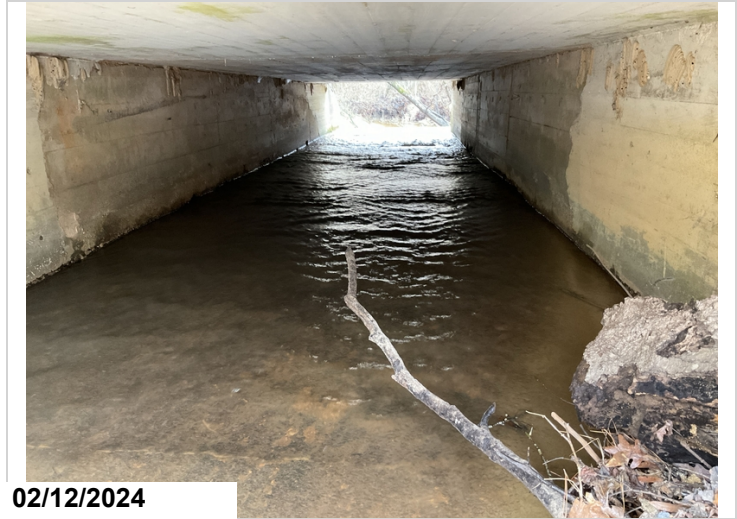
Typical through shot of culvert

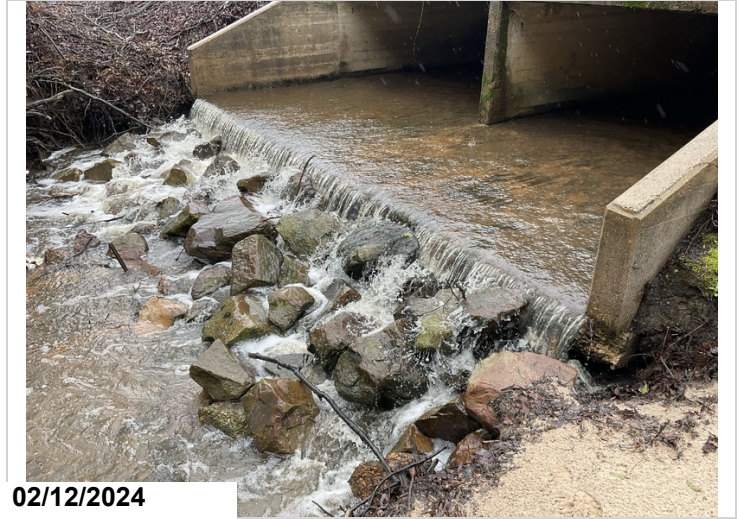
Scour rating is a 6 this inspection due to isolated scour around the footing at the inlet end of the box culvert. The outlet end has had repairs done to fix scour prior to this inspection.

Repairs from past scour

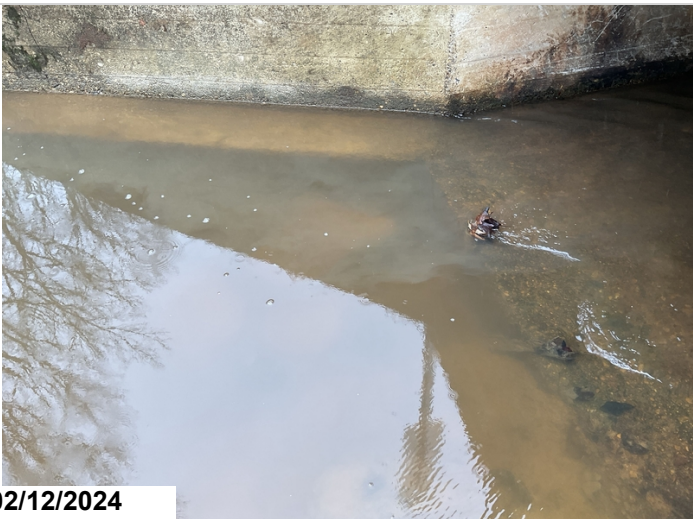
Scour to footing at inlet end.

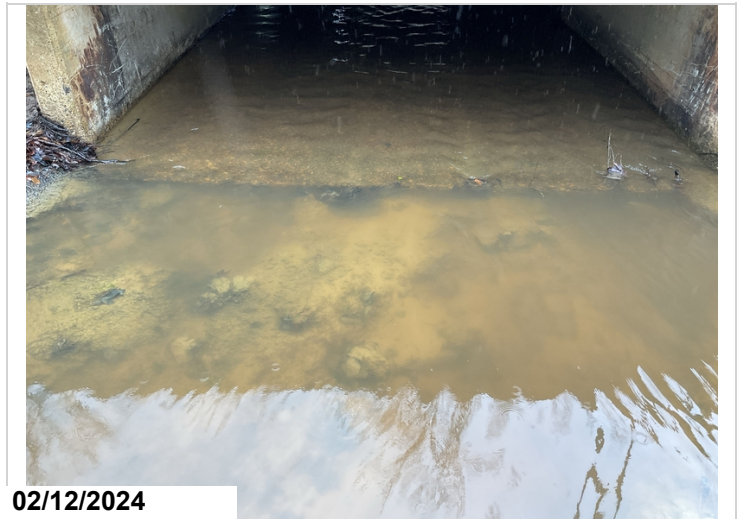
Scour to footing at inlet end.

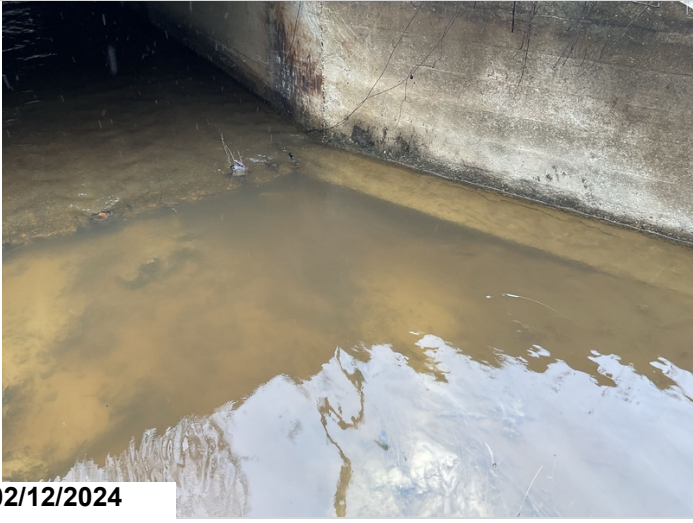
Scour to footing at inlet end.

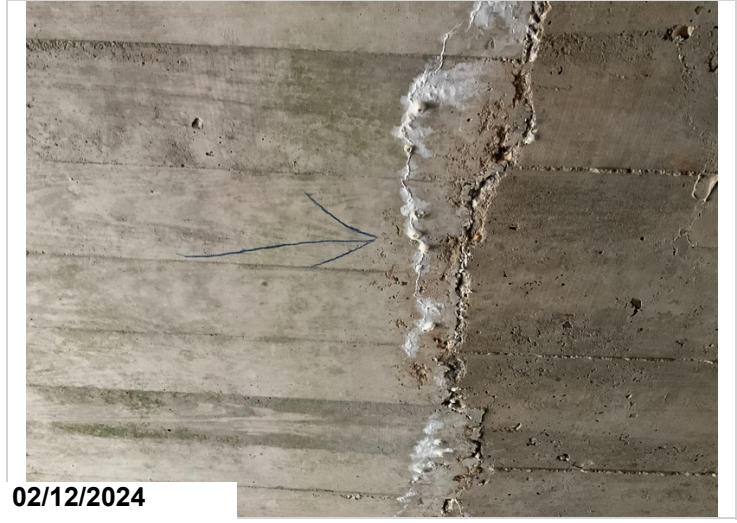
Barrel 2 cracking with efflorescence. CS2

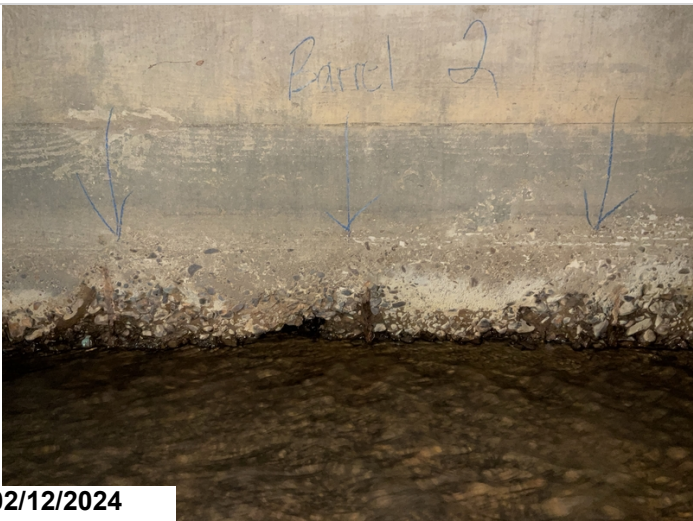
62 - Culverts (6 - Deterioration or initial disintegration, minor chloride contamination, cracking with some leaching, or spalls on concrete or masonry walls and slabs. Local minor scouring at curtain walls, wingwalls or pipes. Metal culverts have a smooth curvature, non-symmetrical shape, significant corrosion or moderate pitting.) The culvert rating is a 6 this inspection due to both barrels 1 and 2 having heavy abrasion at bottom of barrel walls near floor, exposed rebar in various locations of barrels.

Barrel 2 abrasion with rebar exposed. CS3

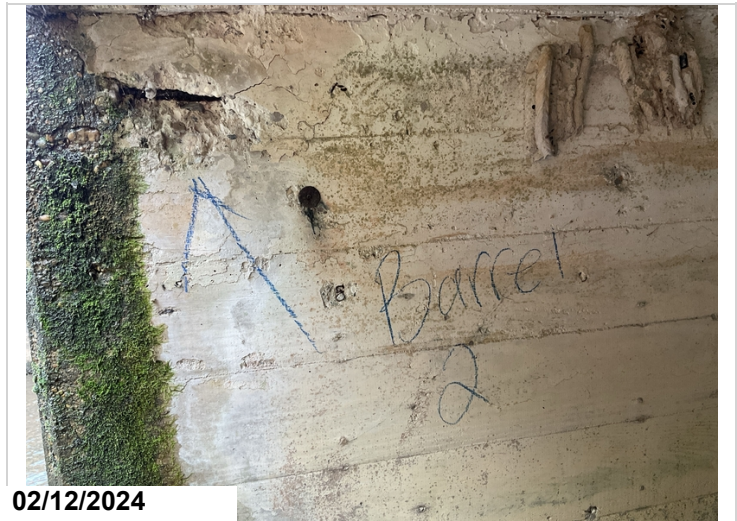
Barrel 2 rebar exposed at outlet end near divider wall. CS3

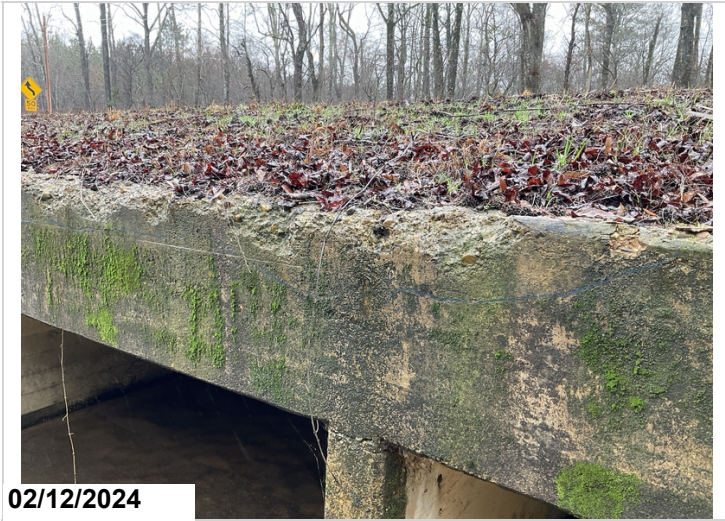
Spalling on outlet end headwall. CS2

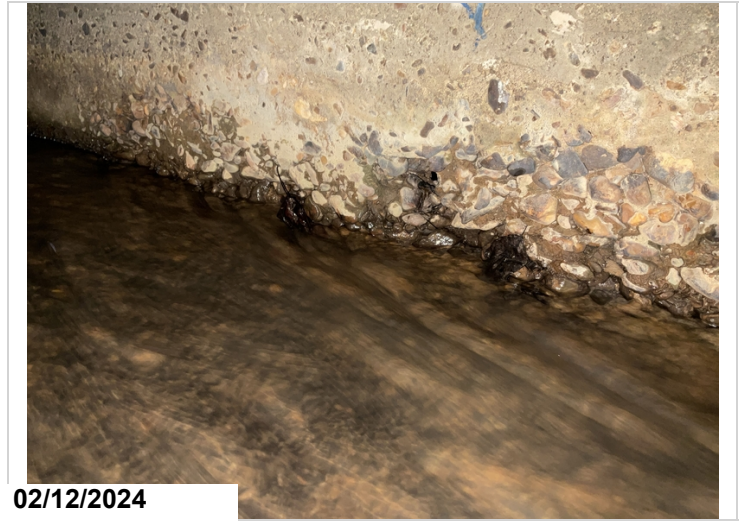
Barrel 1 abrasion. CS3

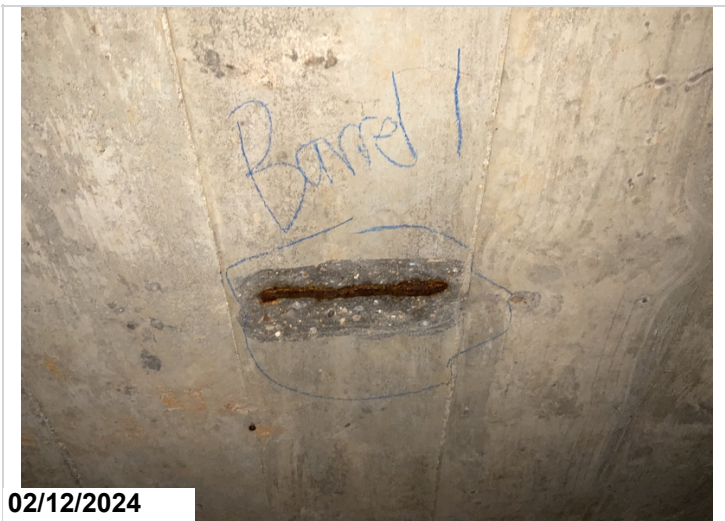
Exposed rebar in barrel 1. CS3

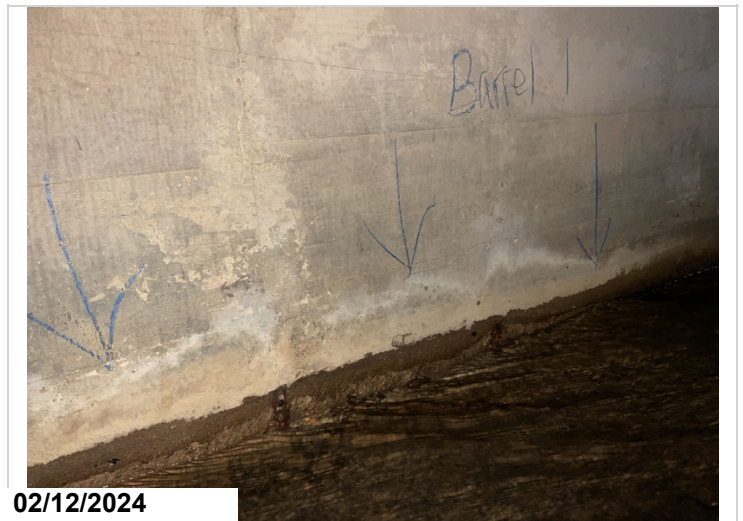
Barrel 1 abrasion. CS3

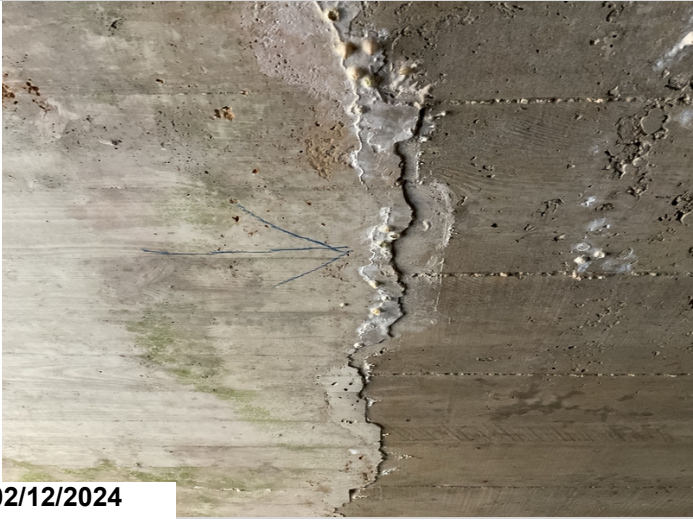
Barrel 1 cracking with efflorescence. CS2

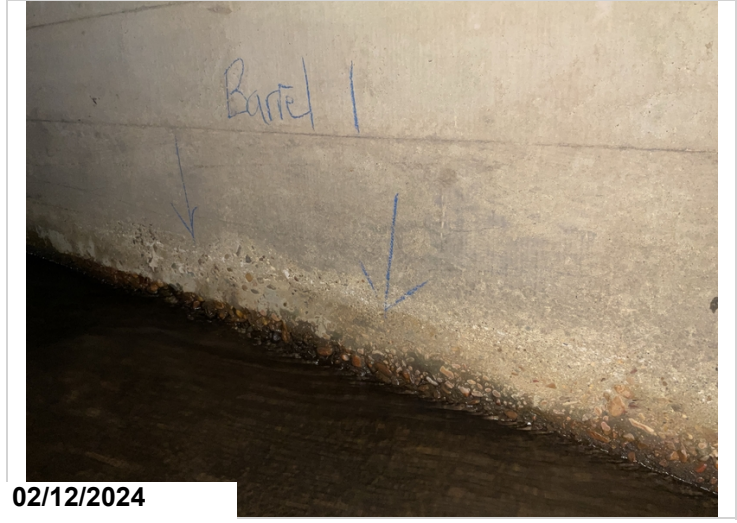
Barrel 1 abrasion. CS3

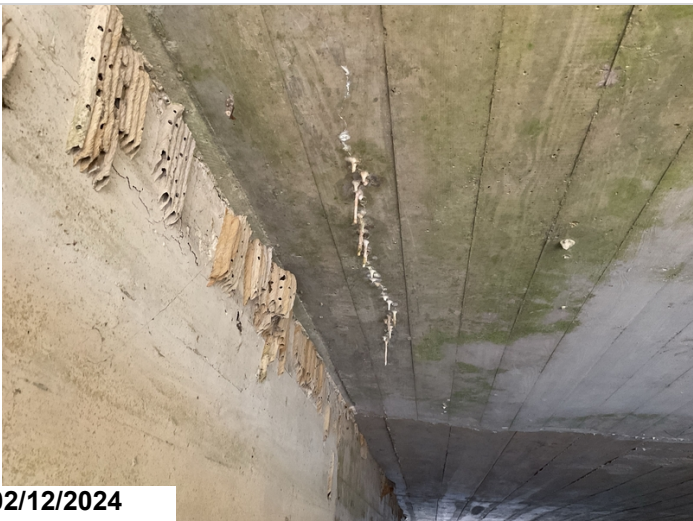
Barrel 1 cracking with efflorescence. CS2

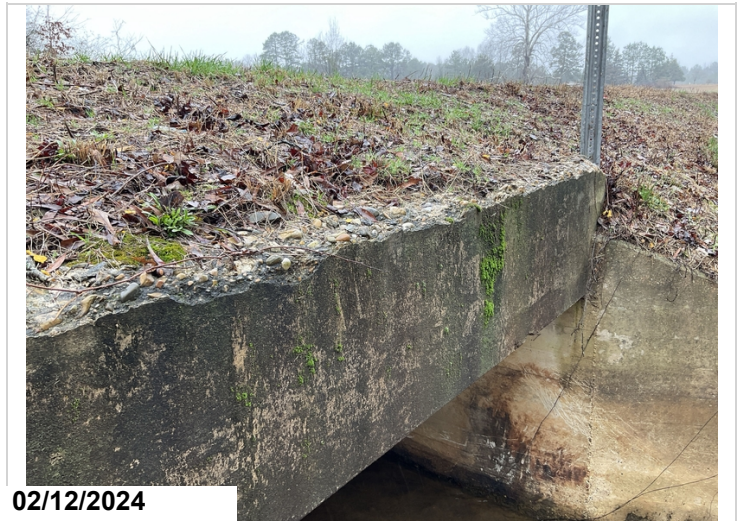
Spalling to inlet end headwall above barrel 1. CS2

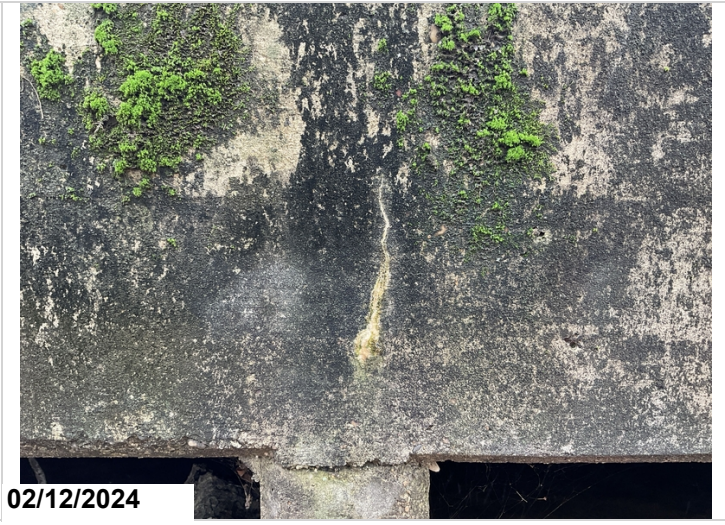
Efflorescence to inlet end headwall. CS2
